Cold Spring Creek 2020 Annual Dike Inspection Report

Cold Spring Creek Dike Inspections

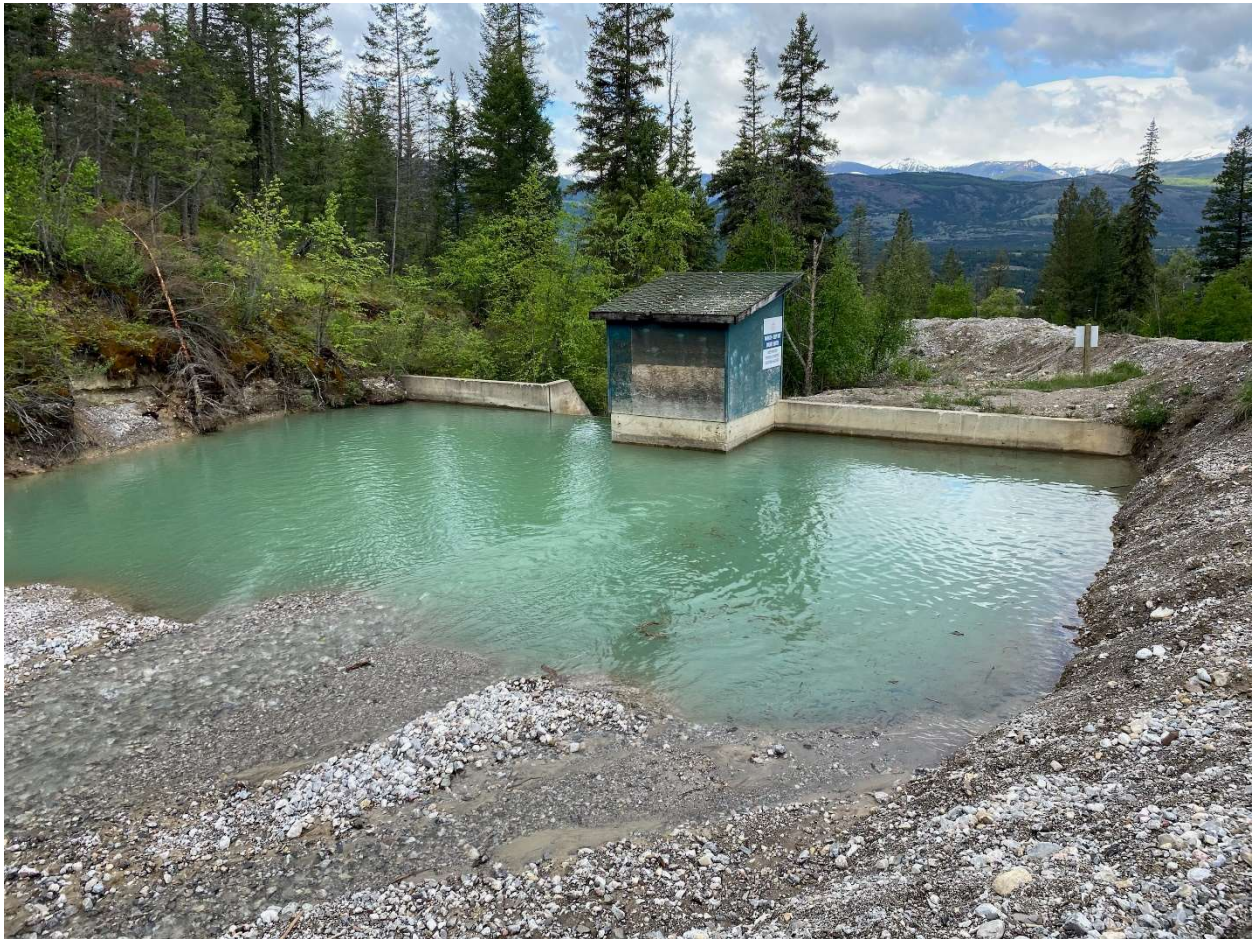
The dam and reservoir were in good condition during the May 5, 2021 inspection. During the May 24, 2021 event it was approximately 75% filled with debris. The debris was removed from the reservoir immediately after the May 24 event.

Photo 1: Cold Spring Creek Dam Reservoir approximately 75% filled with debris. May 28, 2021.

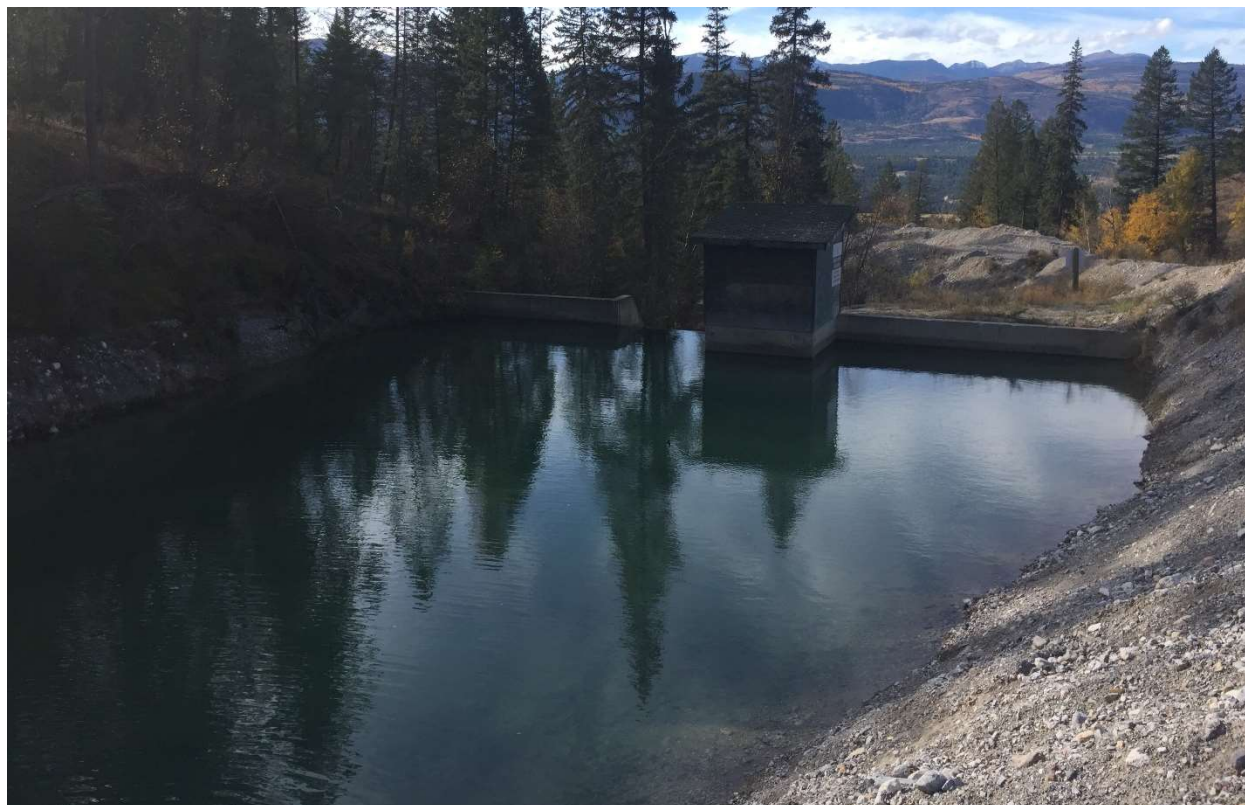
Photo 2: The reservoir with the debris removed. October 21, 2021.

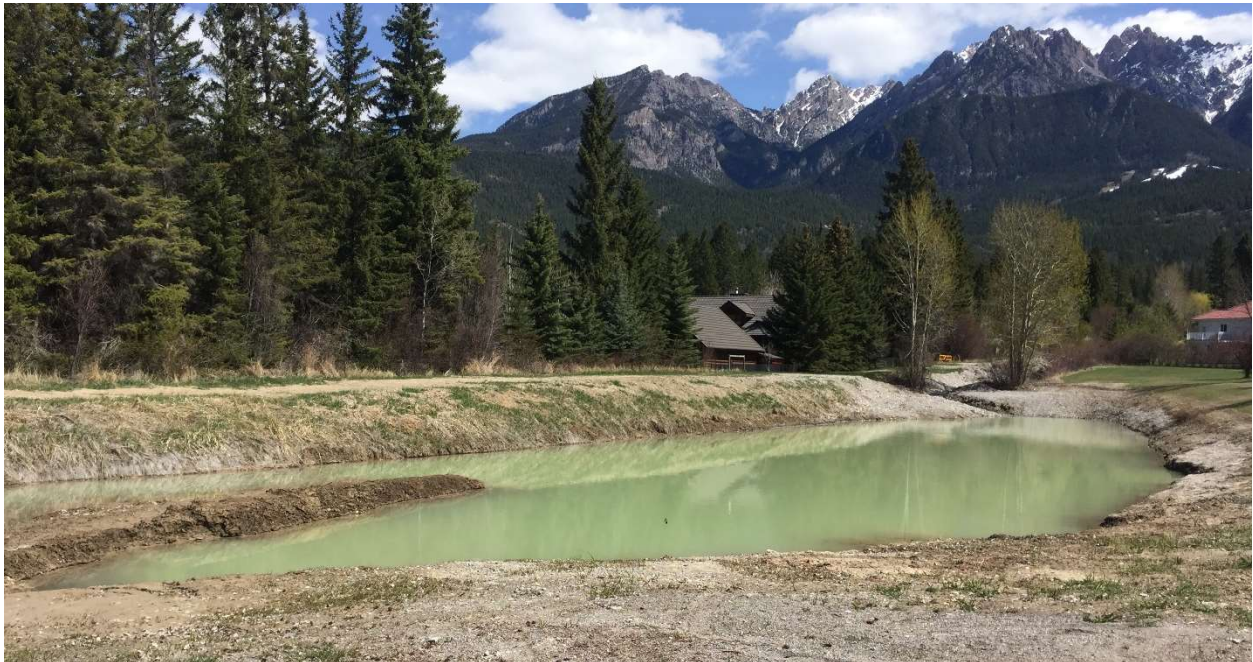
Photo 3: The lower debris trap, May 5, 2021.

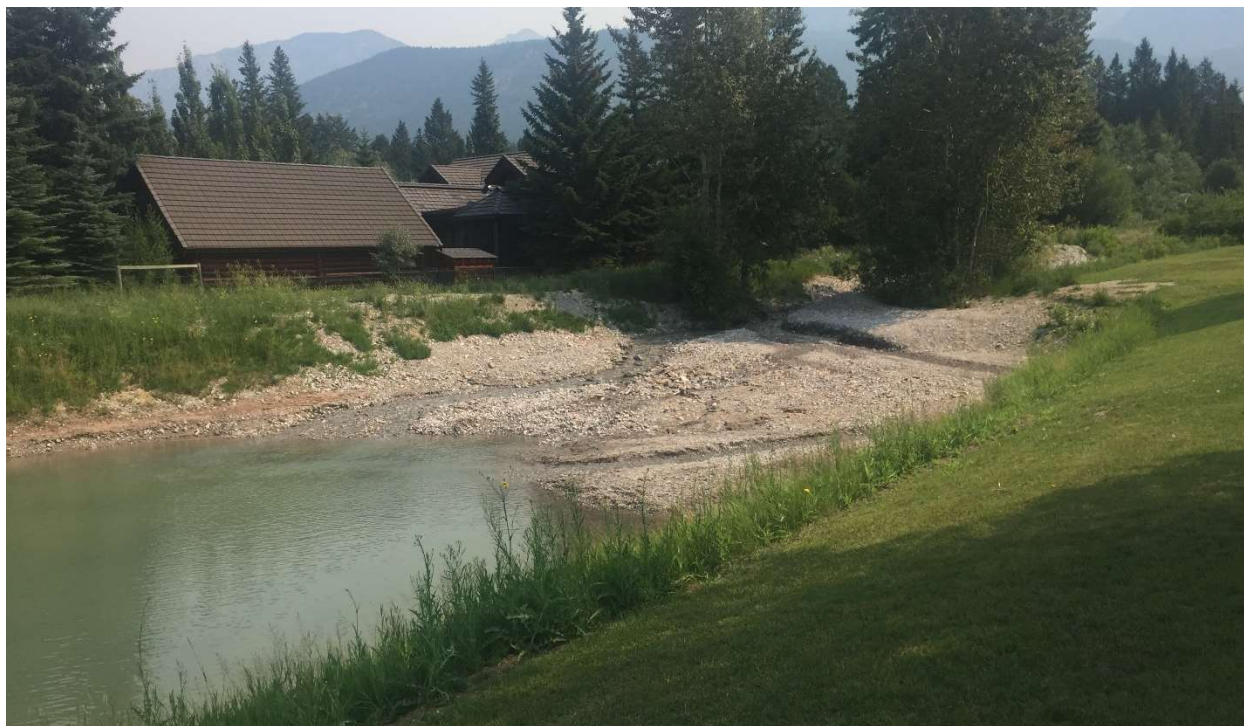
Photo 4: The lower debris trap after the May 24 event. July 15, 2021. The material deposition was minor and the material was not removed.

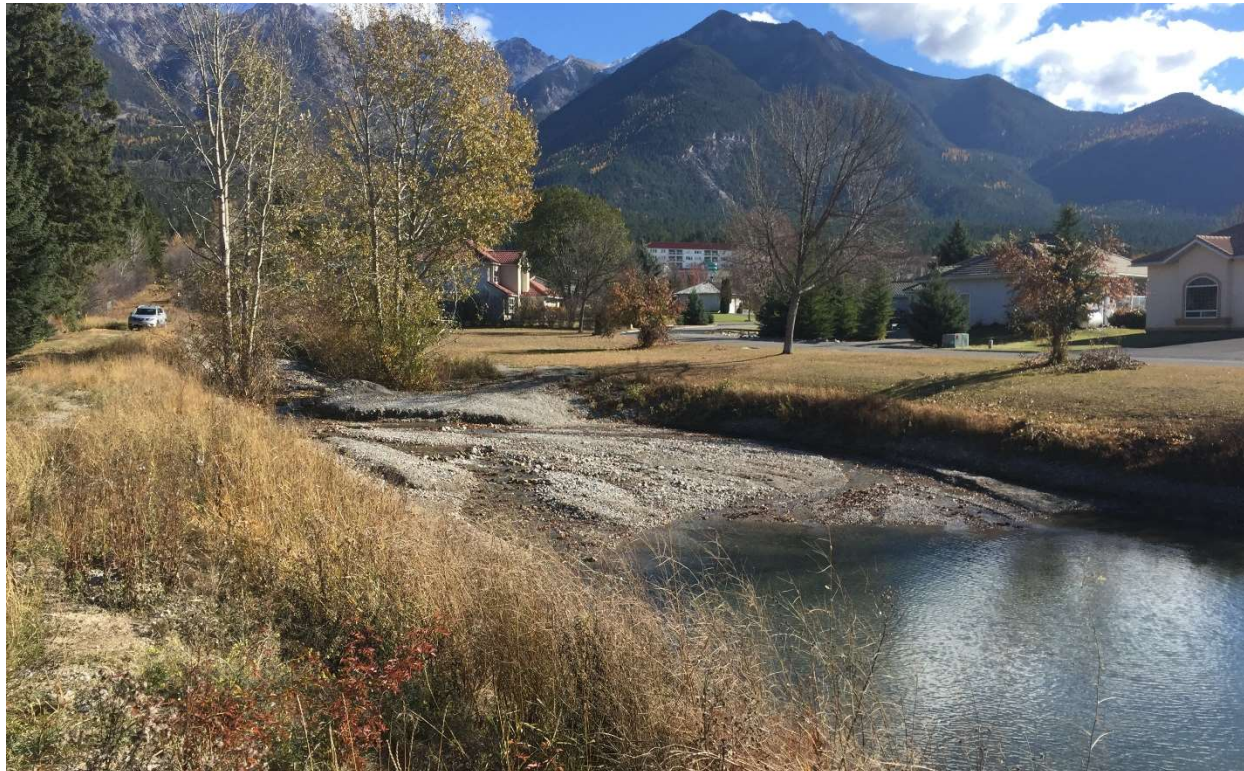
Photo 5: The lower debris trap near completion of debris removal. December 4, 2020.

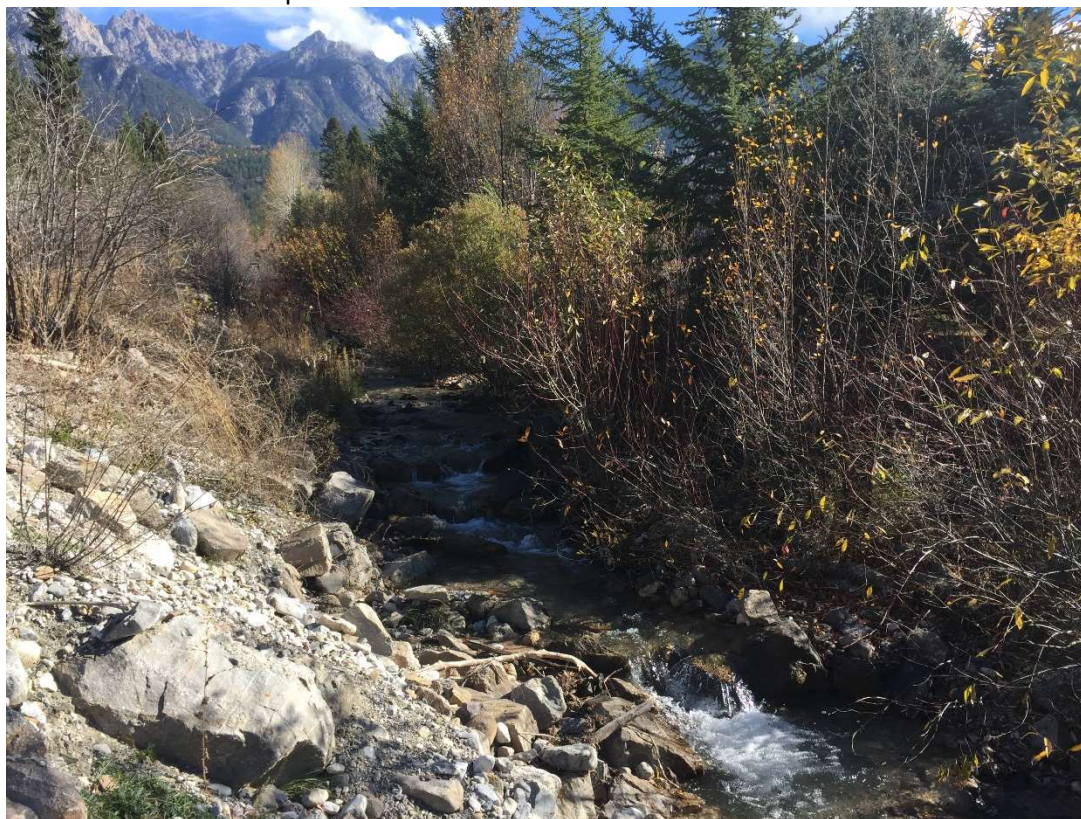
The lower channel was in good condition during the May 5 and October 21 inspection. Vegetation removal should be completed.

Photo 6: Channel immediately upstream of the lowest culvert. October 21, 2021.
