**Regional District of East Kootenay (RDEK)**

**Fairmont Creek Debris Flow Hazard  
and Risk Assessment**

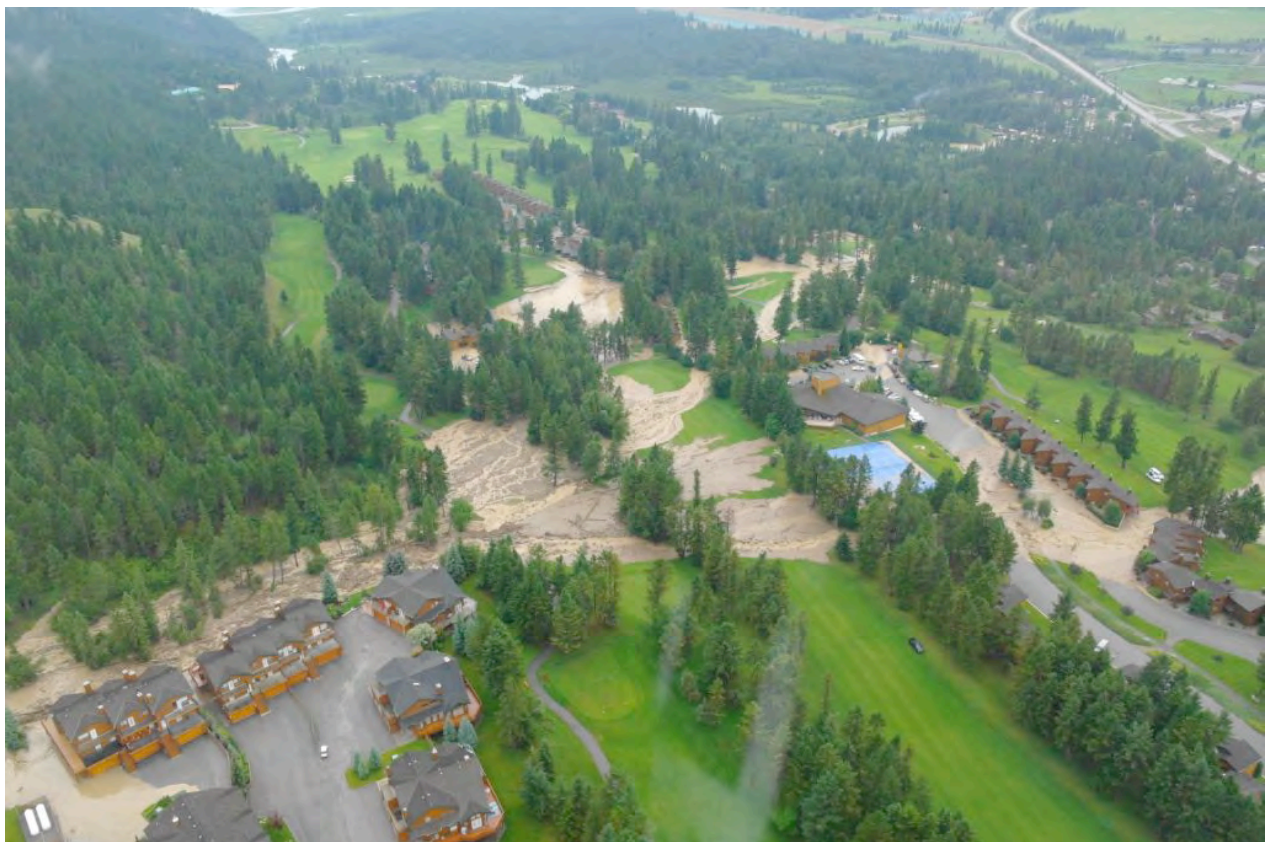
**Prepared for:  
Regional District of East Kootenay**

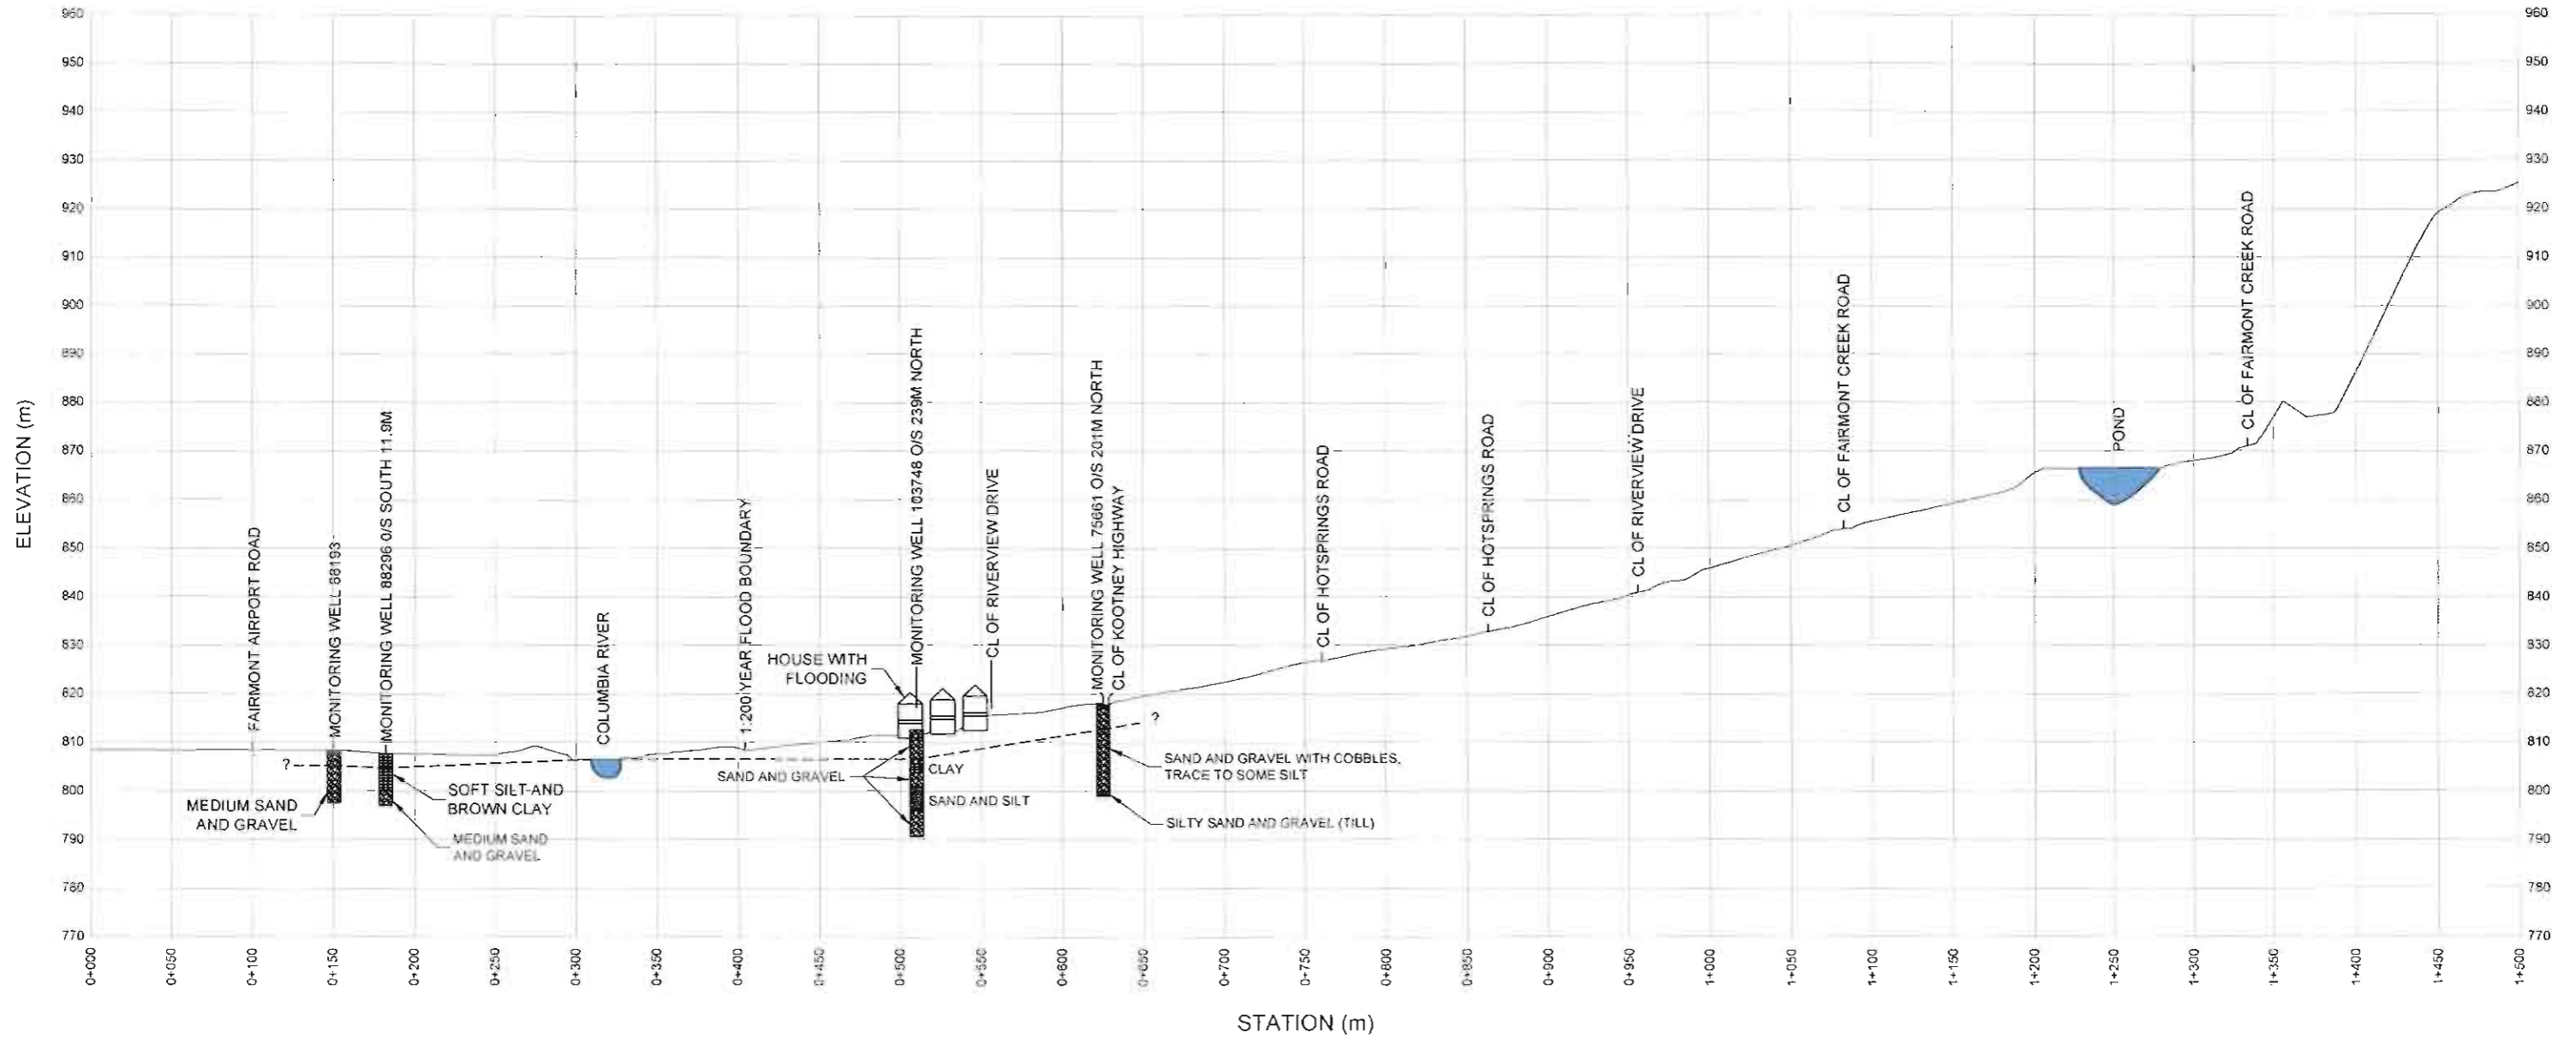
**FAIRMONT CREEK PROFILE**  
SCALE H 1:4000 V 1:1333

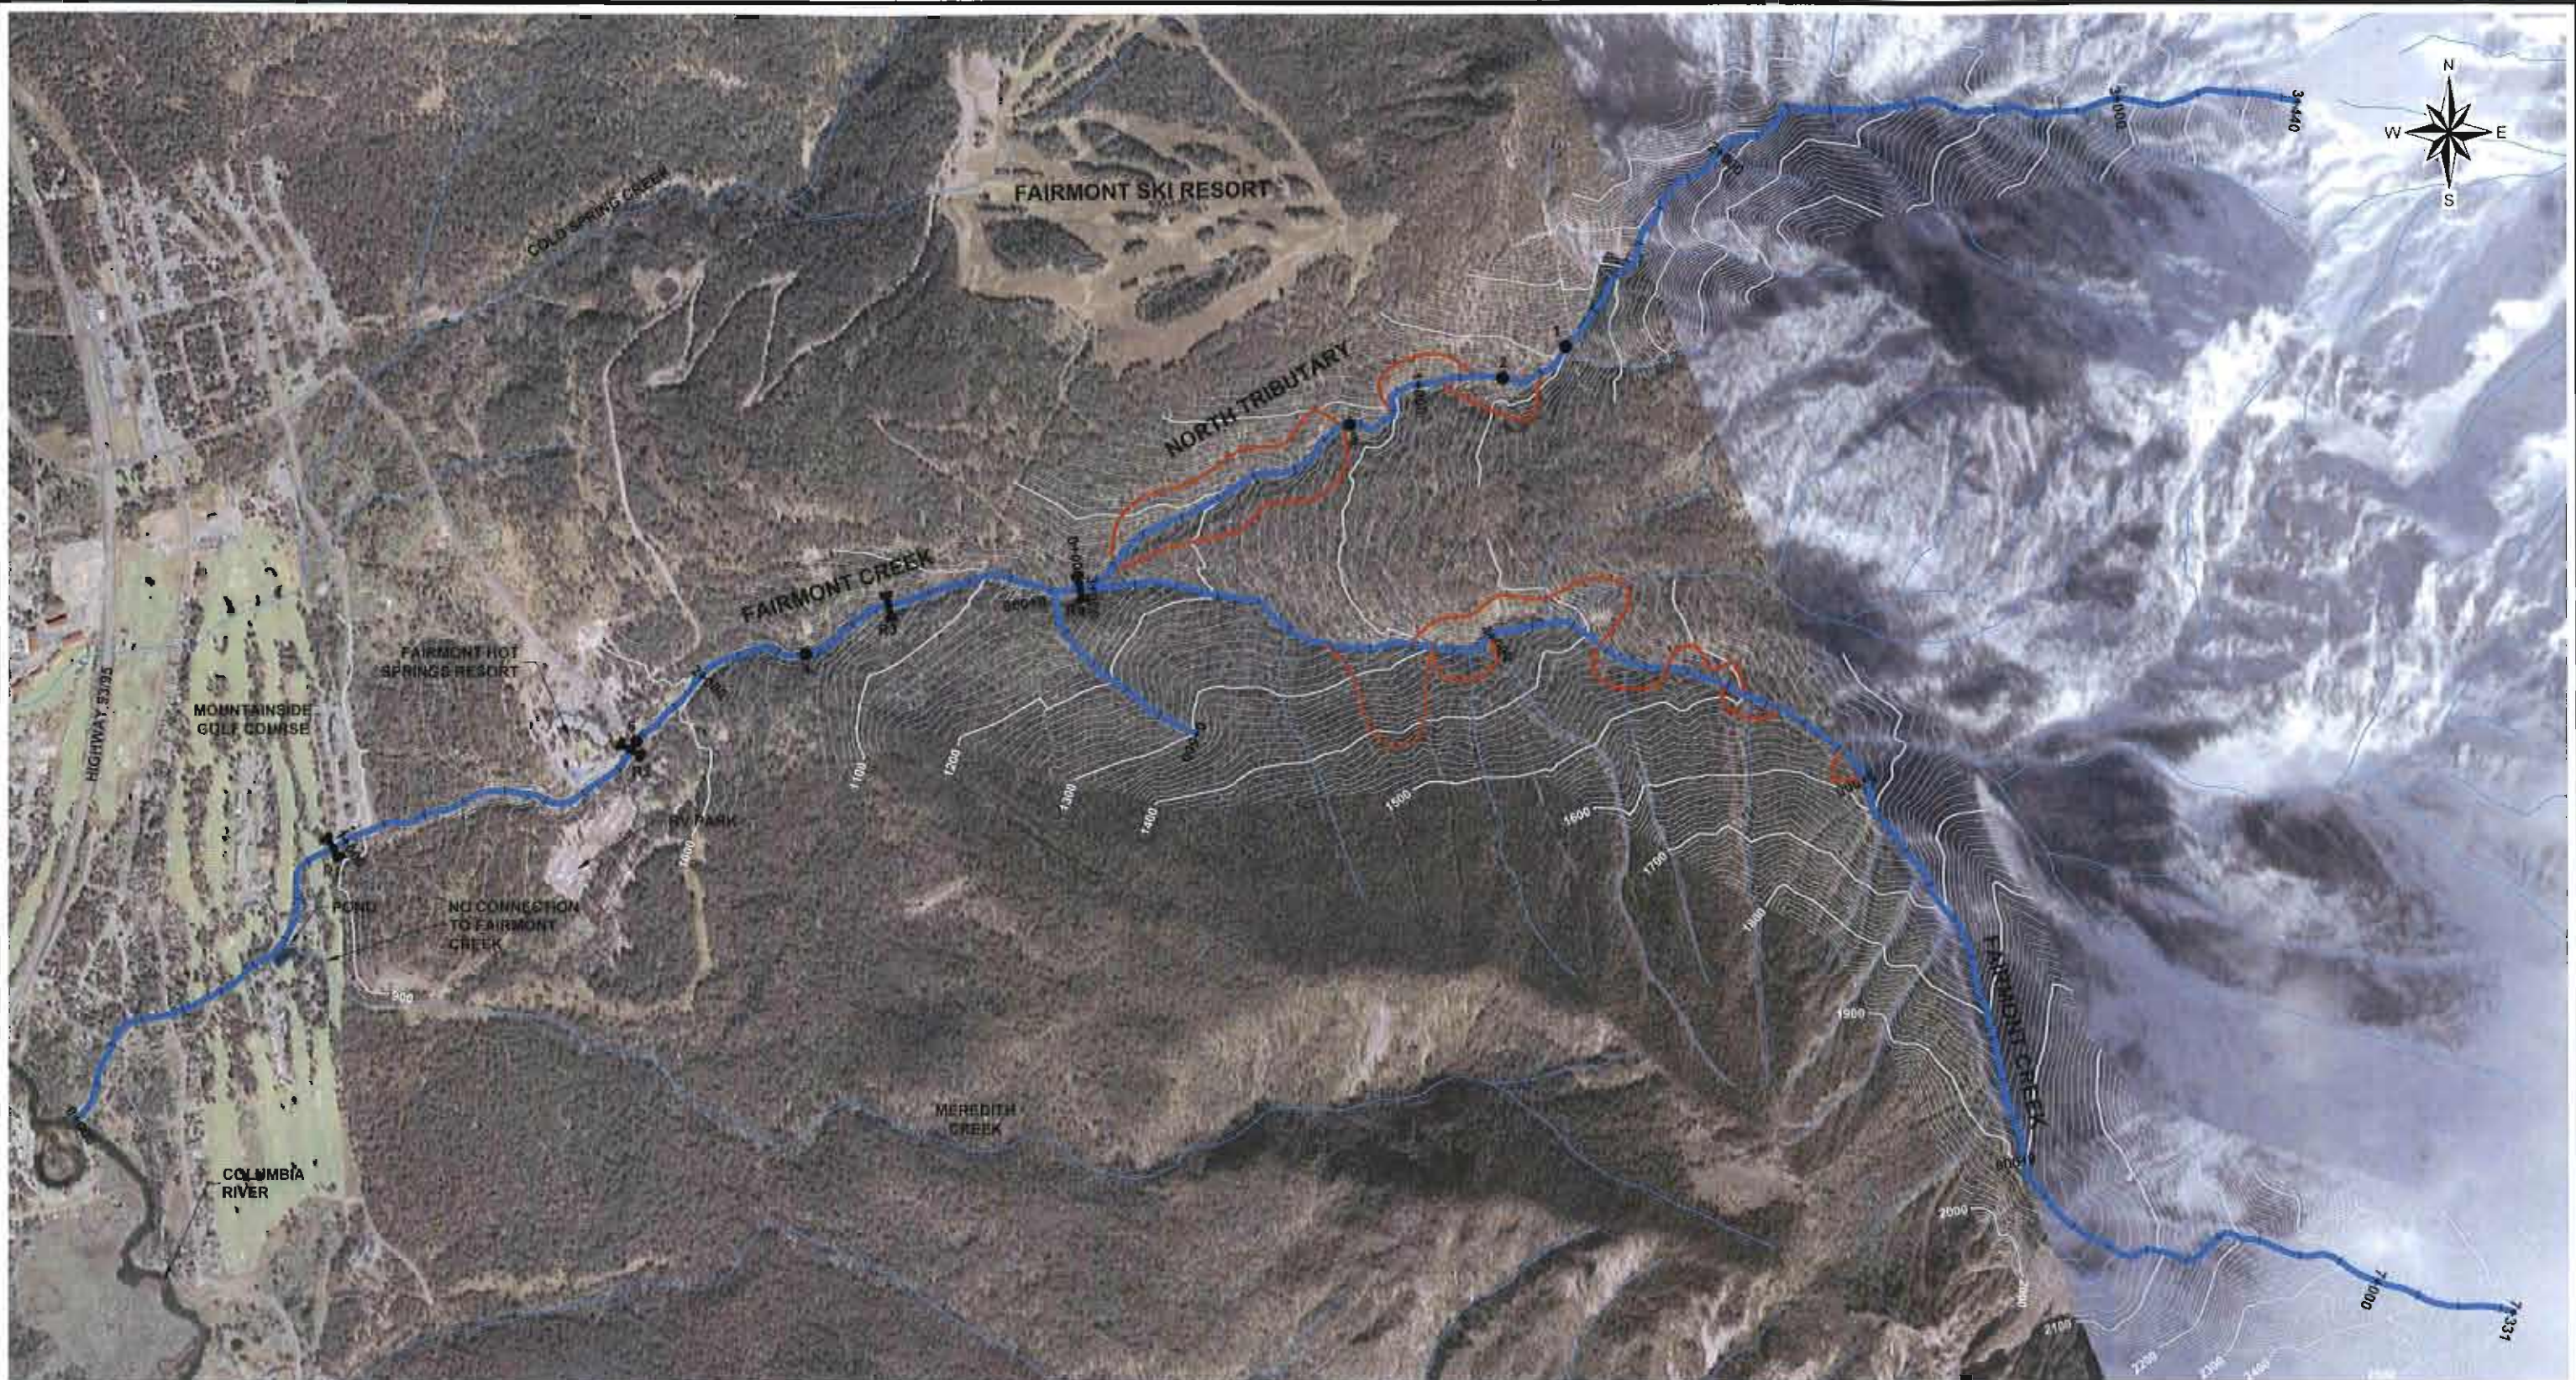
N:\Active\2012\1494\12-1494-0232 Clarke-Fairmont\_Ck\_Drafting\CAD\ Drawing file: 12-1494-0232 Bose.dwg Dec 19, 2012 - 2:32pm

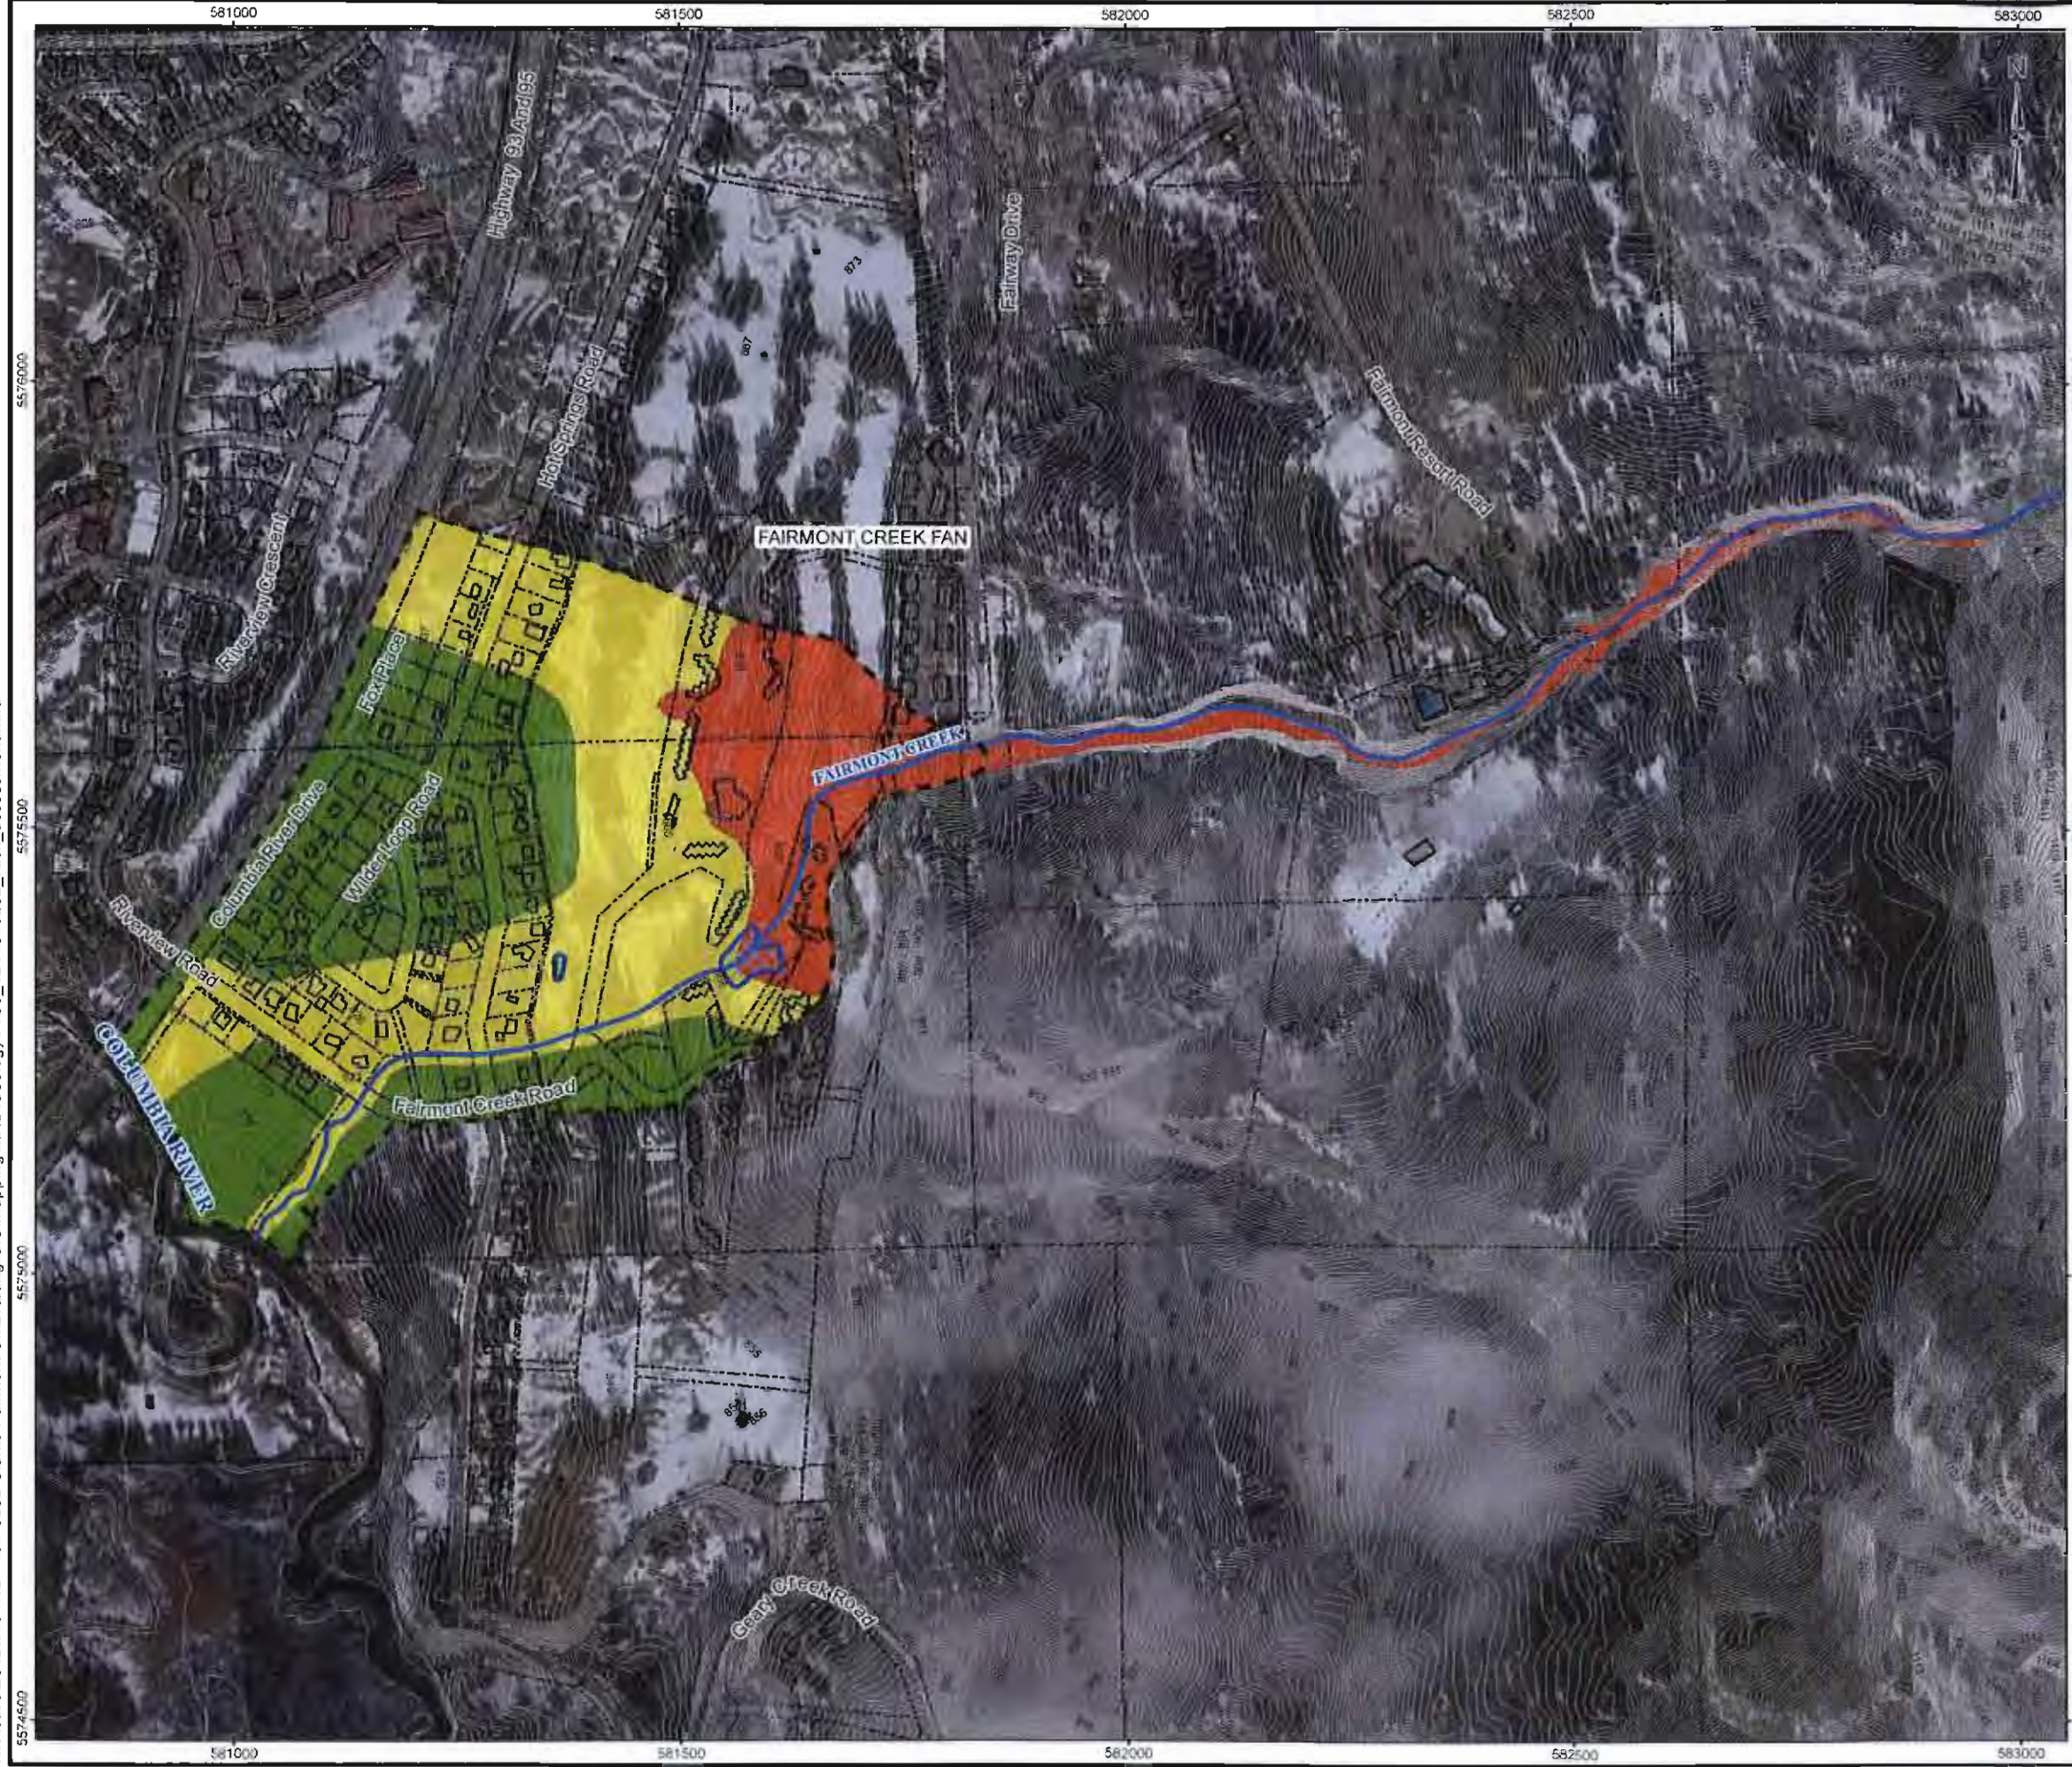
N:\Active\2012\11494\12-1494-0232 Clarke-Fairmont\_Ck\Drafting\GIS\Mapping\MXD\Geology\FIG5\_1214940232\_Risk\_assessment.mxd

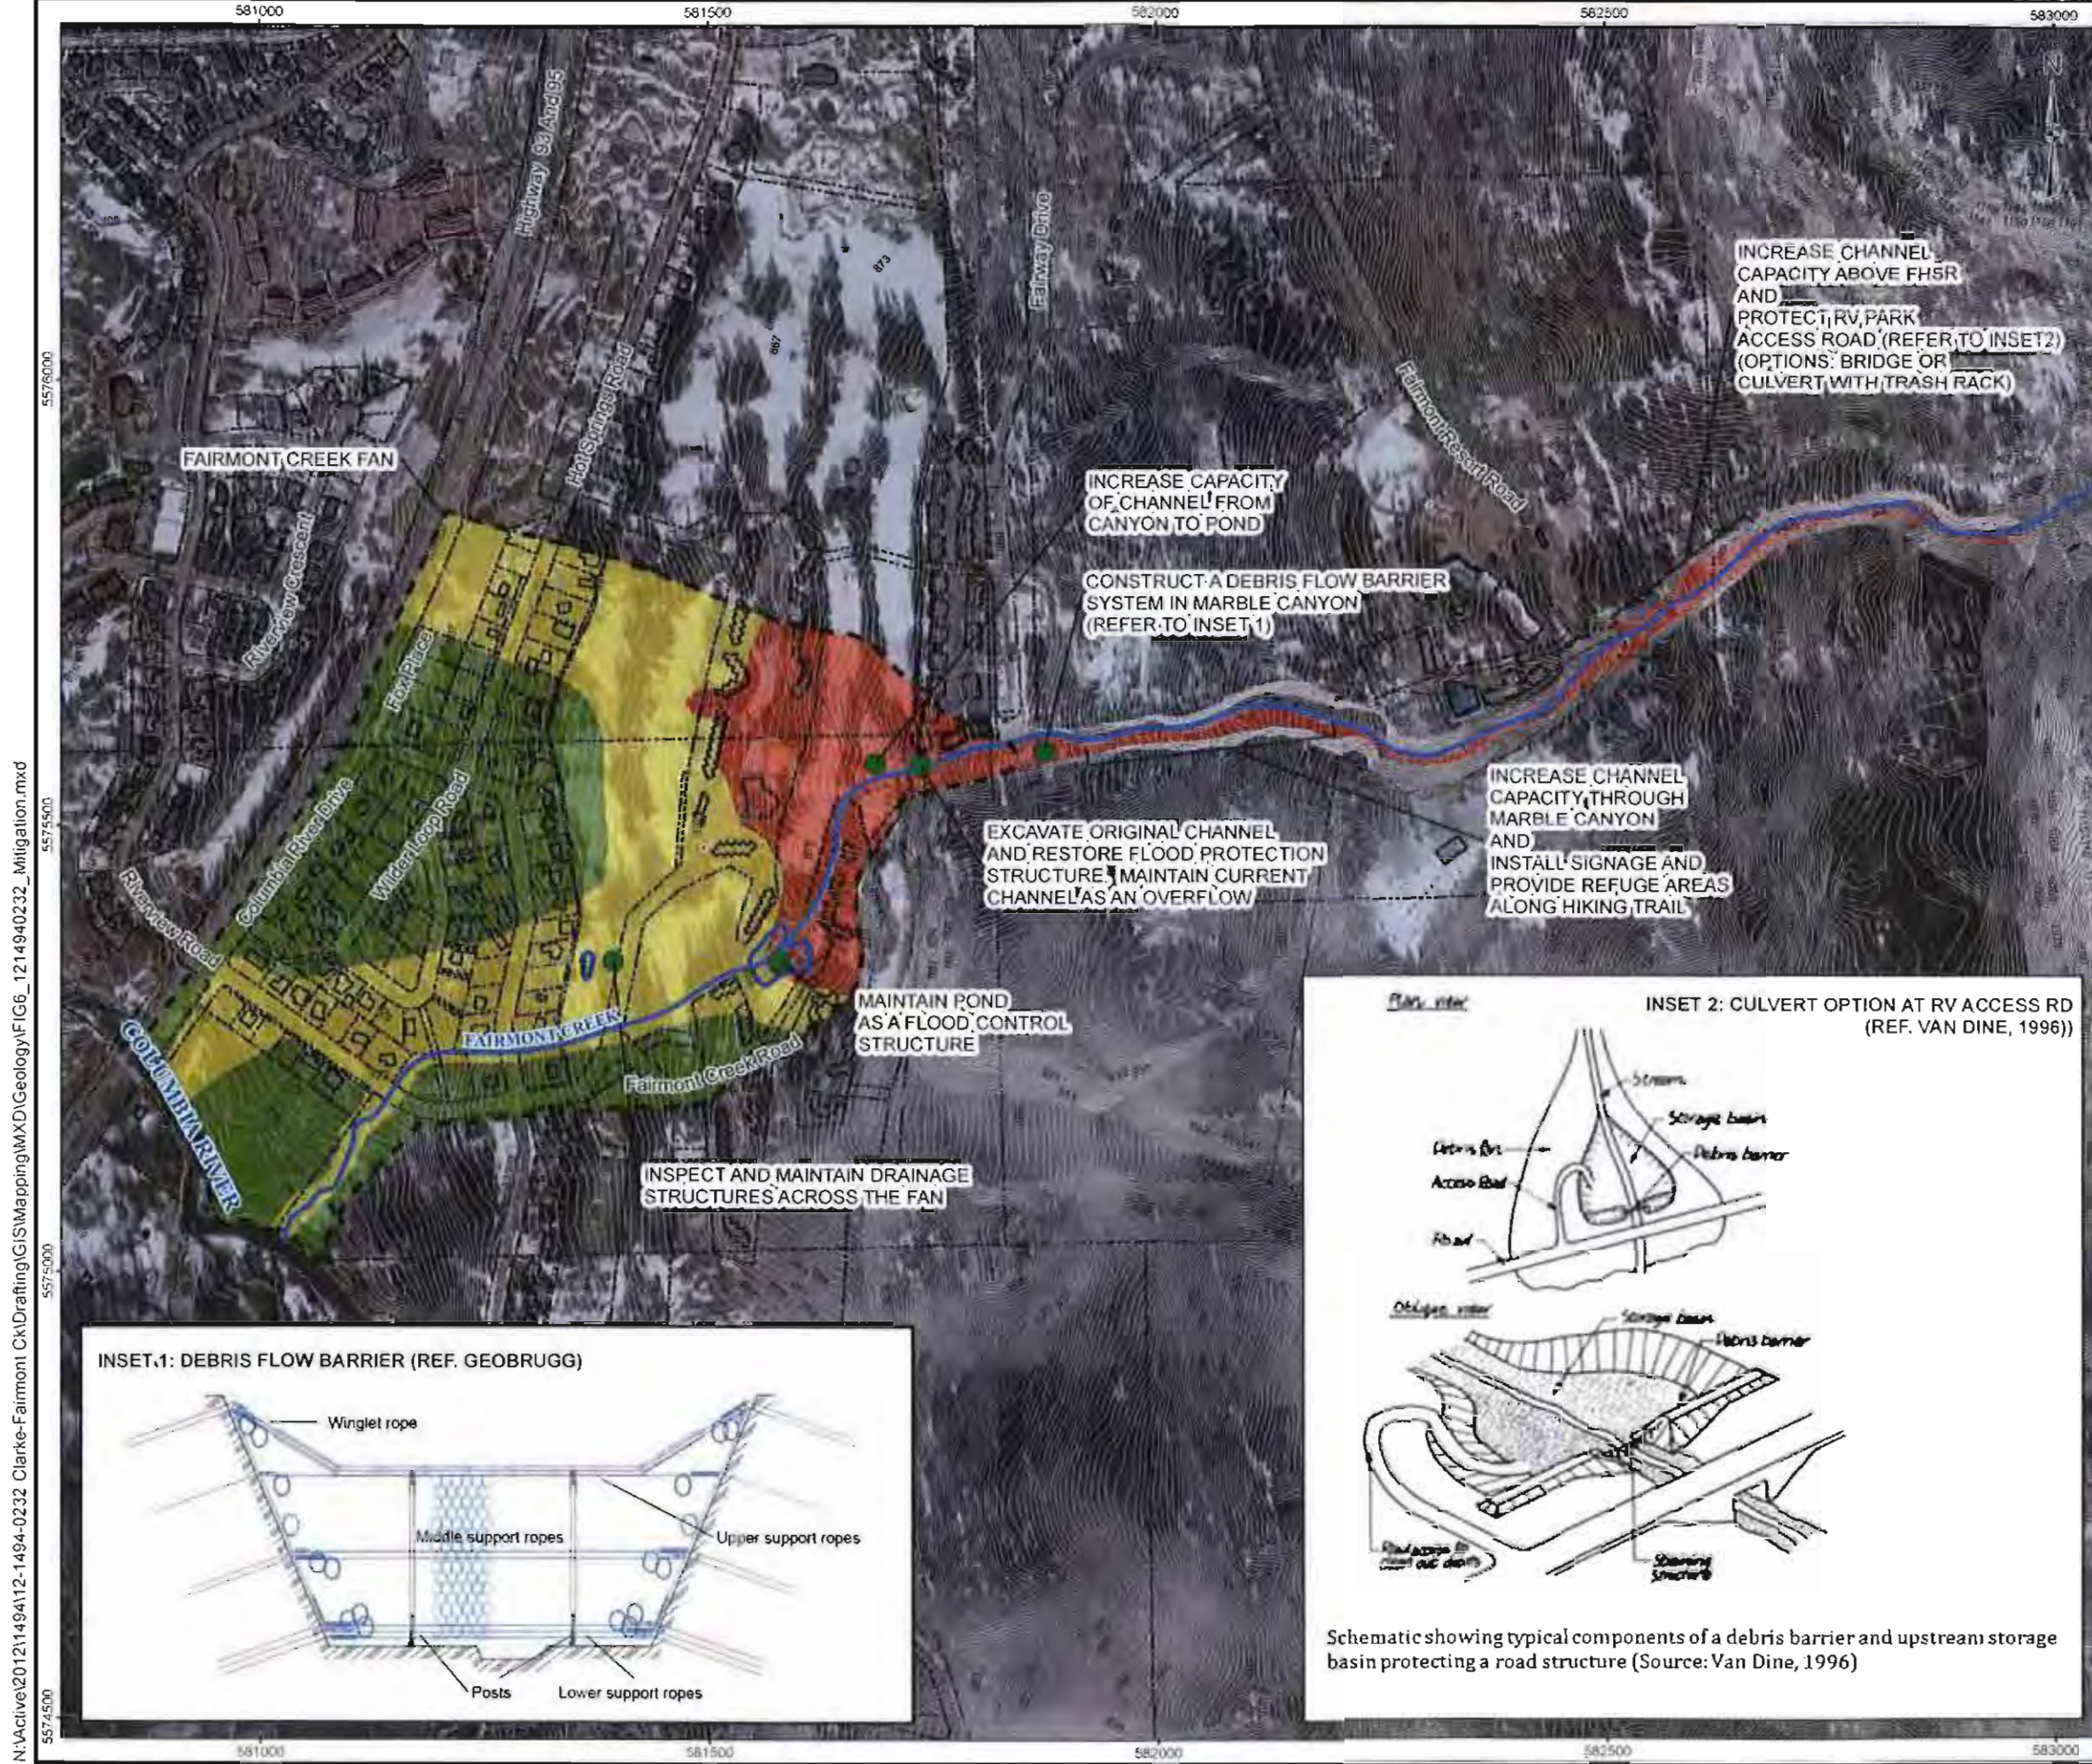
PROJECT	REGIONAL DISTRICT OF EAST KOOTENAY FAIRMONT CREEK DEBRIS FLOW HAZARD AND RISK ASSESSMENT FAIRMONT HOT SPRINGS, B.C.		
TITLE	<b>RISK ASSESSMENT</b>		
	PROJECT NO.	12-1494-0232	Phase 1000
	DESIGN	JC 23 Nov 2012	SCALE AS SHOWN REV 1
	GIS	JG 23 Nov 2012	
	CHECK	GR 19 Dec 2012	
	REVIEW	JC 19 Dec 2012	
			<b>FIGURE:5</b>

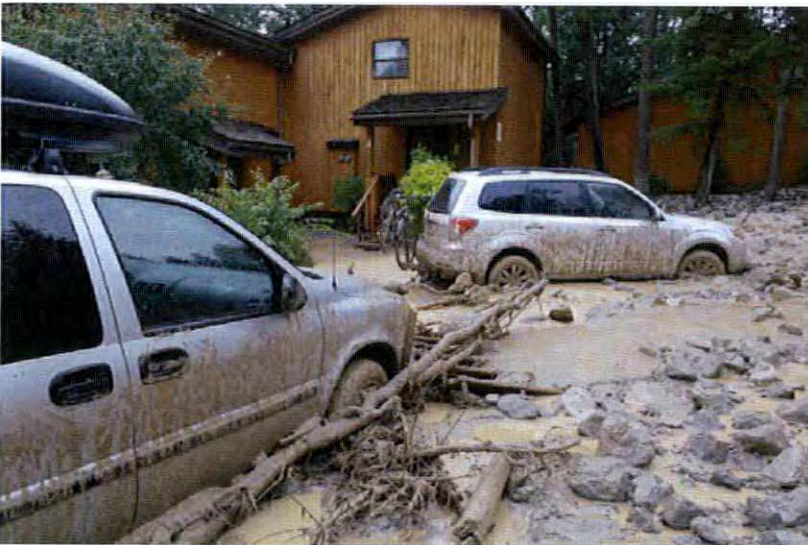
Damage to Mountainside Villas, upper fan (Source A.B.)

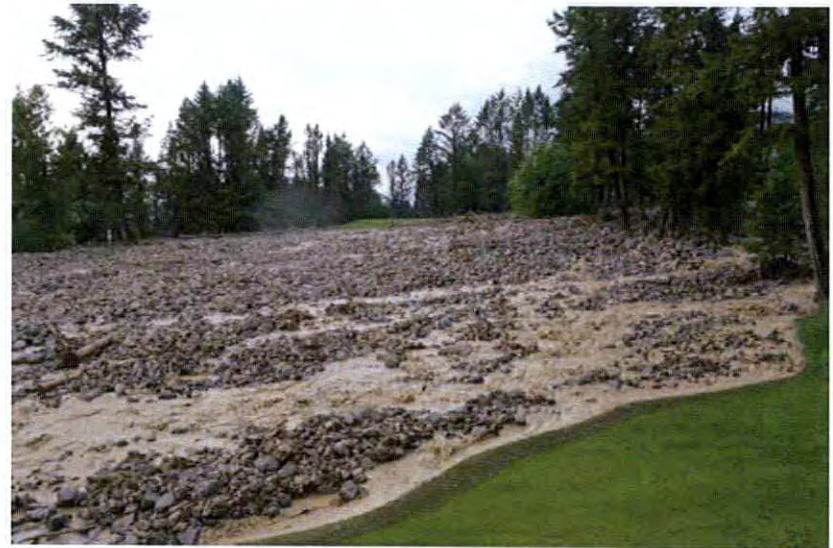
Debris deposition across Fairway 16, upper fan (Source A.B.)

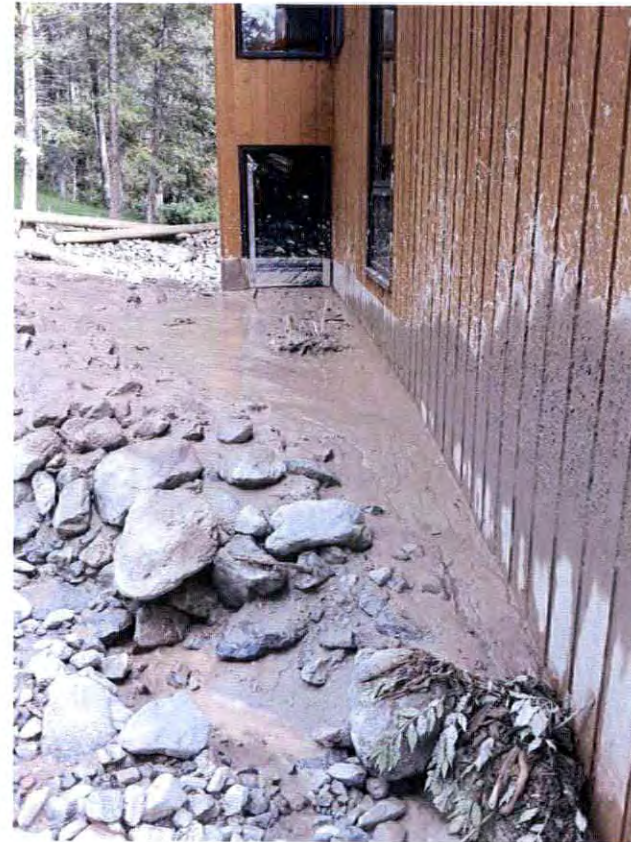
Damage to Mountainside Villas (Source: A. Neal)

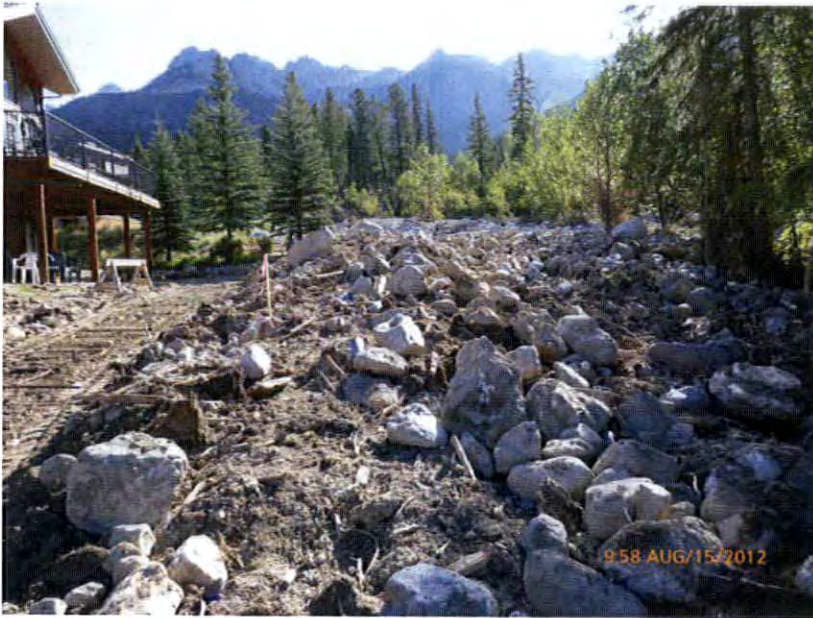
Infilled channel at fan apex, view upstream (near Marble Canyon Condos) (Source A.B.)

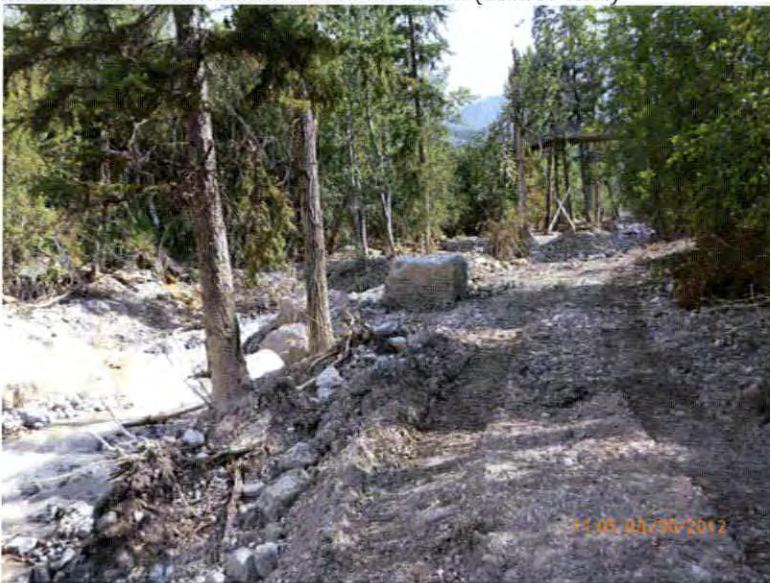
In Marble Canyon, note damaged foot bridge and excavated channel (Source A.B.)

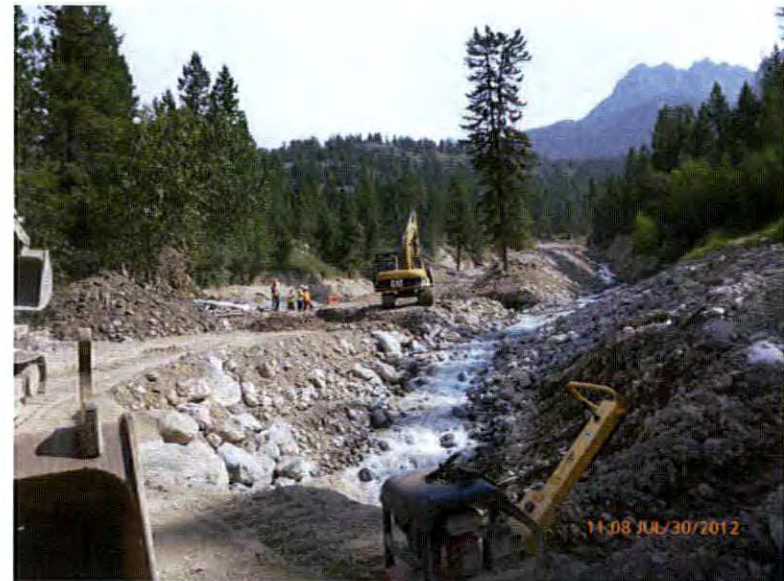
View upstream of Resort road crossing (Source A.B.)

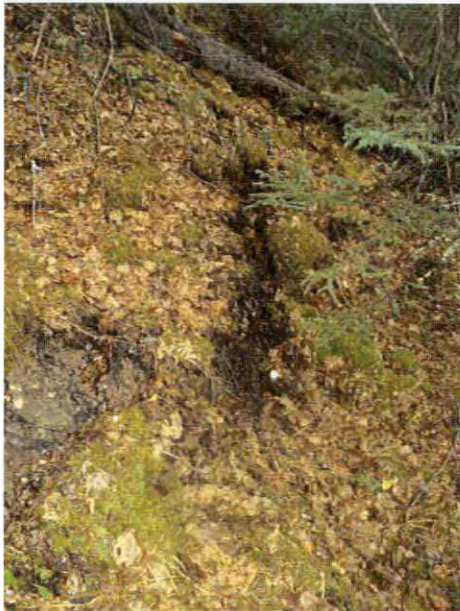
Tension cracks indicating slope instability above north tributary (Oct. 15, 2012)

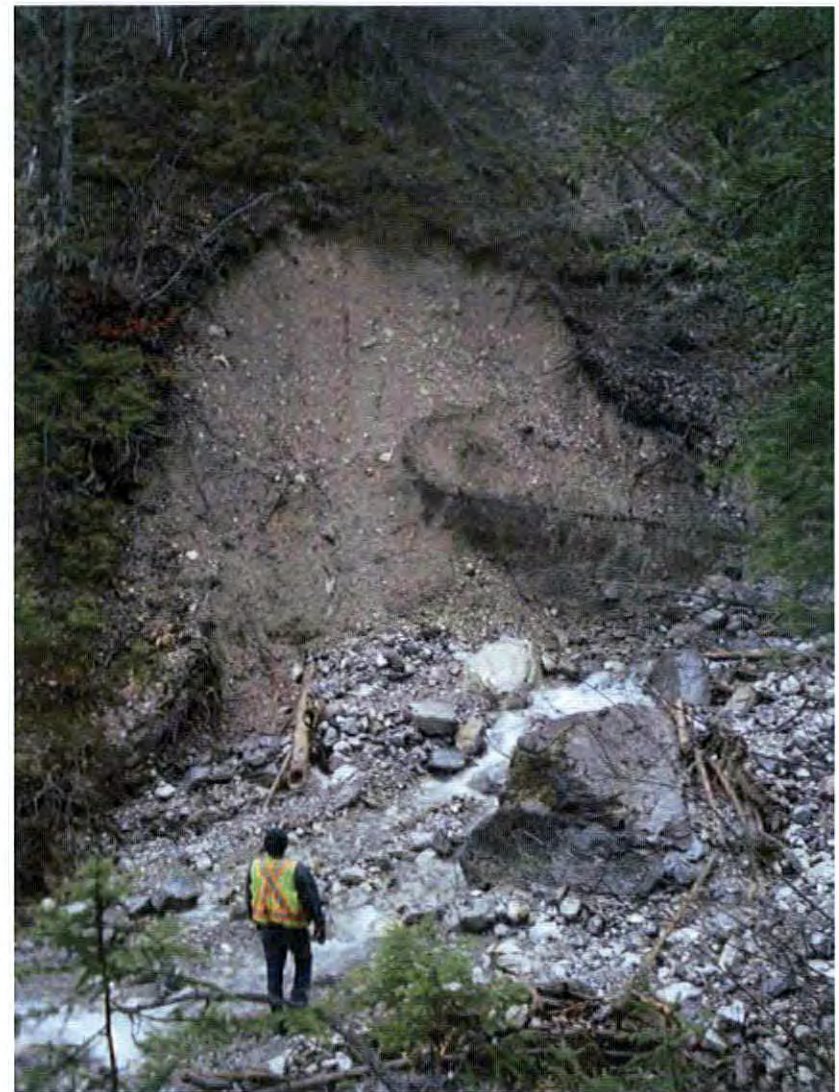
Slump along north tributary (Oct. 15, 2012)

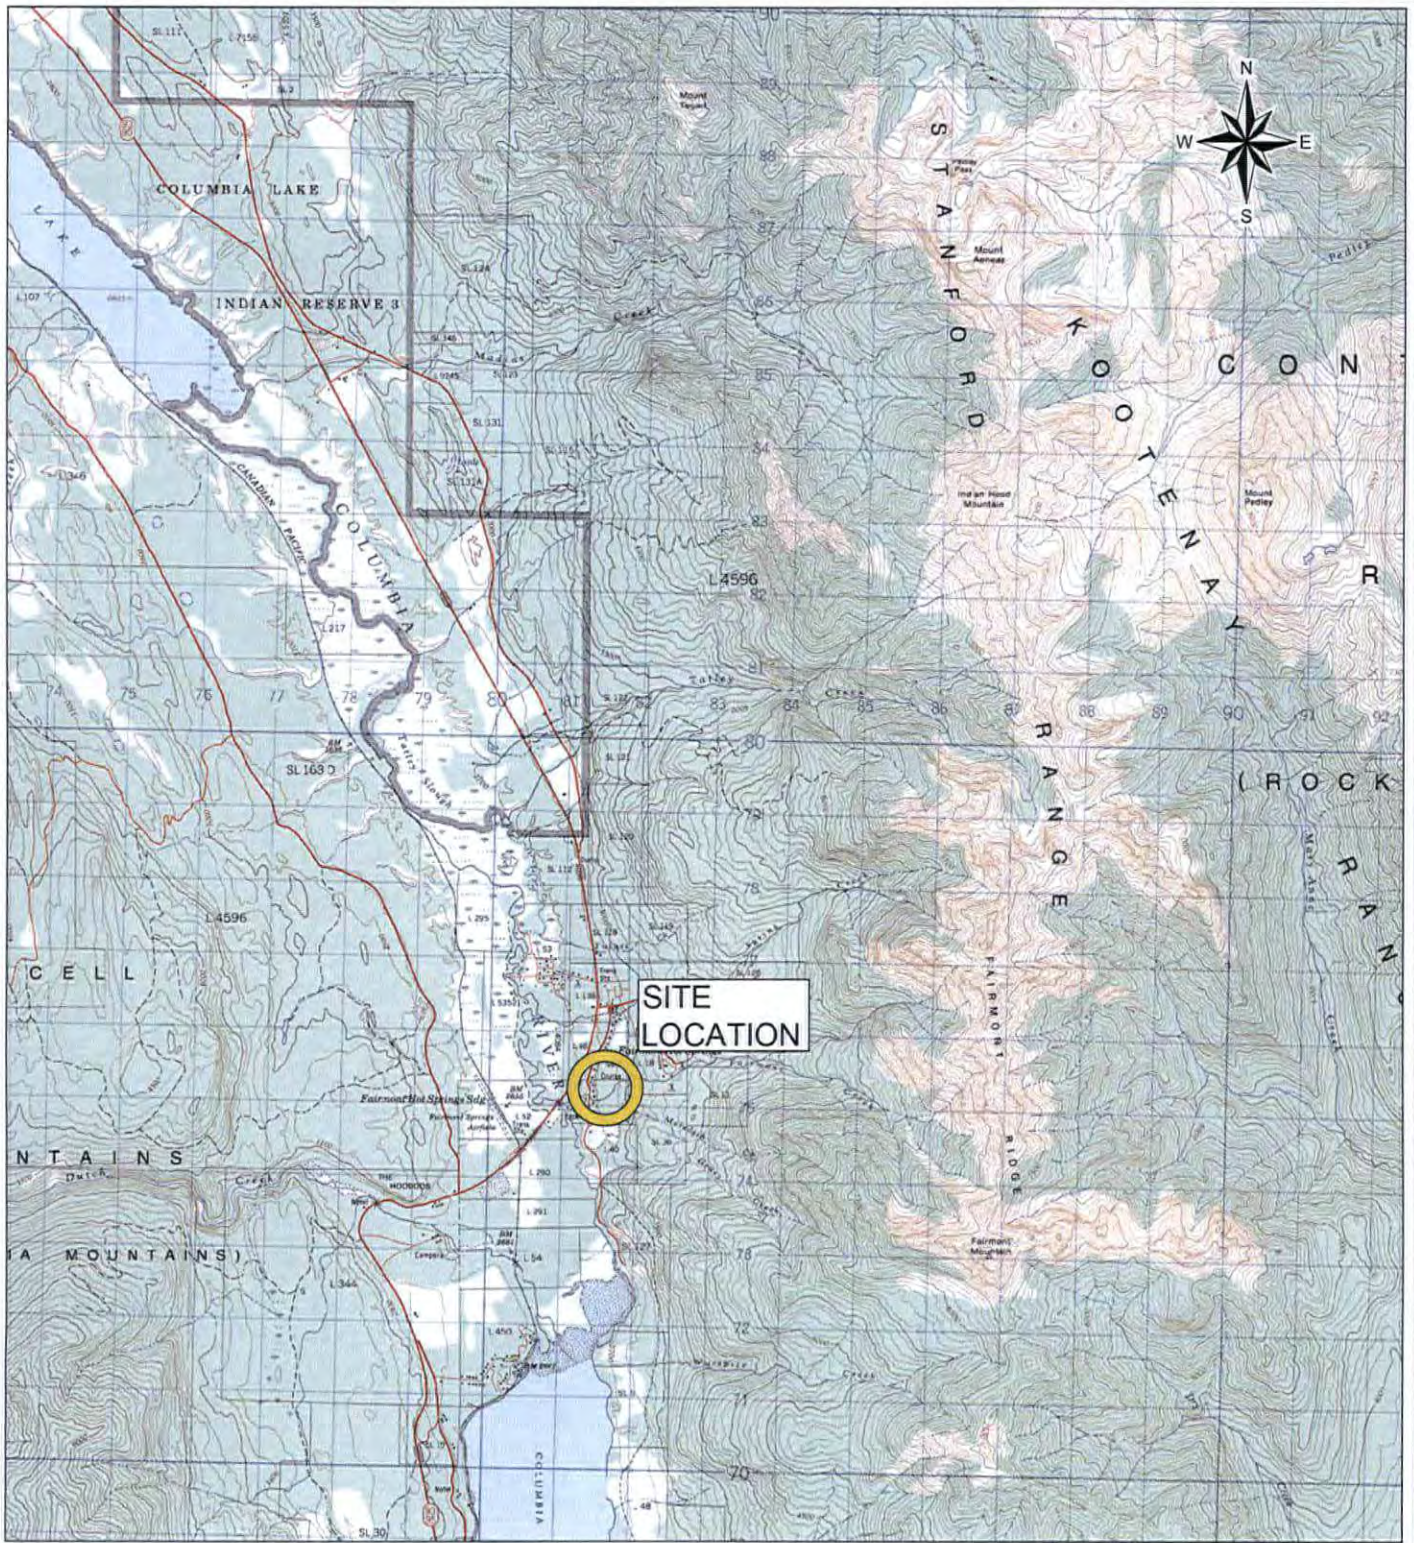
PROJECT  
 REGIONAL DISTRICT OF EAST KOOTENAY  
 FAIRMONT CREEK FLOW HAZARD AND RISK ASSESSMENT  
 FAIRMONT HOT SPRINGS, B.C.
