## **Cold Spring Creek 2020 Annual Dike Inspection Report**

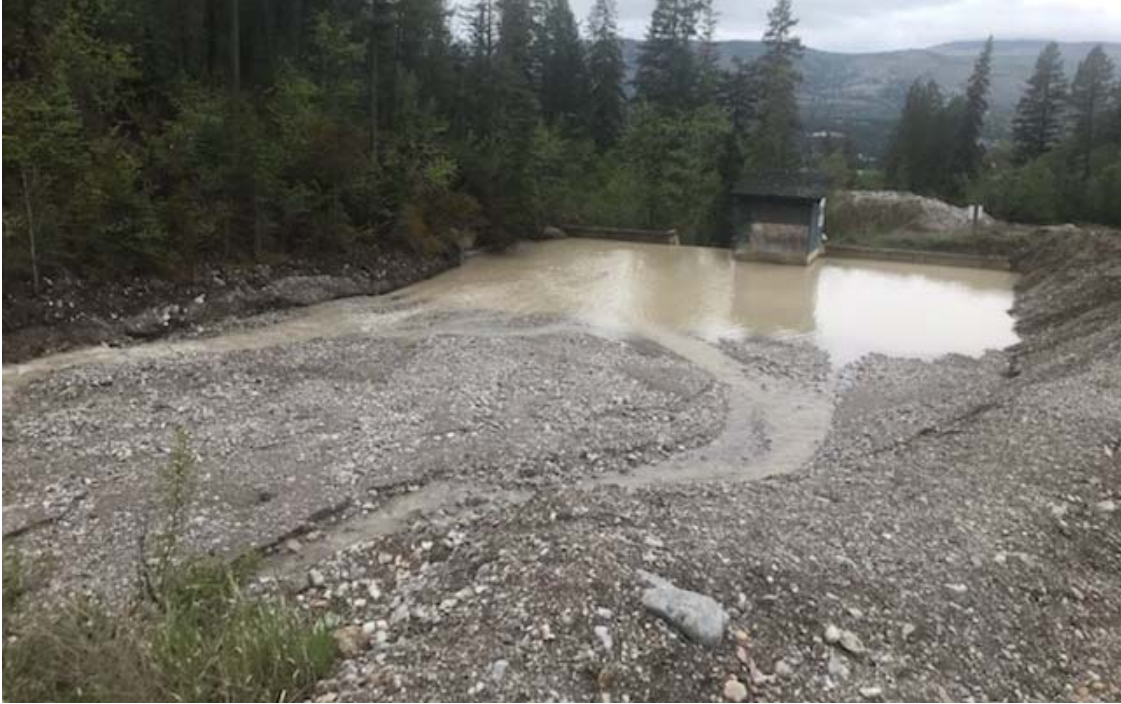
The dam and reservoir were in good condition during the April 23, 2020 inspection. During the May 20, 2020 event it was approximately 60% filled with debris and during the May 31 event, it was filled to capacity and water flowed over the dam and caused some erosion. The debris was removed from the reservoir immediately after the May 31 event.

Photo 1: Cold Spring Creek Dam Reservoir partially filled with debris. May 22, 2020

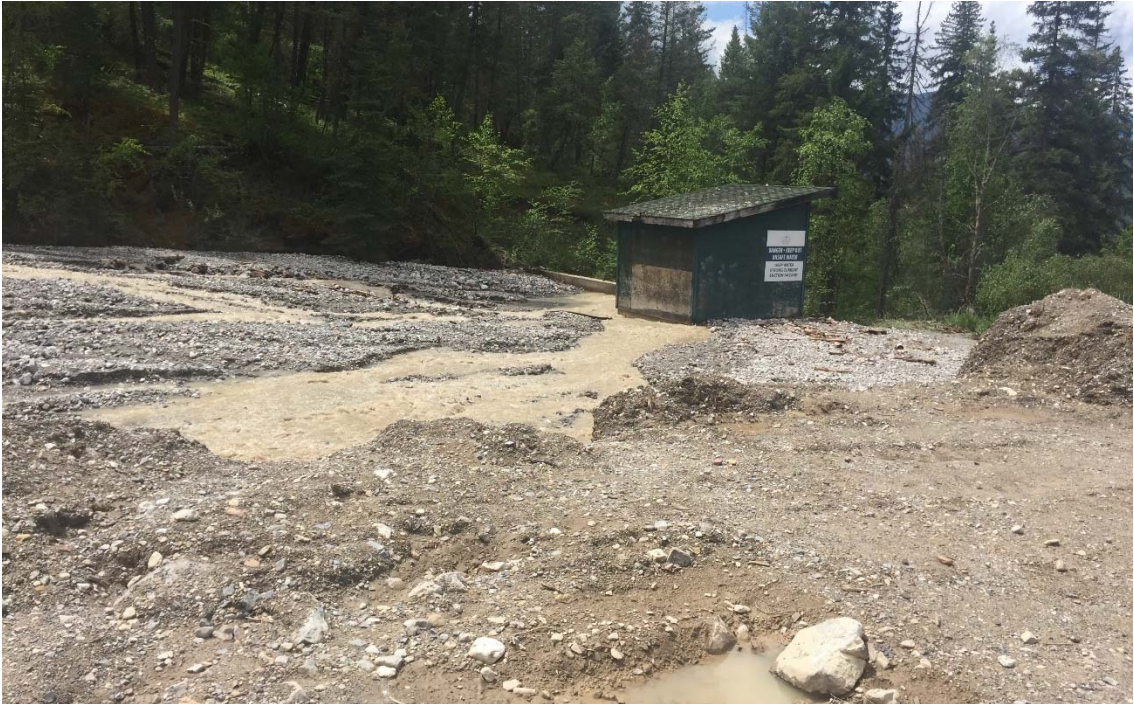
Photo 2: Cold Spring Creek Reservoir after the May 31 event. June 1, 2020.

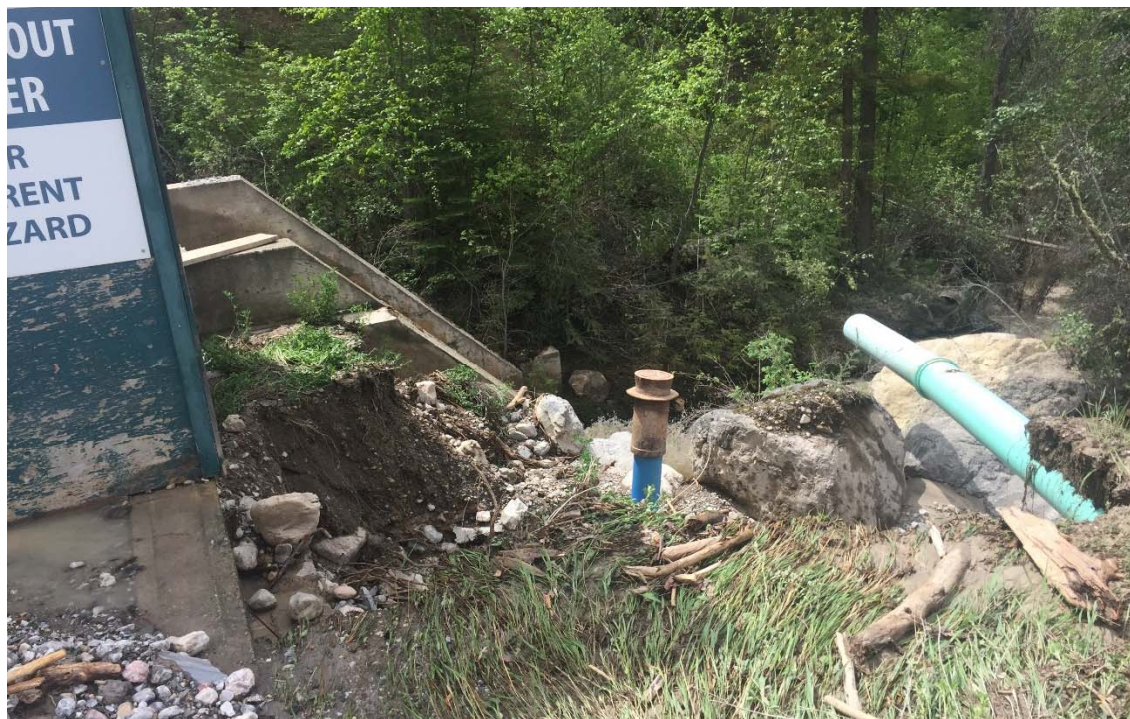
Photo 3: Erosion immediately downstream of the dam after the May 31 event. June 1, 2020.

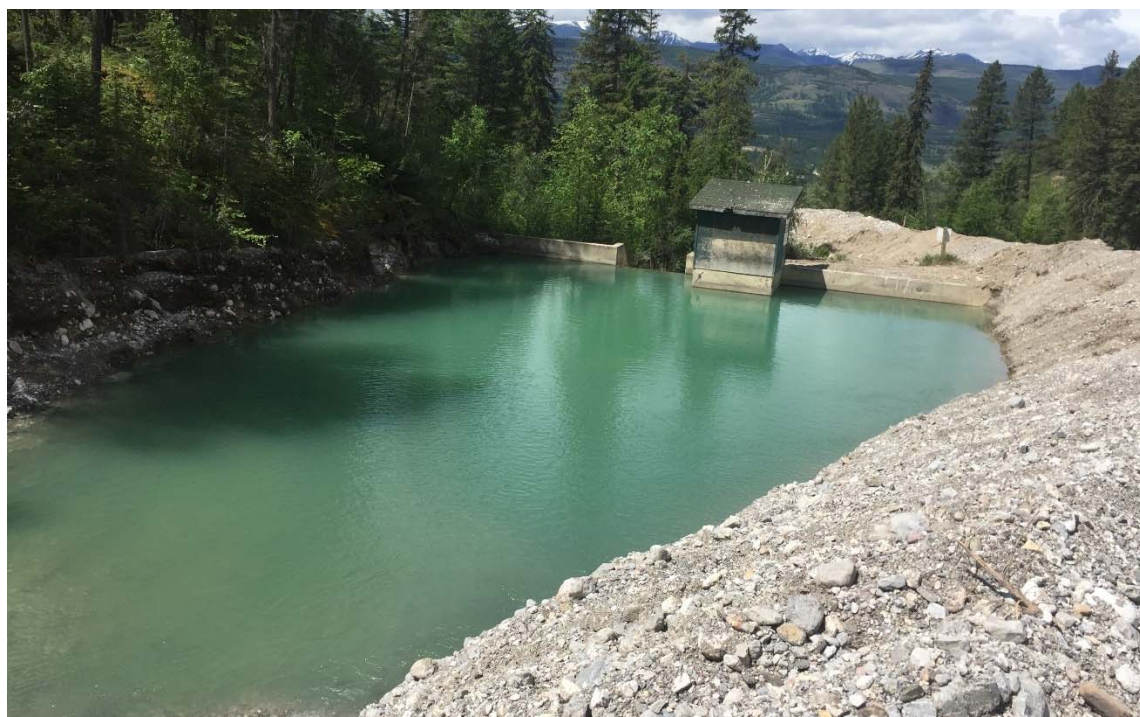
Photo 4: The reservoir with the debris removed. June 15, 2020.

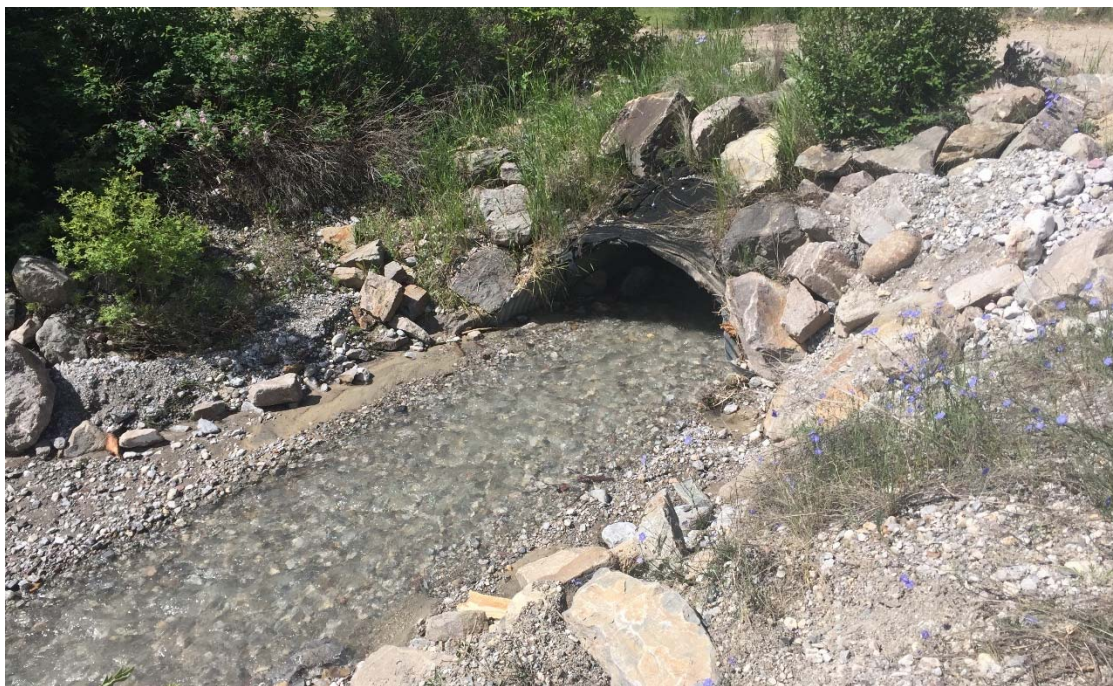
The last culvert along Cold Spring Creek before the lower debris trap is experiencing some very minor underflow piping. The situation is being monitored. The same culvert was approximately 30% filled with gravels and was cleaned out in August 2016. Both upstream culverts along the bank protected works are in good condition and functioning properly.

Photo 5: The culvert immediately upstream of the lower debris trap. June 10, 2020.

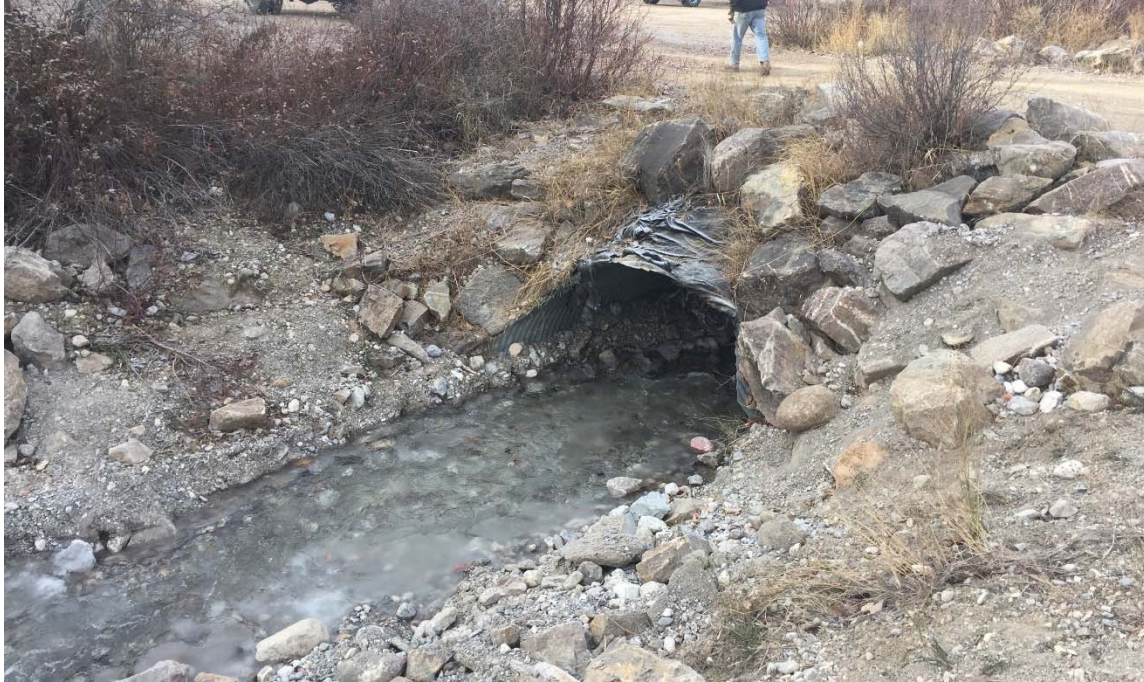
Photo 6: Culvert upstream of the debris trap after cleaning. November 30, 2020.

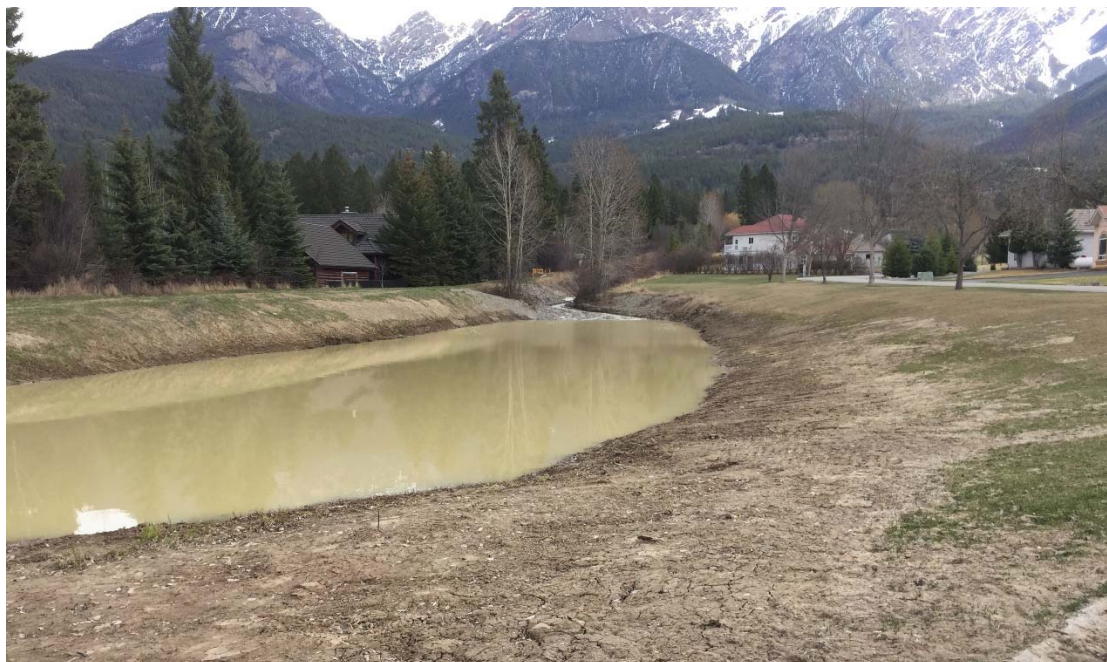
The debris trap was in good condition during the April 23 inspection. The trap was filled to capacity during the May 31 event and was cleaned in the fall of 2020.

Photo 7: The lower debris trap, April 23, 2020.

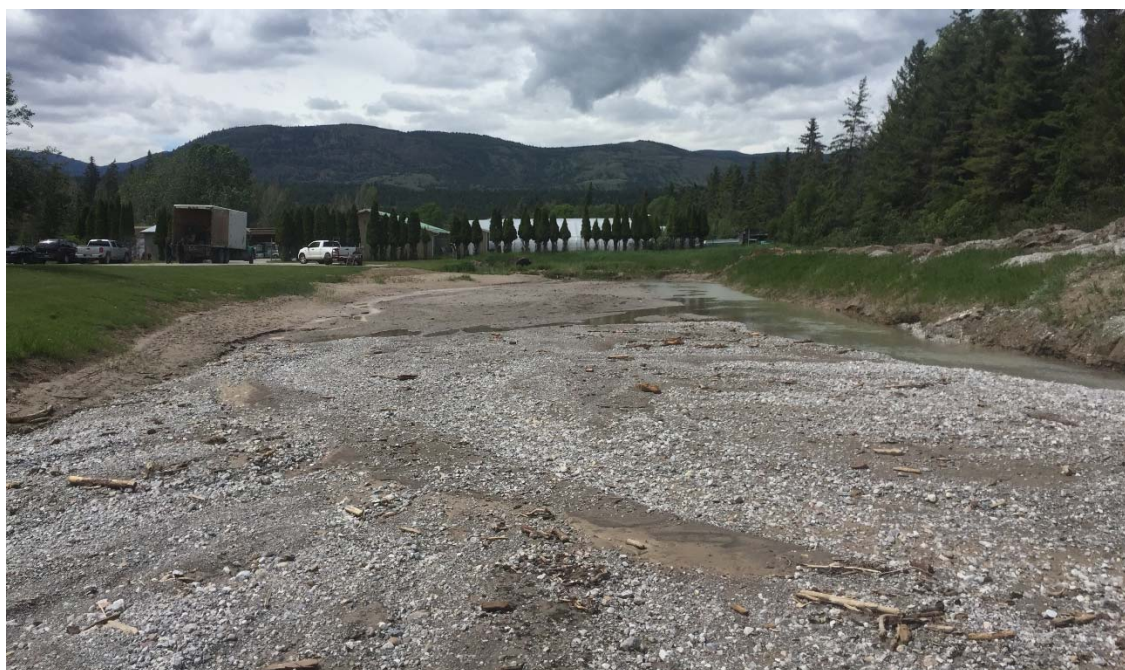
Photo 8: The lower debris trap after the May 31 event. June 9, 2020.

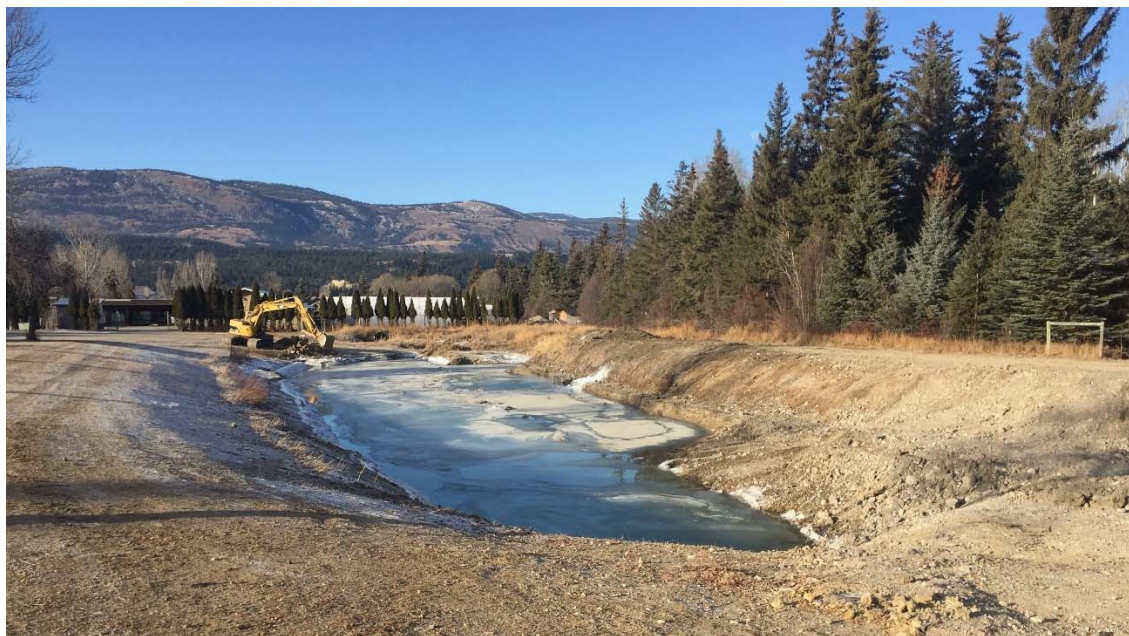
Photo 9: The lower debris trap near completion of debris removal. December 4, 2020.

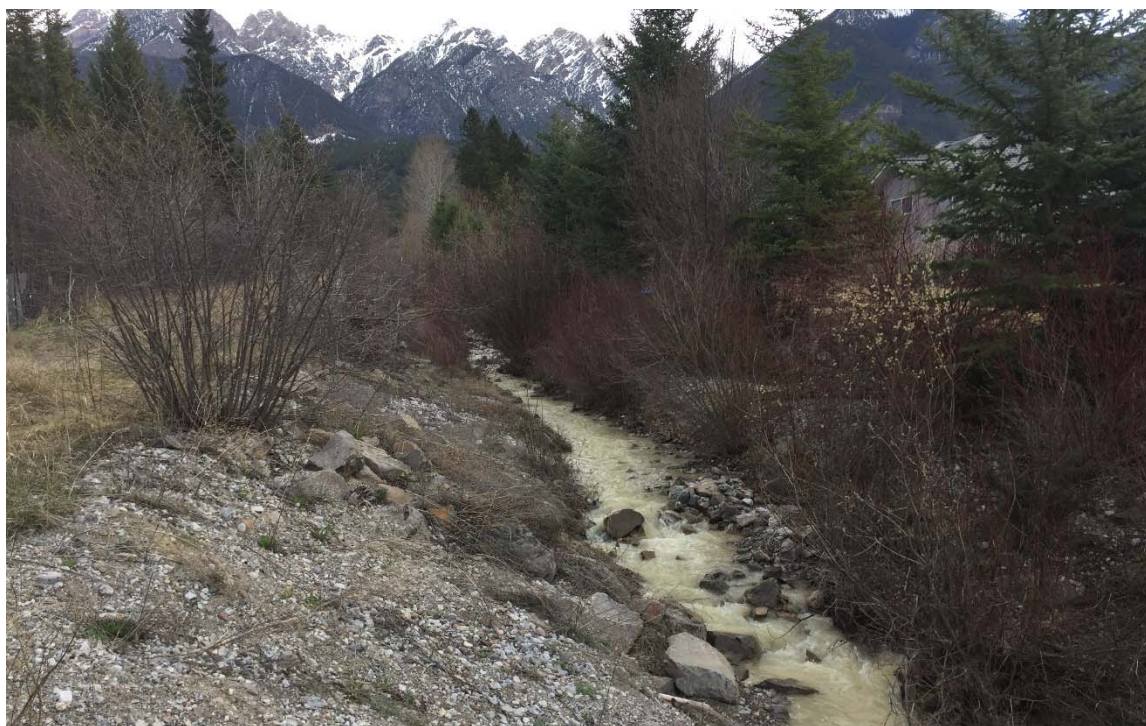
The lower channel was in good condition during the April 23 inspection. Vegetation removal should be completed.

Photo 10: Channel immediately upstream of the lowest culvert. April 23, 2020.

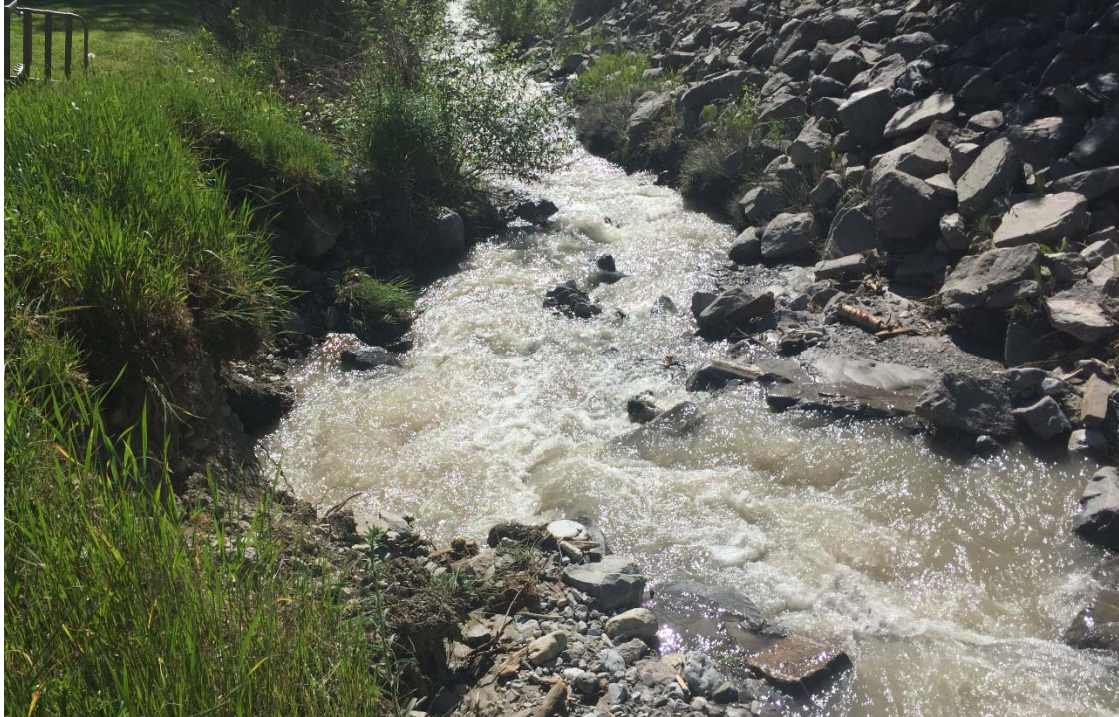
During the May 31 event there was some minor damage to the bank protection behind 2025 Riverview Road. It was repaired to prevent additional bank erosion and property damage.

Photo 11: Bank erosion behind 2025 Riverview Road. June 3, 2020.

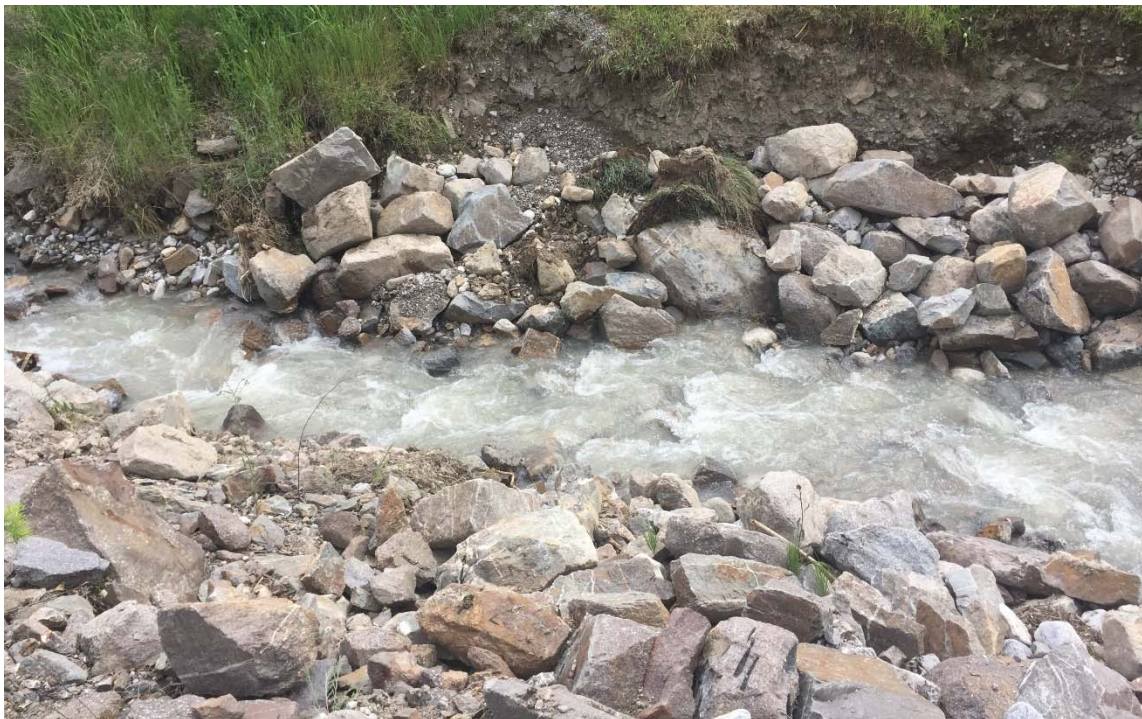
Photo 12: Repair of bank erosion. June 9, 2020.
