Cold Spring Creek 2014 Annual Dike Inspection Report

The dike/bank protection works was inspected on April 30, 2014 with follow up monitoring inspections on June 3, 2014 and June 24, 2014. The formal inspection day was warm and sunny and approximately 23°C.

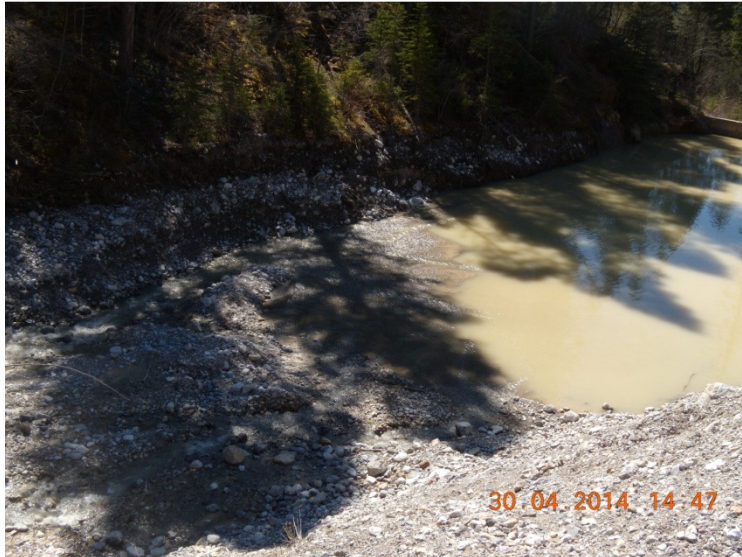
The upstream conditions above the dike/bank protection works were normal on the formal inspection day, April 30, 2014. However, the high turbidity of the water indicated significant snow melt and potential material transmission from above as the dam reservoir had partially infilled from the spring freshet and spring rain.

April 30, 2014 Reservoir Sediment Deposition

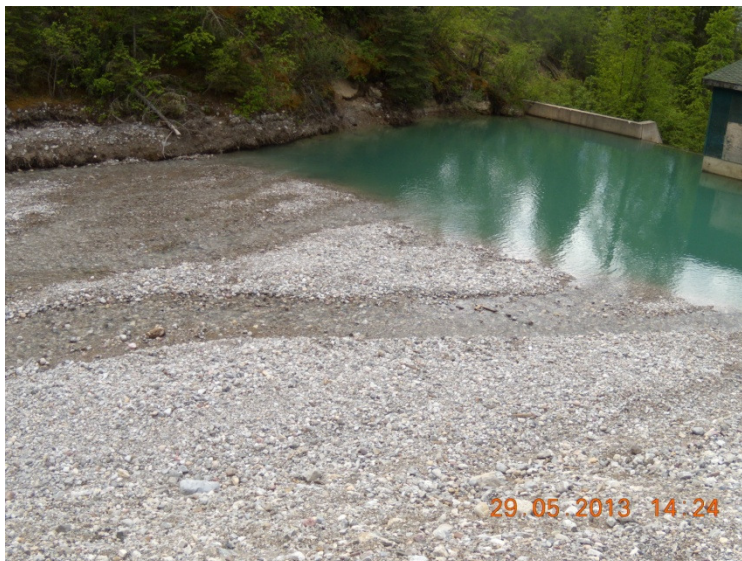
May 29, 2013 Reservoir Sediment Deposition

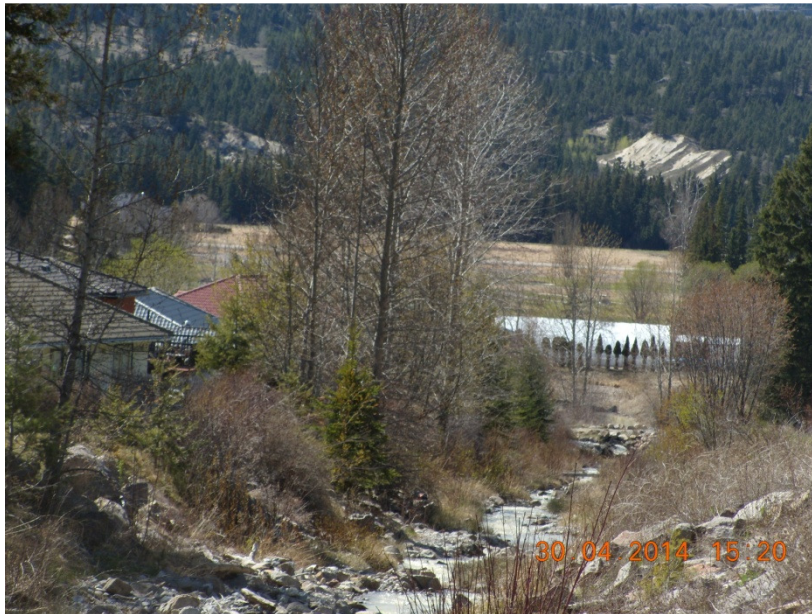
The channel from Highway 93/95 to the debris trap (dike/bank protected area) is in good condition

2014 Channel Condition

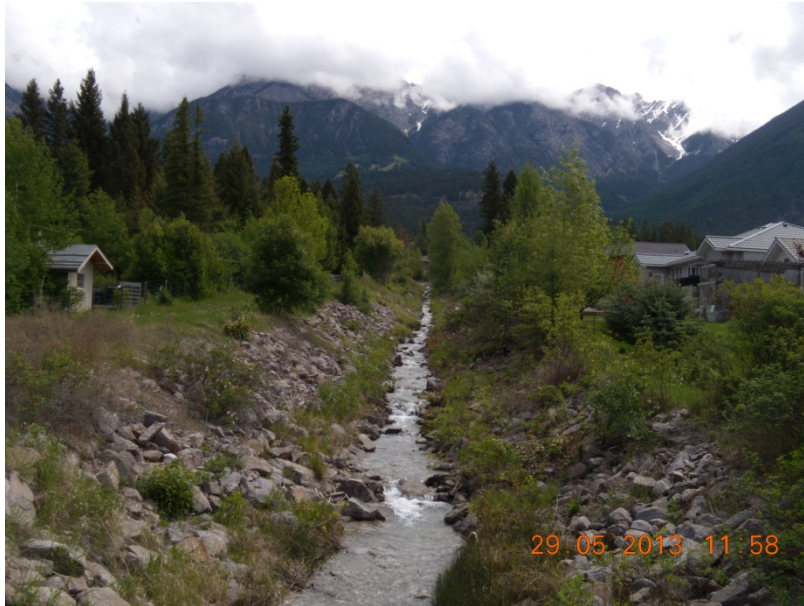
2013 Channel Brushed Channel

The complete bank protection works were brushed in 2012 which allows for ease of inspection of the rip rap lined banks and maintains the integrity of the works. Brushing is not anticipated until 2015

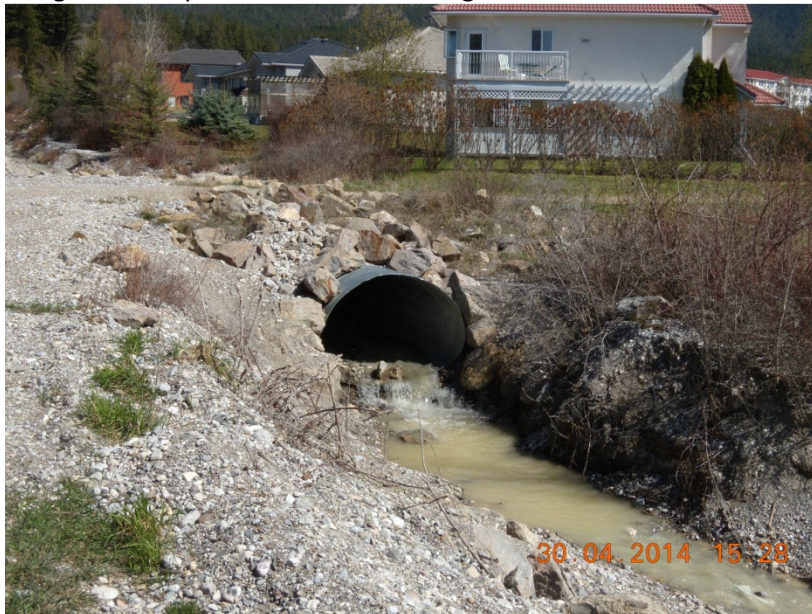
The last culvert along Cold Spring Creek prior to flowing into the lower debris trap is experiencing some very minor underflow piping, which is causing some very minor scour under the culvert. The situation is being monitored and the two photos below document the present condition. Both upstream culverts along the bank protected works are in good condition and functioning properly.

Culvert condition at the time of formal inspection April 30, 2014

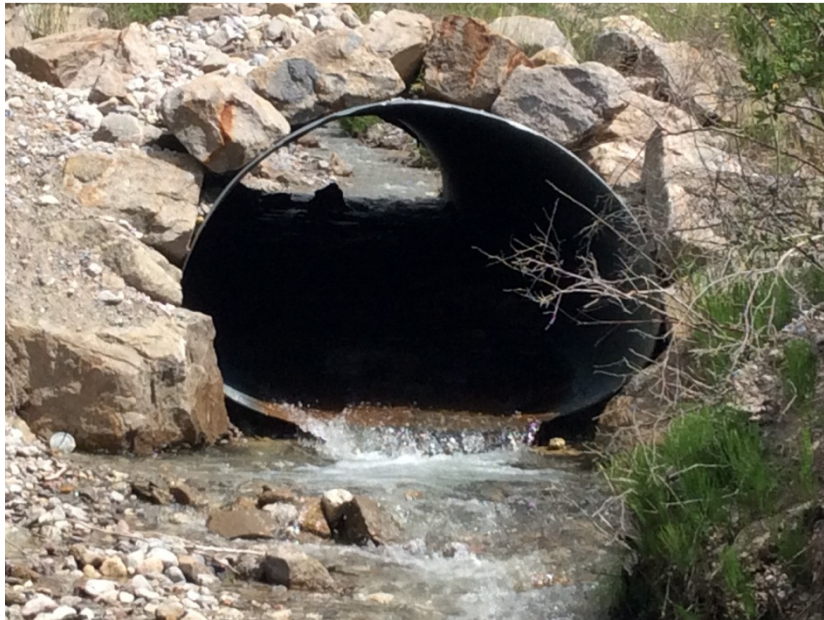
Culvert condition at the time of monitoring inspection June 24, 2014

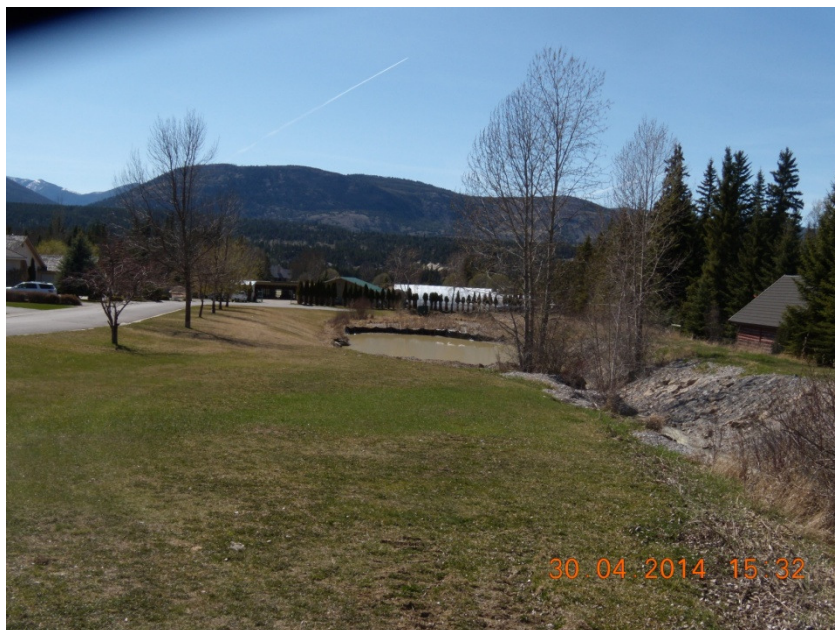
The debris trap on Cold Spring Creek was significantly infilled with sediment in 2013 from many years of sediment transmission. On June 20 2013 a small debris flow occurred on Cold Spring Creek. Material removals occurred at the upstream dam reservoir, small mid section debris trap along the bank protection works and at the last culvert along the bank protected section. All these locations were cleared of transported gravel from the debris flow and the front half of the lower debris trap was cleared of deposition in the summer of 2013. The funding for removal of the transported debris flow material was primarily from Emergency Management BC (EMBC) emergency response funds. The RDEK provided some funds for additional material removal on the lower debris trap. The completion of sediment removal on the lower debris trap is scheduled for 2014. An approved Section 9 Water Act application is in place for material removal in late August of 2014.

2014 conditions at the lower debris trap on Cold Spring Creek

The RDEK has budgeted for the removal of the sediment build up in the lower debris trap in late August 2013. An approved Section 9 Water Act application for removal is in place and the work should be completed in 2 to 3 days of equipment operation.

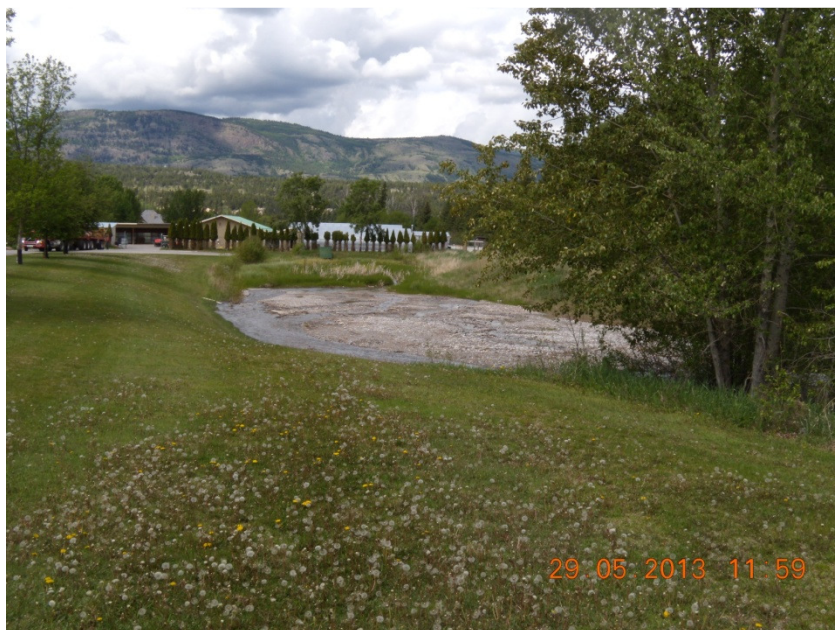
Debris Trap Sediment Deposition prior to the 2013 debris flow
