Fairmont Creek Annual Dike Inspection

Fairmont Creek Inspection

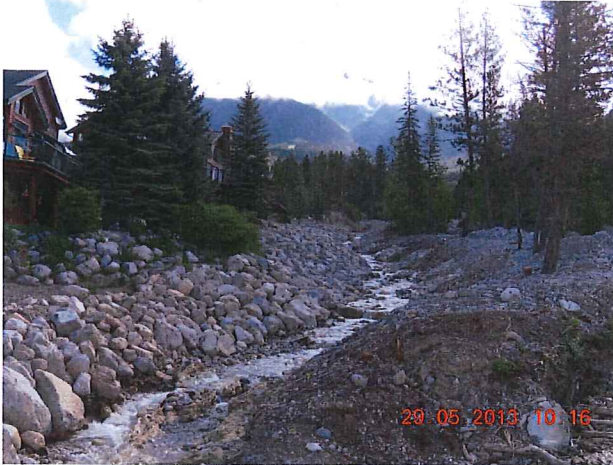
- Grade controls in good condition
 - Plug unaffected by water flow
 - Pool flush high water mark evident
 - Some minor bank erosion above dike/bank protection works

- Calcification in creek channel beginning to re-establish in the recently repaired original channel
 - Creek channel above the dike and bank protection works to the campground road in good condition

May 29, 2013 Dike/Site Conditions

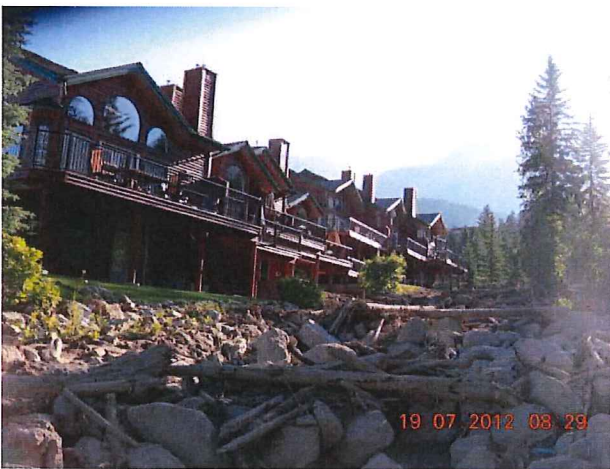
Post Debris Flow Event July 19, 2012 Dike Site Conditions

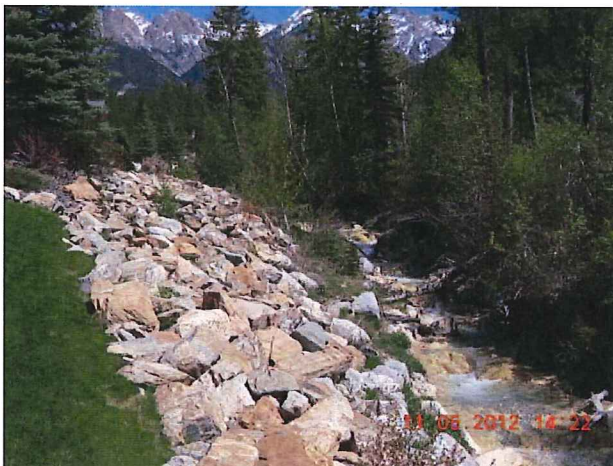
Pre-Debris Flow Event May 11, 2012 Site Conditions
