# **Fairmont Creek 2021 Annual Dike Inspection Report**

## **Fairmont Creek Dike Inspections**

An inspection was completed on May 5, 2021 and was conducted by Kara Zandbergen, RDEK Engineering Technician. All sections of the dike were found to be in good condition at that time and ready for freshet. Subsequent inspections were completed after the event and as the cleanup progressed and in early October.

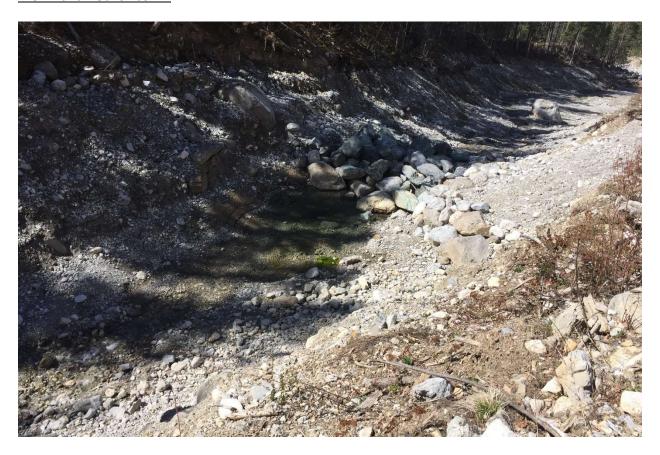
Photo 1: The uppermost weir in the system, Weir #1. May 5, 2021.

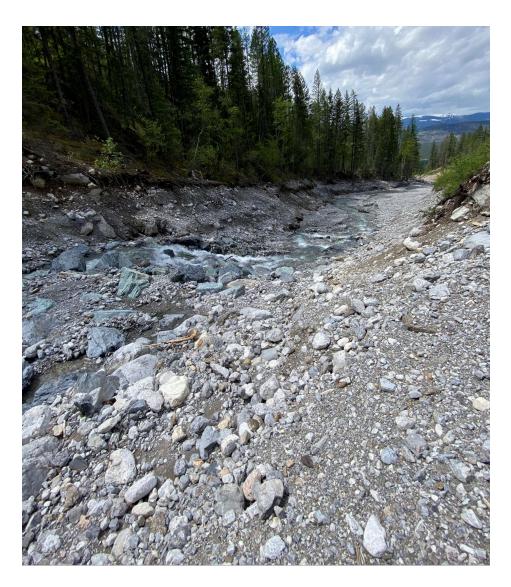
Photo 2: Weir 1, filled with debris material from the May 24 event. May 27, 2021.

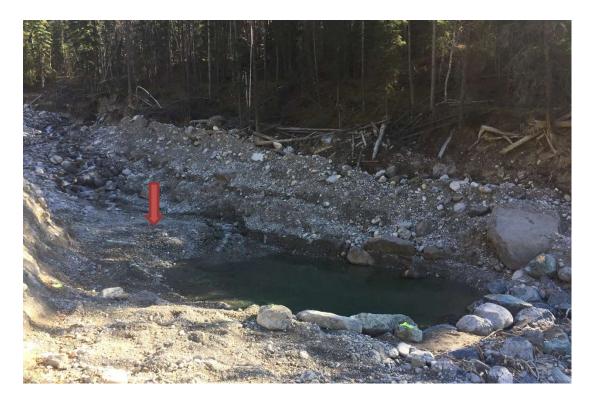
Photo 3: Weir 1 with debris flood material was removed. October 21, 2021.

• 4,200 cubic meters of debris were removed from Debris Basins 1, 2 and 3.

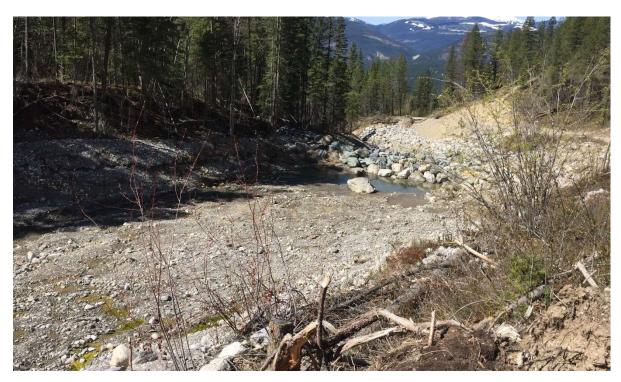
Photo 4: Weir 2 in good condition looking downstream. May 5, 2021.

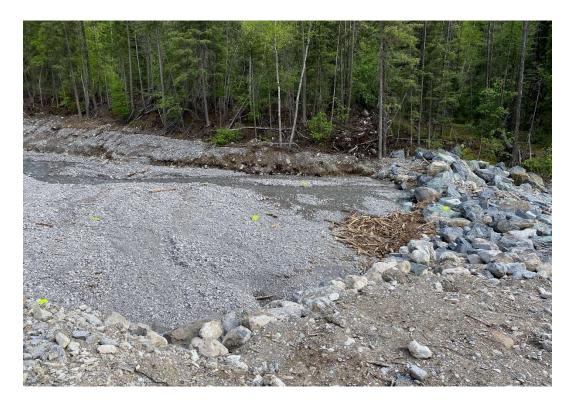
Photo 5: Weir 2 looking upstream. The basin is partially filled with debris flood material. May 29, 2021.

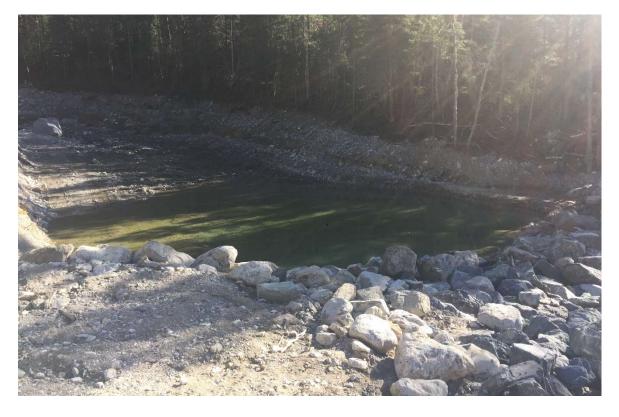
Photo 6: Weir 2 basin with debris flood material removed. October 21, 2021.

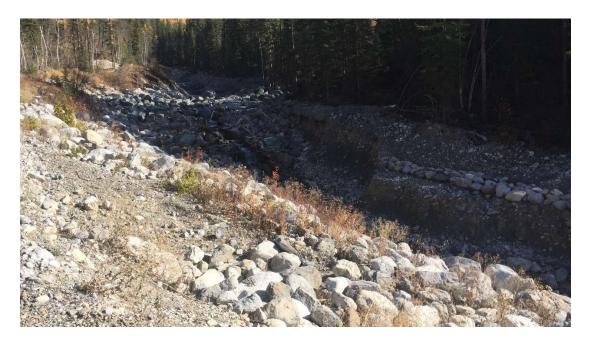
## Weir 2 Downstream Scour

Photo 7: Weir 2 downstream face and scour that occurred primarily during the May 31 event. This was to be repaired in 2021 but was deferred due to the DFA funding not being approved. The armouring on the right bank was not damaged and the damage has not progressed significantly since the May 31, 2020 event. October 21, 2021.

- Weir 2 scour repairs;
- Material removal from Pond 12; and
- Repair of minor dike slump upstream of Pond 12.

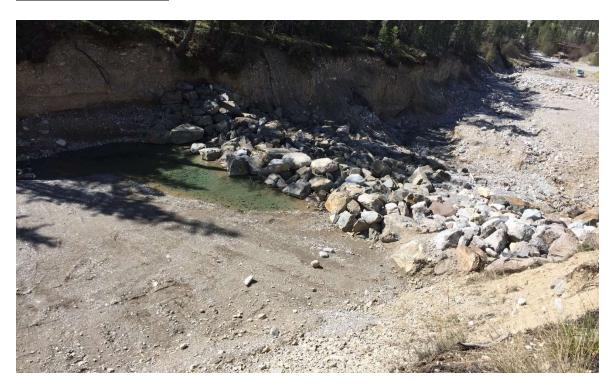
Photo 8: Weir 3 and basin in good condition. May 5, 2021.

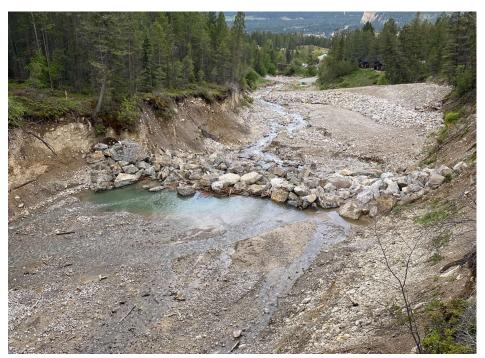
Photo 9: Weir 3 and basin after the May 24 event. May 28, 2021.

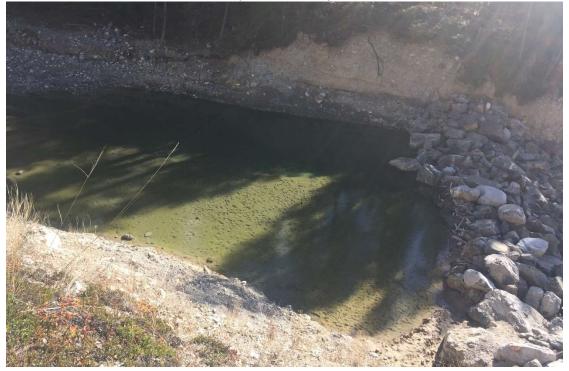
Photo 10: Weir 3 and basin after the debris material was removed. October 21, 2021.

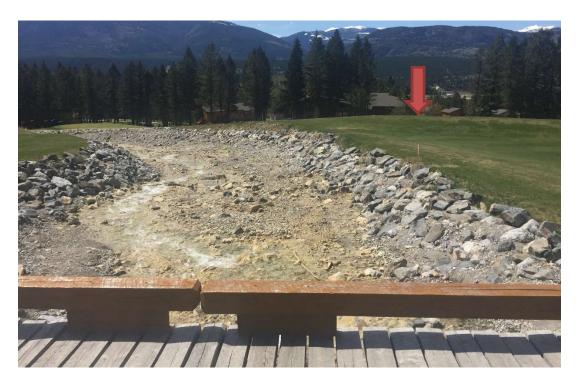
Photo 11: Golf course channel looking downstream from the cart path bridge. Channel is in good condition. The dike on the right hand side of the channel (red arrow) is in good condition. May 5, 2021.

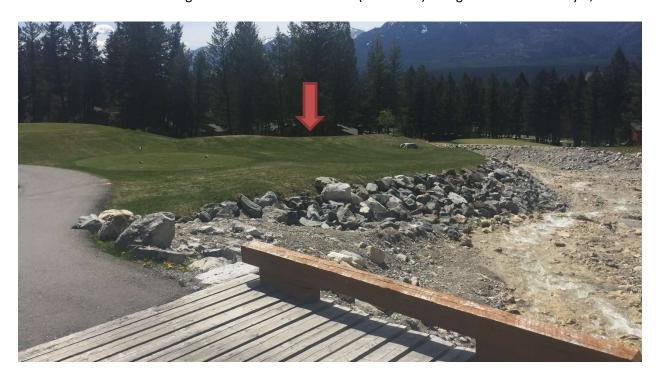
Photo 12: The left hand dike is in good condition. May 5, 2021.

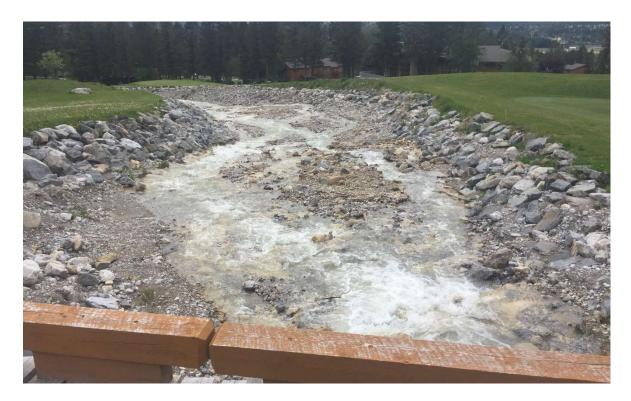
Photo 13: Golf course channel looking downstream from the cart path bridge on May 26, 2021. There was minimal debris deposition, flow was contained in the channel and the dikes were not impacted.

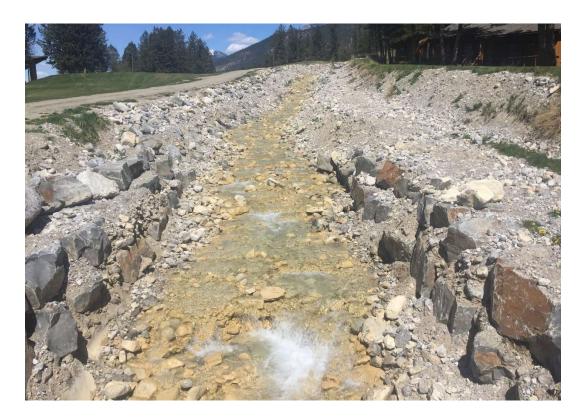
Photo 15: Lower portion of the golf course channel looking upstream from the pedestrian bridge near the Hole 12 pond. The channel and dikes were in good condition. May 5\_2021.

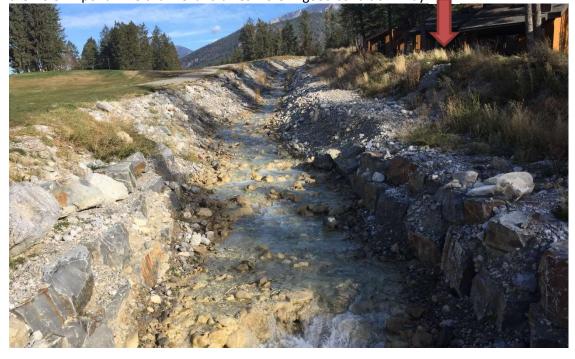
Photo 16: Lower portion of the golf course channel. There is a small area of settlement on the dike slope at the arrow. See Photo 17. October 21, 2021.

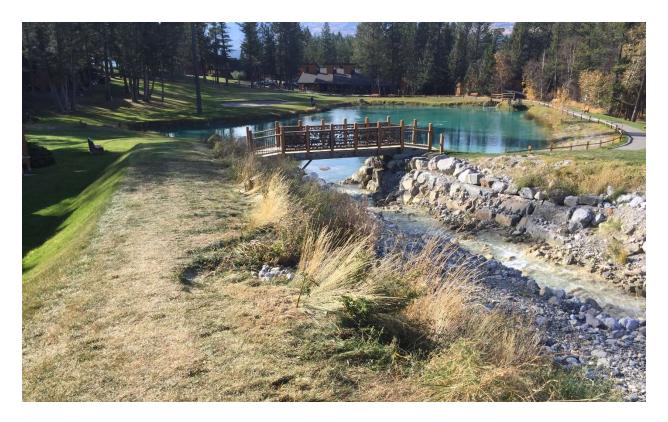
Photo 17: Area of settlement on the dike. This will be monitored in early 2022 and repaired pre-freshet if required. October 21, 2021.

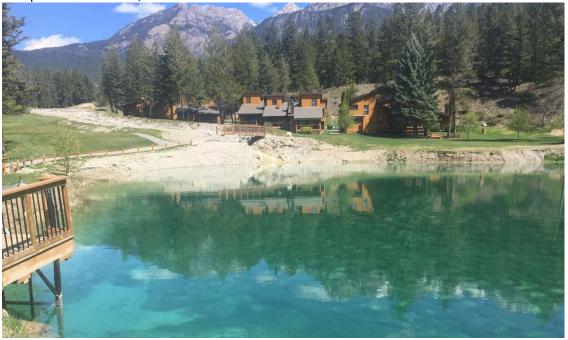
Photo 18: Hole 12 Pond with no material deposition at the inlet and good condition with lots of capacity. May 5, 2021.

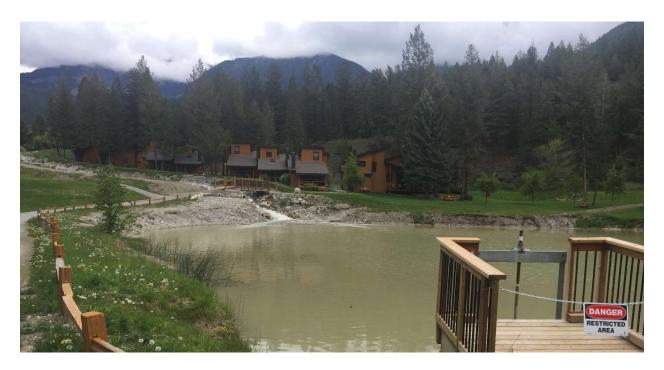
Photo 19: Hole 12 pond inlet with minimal deposition at the inlet. May 26, 2021.

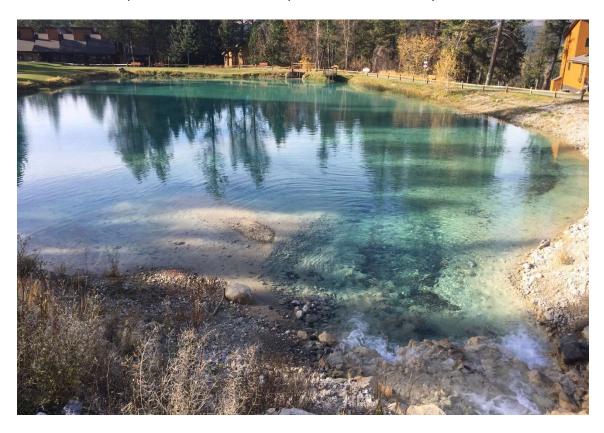
Photo 20: Hole 12 pond taken from near the inlet. Some material deposition has occurred through the summer. This will be evaluated in early April and some material may be removed. October 21, 2021.
