## Fairmont Creek 2014 Annual Dike Inspection Report

## Fairmont Creek Inspection

The inspection occurred between 1:00 pm and 2:30 pm on April 30, 2014 and was conducted by RDEK engineering technician Jim Maletta. The conditions at the time of inspection were clear, sunny and approximately 23° C.

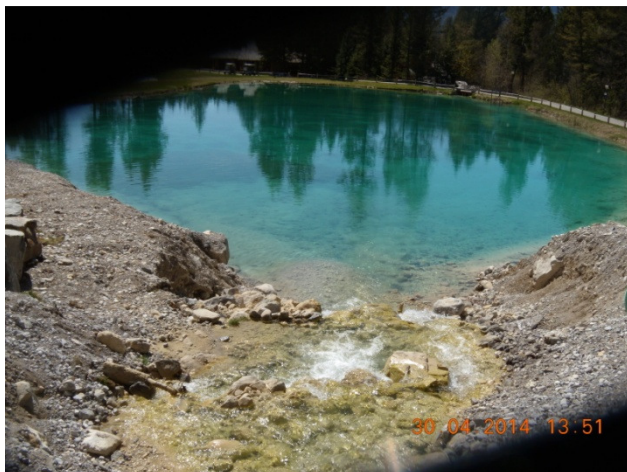
Golf Course Pond/Debris Trap pre-event

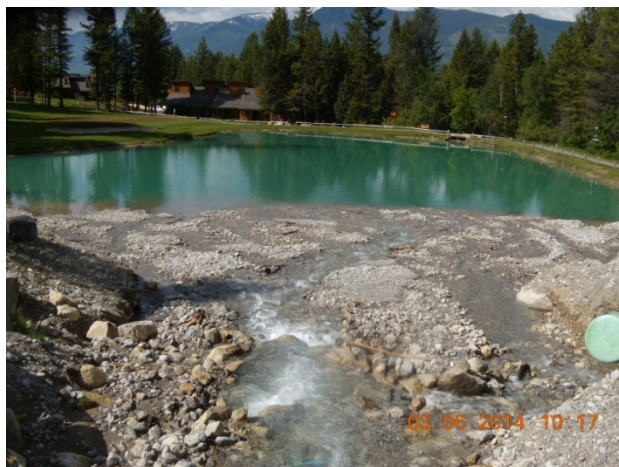
Monitoring inspections have been conducted at the Fairmont Creek works and upstream and downstream of the works on May 27 (Brian Funke, Engineering Services Manager), June 3 and June 23 (Jim Maletta, Engineering Services Technician) following a May 25 very small debris flow. Other monitoring over the year typically occurs quarterly or after high rainfall events. As well, FHSR golf course staff monitor sections of Fairmont Creek daily. The May 25 debris flow transmitted an estimated 50m<sup>3</sup> to 100 m<sup>3</sup> of sediment to the entry of the golf course pond/debris trap.

Golf Course Pond/Debris Trap post event
