## 2012 Cold Spring Creek Dike Inspection Report

Water Course 1: Cold Spring Creek

GPS Number 330

The Dike was inspected on Friday May 11, 2012.

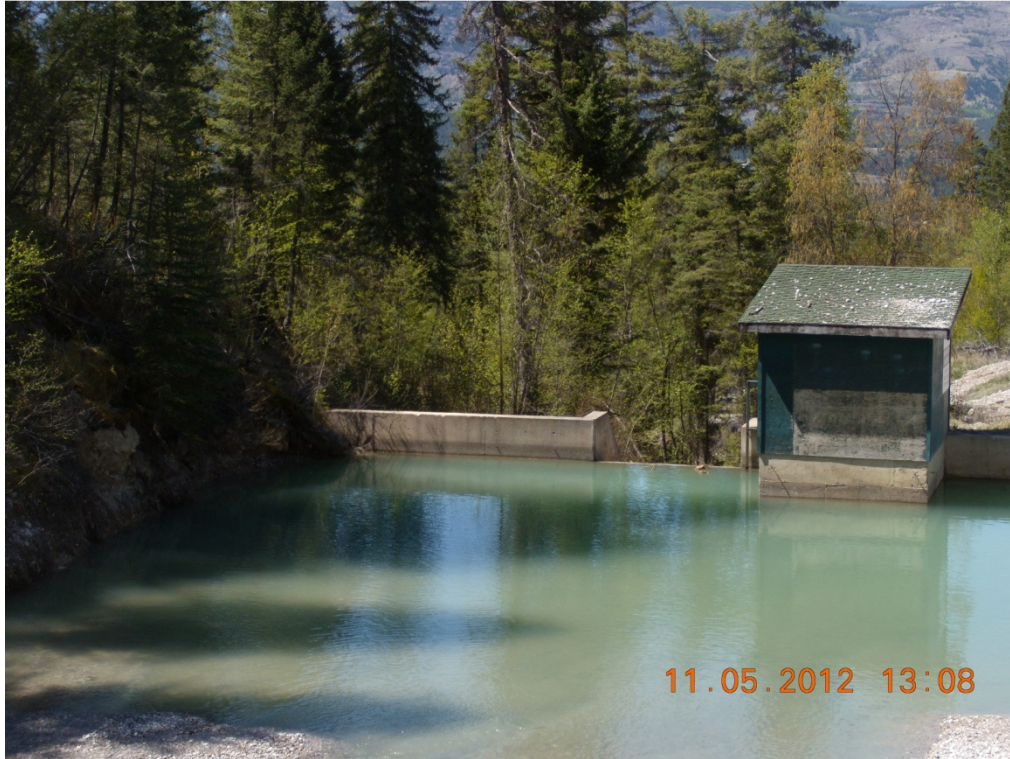
Upstream Dam

The upstream conditions were normal, no debris existed at the entry of 2 culverts that Cold Spring Creek flows through in between the dam and dike protected area. An upstream dam had minimal debris in the reservoir at the time of inspection, as it had been cleared out of deposited material from a debris flow in the summer of 2011. Cold Spring Creek channel had normal levels of gravel and debris in the channel above the dike protected areas.

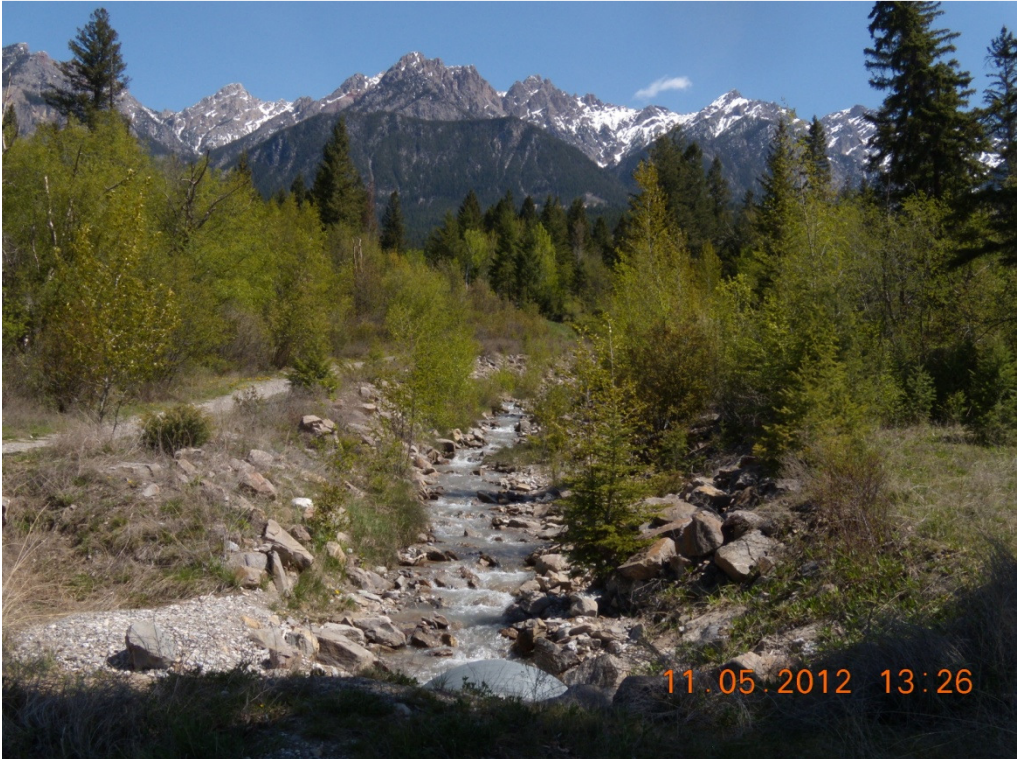
Cold Spring Creek above Riverview Drive (RDEK Maintenance Section)

The dike armoring is in good condition with no signs of erosion or high water over the past 12 months. The flow through the channel is similar to last year. Vegetation is present in the armoring of the dike and removal of brush for the section of dike the RDEK is responsible for, is planned for the fall of 2012 when minimal flow is likely. The brushing was originally scheduled for 2011, but due to RDEK personnel availability, the work was postponed until 2012. Through the Statutory Right of Way agreement established between the RDEK and Riverview North NES 183 Strata, brushing for the dike protected area between Riverview Drive and the entrance to the stilling basin is the responsibility of the Riverview North NES 183 Strata. The Strata has been advised of their maintenance responsibility for the dike works along Cold Spring Creek, and will be provided with a copy of this report. (please see attached photos)

Removal of vegetation from the RDEK section of the dike that the RDEK is responsible for, will be executed in the fall of 2012. Gravel removals from the stilling basin will also be undertaken in 2012, a Section 9 Works in and around a Stream, will be submitted before the end of June for removals in the fall of 2012

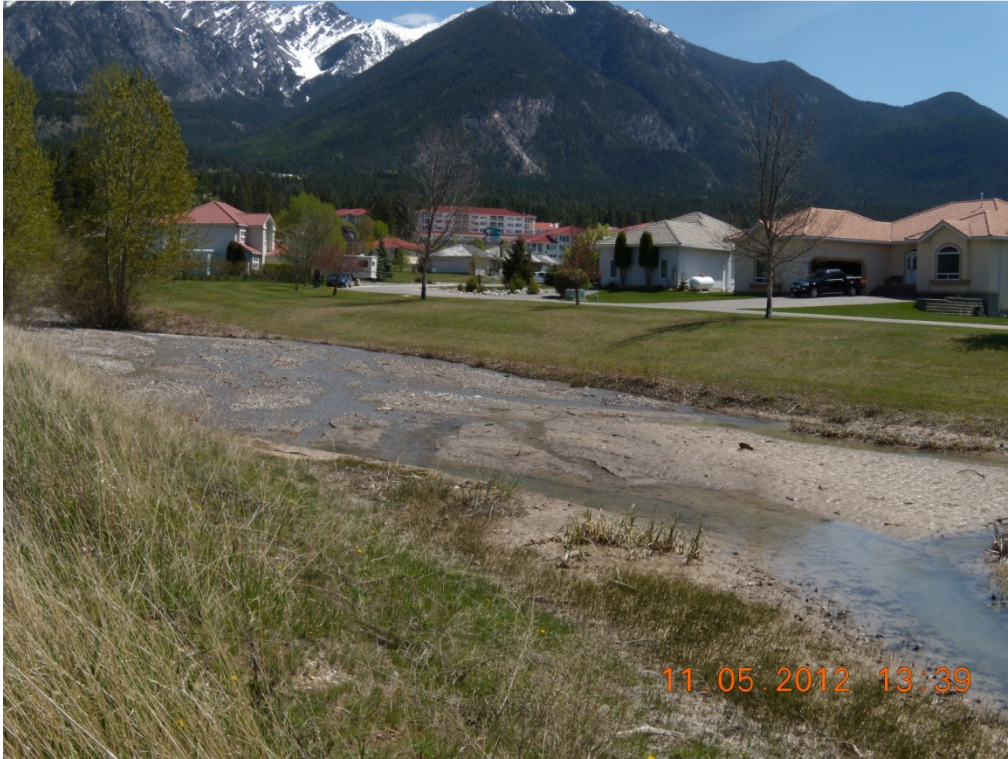
Cold Spring Creek Stilling Basin Gravels Deposition
