Fairmont Creek 2019 Annual Dike Inspection Report

May 8, 2019 Fairmont Creek Dike Inspection

August 20, 2019 Fairmont Creek Dike Inspection

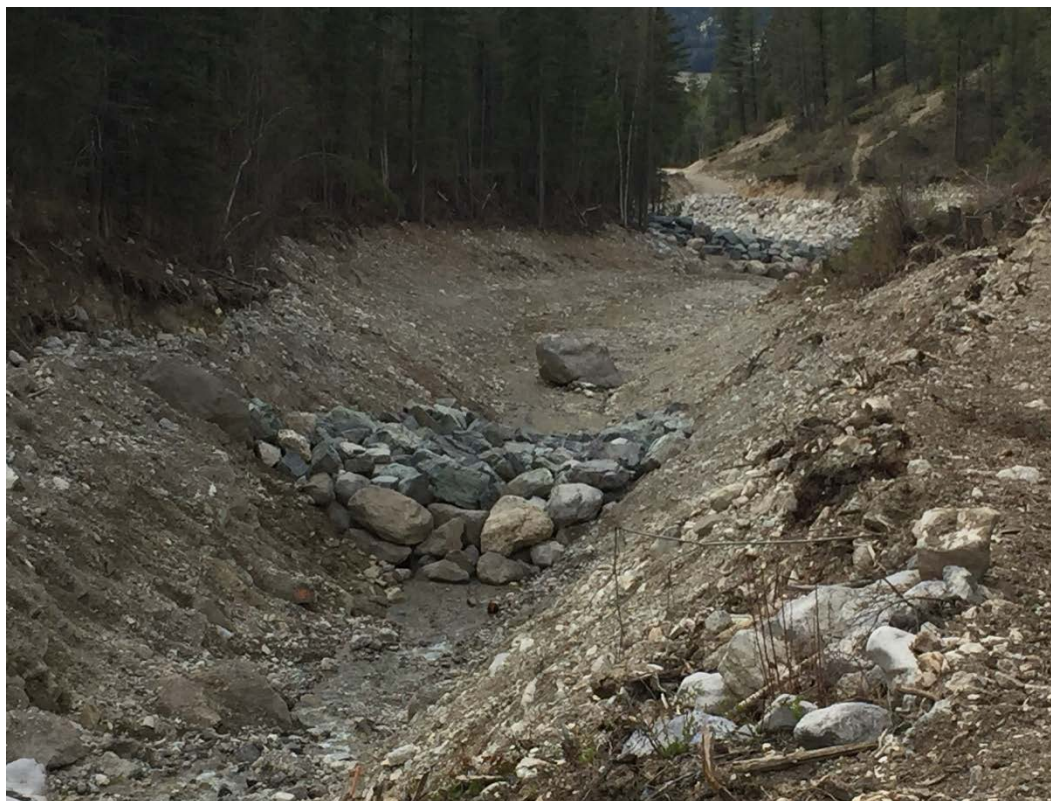
Photo 2: The uppermost weir in the system, Weir #1, is in the foreground; Weir #2 is seen in the background.

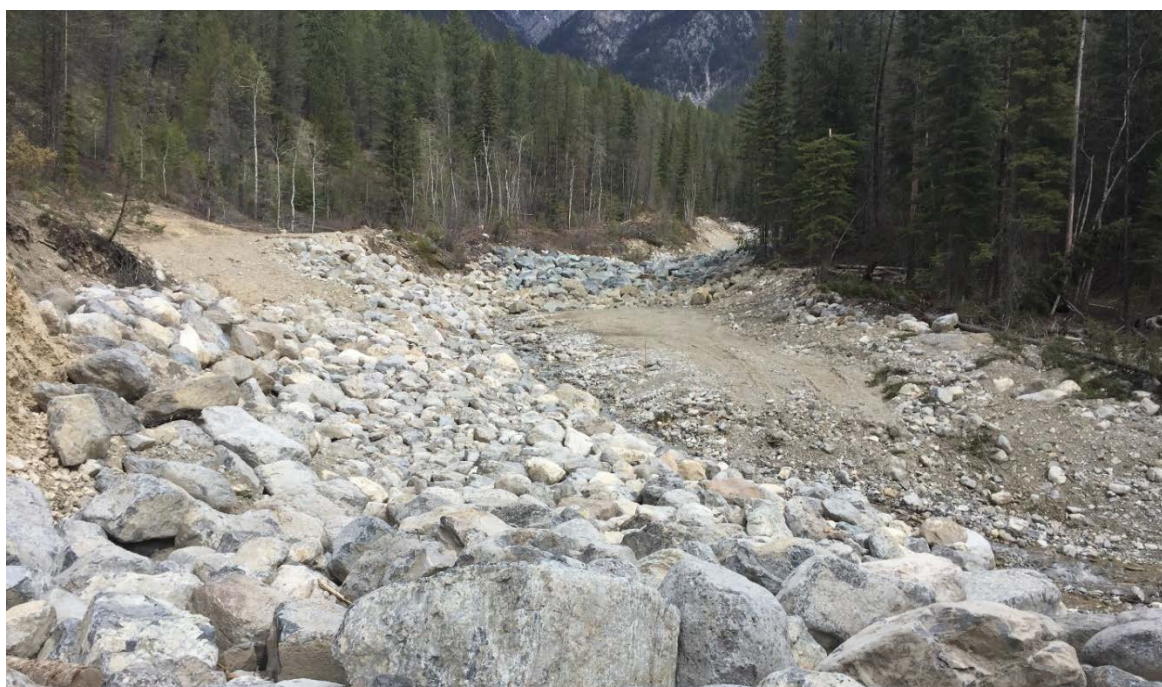
Photo 3: Looking upstream at Weir #2 from the bank armoring below.

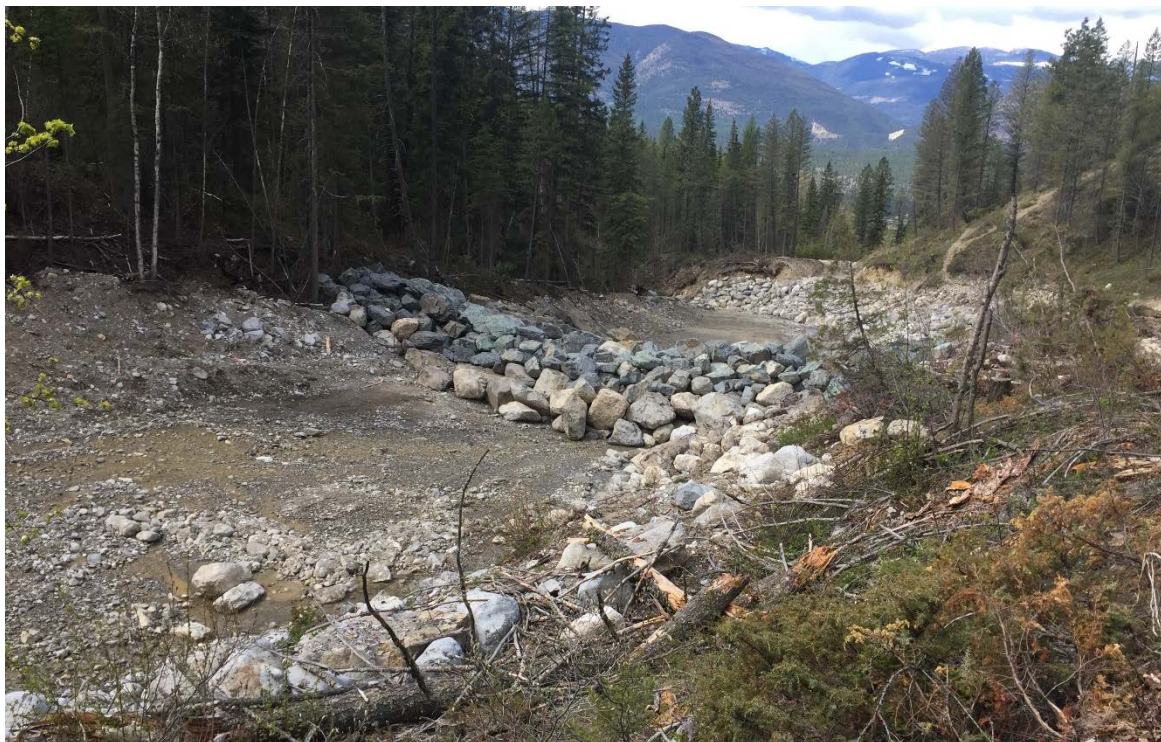
Photo 4: Weir #2 in the foreground with bank armoring in the background.

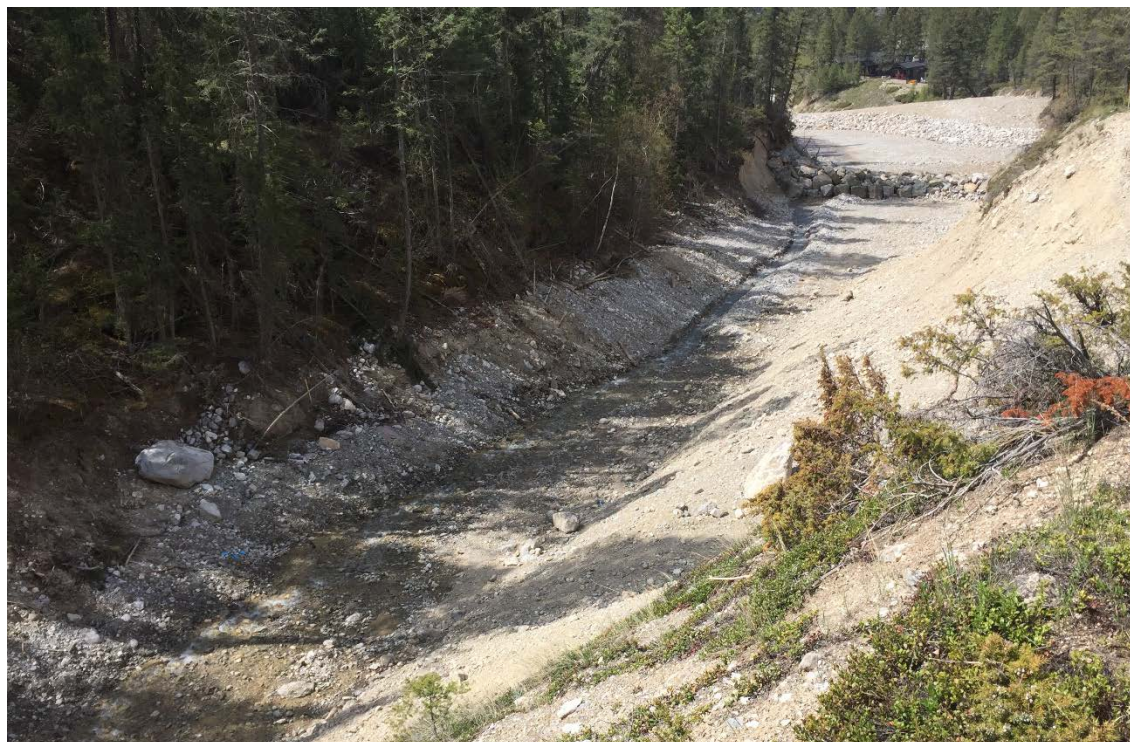
Photo 5: Weir #3 with bank armoring slightly past it.

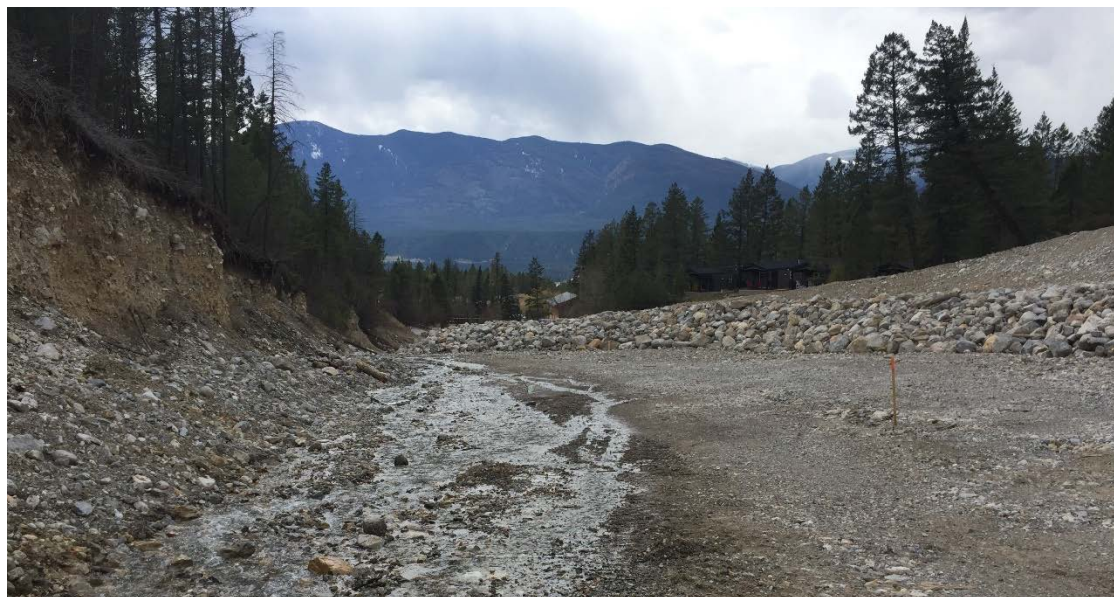
Photo 6: Bank armouring below Weir #3.

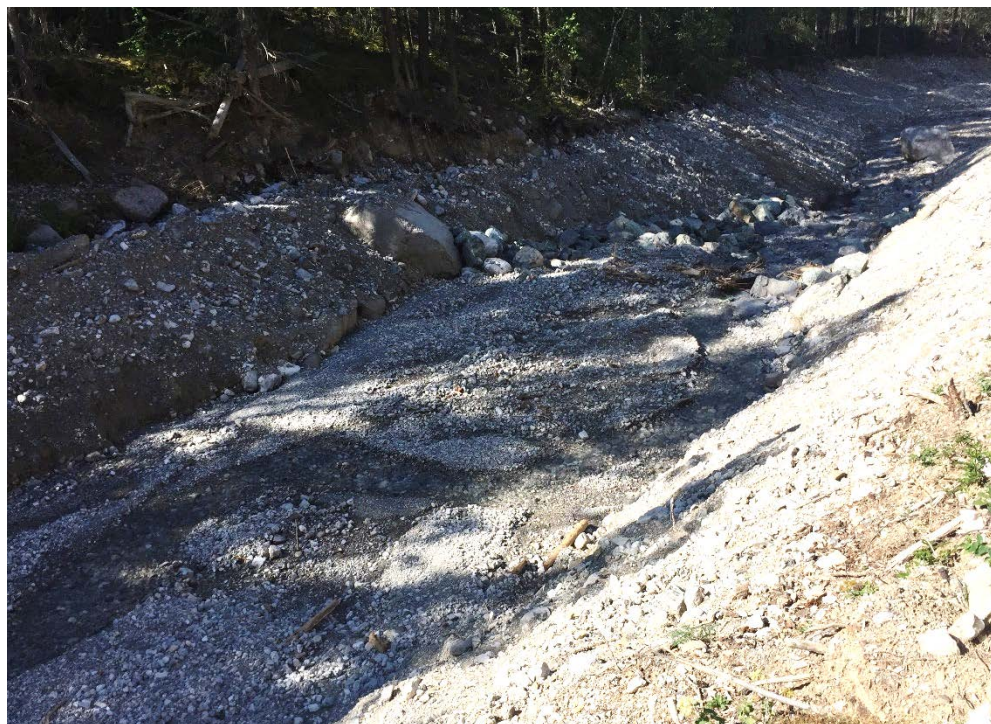
Photo 7: Weir #1, looking downstream. The storage area upstream of the weir was filled to capacity with approximately 1,225 cubic metres of debris flood material.

As noted above, the uppermost debris trap was filled to capacity. Approximately 1,225 cubic metres of debris was removed from the trap and access to the upper weirs was improved. EMBC has approved funds to assist with the debris removal. The work was completed in November and December, 2019 by Ralph Stewart Contracting.

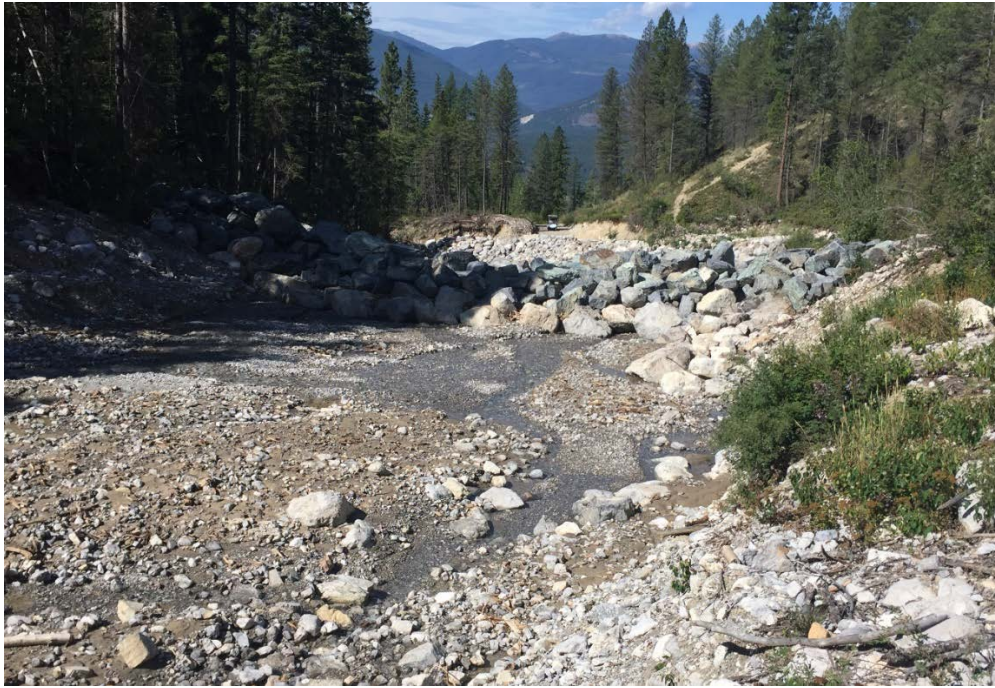
Photo 8: Weir #2, looking downstream. There is a small amount of material in front of the weir that was eroded between weirs #1 and #2.

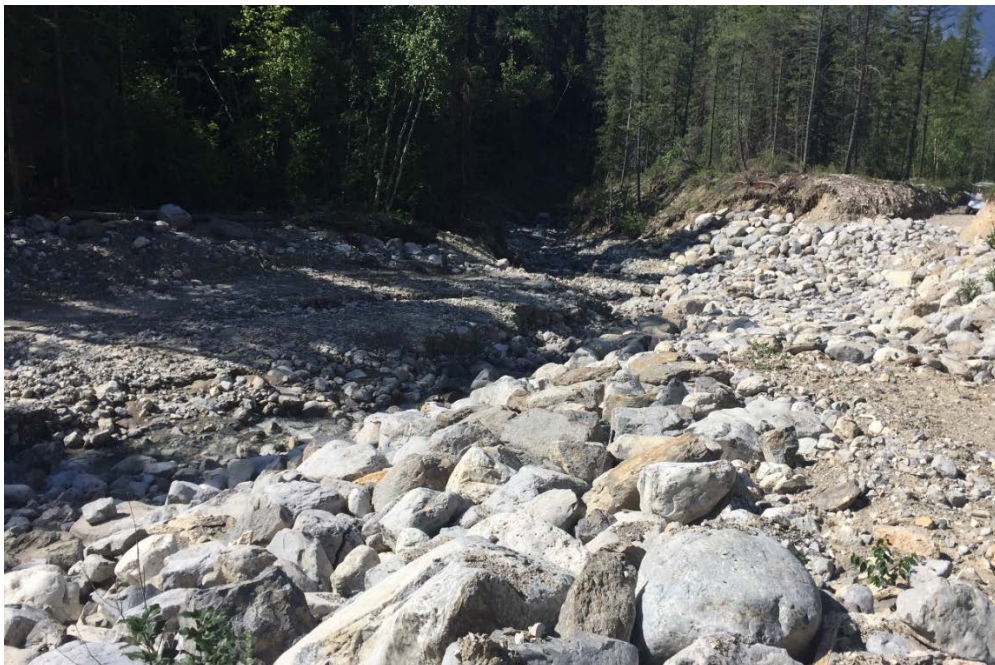
Photo 9: Bank protection downstream of Weir #2. Note the eroded channel below the protected bank. This material was transported downstream.

Excess easily erodible material was removed from downstream of Weir #2. This was completed to prevent this material from being transported downstream and taking up storage space in front of Weir #3. This work was funded under the Fairmont Creek Debris Flow Mitigation Project Phase 2 grant from EMBC. Approximately 1,450 cubic metres of material was removed.

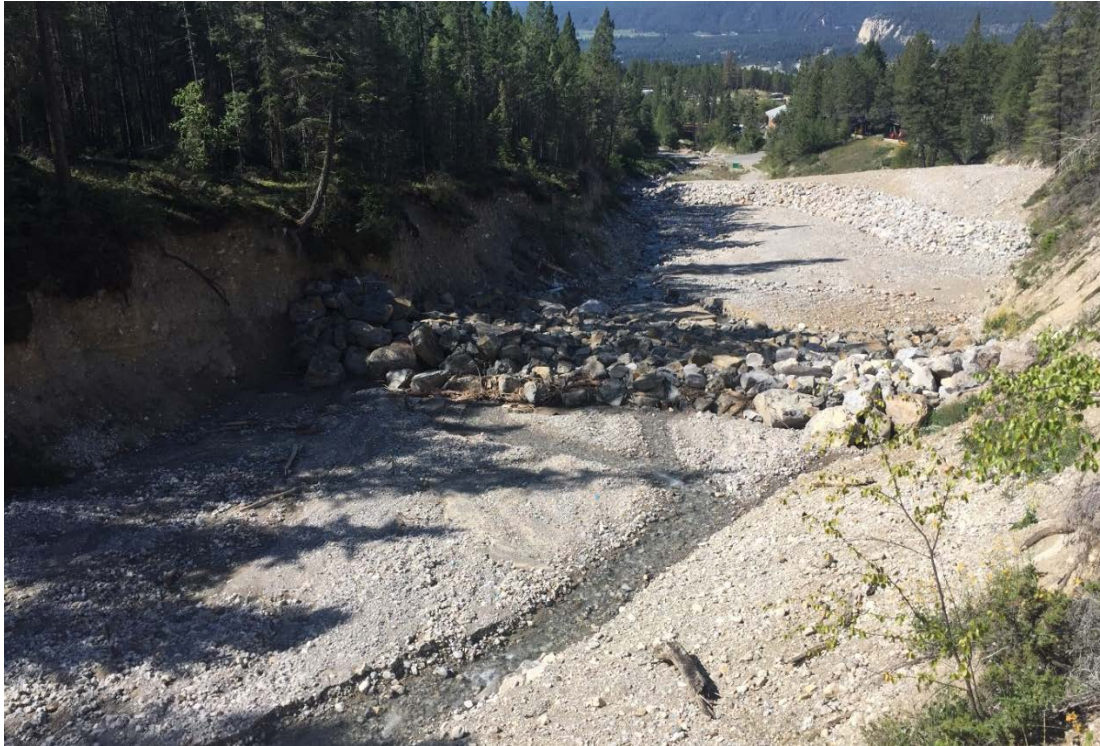
Photo 10: Weir #3, Looking downstream. There is a small amount of material deposited in front of the weir that came from the eroded channel upstream.

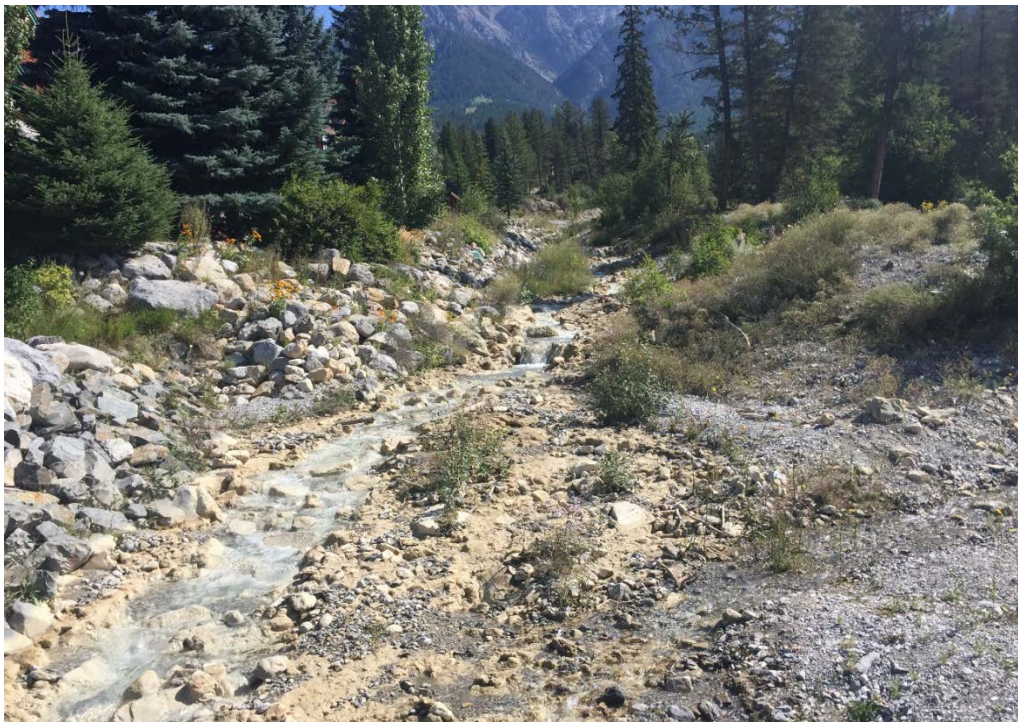
Photo 11: Looking upstream from the cart path bridge (upper extent of the Phase 1 works). No appreciable change from 2018.

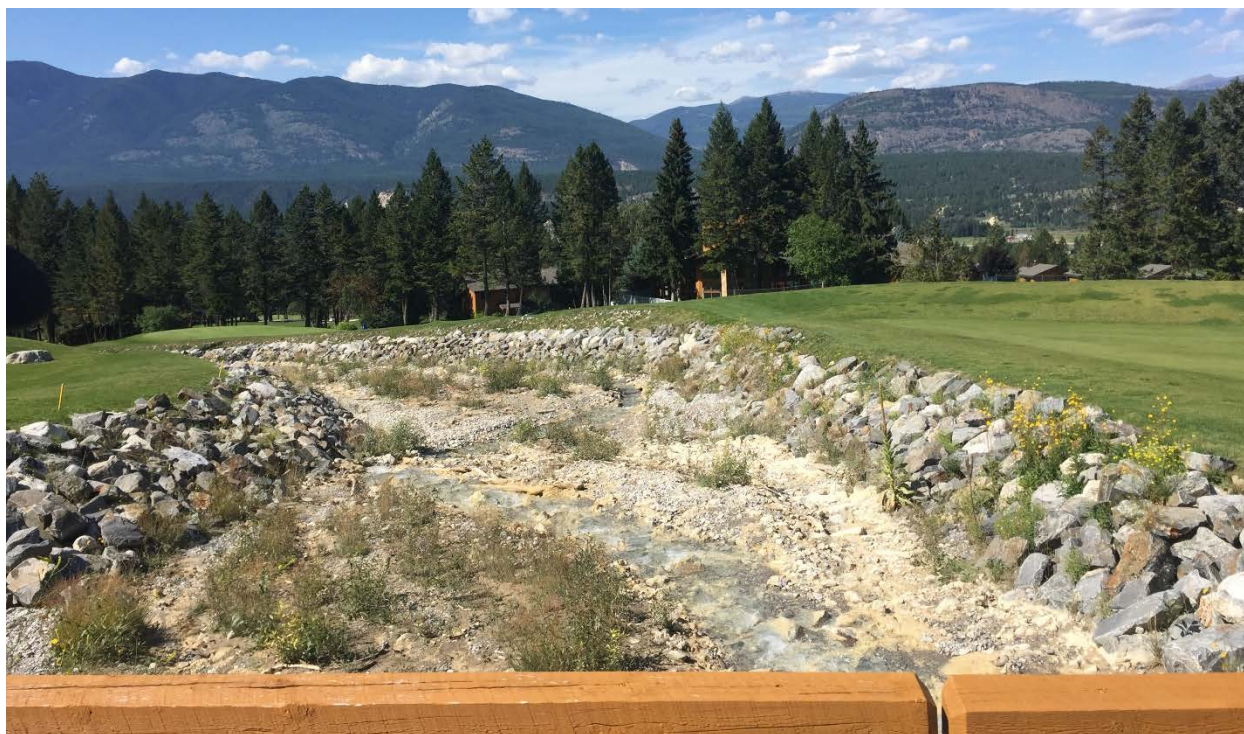
Photo 12: Looking downstream from the cart path bridge. No appreciable change from 2018.

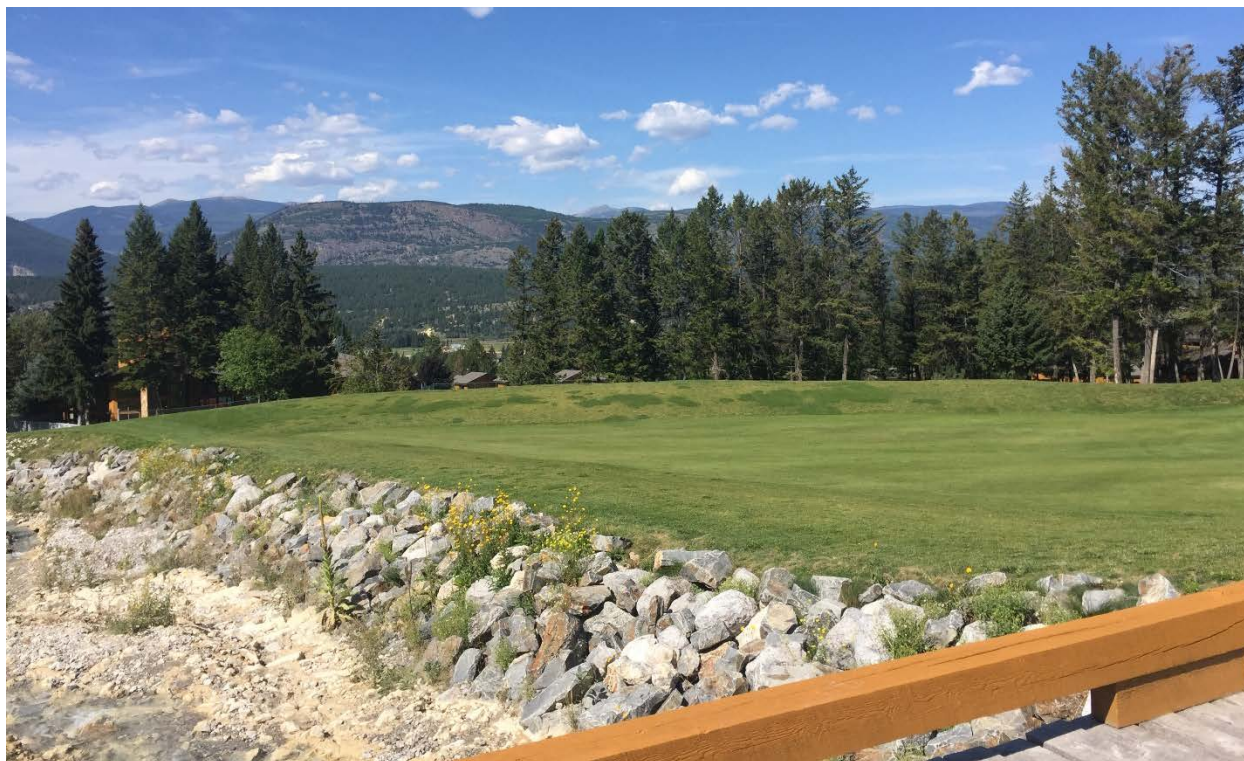
Photo 13: Right hand berm. The berm is in good condition.

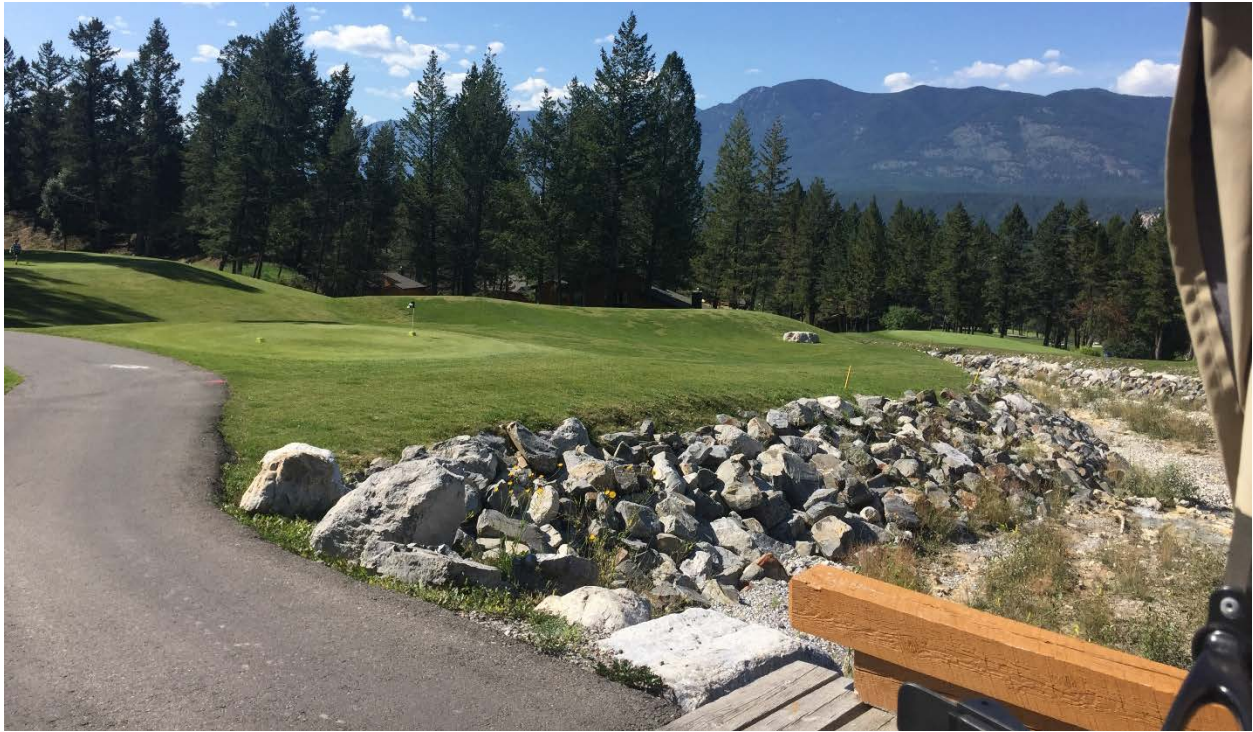
Photo 14: Left hand berm. The berm is in good condition.

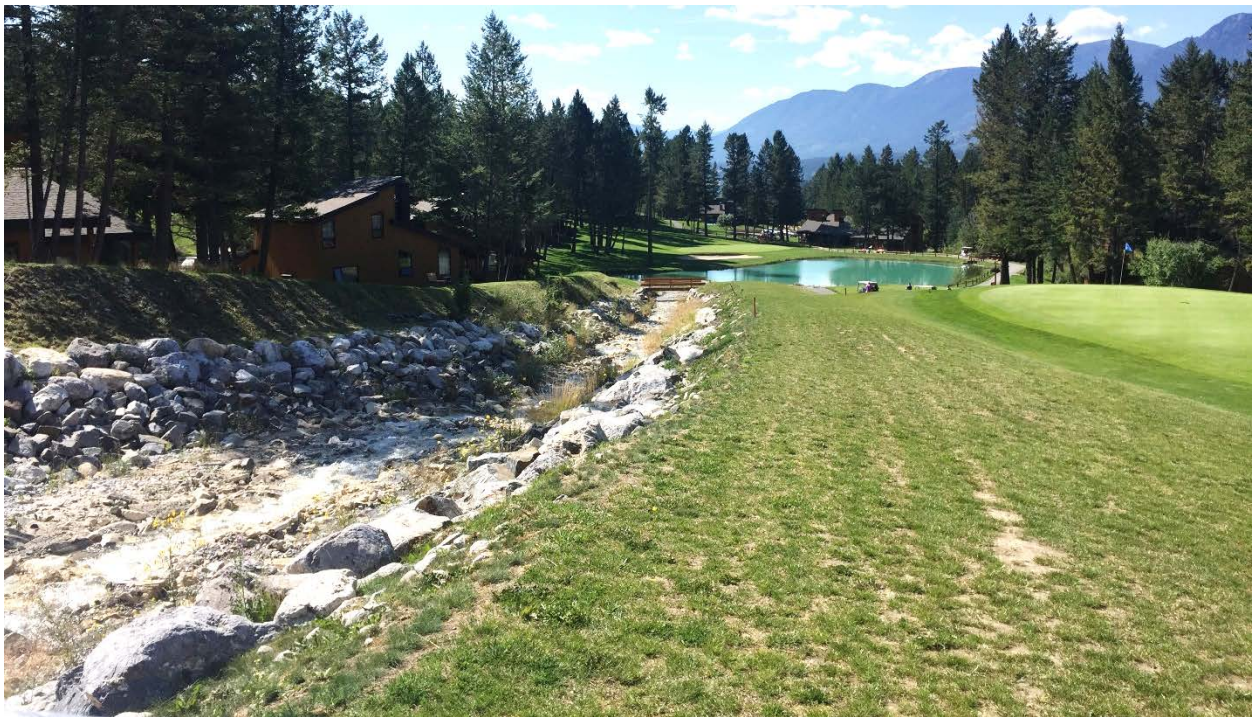
Photo 15: Looking downstream. The berms and bank protection on both sides are in good condition.

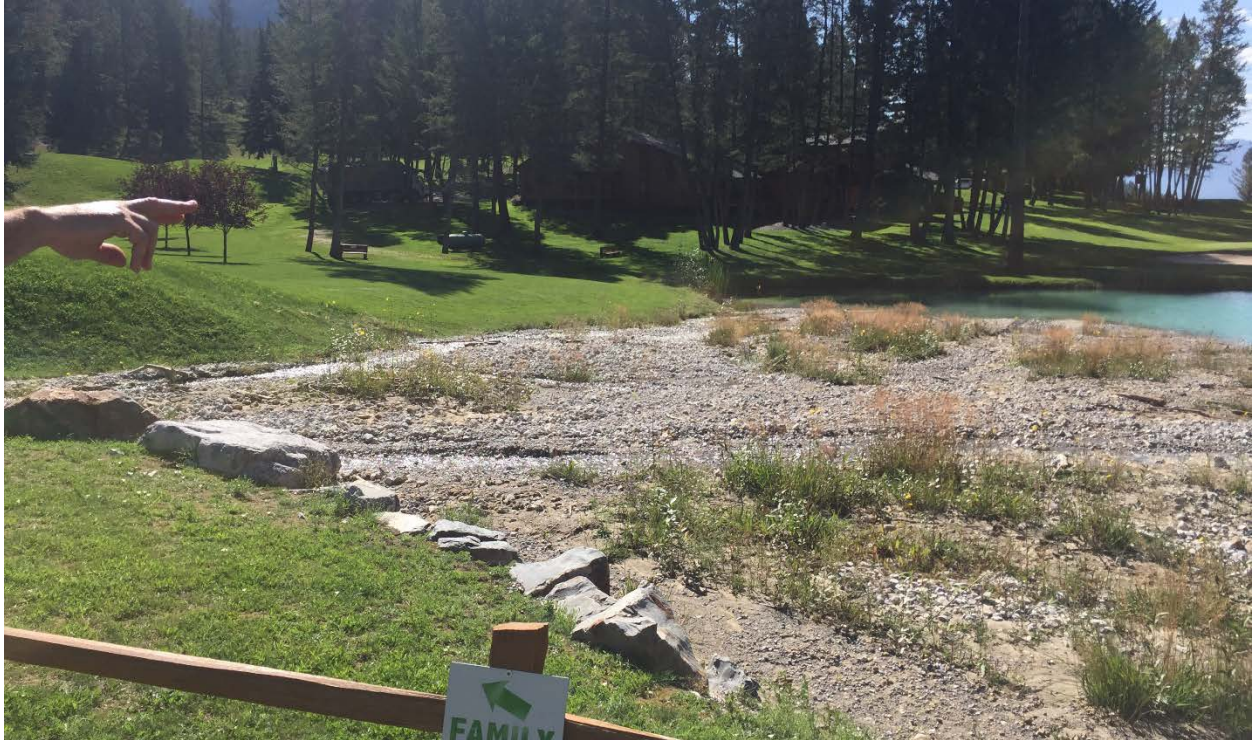
Photo 16: Entrance to the debris pond. There is a very small amount of locally eroded material recently deposited.

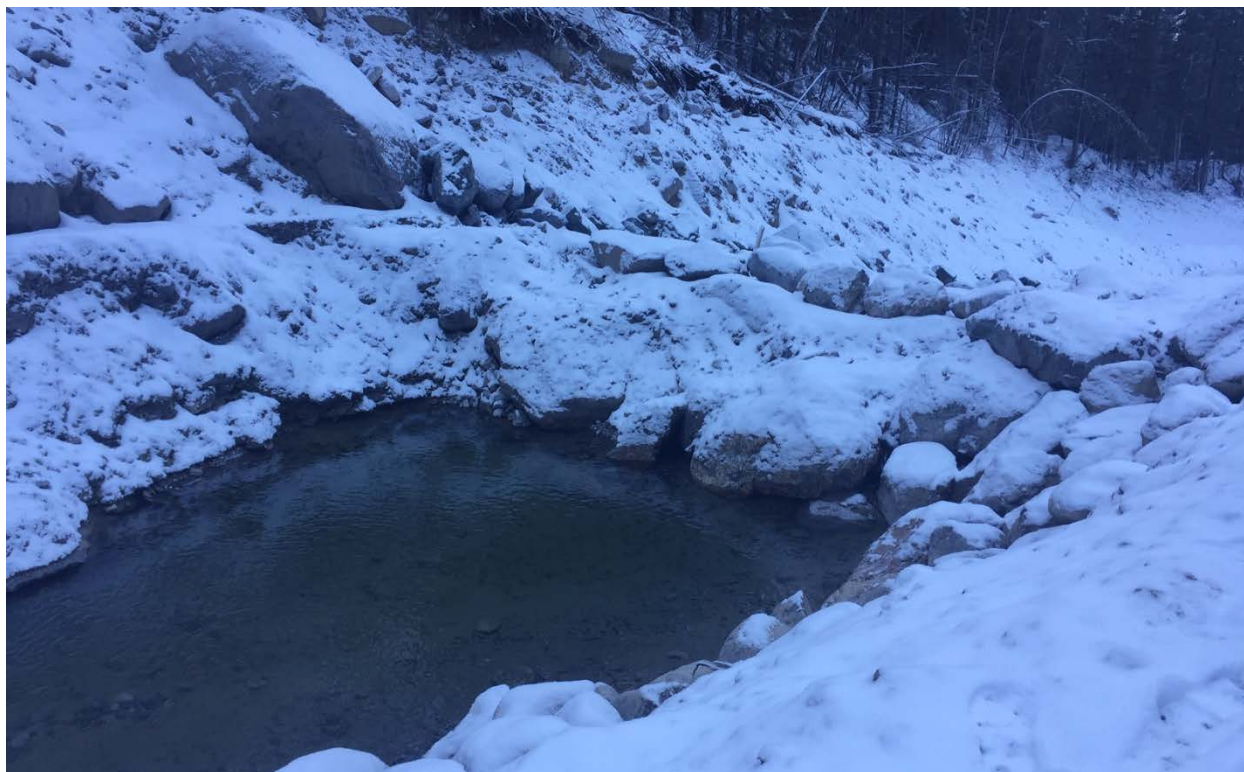
Photo 16: Weir #1 basin cleared of debris. December 9, 2020.

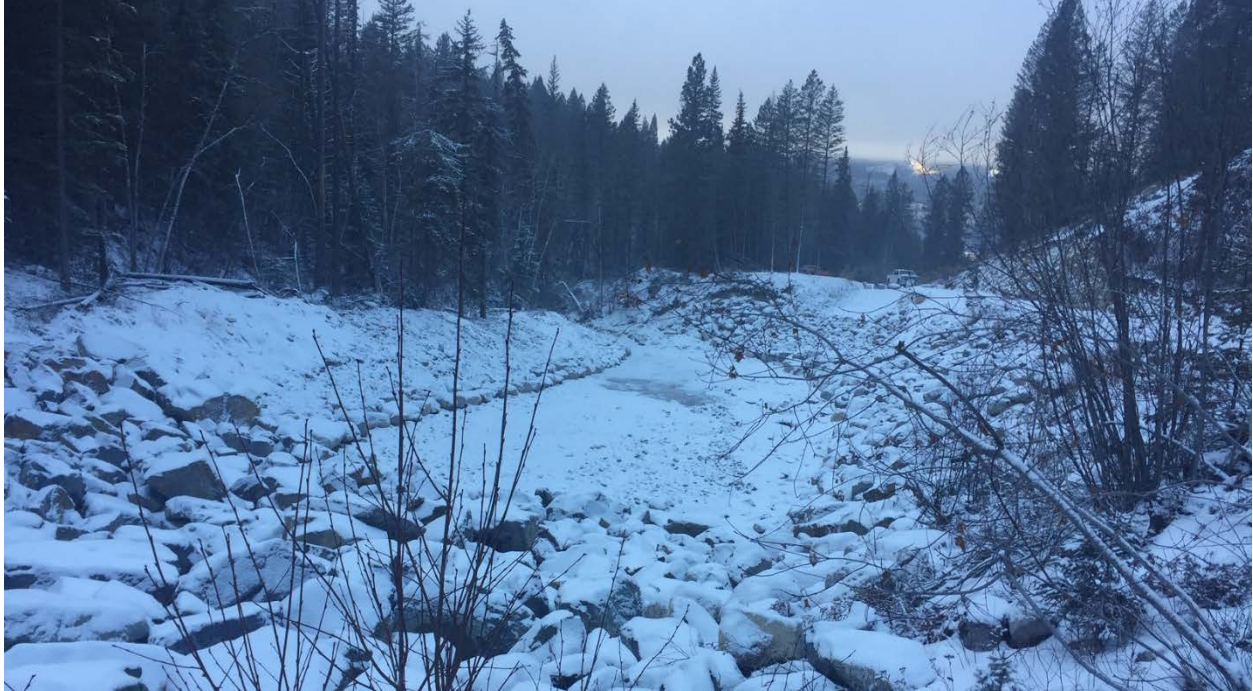
Photo 17: Creek channel below Weir #2. December 9, 2019.
