DEBRIS TORRENT CONCERNS
COLD SPRING AND FAIRMONT CREEKS

By: Dwain Boyer, P.Eng.
Water Management Branch
Nelson, B.C.

March 8, 1989

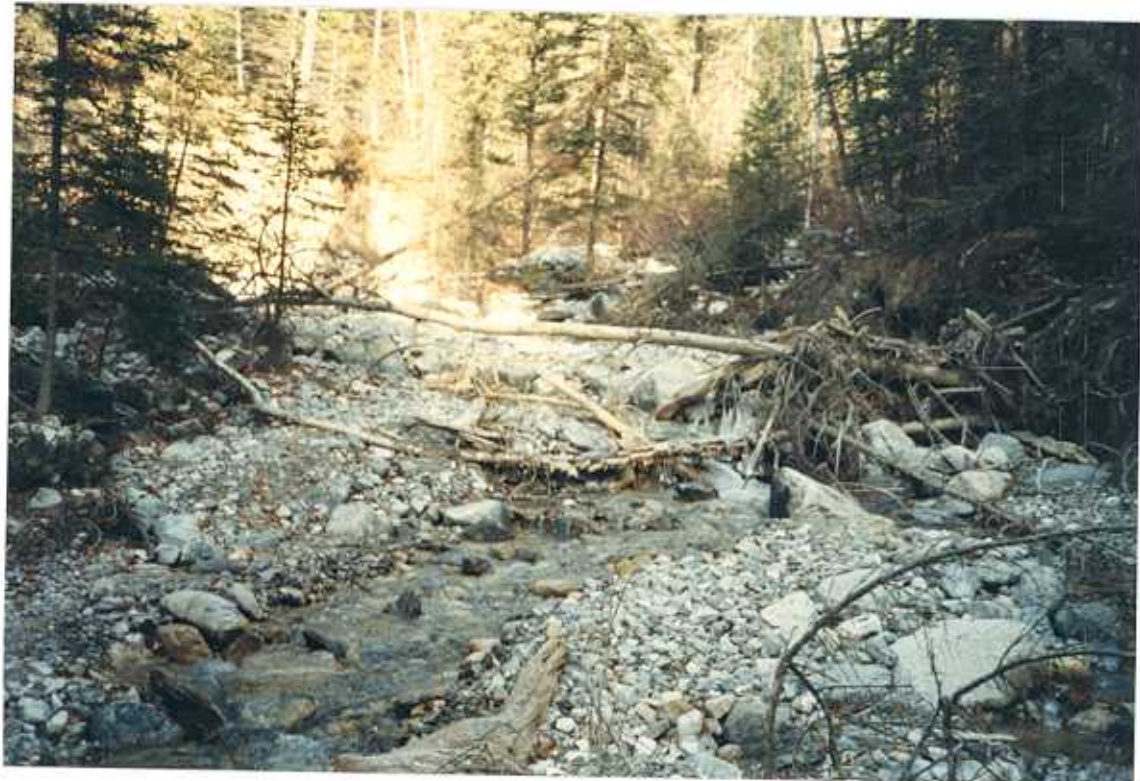
Photo #1 - Looking upstream approximately 600 m upstream from the road crossing (see Photo # 6). Note: excessive material in channel available for movement downstream; high bank in the left background confines flow from moving to the north at this point

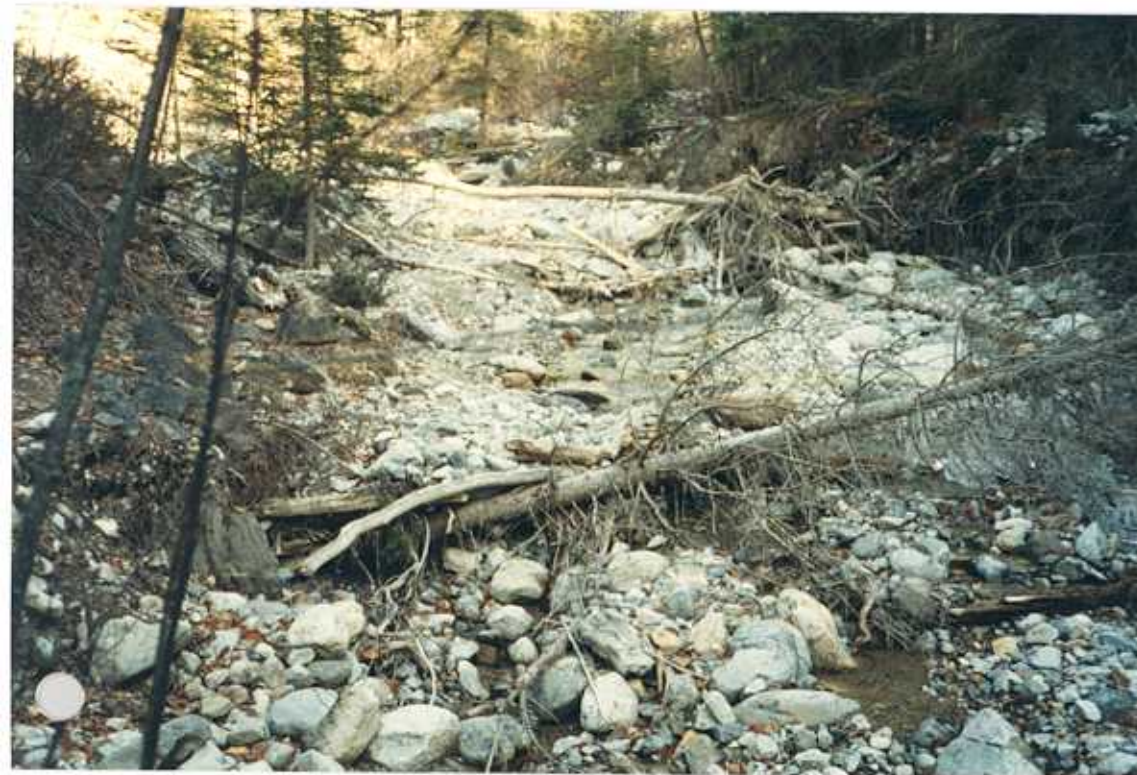
Photo #2 - Looking upstream approximately 595 m upstream from road crossing. Note gravel and cobble sized material recently deposited behind tree in channel

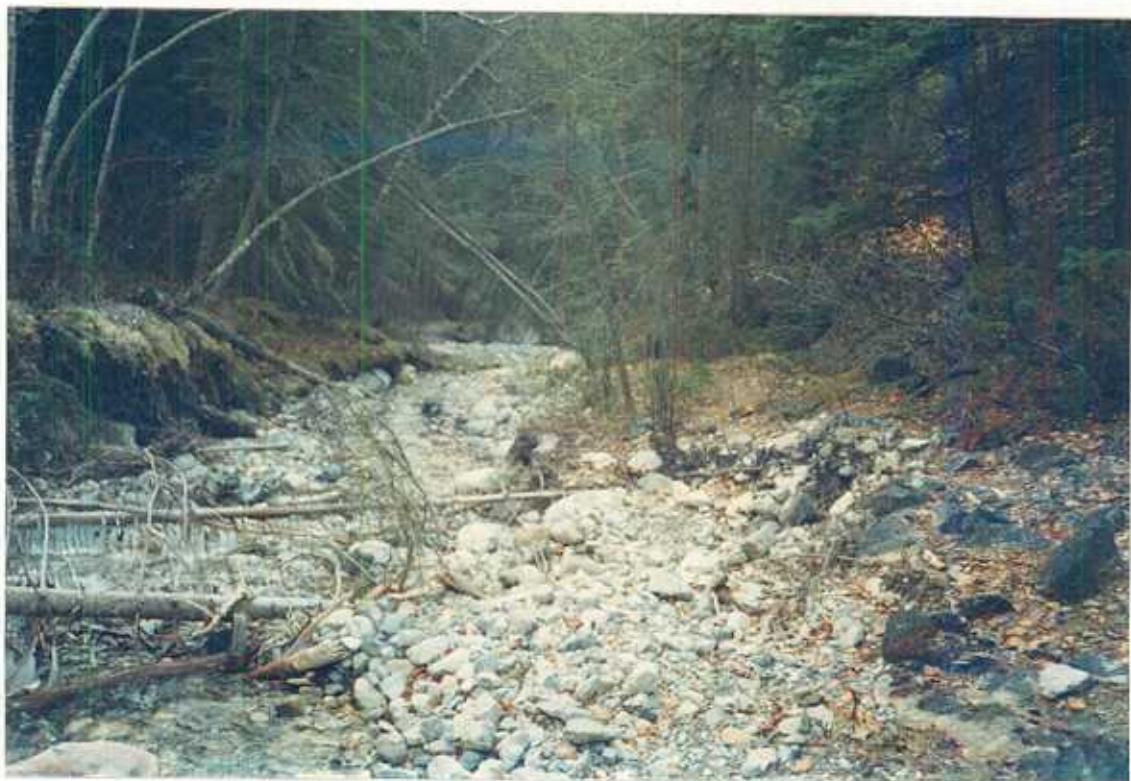
Photo #3 - Looking downstream from 595 m upstream from
road crossing

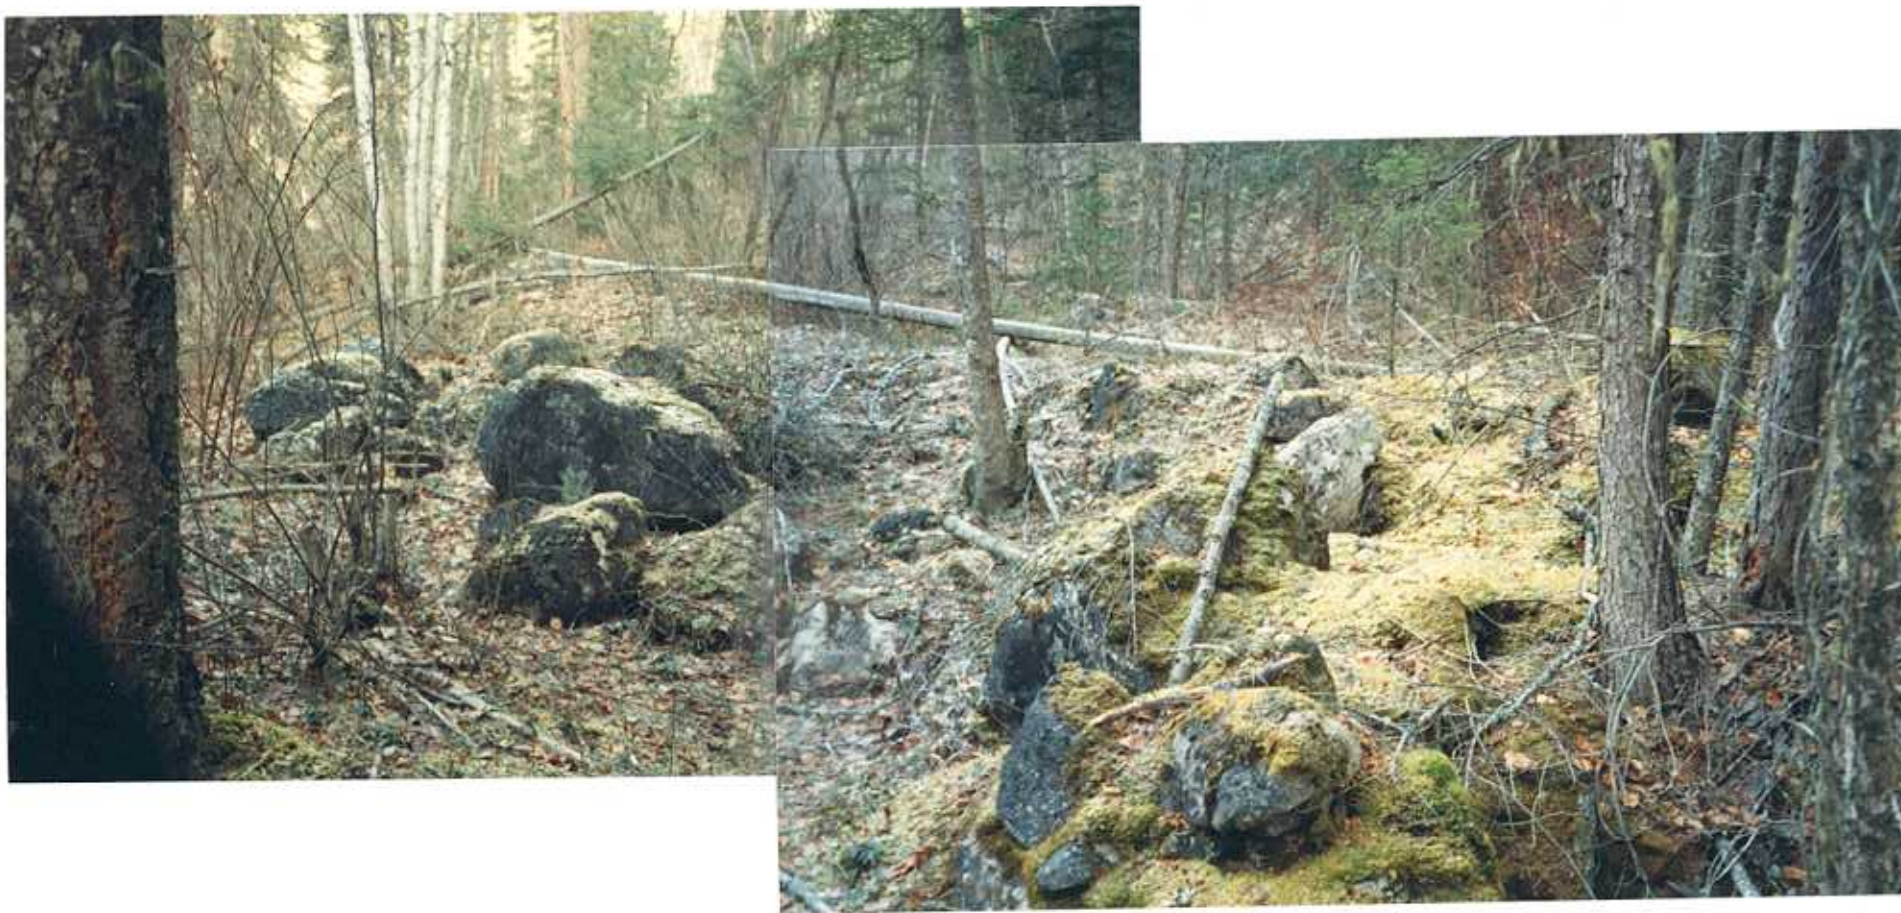
Photo #4 - Remnants of a debris flow, approximately 610 m upstream from road crossing on the southside of the valley floor. These remnants are in the right background of Photo #1

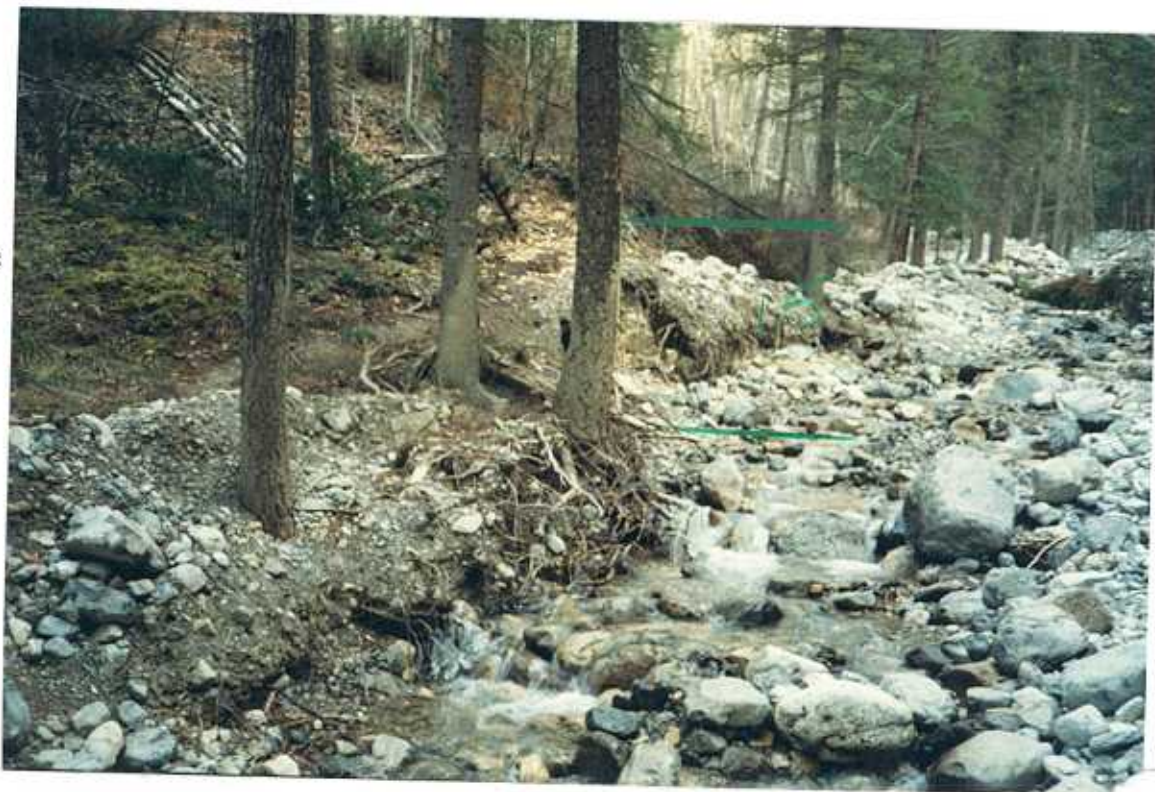
Photo #5 - Looking upstream at north (right) bank approximately 200 m upstream from road crossing. Note mud marks on trees 1.5 m above the ground

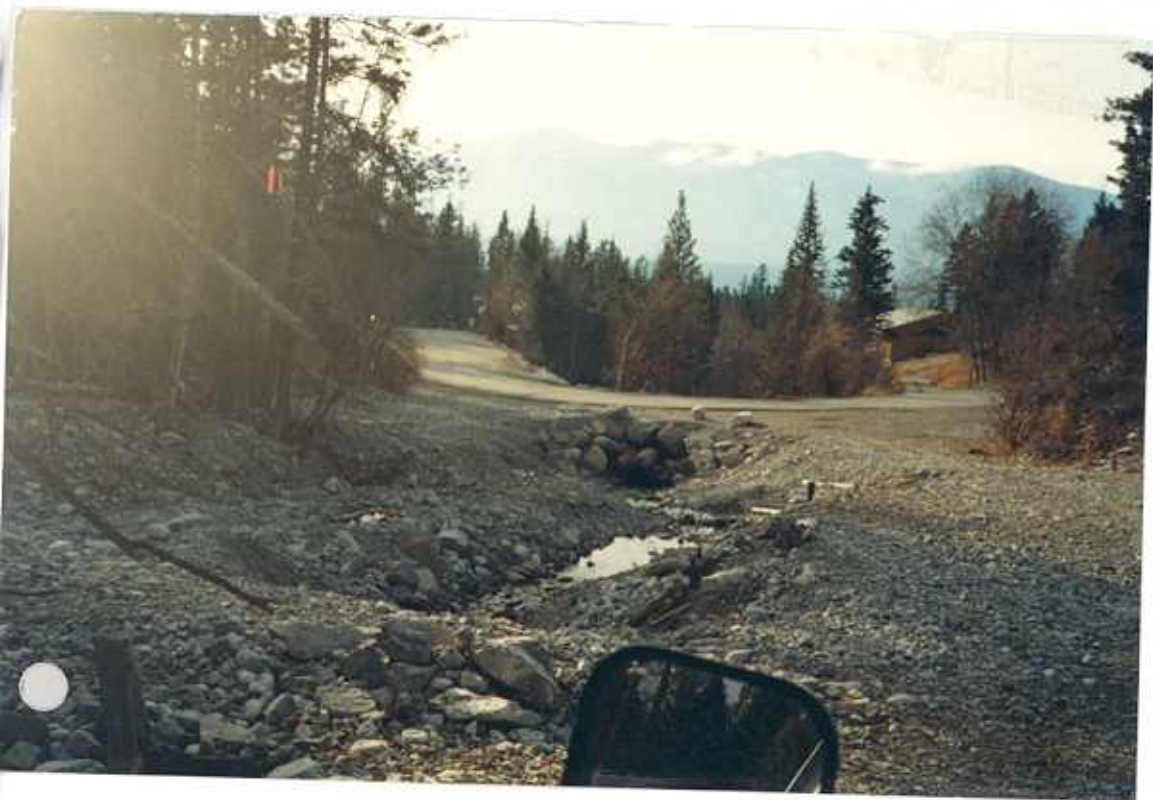
Photo #6 - Looking downstream at road crossing (see attached location map)

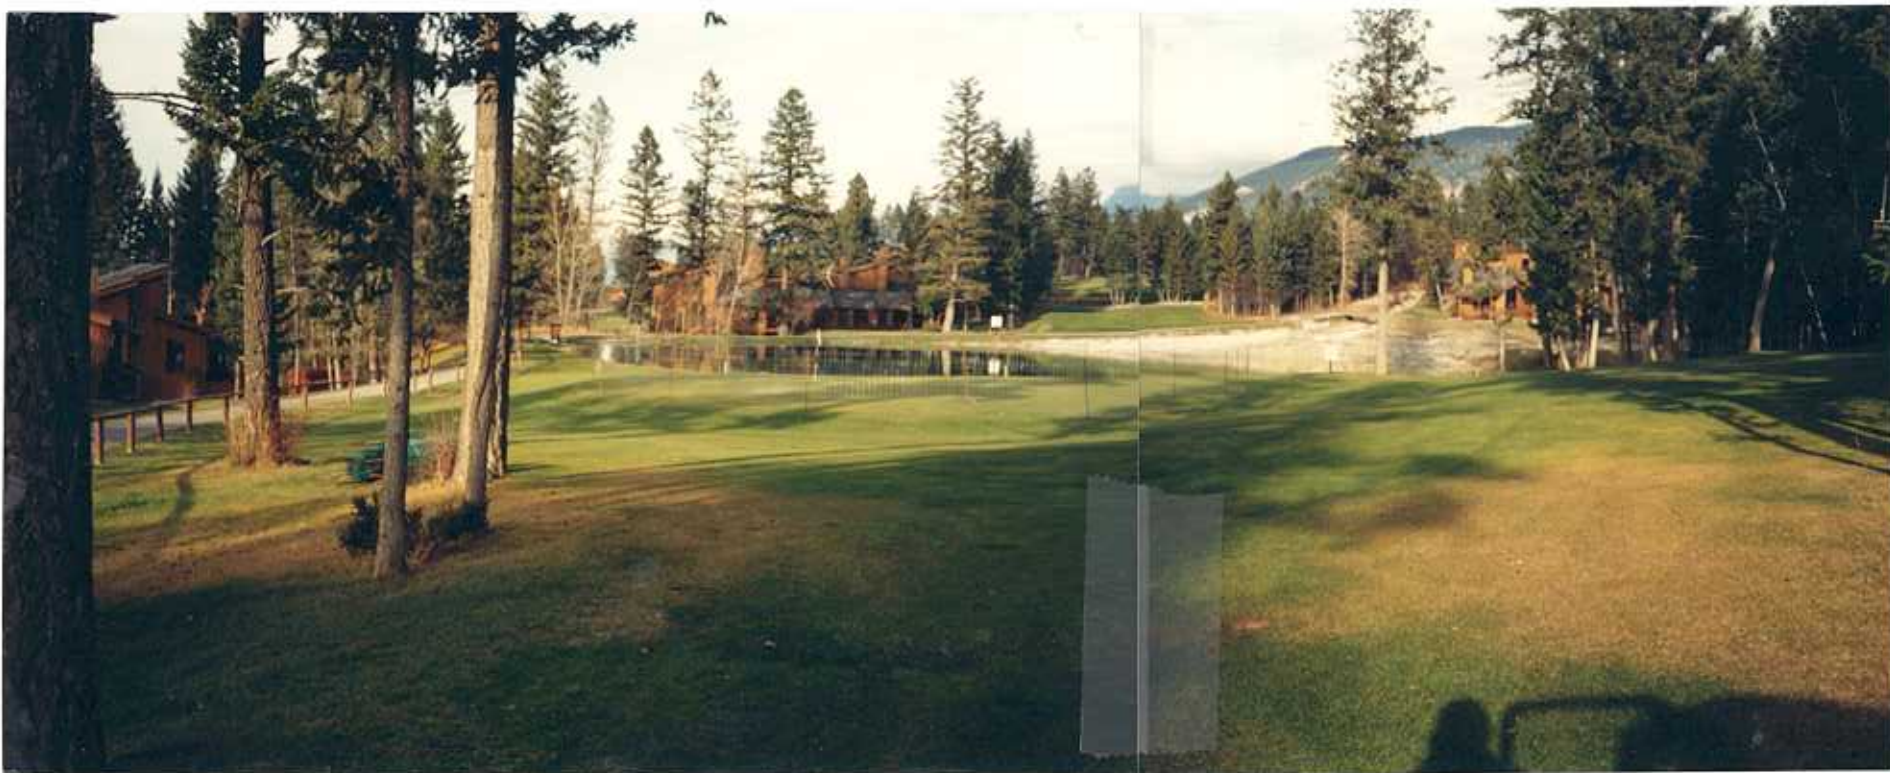
Photo #7 - Looking north of first pond on golf course Fairmont Creek enters
the pond from the right side of photo. This and the next pond downstream
were filled with sediment during a recent debris torrent

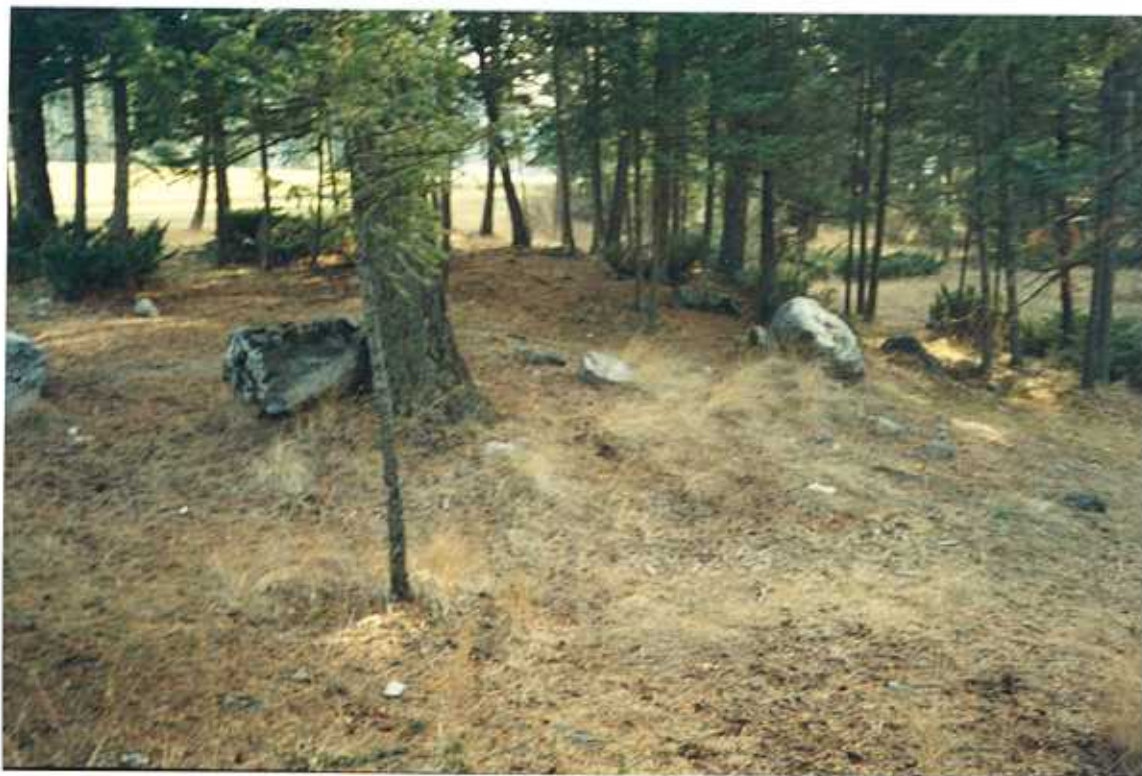
Photo #8 - Photo shows
large boulders on land
surface and bent trees

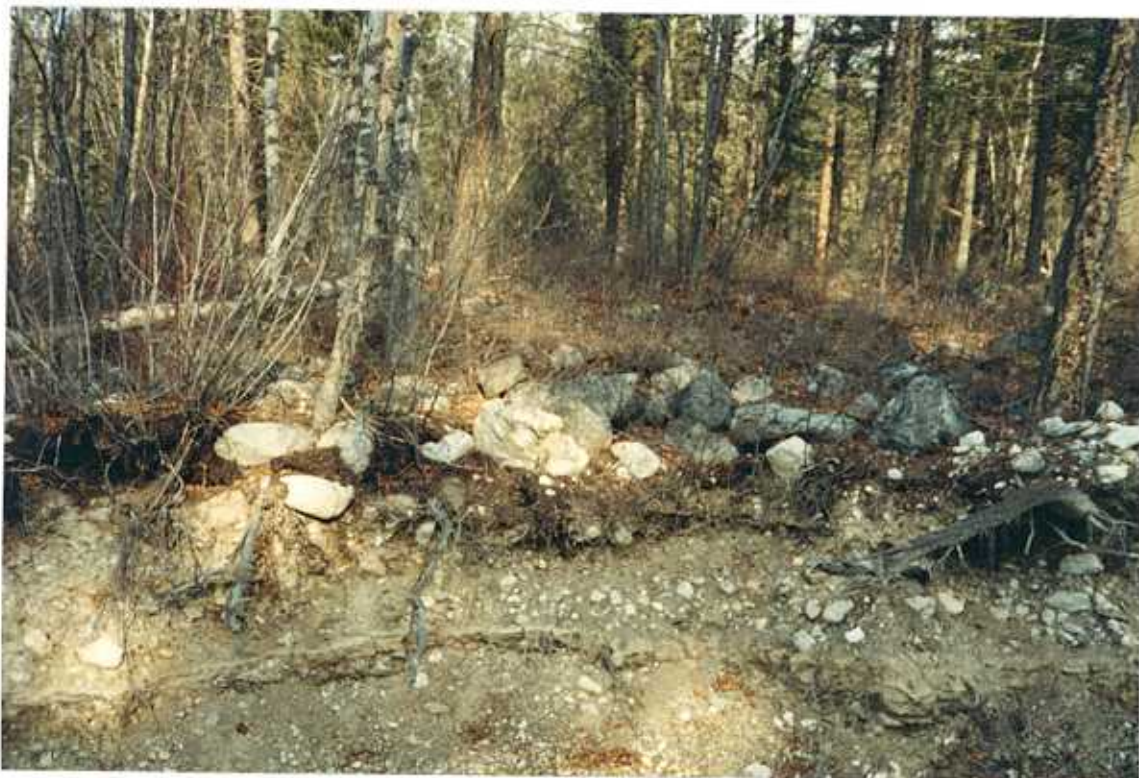
Photo #1 - View of remnants of a recent debris torrent on the
valley floor adjacent ~~to~~ north of the intake pond
~~and~~

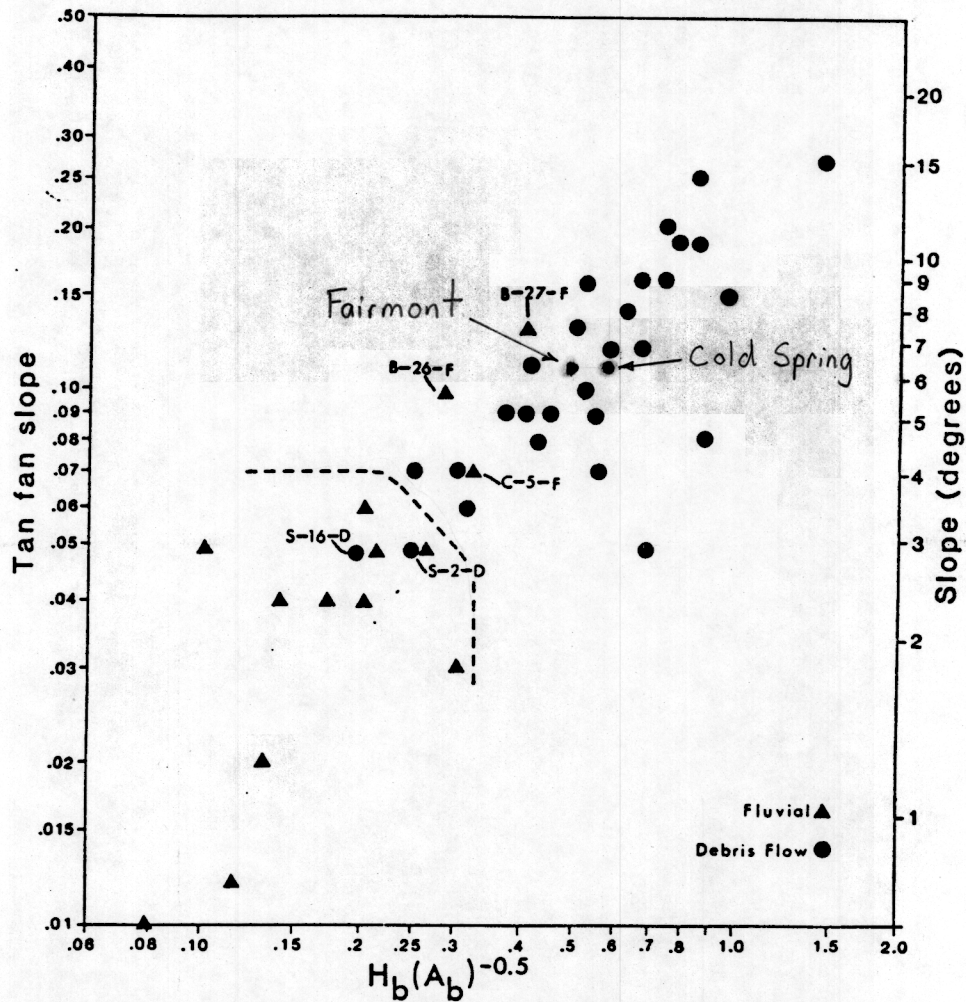
- (b) The presence of debris flow levees and lobes on the fan surfaces (Attachment 2 and air photographs BC 78147 nos. 149 & 150).
- (c) The presence of oversized lone boulders on the fan surface.
- (d) Steep 'active' slopes in the upper drainage basin .
- (e) The presence of several sources of sediment in the upper drainage which could be mobilized into a debris torrent (air photographs).
- (f) Methodology developed by Jackson et al (2) suggests that both the Cold Spring and Fairmont Creek fans are affected by debris flow processes (Attachment 3).

Figure 7. Plot of tangent of fan slope versus Melton's ruggedness number ($H_b A_b^{-0.5}$) for 42 fans from three study areas. H_b is basin height measured from fan apex to basin high point, and A_b is basin area above fan apex. B refers to Bow Valley; S, Kananaskis Valley/Spray Lakes Reservoir; C, Crowsnest Pass. Broken line separates fans presently having and presently lacking debris flow hazard.
