February 2, 1995

FAIRMONT HOT SPRINGS RESORT AREA **Coldspring Creek - Highway 93 Crossing**

COLDSPRING CREEK - HIGHWAY 93 CROSSING

DEBRIS FLOW PLANNING

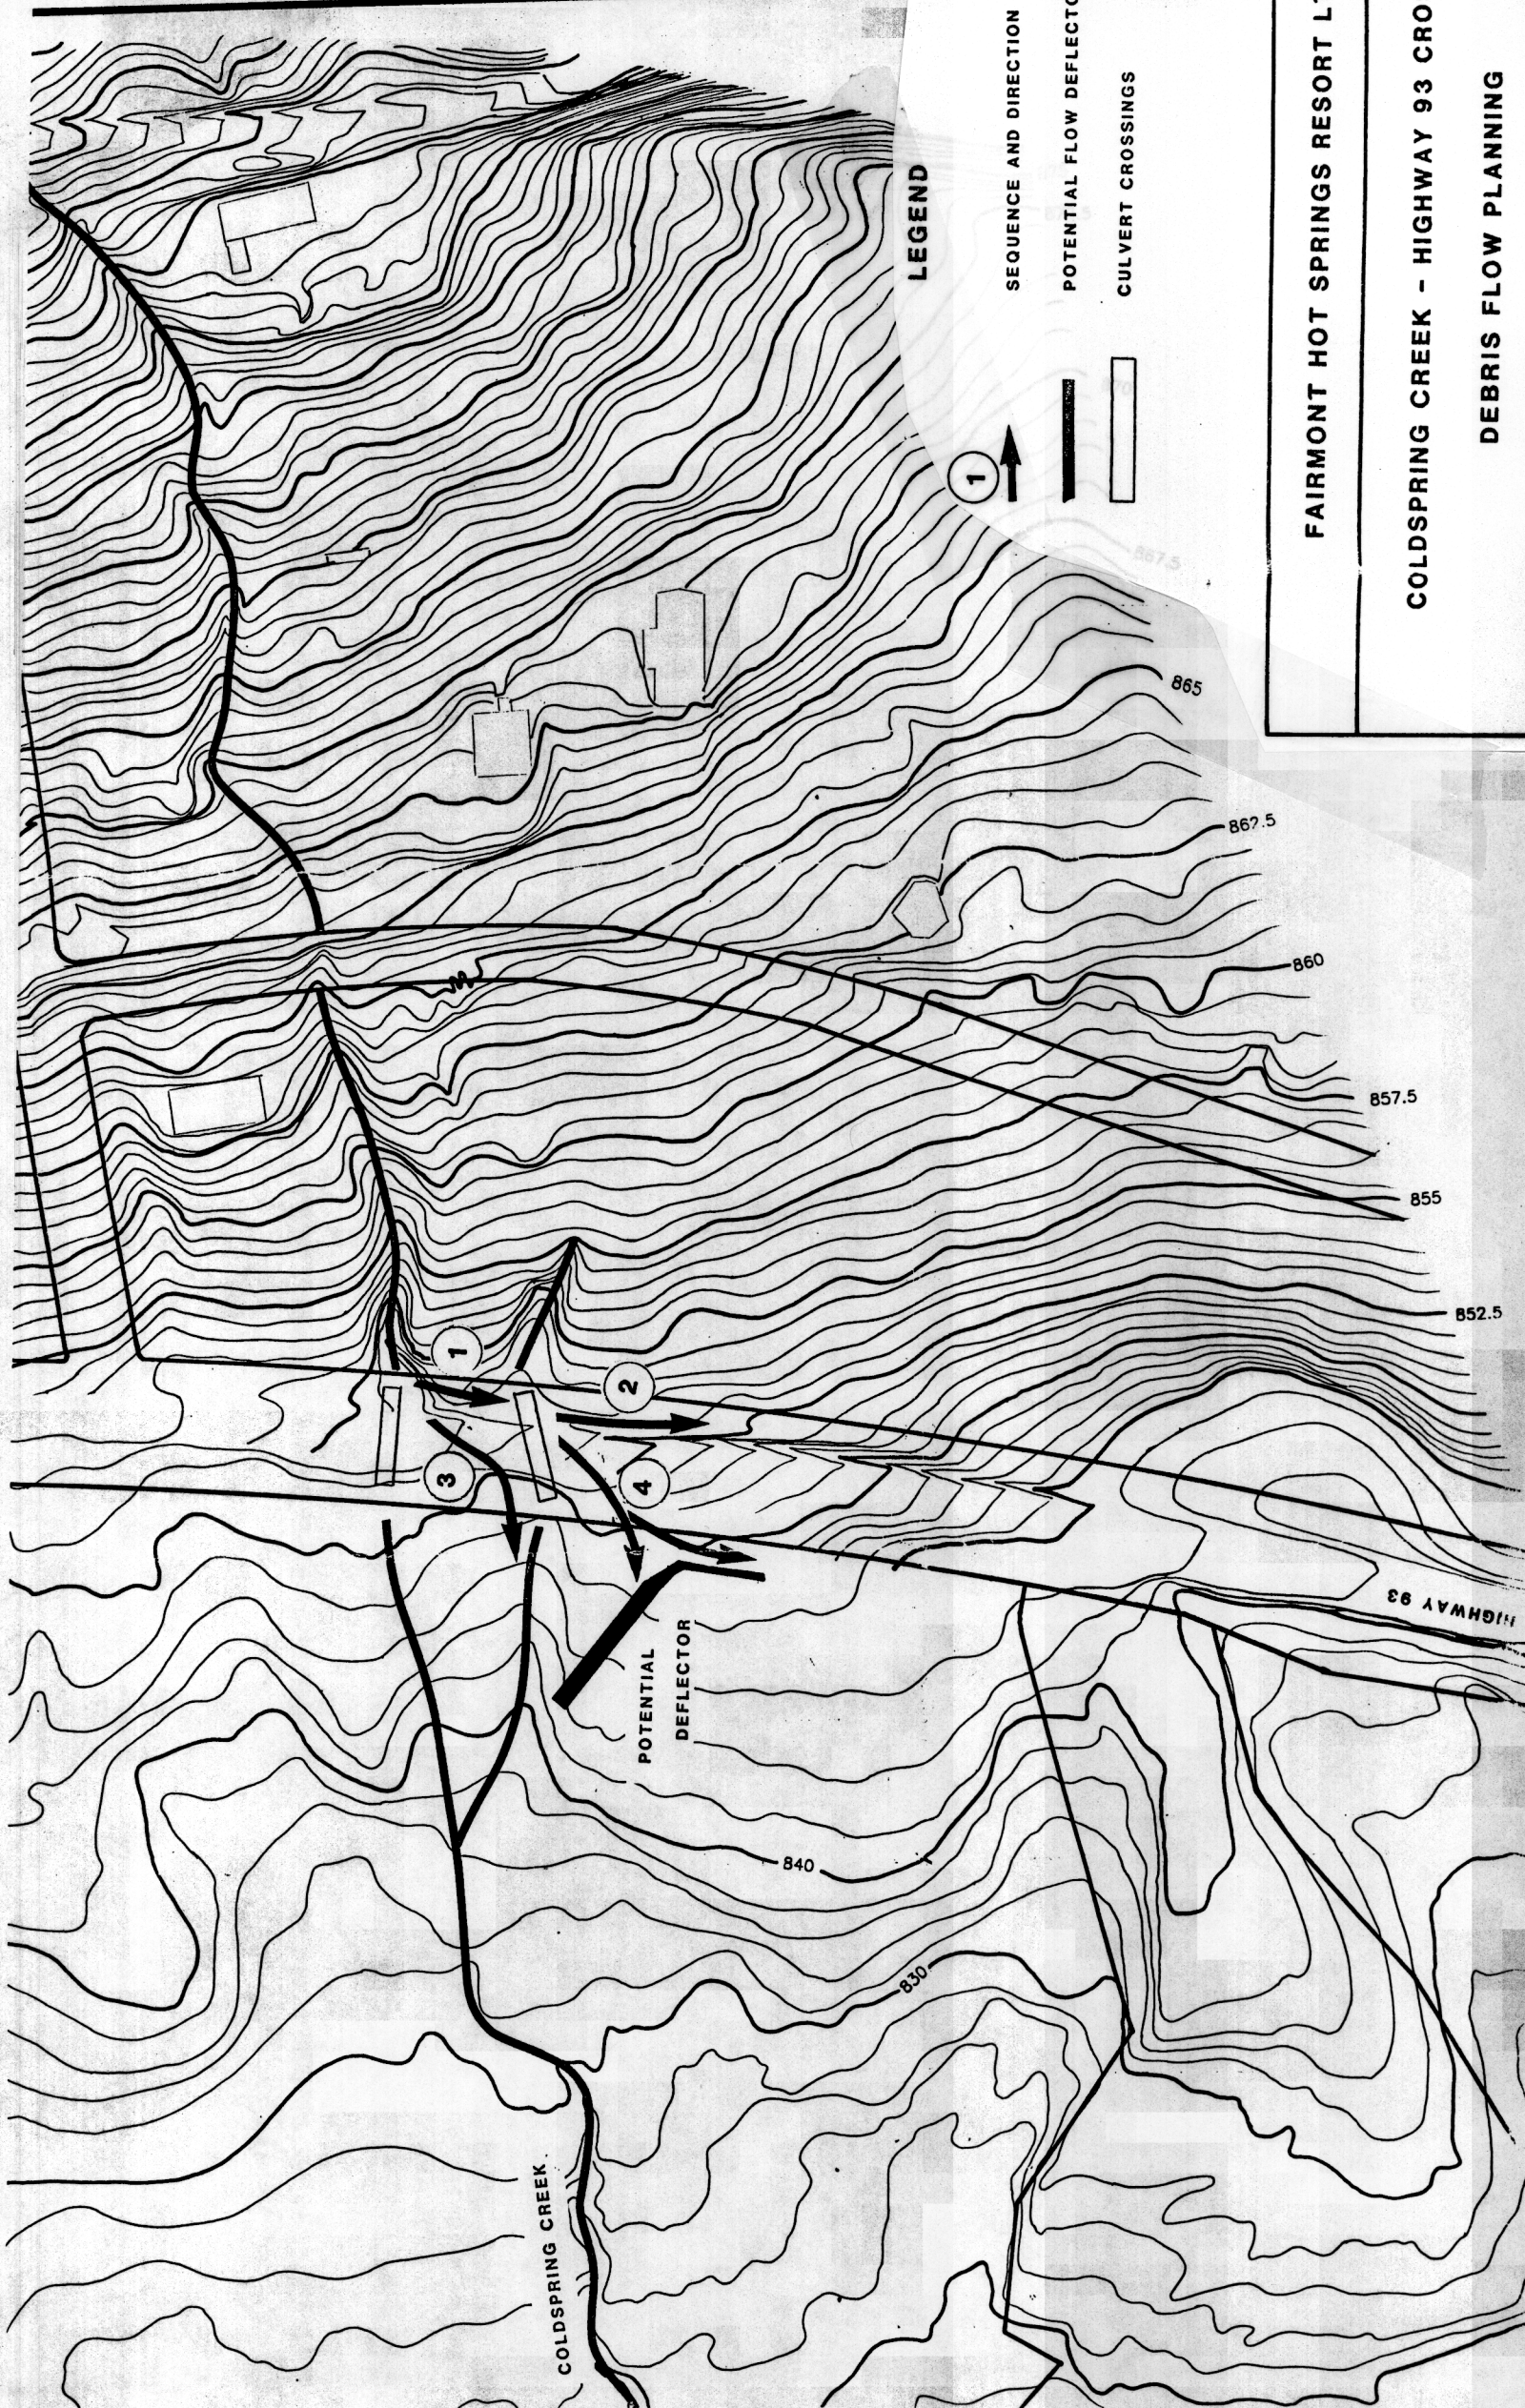
exceedence of the highway culvert debris would be deposited and block the culvert. The flows would then follow along the road ditch to a second culvert, shown as arrow 1 on the figure. The second culvert would block off and flows would continue along the ditch, shown as arrow 2. The slope is sufficiently shallow to allow deposition of material along the ditch. As material is deposited in the ditch it would become blocked and the flows would overtop the highway as shown with arrow 3. These flows would enter the secondary channel and return to Coldspring Creek. The scenario presented thus far would present no more than a minor inconvenience to highway traffic with no threat to downstream development..

In the event of a sufficiently large flow there is a possibility that flows would be directed, by the deposited material, to an area as shown with arrow 4. This would allow the flows to depart from the constructed control works. We can prevent this occurrence by constructing a deflector to direct flows back into the channel or to confine them to the road ditch as shown. As discussed earlier the need for such a deflector structure will decrease as the channel between the highway and the reservoir is stabilized. ←

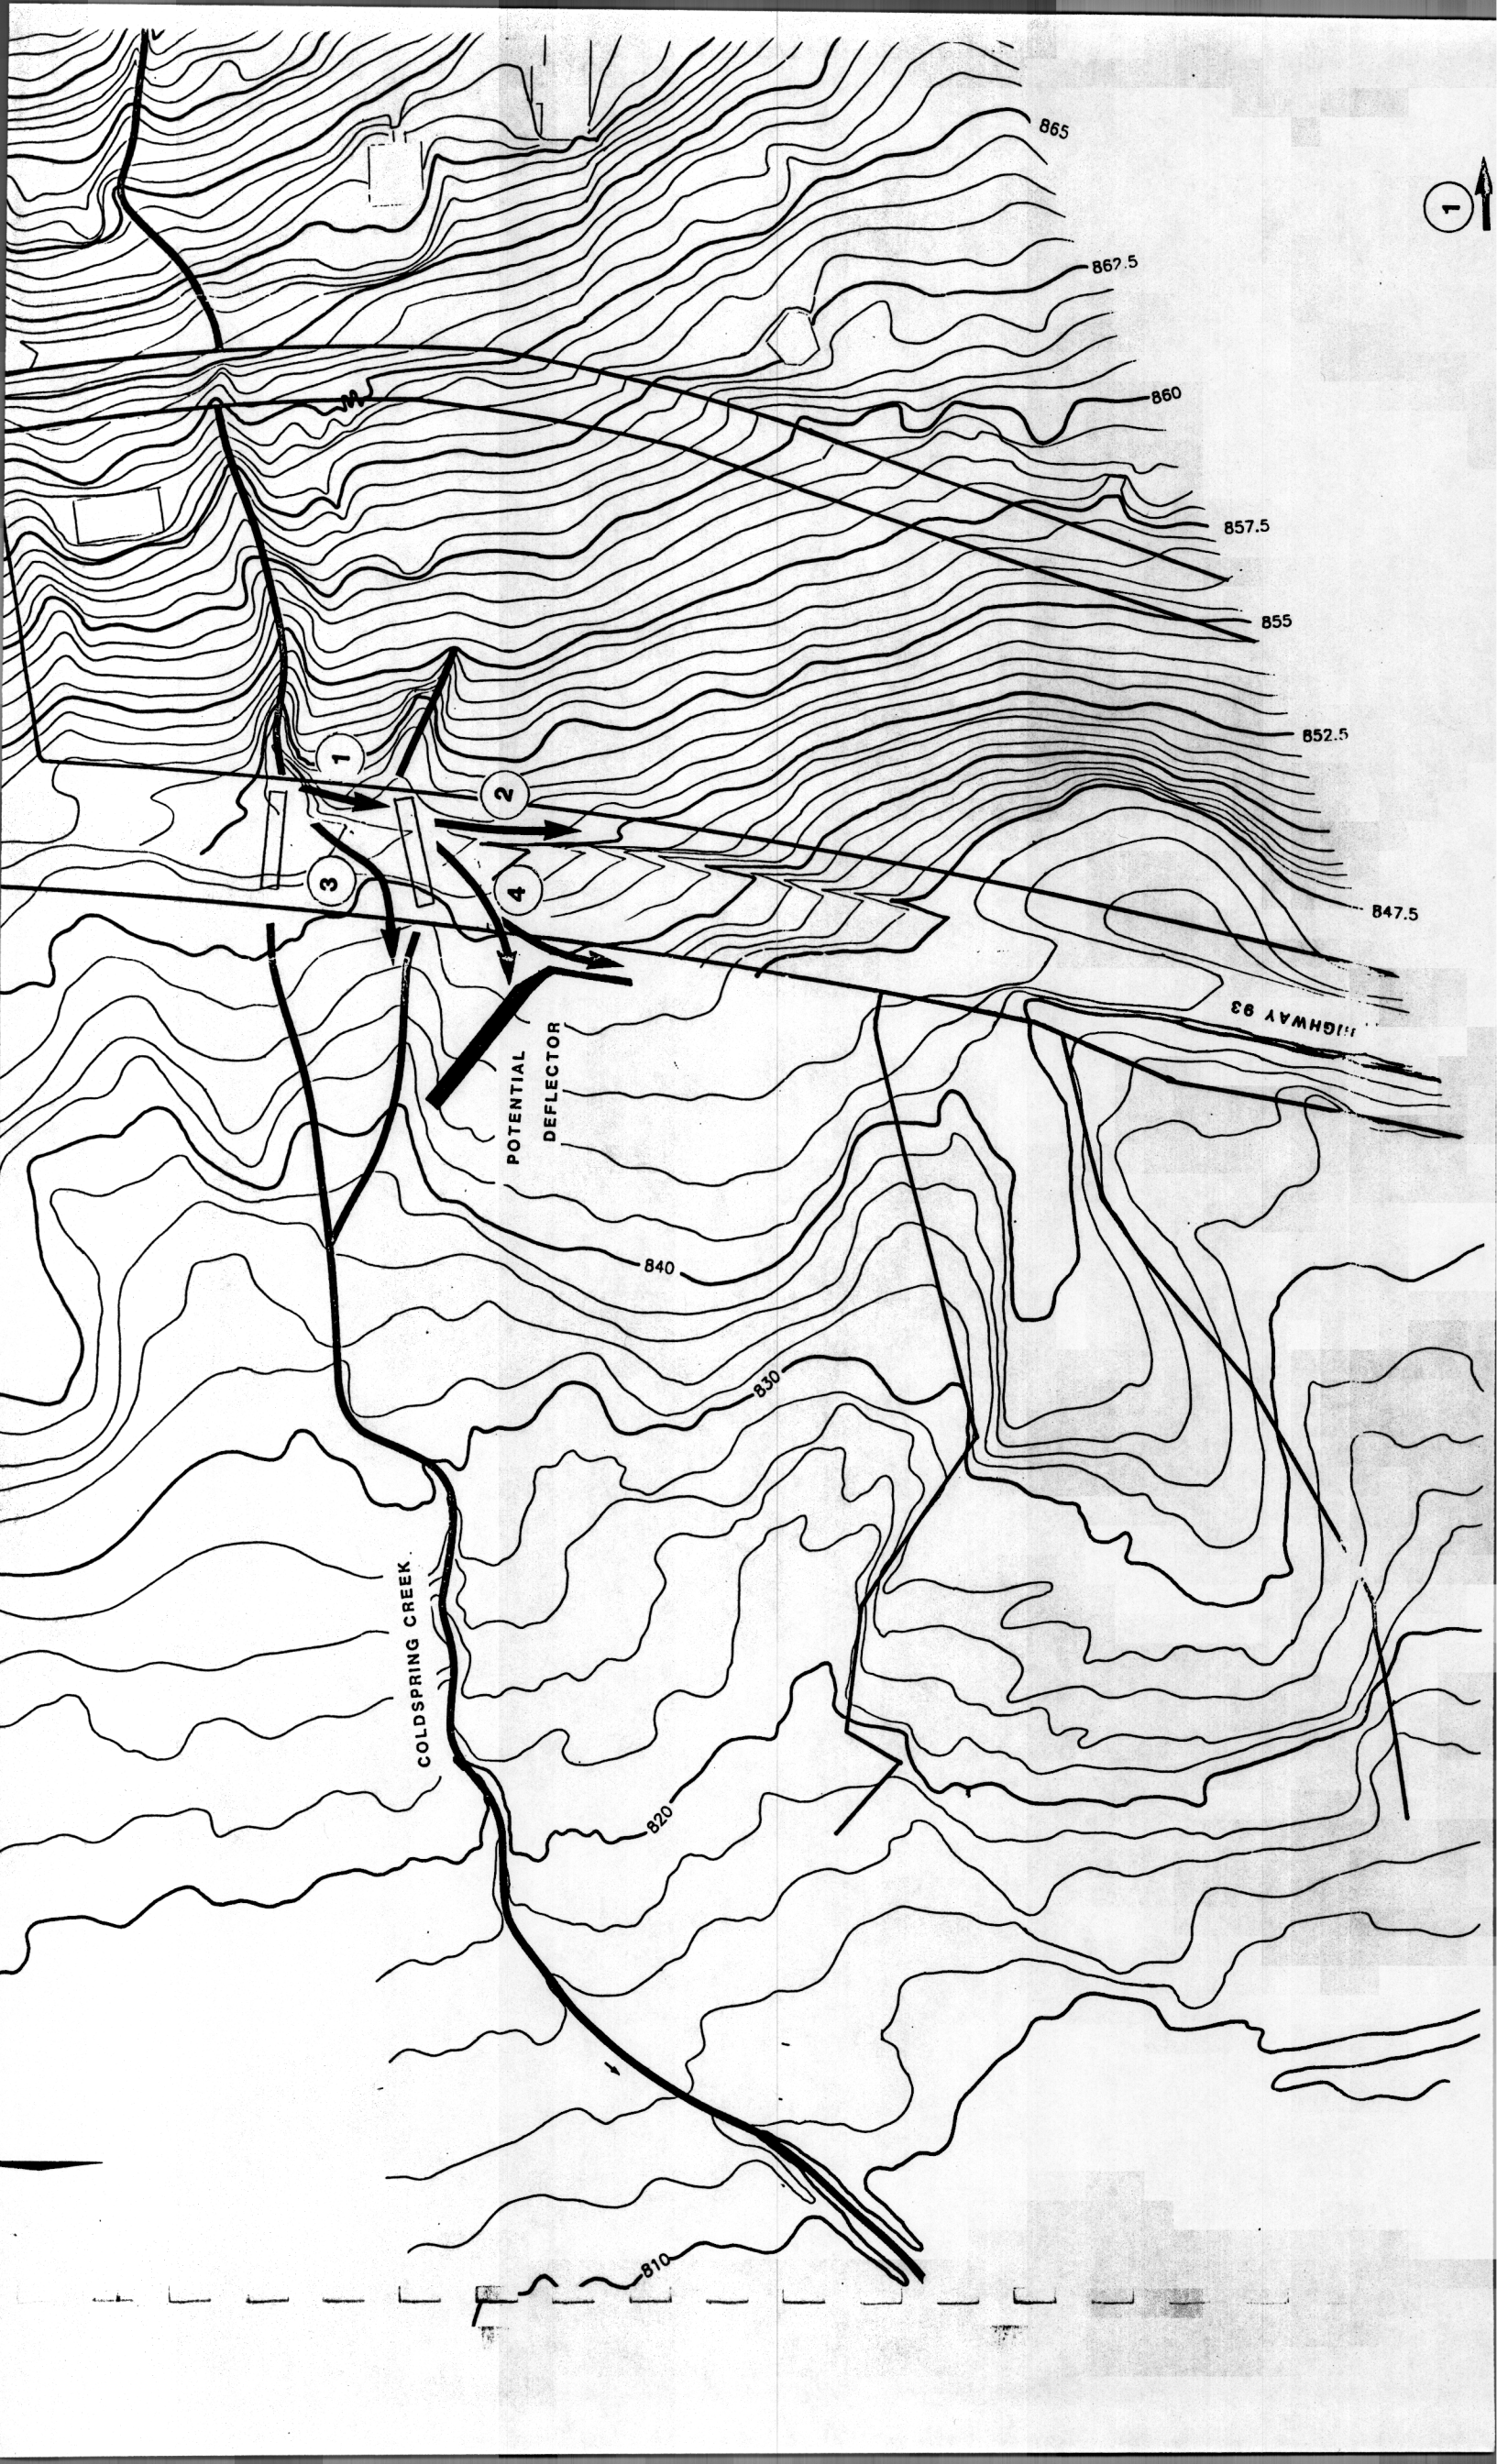
exceedence of the highway culvert debris would be deposited and block the culvert. The flows would then follow along the road ditch to a second culvert, shown as arrow 1 on the figure. The second culvert would block off and flows would continue along the ditch, shown as arrow 2. The slope is sufficiently shallow to allow deposition of material along the ditch. As material is deposited in the ditch it would become blocked and the flows would overtop the highway as shown with arrow 3. These flows would enter the secondary channel and return to Coldspring Creek. The scenario presented thus far would present no more than a minor inconvenience to highway traffic with no threat to downstream development..

In the event of a sufficiently large flow there is a possibility that flows would be directed, by the deposited material, to an area as shown with arrow 4. This would allow the flows to depart from the constructed control works. We can prevent this occurrence by constructing a deflector to direct flows back into the channel or to confine them to the road ditch as shown. As discussed earlier the need for such a deflector structure will decrease as the channel between the highway and the reservoir is stabilized. ←
