Fairmont Creek 2017 Annual Dike Inspection Report

May 4, 2017 Fairmont Creek Dike Inspection

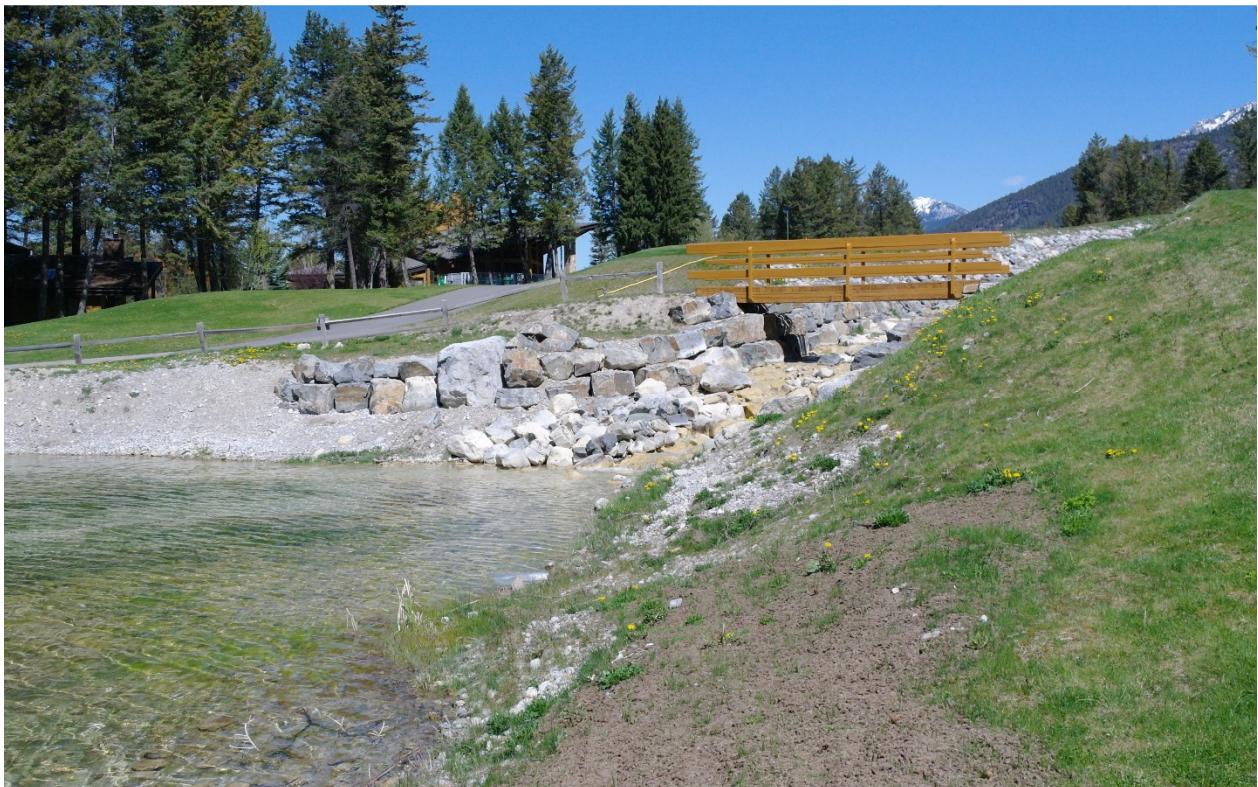
Photo 1: Downstream extent of the dike and bank protection works at the entrance to the debris pond.

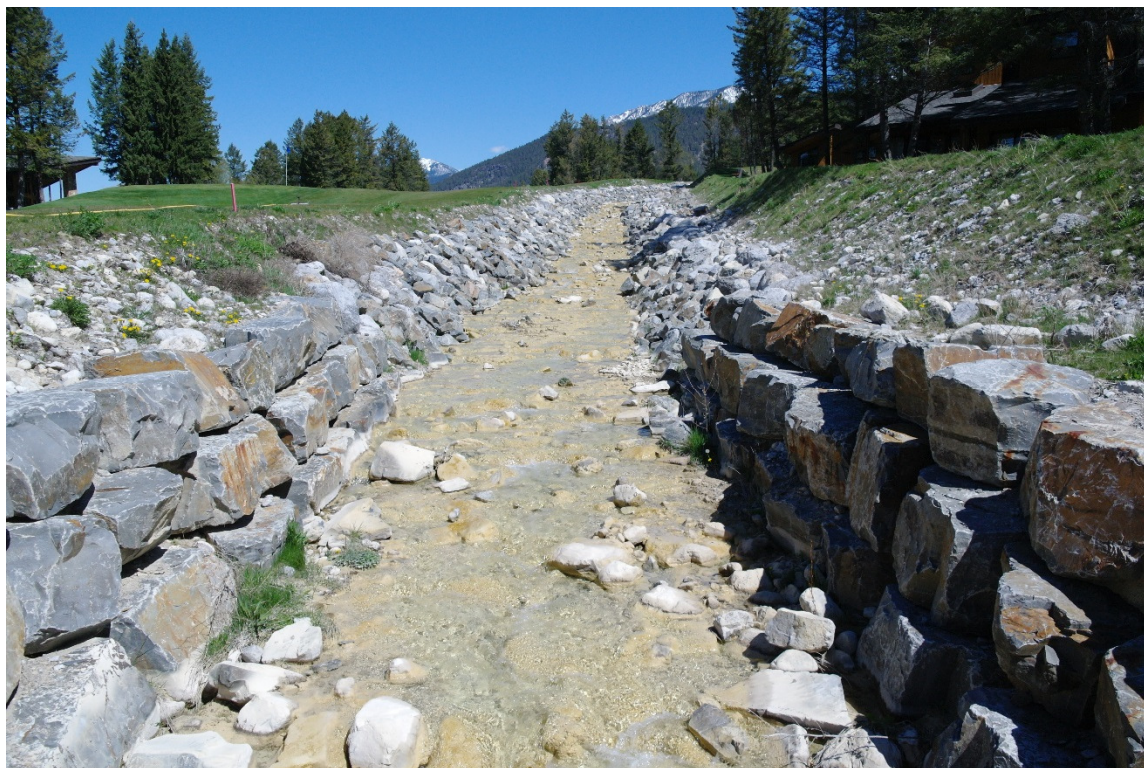
Photo 2: Looking upstream from the pedestrian bridge on the previous photo.

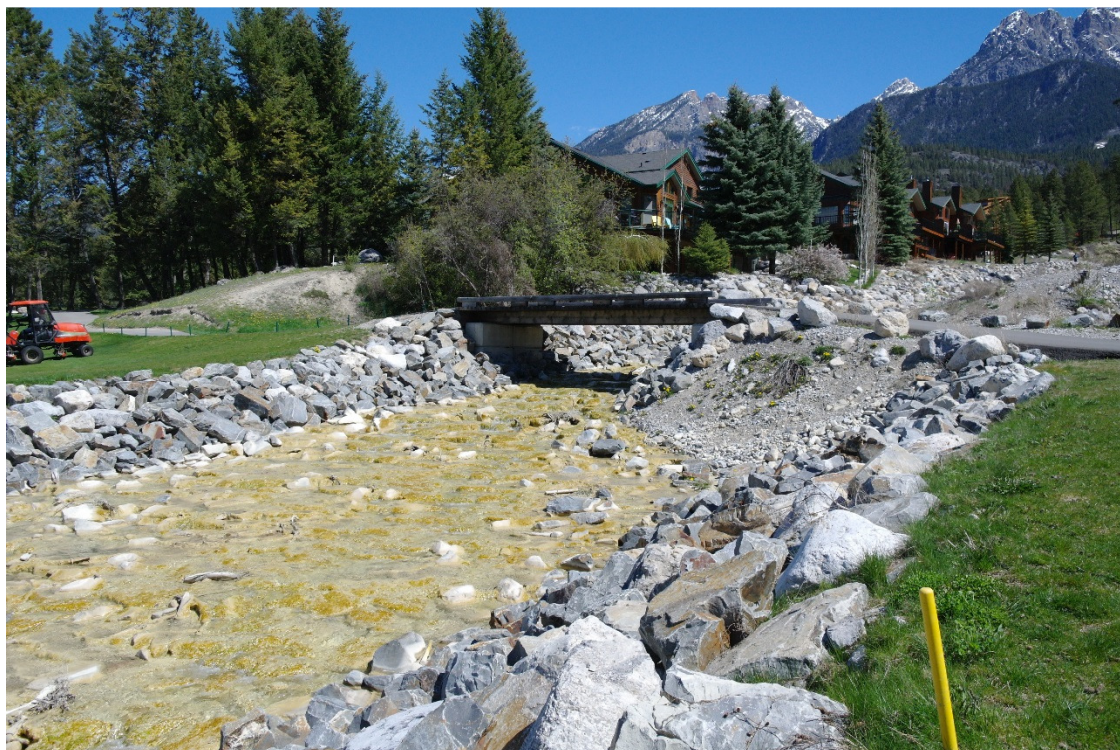
Photo 3: Cart Path Bridge at the upstream end of the golf course section of the channel.

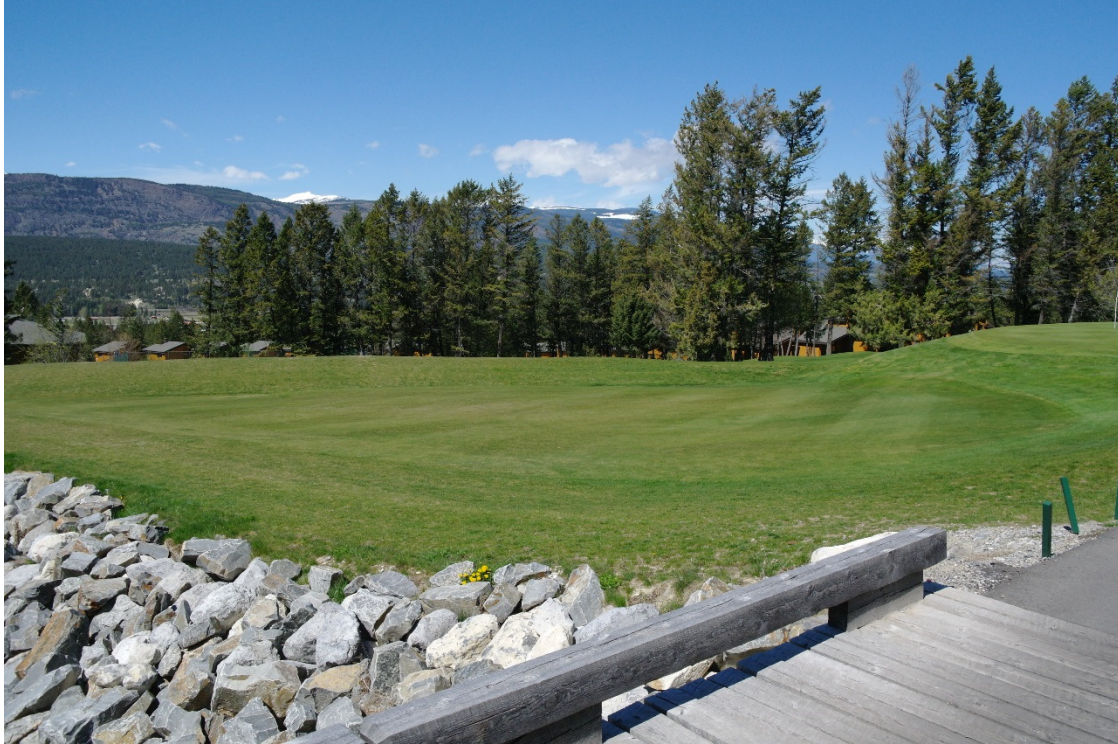
Photo 4: Right bank berm. Picture taken from the cart path bridge.

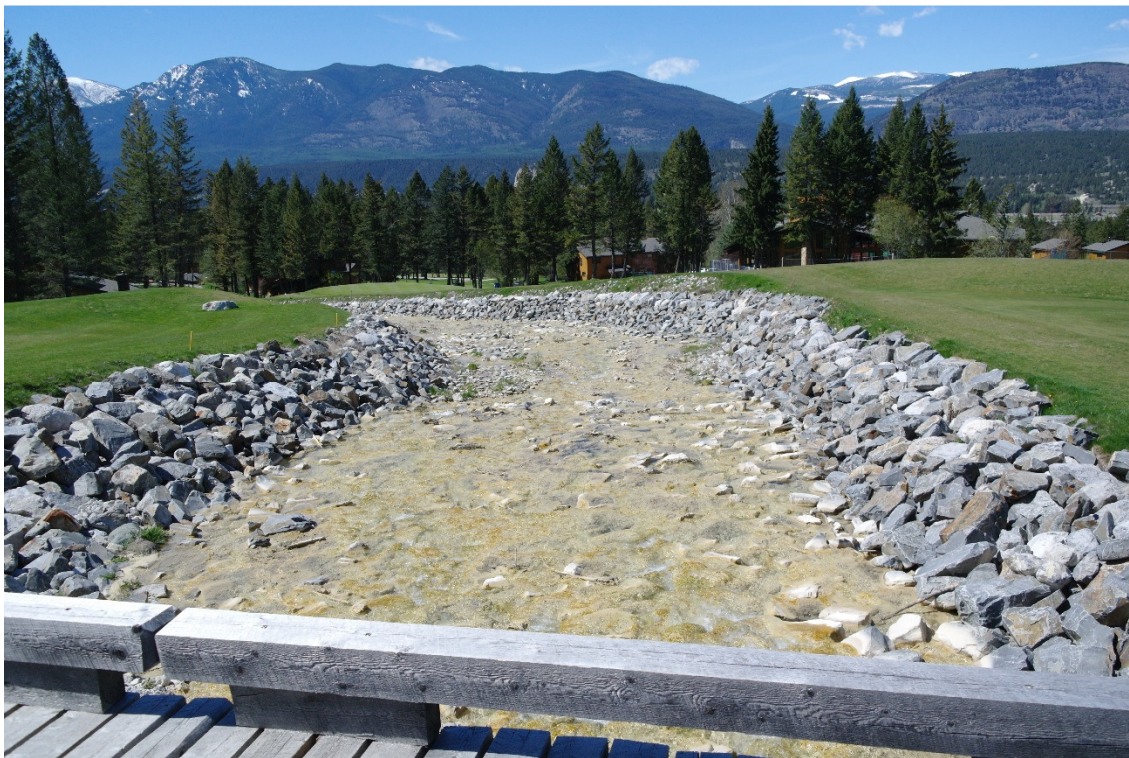
Photo 5: Widened channel. Picture taken from the cart path bridge.

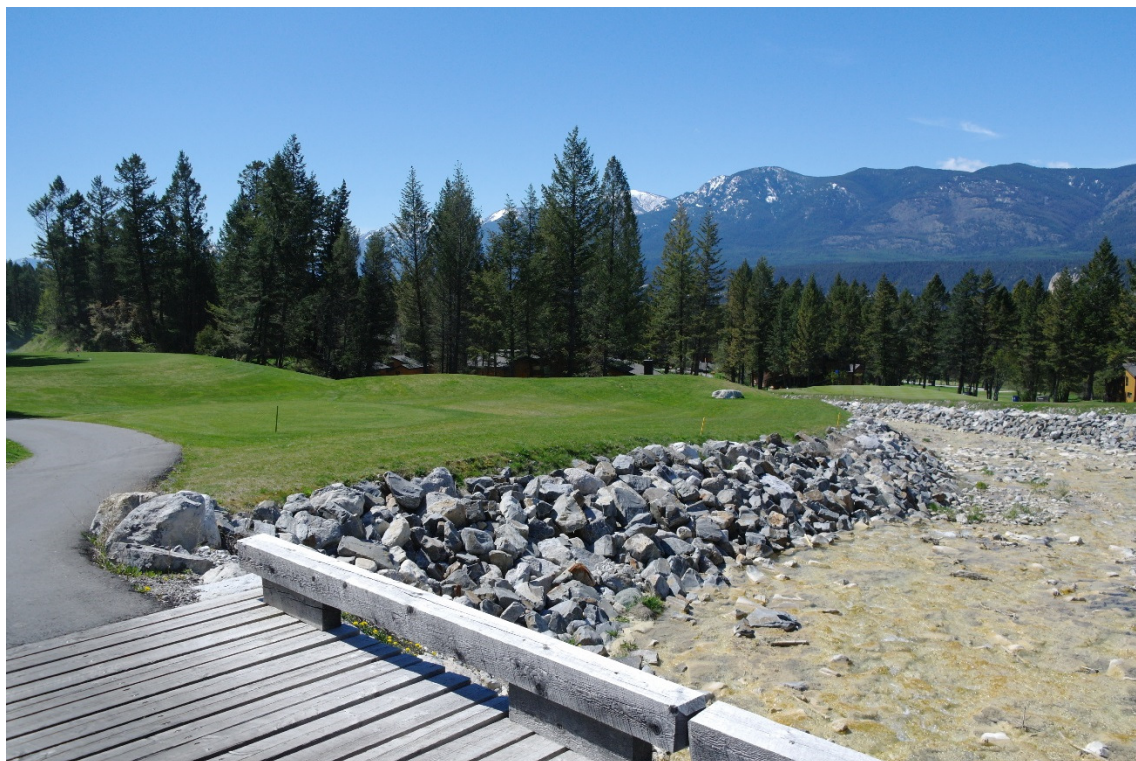
Photo 6: Left bank berm. Picture taken from the cart bridge.

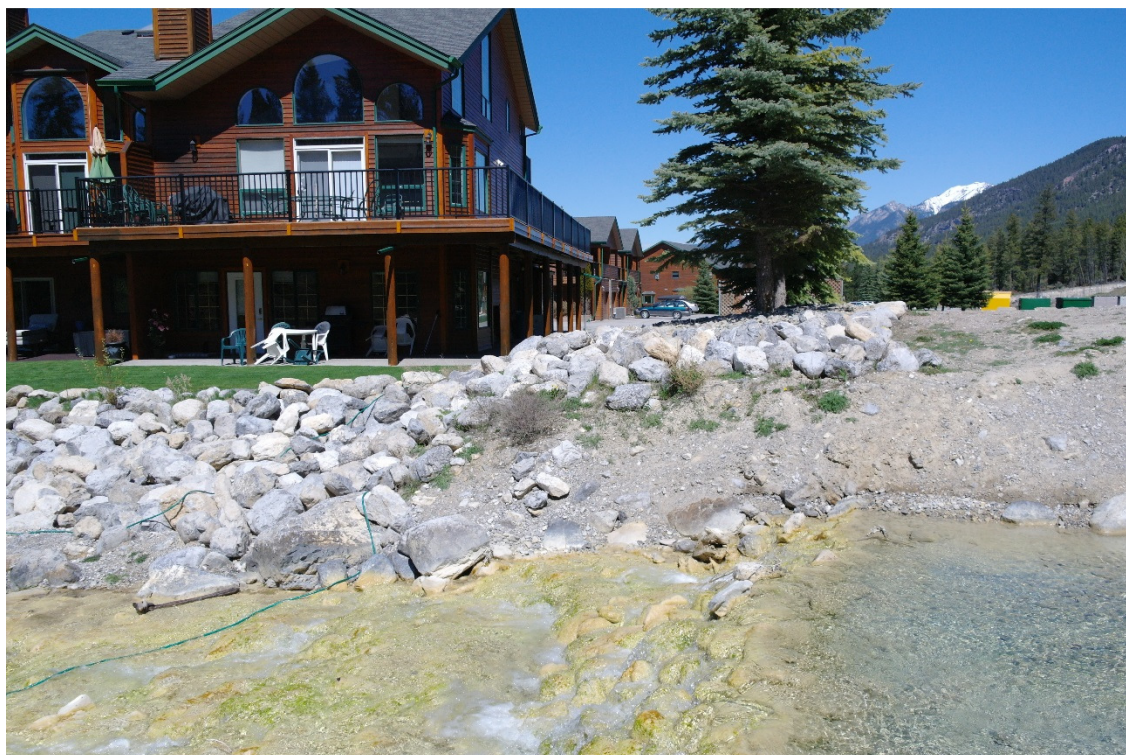
Photo 7: Upstream extent of the DFA works and bank protection.

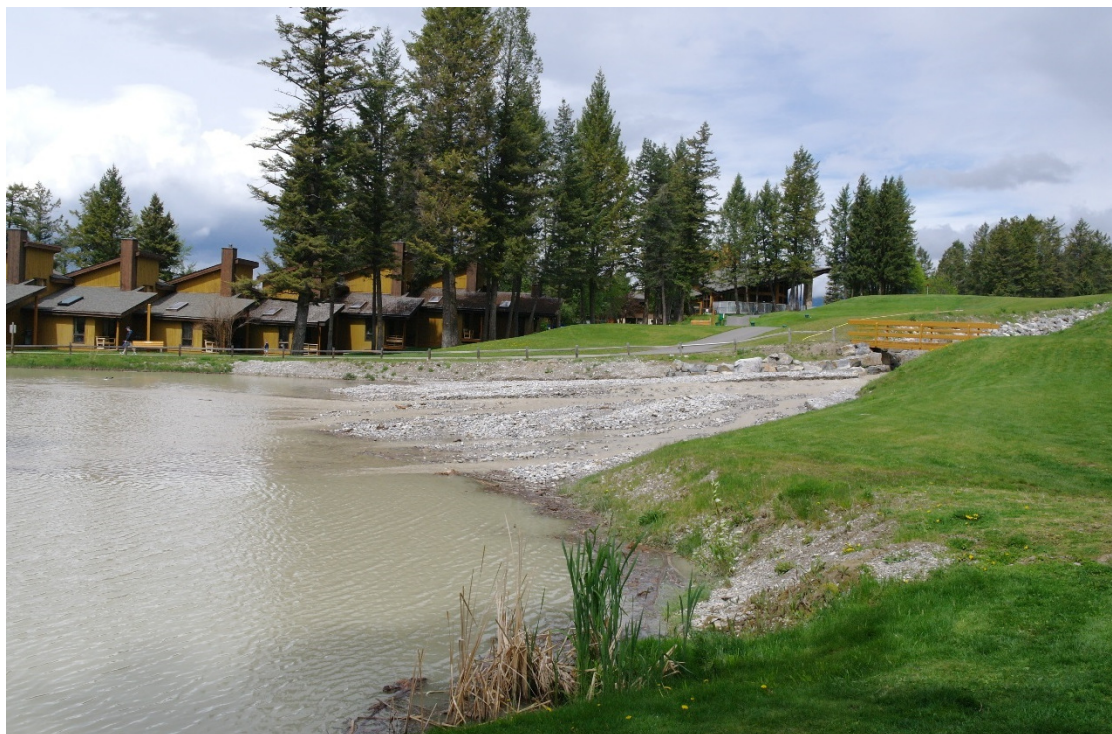
On May 12, 2017, a small amount of debris came down Fairmont Creek to the debris trap pond. An estimated 1,200 m³ of debris material was deposited in the pond and additional debris was along the creek bed. Removal of the debris is planned for 2018 following completion of the Fairmont Creek Debris Flow Project Phase 2 works.

Photo 8: Entrance to the debris pond.

The debris from May 12, 2017 is scheduled to be removed after the Phase 2 construction has been completed. After the construction is complete, the RDEK will also begin the process of establishing a legal right of way for the Fairmont Creek dike system.

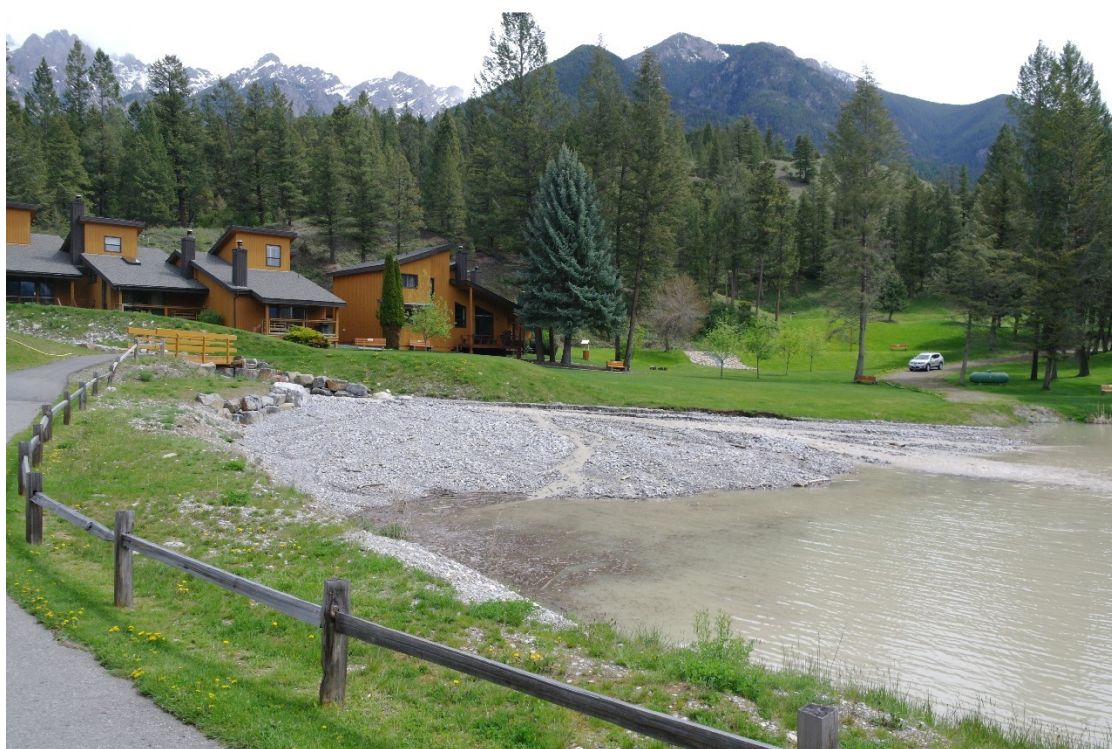
Photo 9: Entrance to the debris pond. Photo taken from the other side of the pond than the previous photo.

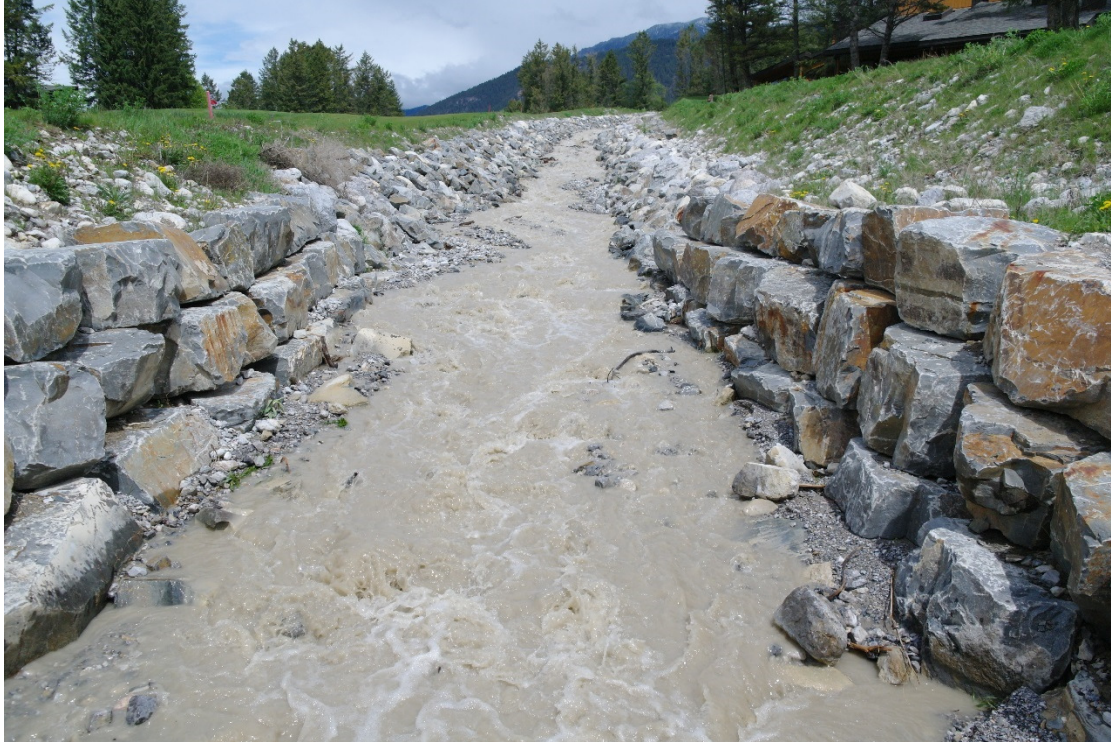
Photo 10: Looking upstream from the pedestrian bridge.

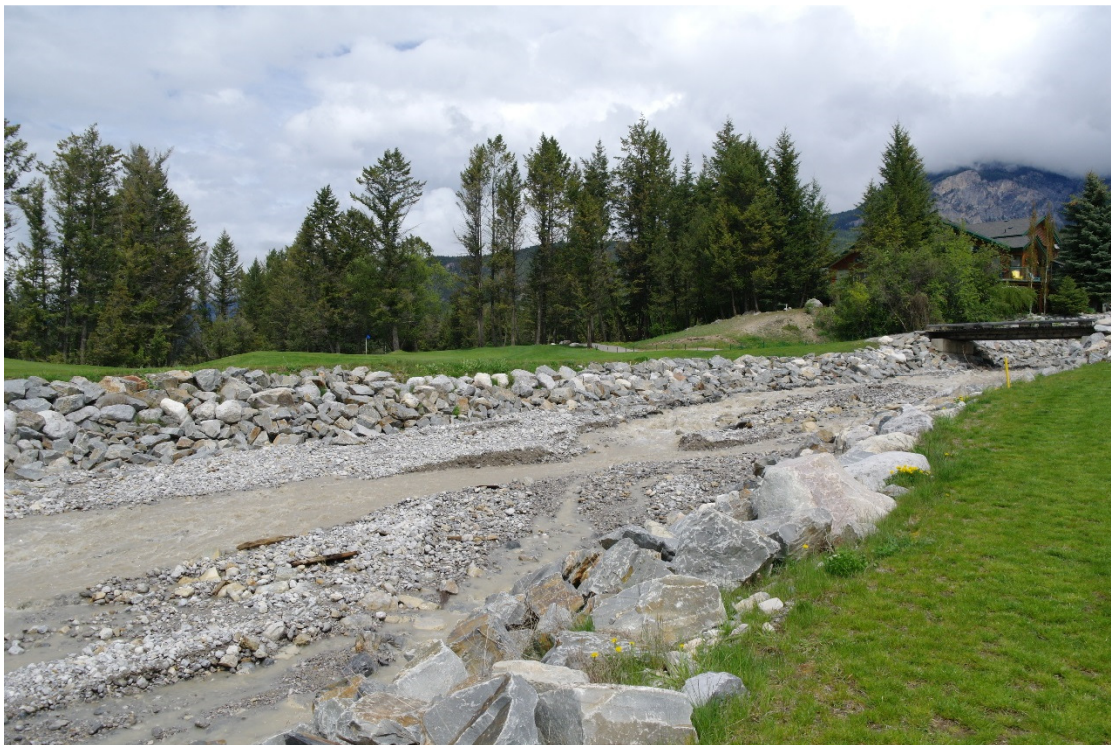
Photo 11: The widened section of creek below the cart path.

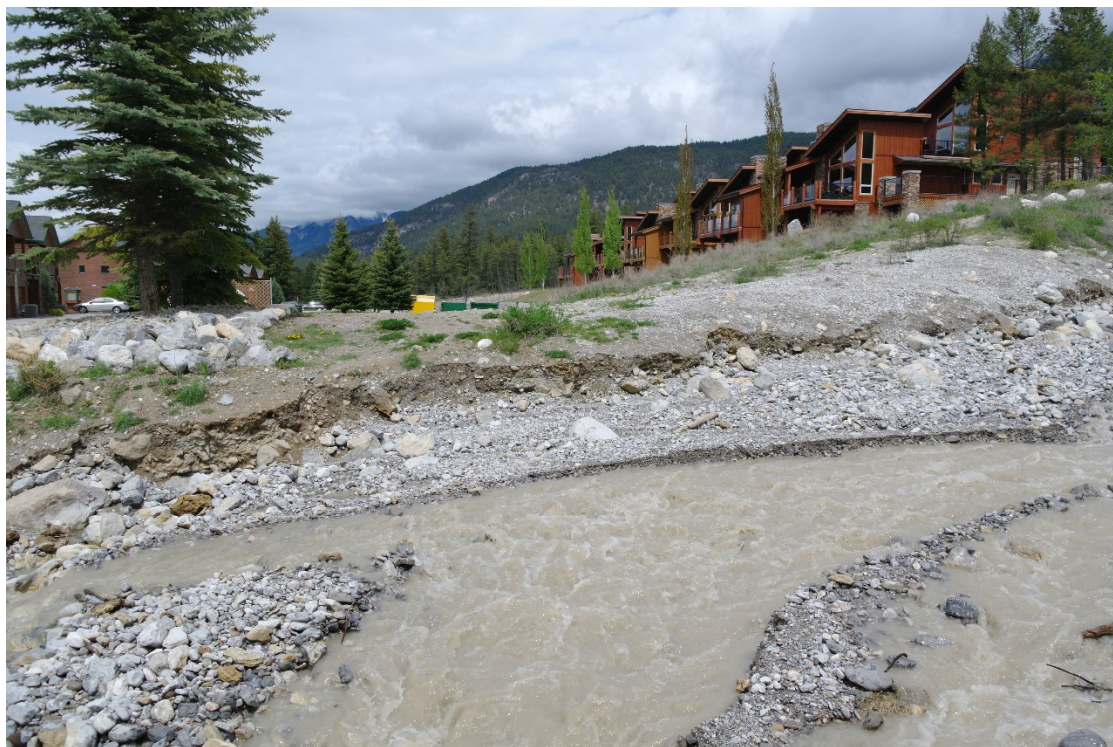
Photo 12: Upstream extent of the DFA works and bank protection. When comparing with Photo 7, the bank erosion, damage to the grade control structures and debris deposition is very apparent.
