## Fairmont Creek 2020 Annual Dike Inspection Report

## Fairmont Creek Dike Inspections

An inspection was completed on April 23, 2020 and was conducted by Kara Zandbergen, RDEK Engineering Technician. All sections of the dike were found to be in good condition at that time and ready for freshet. Subsequent inspections were completed after each event and as the cleanup progressed.

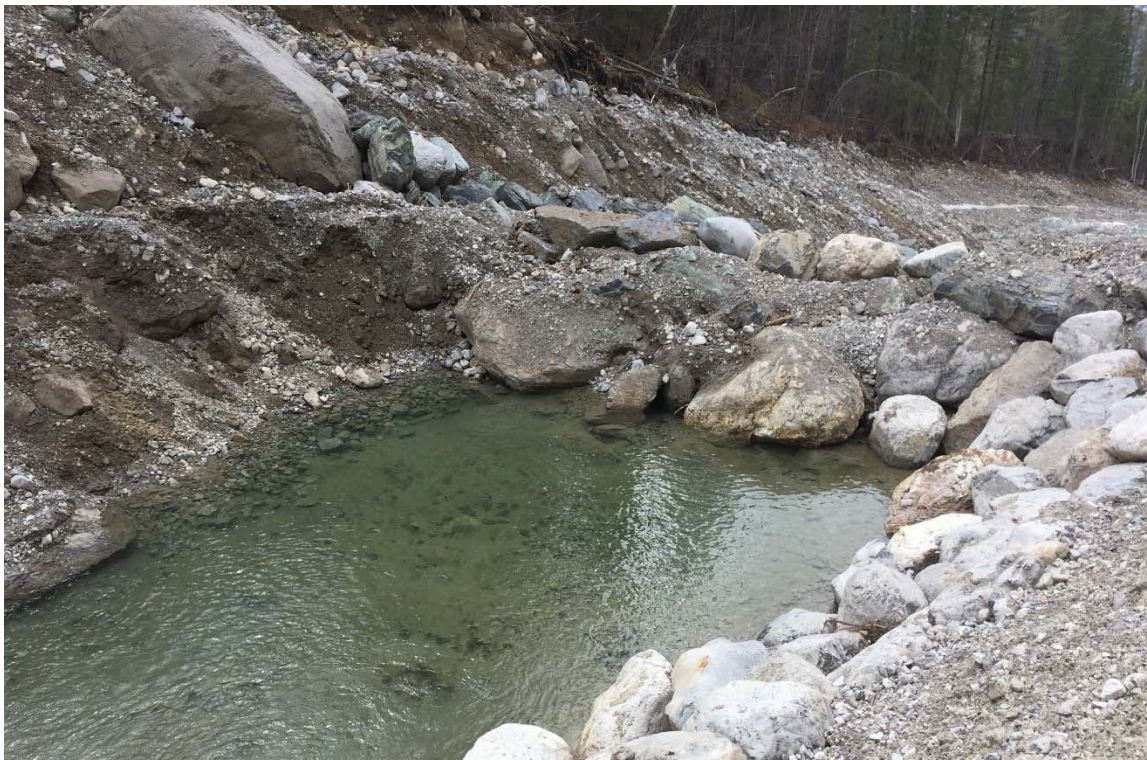
Photo 1: The uppermost weir in the system, Weir #1. April 23, 2020.

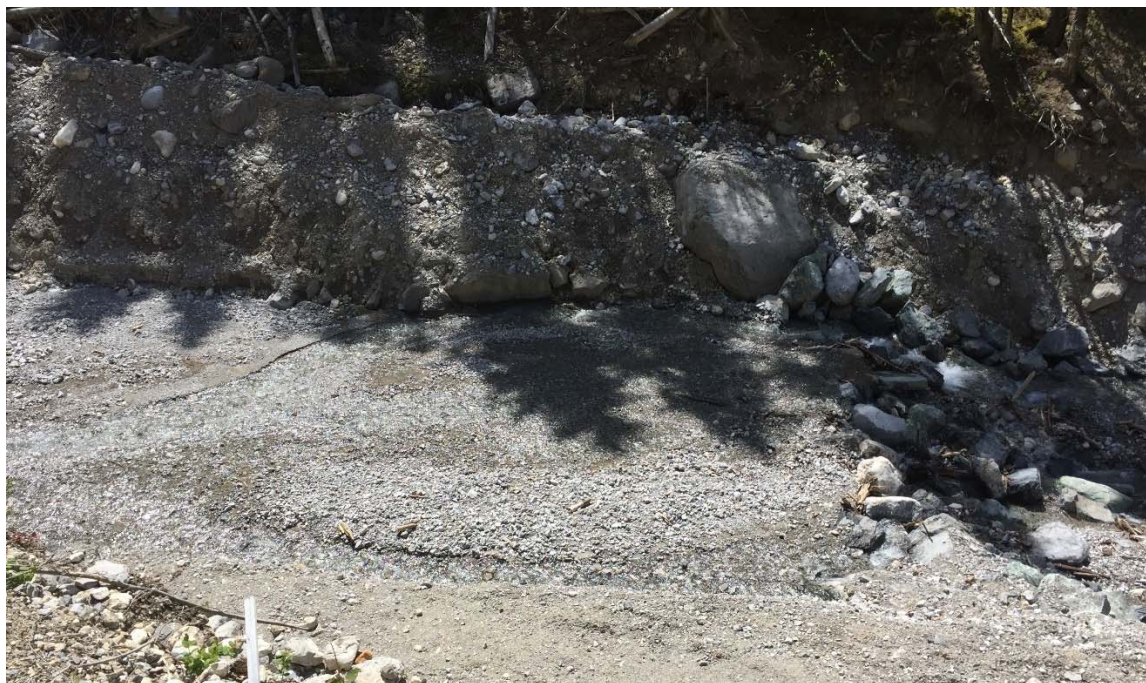
Photo 2: Weir 1, filled with debris material from the May 20 event. May 28, 2020.

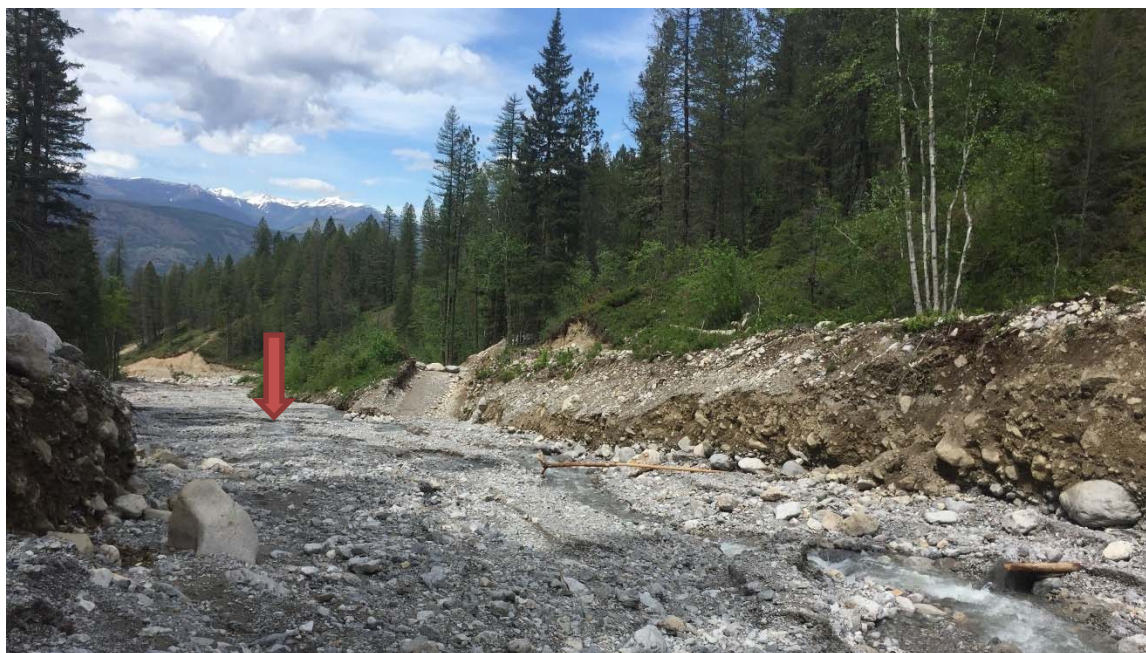
Photo 3: Weir 1 was completely covered with material from the May 31 event. The weir is located near the small access road as marked by the arrow. June 2, 2020.

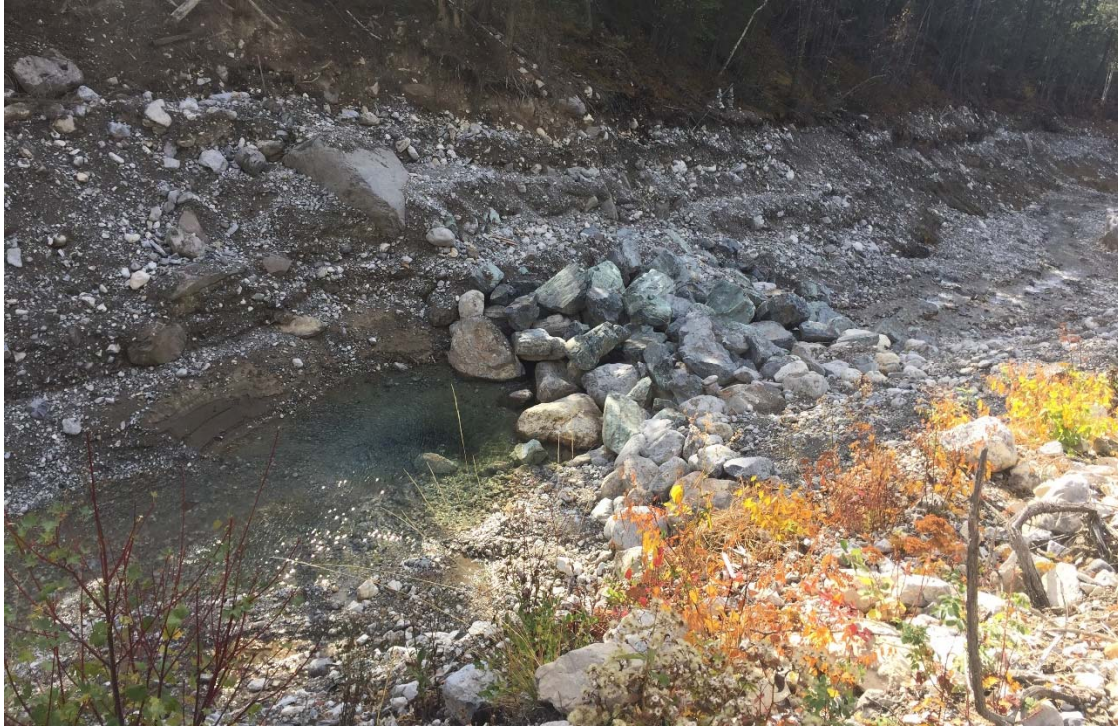
Photo 4: Weir 1 with debris flood material was removed. October 15, 2020.

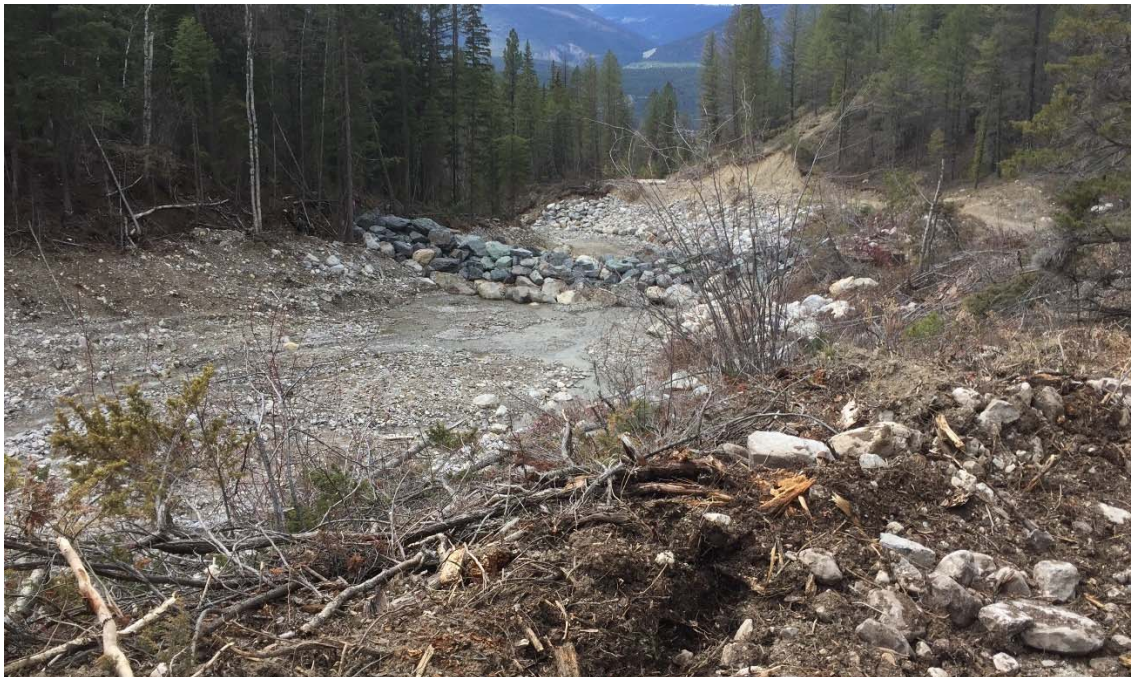
Photo 5: Weir 2 in good condition looking downstream. April 23, 2020.

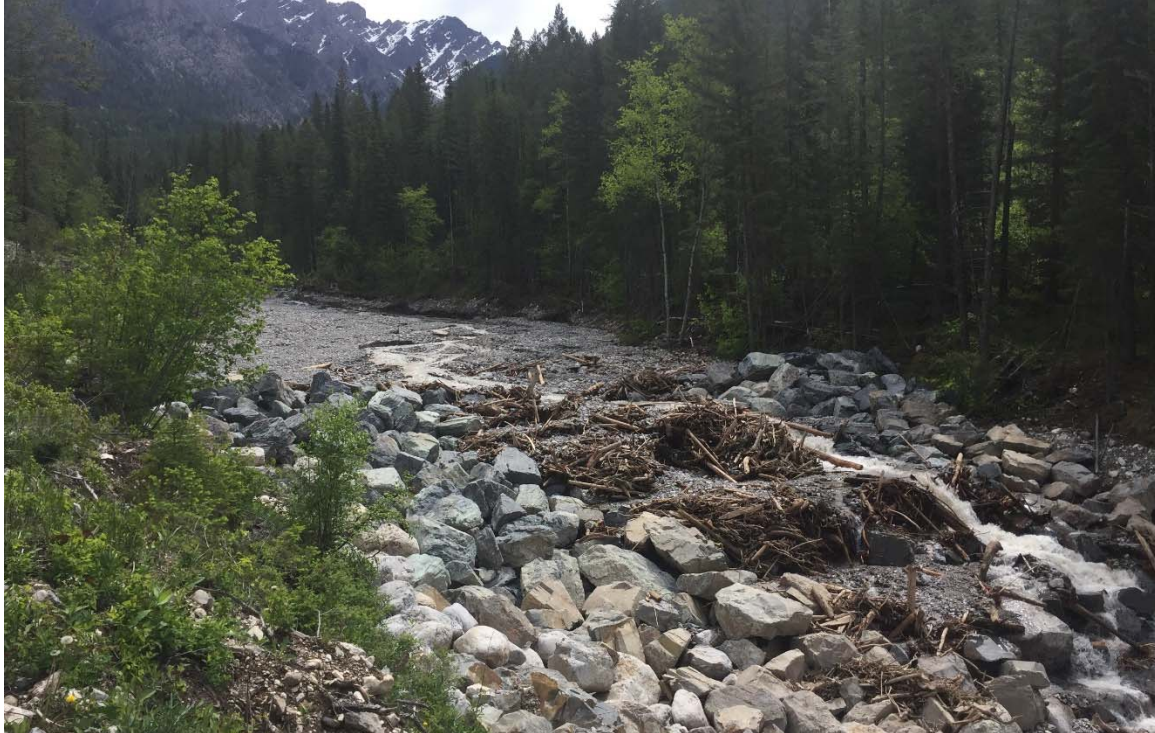
Photo 6: Weir 2 looking upstream. The basin is completely filled with debris flood material from Weir 2 continuing above Weir 1 which was buried by material. June 2, 2020.

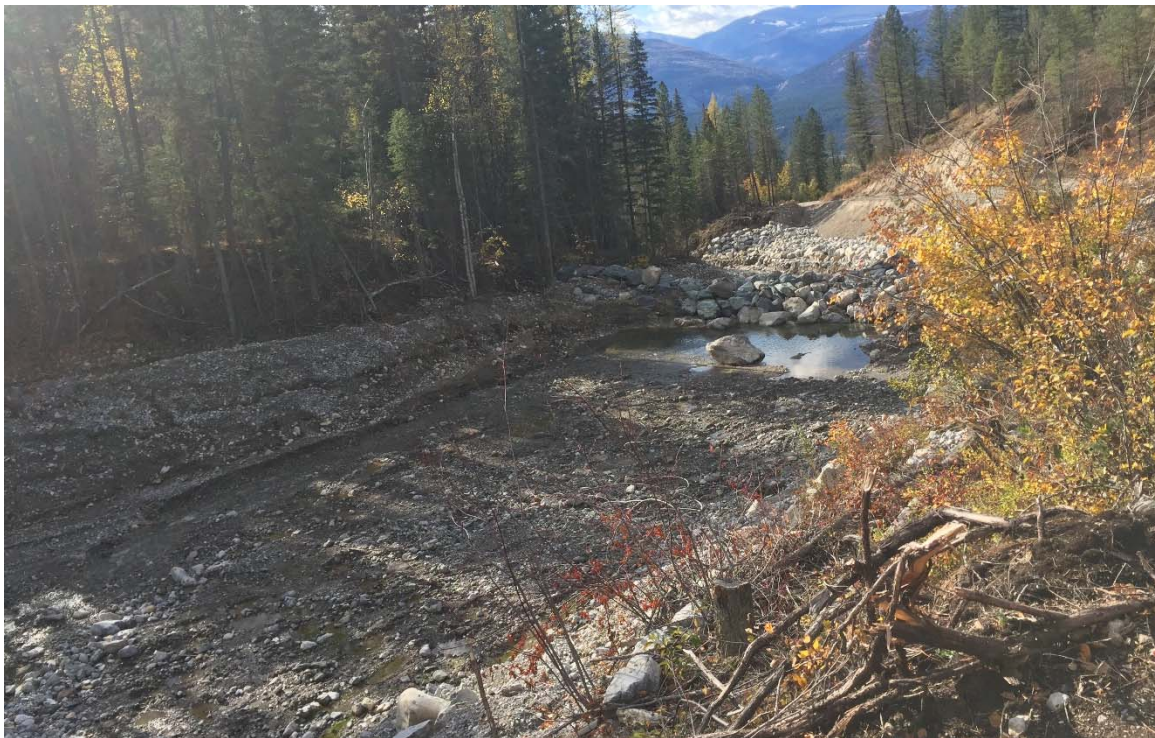
Photo 7: Weir 2 basin with debris flood material removed. October 15, 2020.

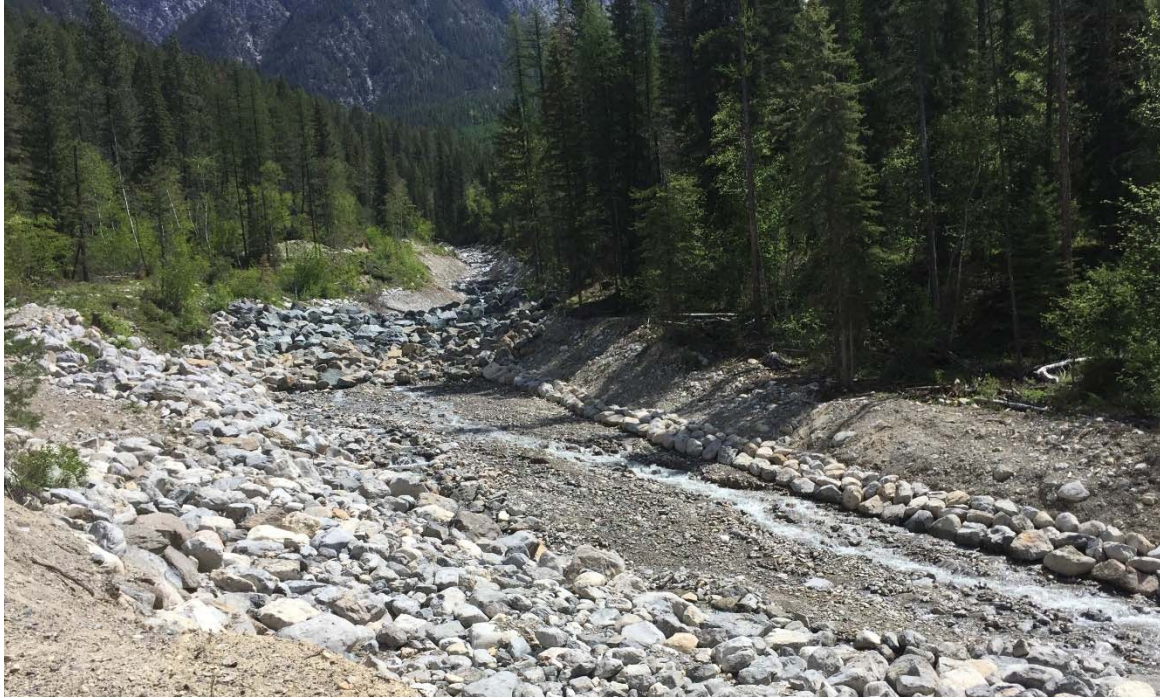
Photo 8: Weir 2 downstream face and channel in good condition. May 28, 2020.

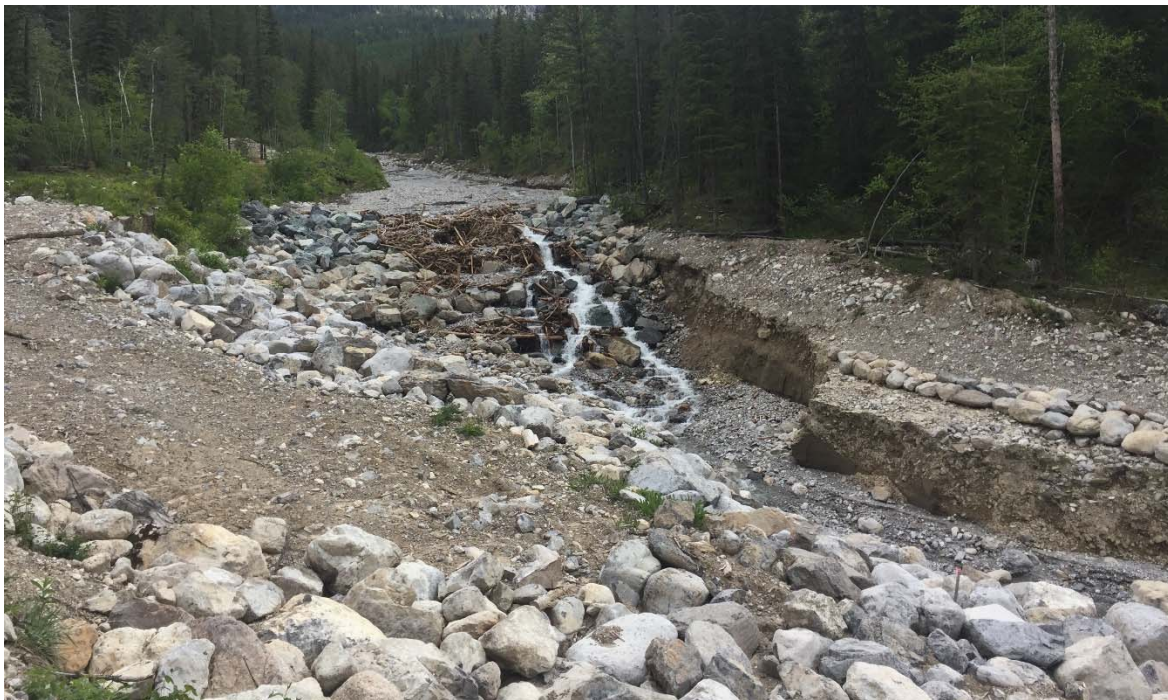
Photo 9: Weir 2 downstream face and scour after the May 31 event. This will be repaired in 2021. The armouring on the right bank was not damaged. June 4, 2020.

At this time, the RDEK intends to repair the scour downstream of Weir 2 as early as possible in 2021.

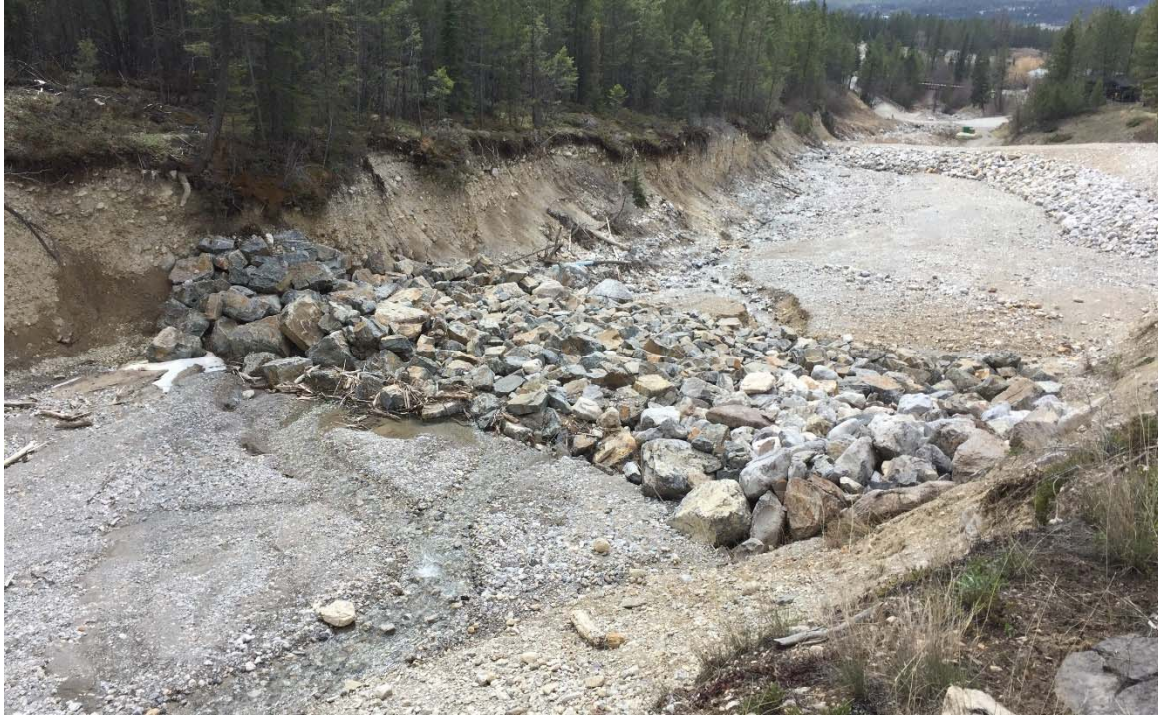
Photo 10: Weir 3 and basin in good condition. There was a very small amount of material captured behind the weir in August 2019. April 23, 2020.

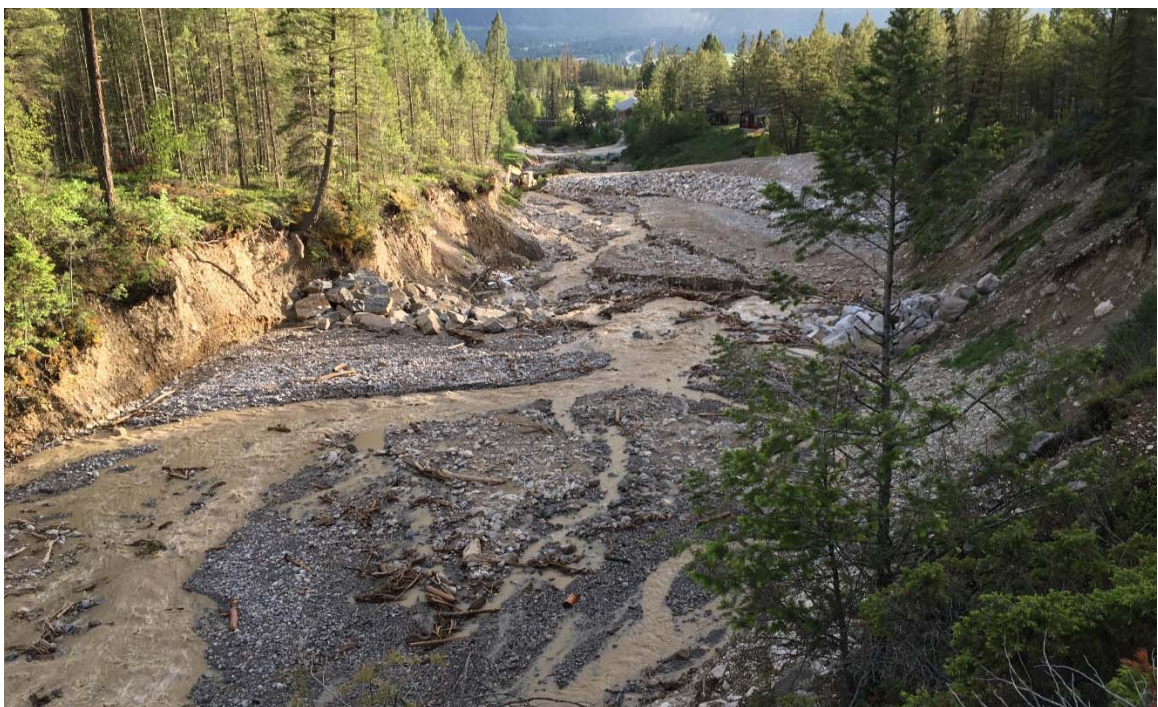
Photo 11: Weir 3 and basin after the May 31 event. There was minor scour downstream of the weir that did not require repairs. June 1, 2020.

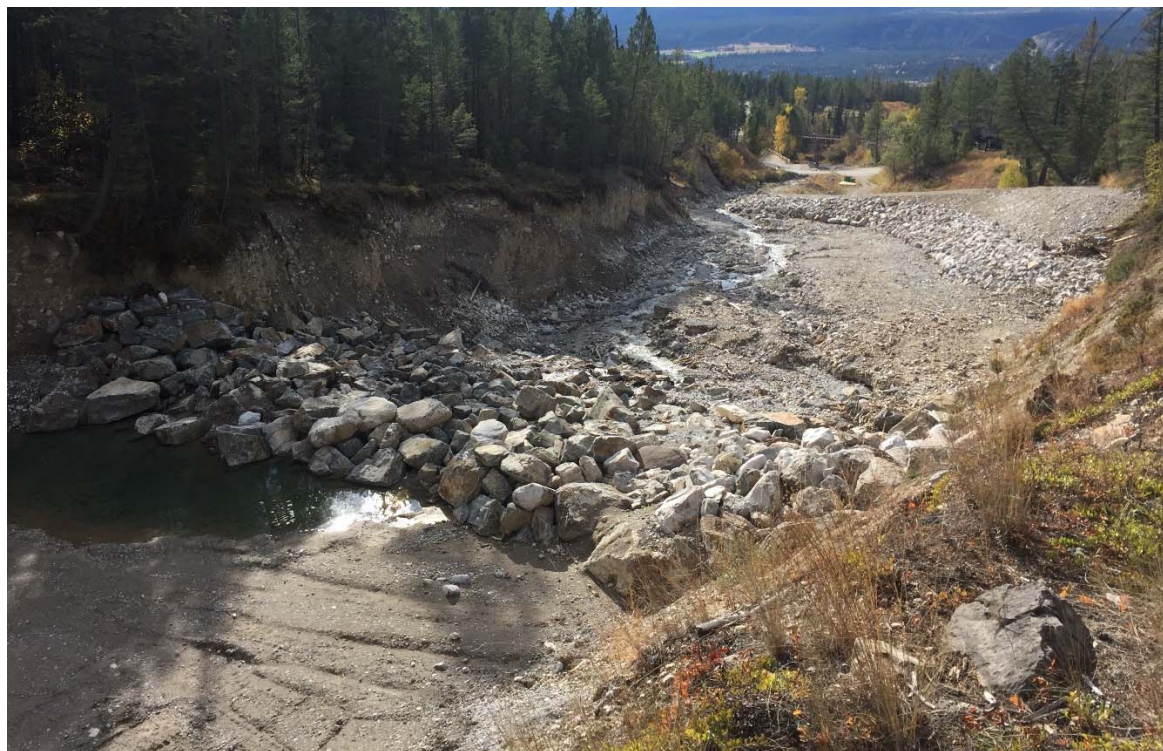
Photo 12: Weir 3 and basin after the debris material was removed. October 15, 2020.

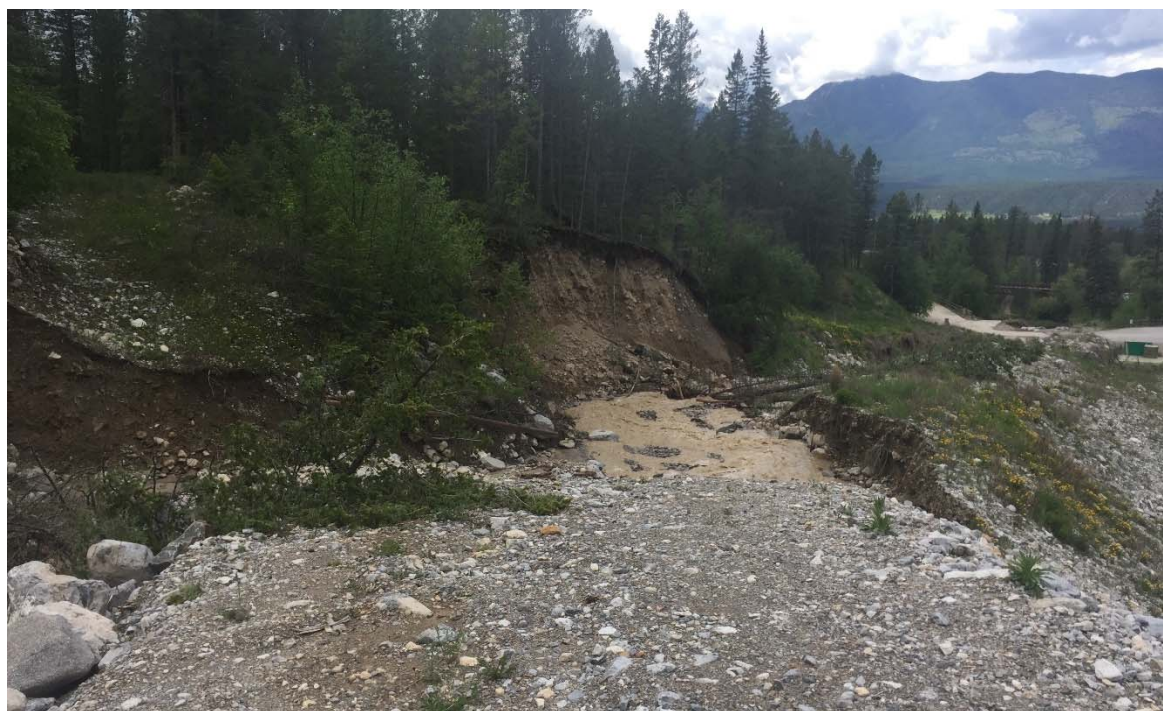
Photo 13: Erosion of the berm above the FHSR water mixing sheds. May 31, 2020.

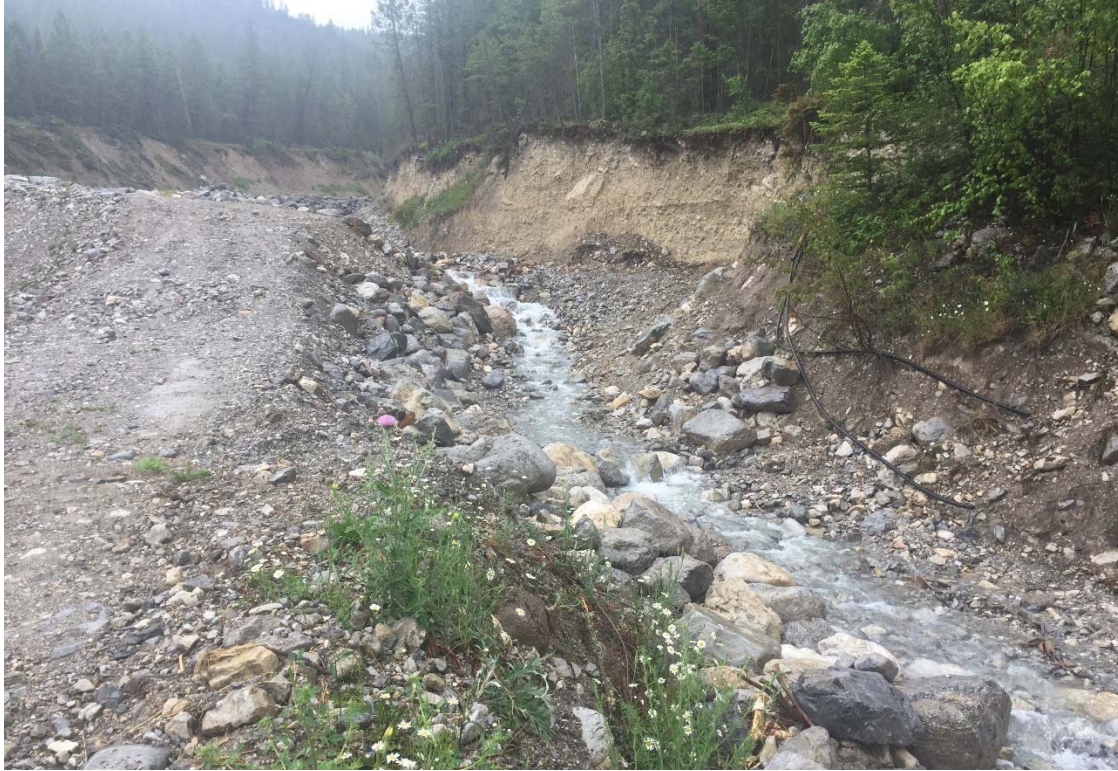
Photo 14: The berm was repaired immediately. July 7, 2020.

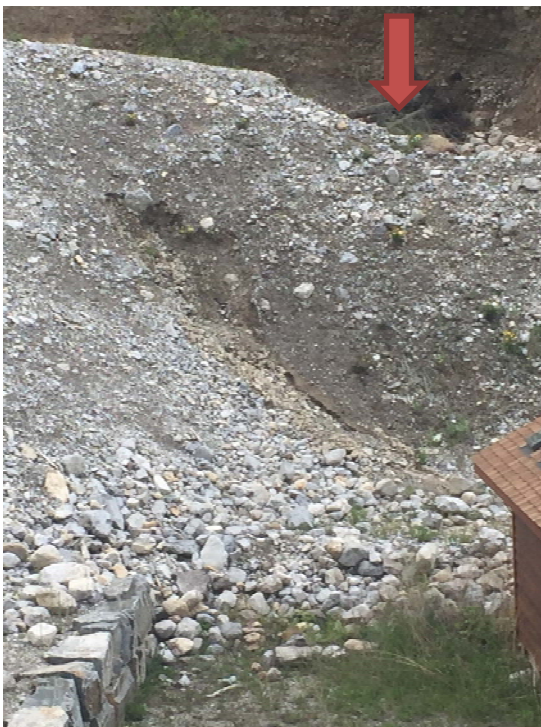
Photo 15: There was some minor seepage on the downstream face of the berm. Seepage was clear and stopped once the repair of the erosion was completed. The arrow shows the location of the erosion in the previous pictures. June 1, 2020.

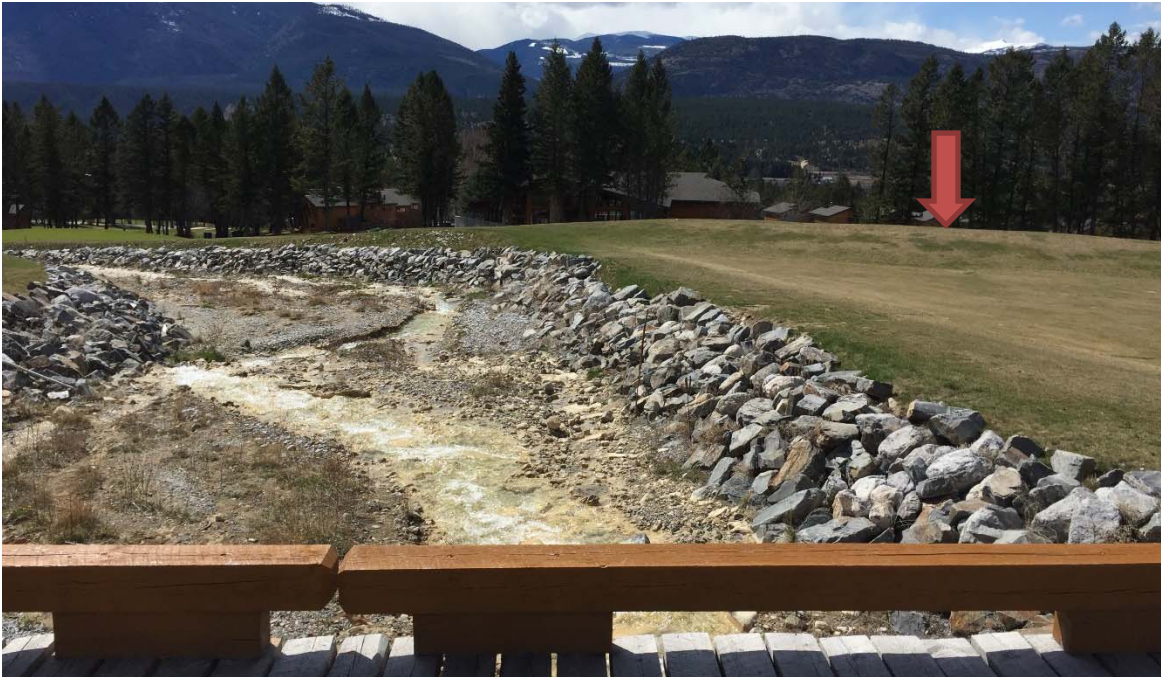
Photo 16: Golf course channel looking downstream from the cart path bridge. Channel is in good condition with some minor infilling from the August 2019 event. The dike on the right hand side of the channel (red arrow) is in good condition. April 23, 2020.

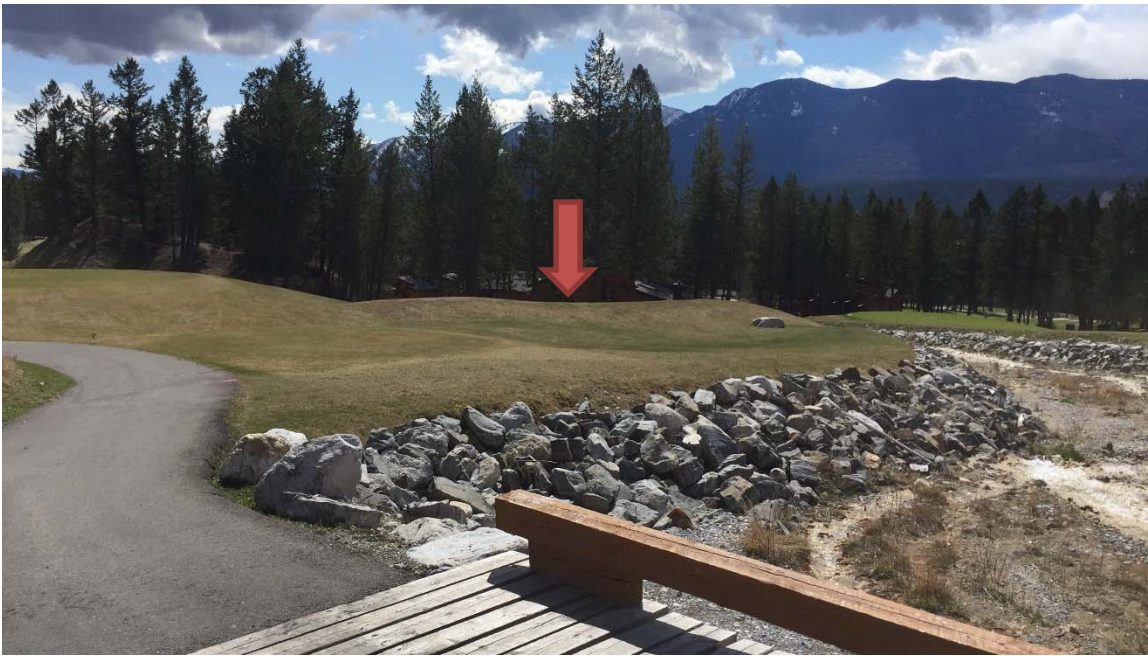
Photo 17: The left hand dike is in good condition. April 23, 2020.

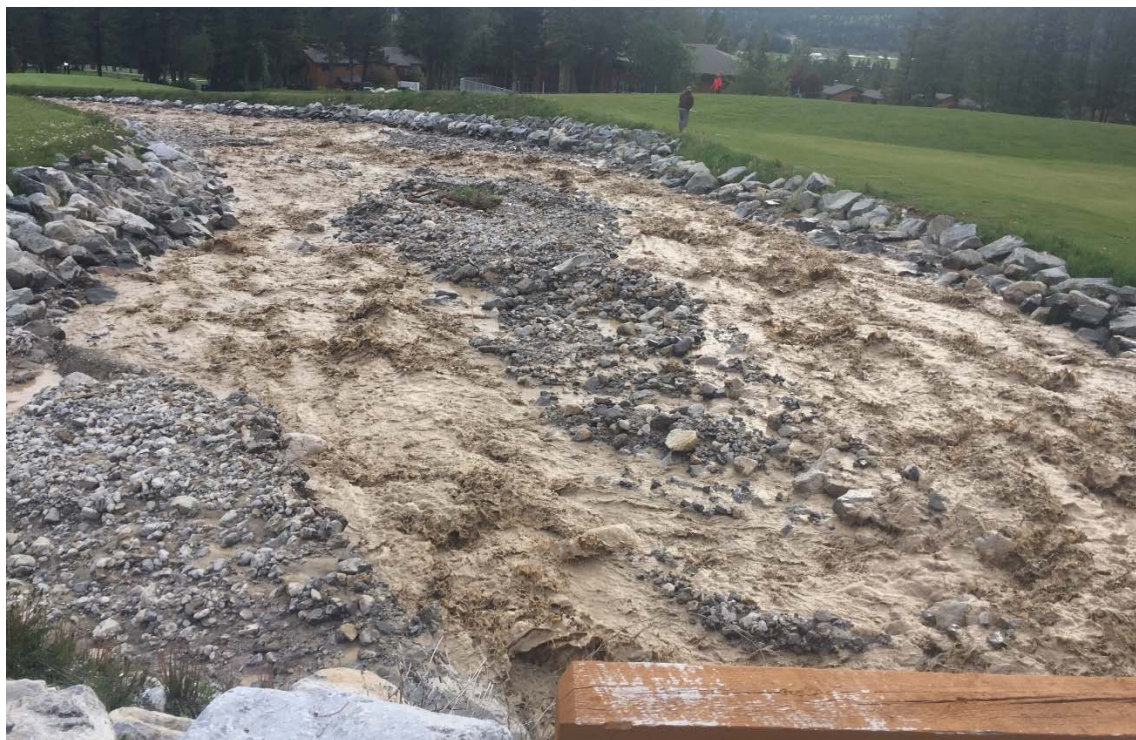
Photo 18: Golf course channel looking downstream from the cart path bridge on May 31, 2020. The debris and water were contained in the channel and the dikes were not impacted.

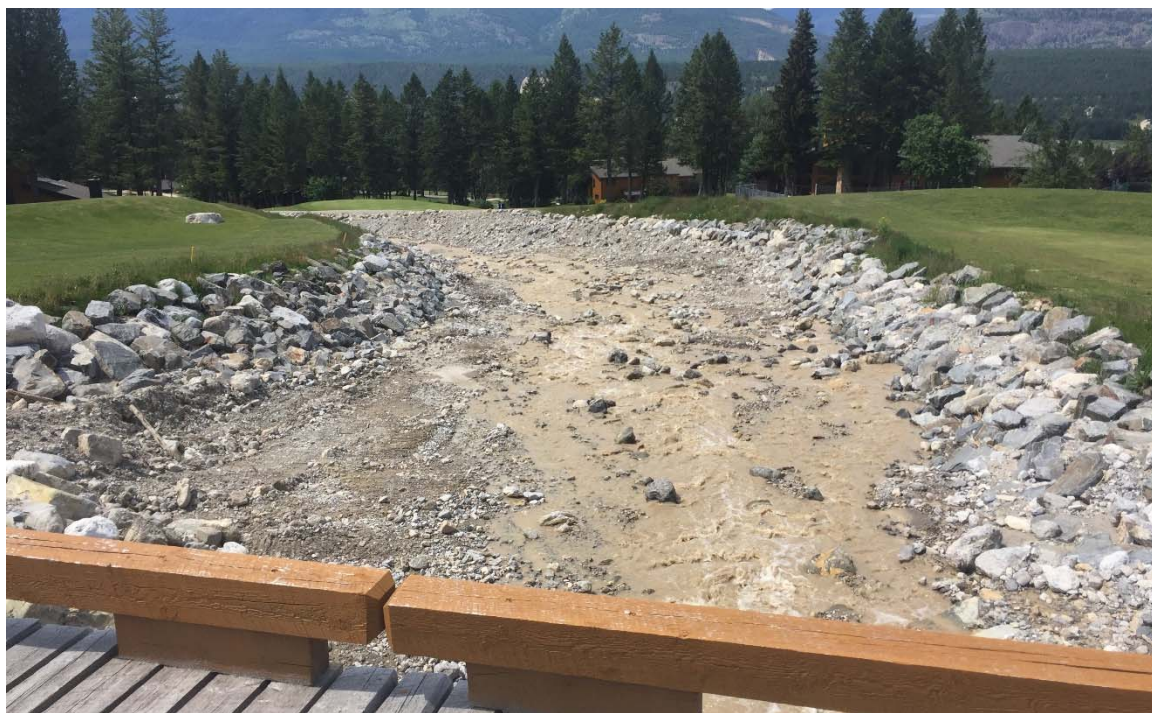
Photo 19: Golf course channel with debris material removed. June 23, 2020.

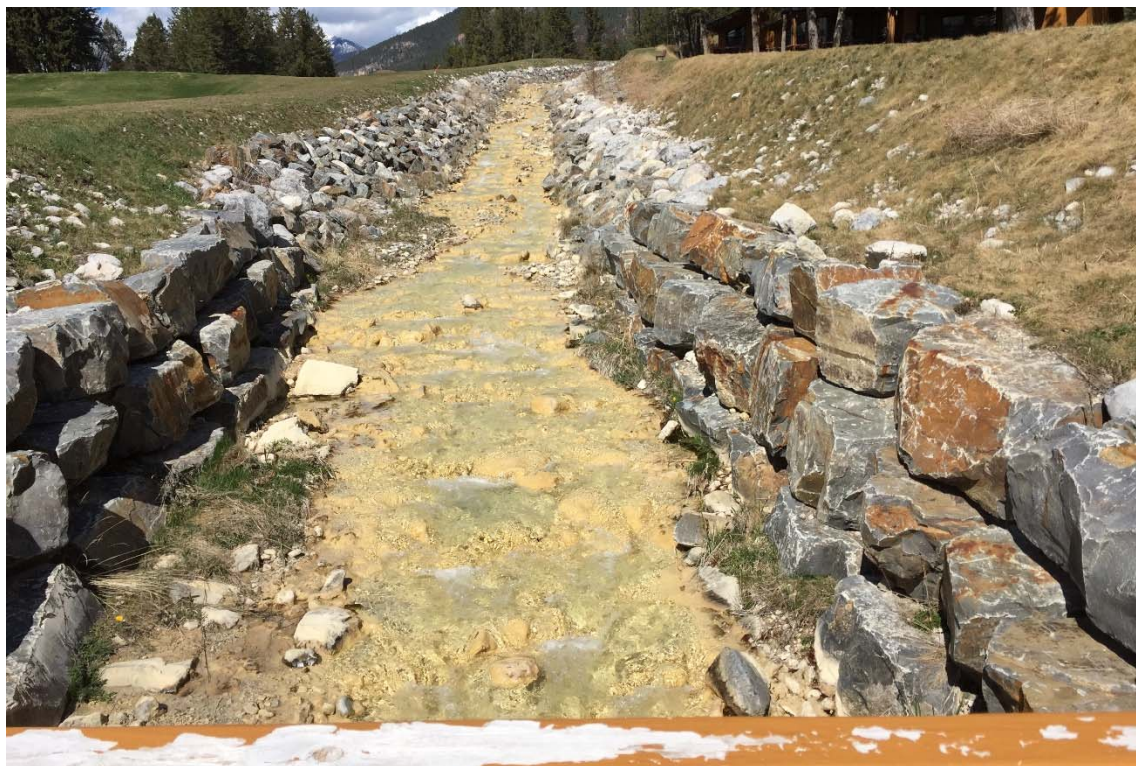
Photo 20: Lower portion of the golf course channel looking upstream from the pedestrian bridge near the Hole 12 pond. The channel and dikes were in good condition. April 23, 2020.

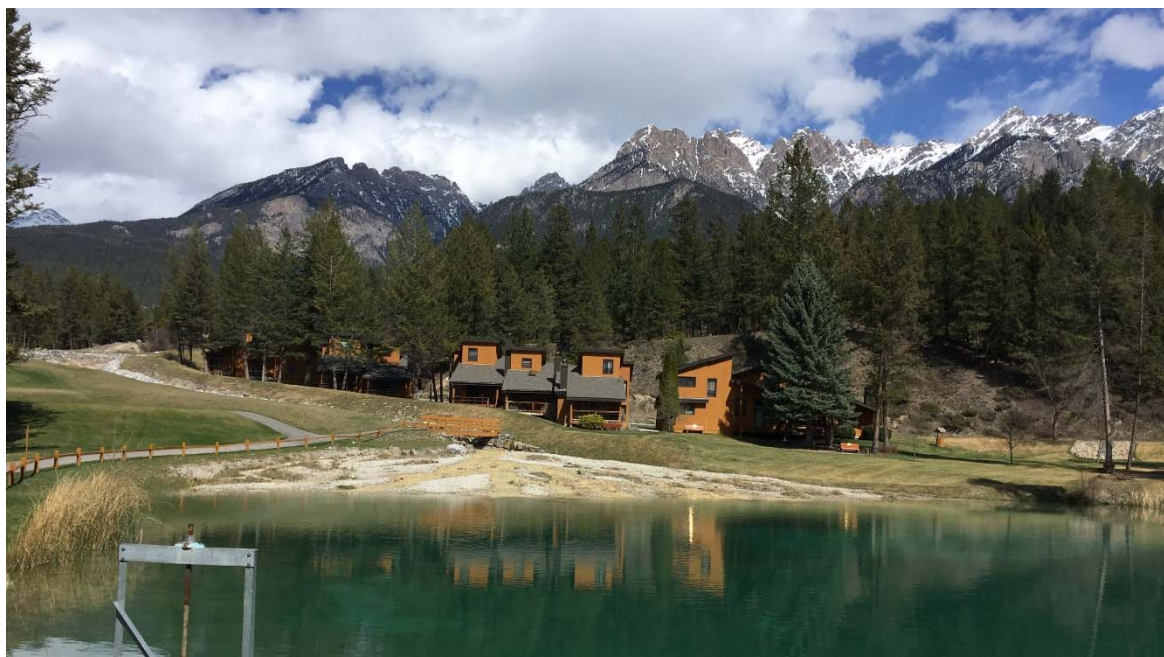
Photo 21: Hole 12 Pond has some material deposition at the inlet but is in good condition with lots of capacity. April 23, 2020.

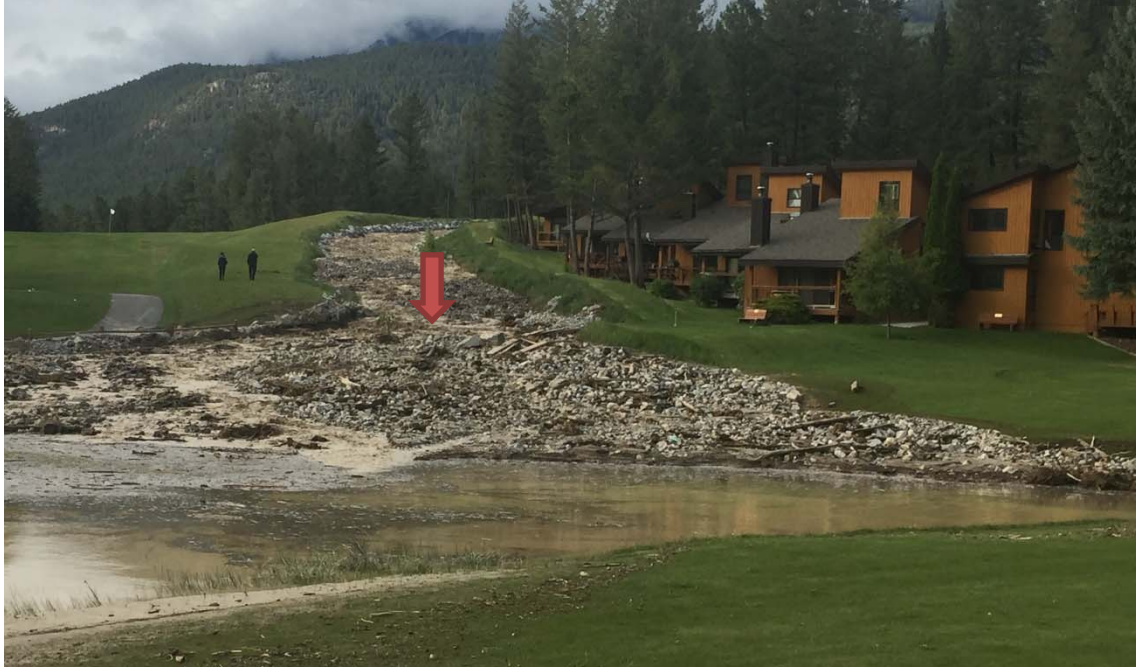
Photo 22: This photo shows the Hole 12 pond inlet and the lower channel. The lower channel was filled with debris and there was minor damage to the right hand dike. The pedestrian bridge that Photo 20 was taken from was destroyed. The pond was filled with debris. May 31, 2020.

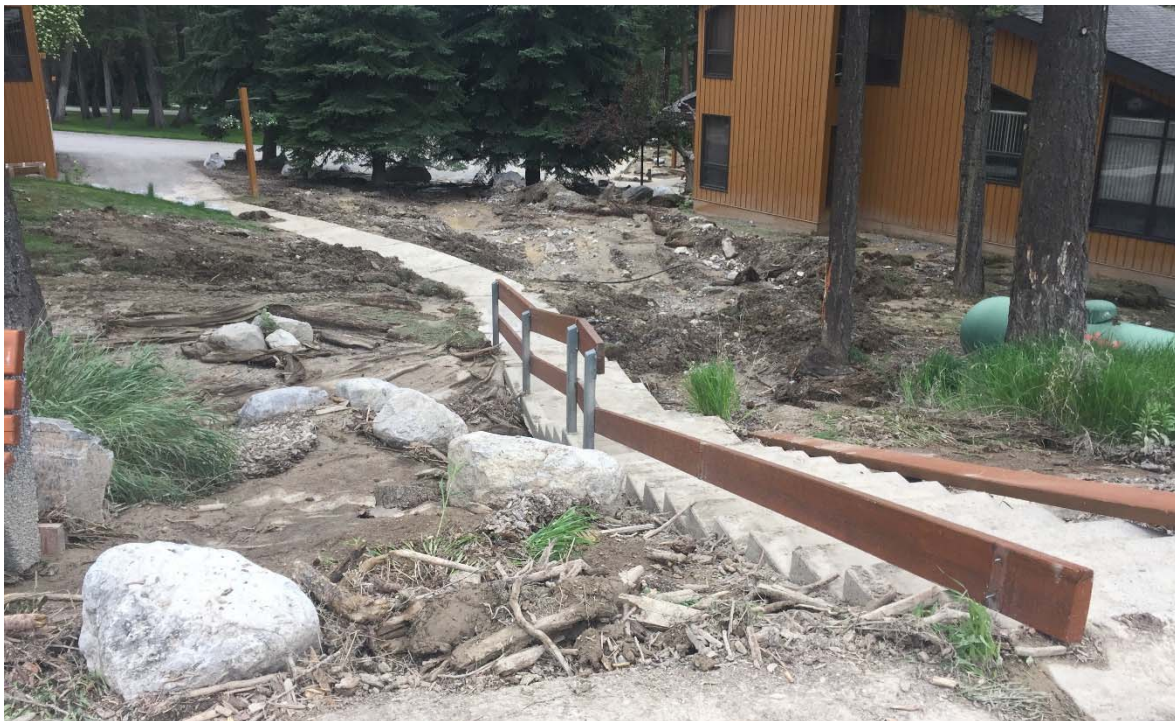
Photo 23: The flood flow exceeded the capacity of the spillway and the pond overtopped and water flowed between the condos on the downstream end of the pond. May 31, 2020.

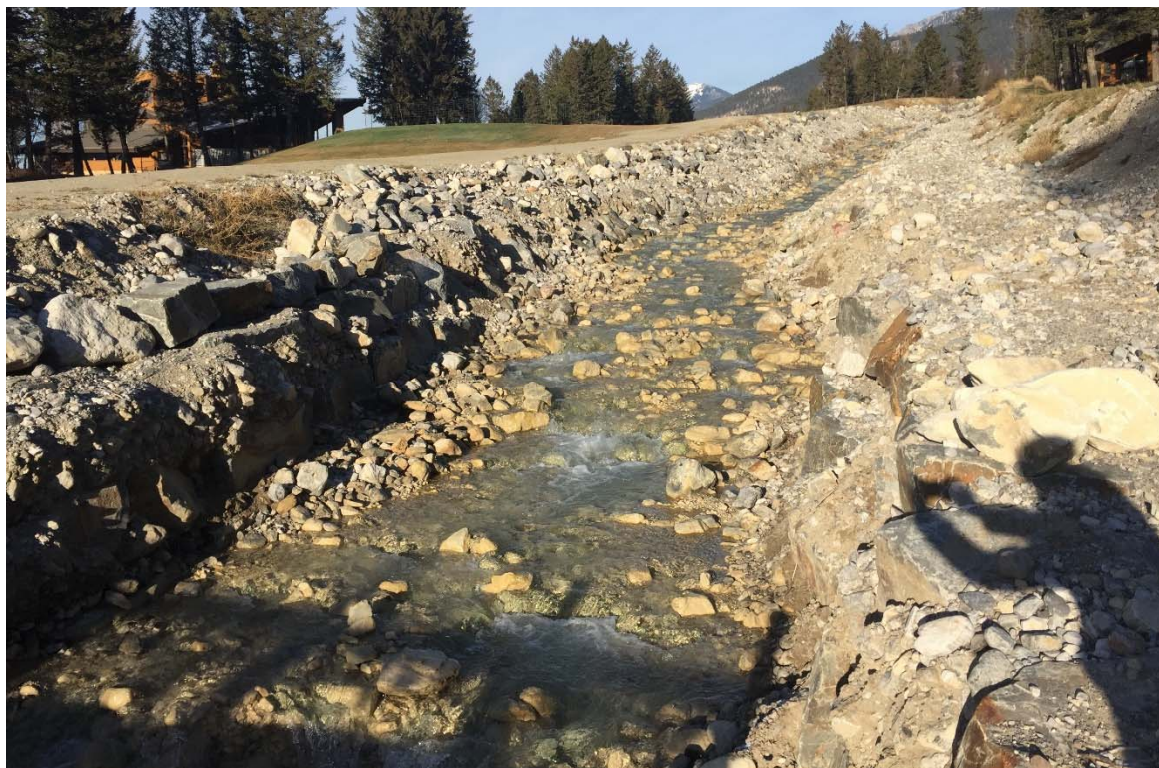
Photo 24: Lower portion of the golf course channel with debris material removed. December 4, 2020.

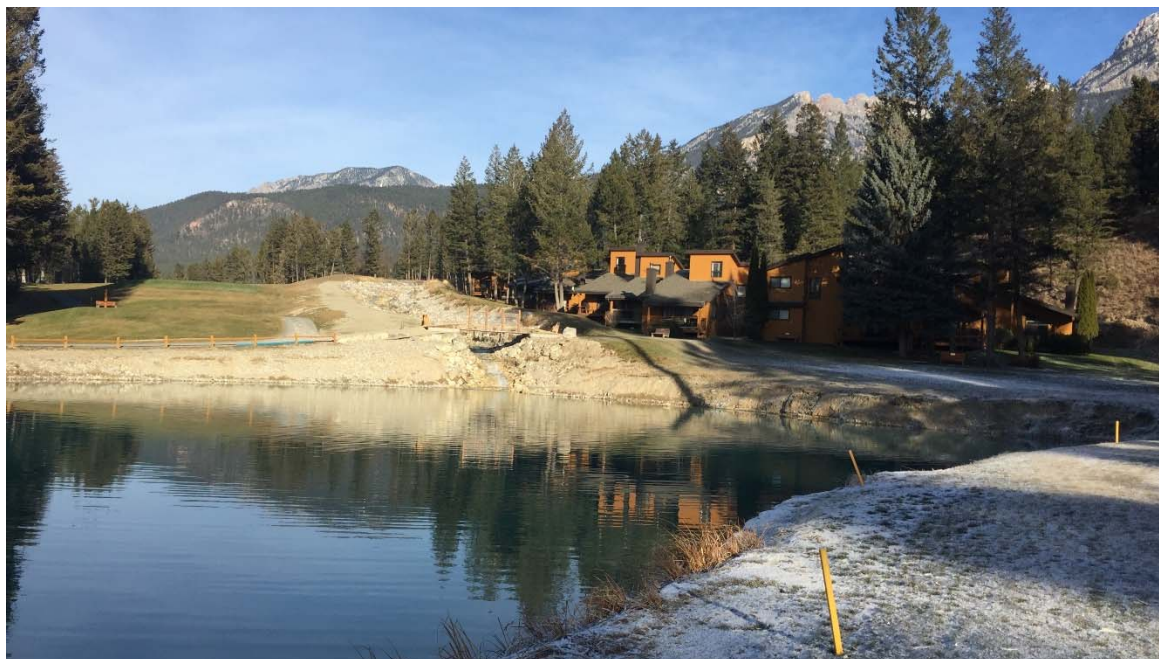
Photo 25: Hole 12 pond with debris material removed. December 4, 2020.

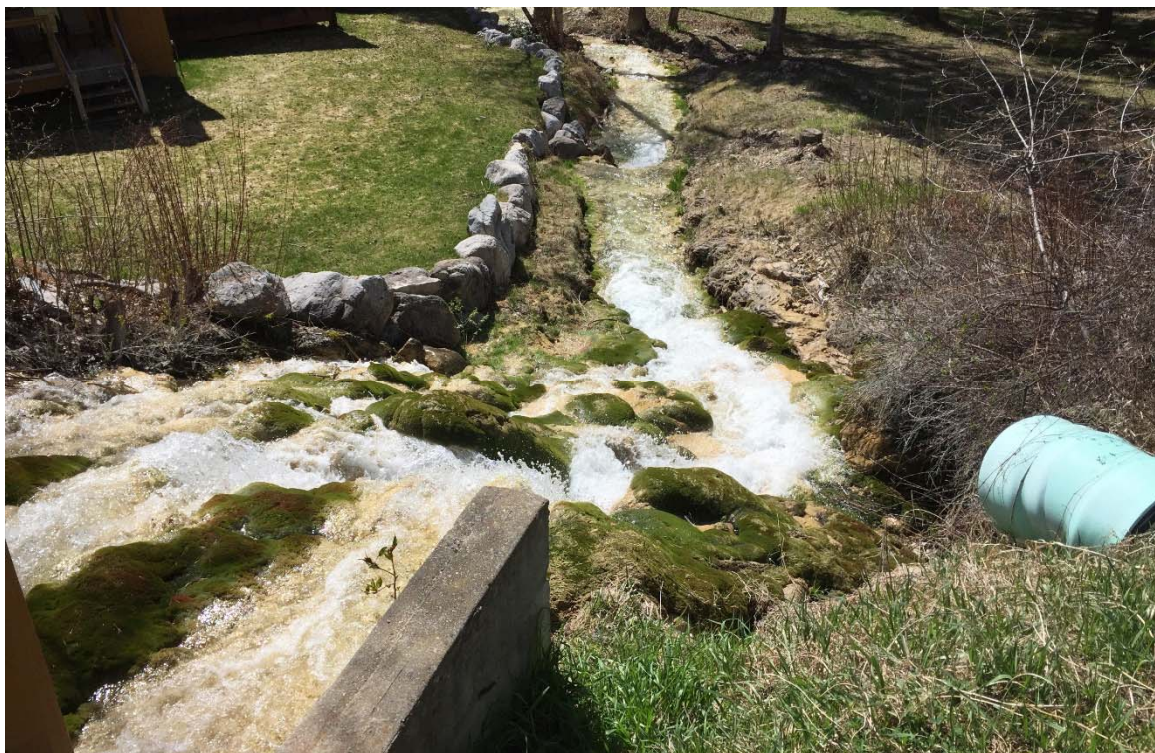
Photo 26: Pond outlet and channel in good condition. April 24, 2020.

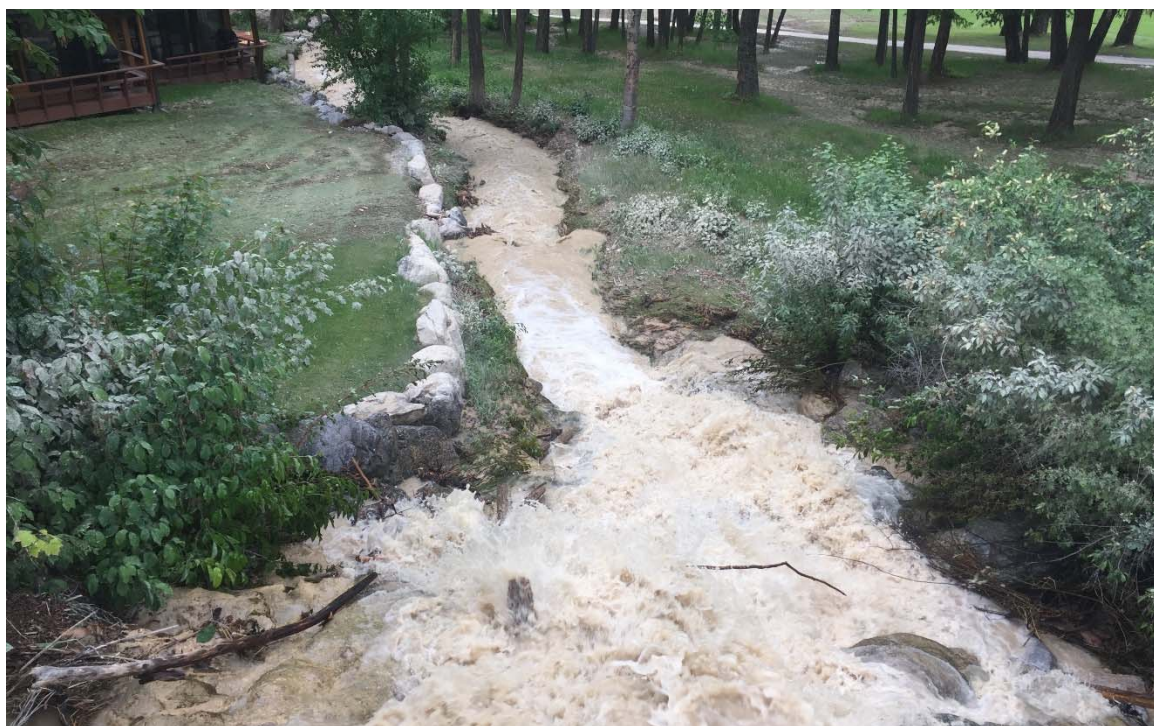
Photo 27: Pond outlet and channel during the May 31, 2020 event. The channel was not damaged and contained the flow. May 31, 2020.
