## Fairmont Creek 2020 Annual Dike Inspection Report

## Fairmont Creek Dike Inspections

An inspection was completed on April 23, 2020 and was conducted by Kara Zandbergen, RDEK Engineering Technician. All sections of the dike were found to be in good condition at that time and ready for freshet. Subsequent inspections were completed after each event and as the cleanup progressed.

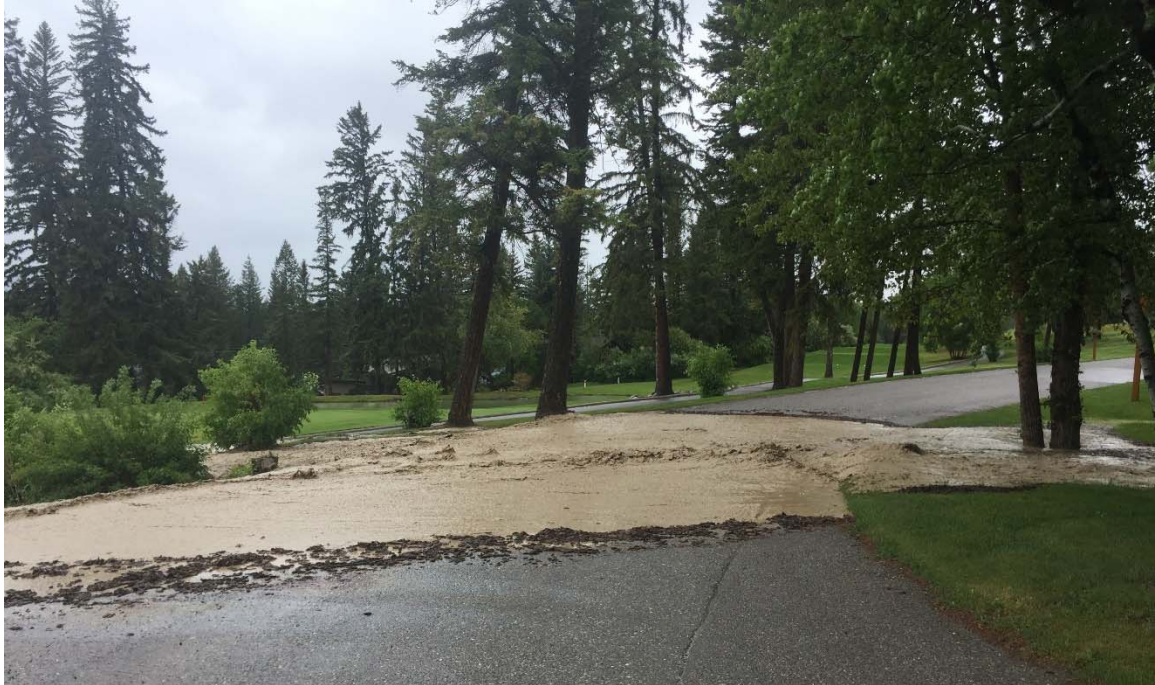
Photo 28: The culvert immediately downstream of the pond was blocked and could not contain the flood flow. Water flowed over the golf course and through residential properties before returning to the channel. May 31, 2020.
