Our File: 35329

RE: Flood Protection Works Inspection – Coldspring Creek at the Water Supply Dam

RE: Flood Protection Works Inspection – Coldspring Creek

RE: Flood Protection Works Inspection – Fairmont Creek

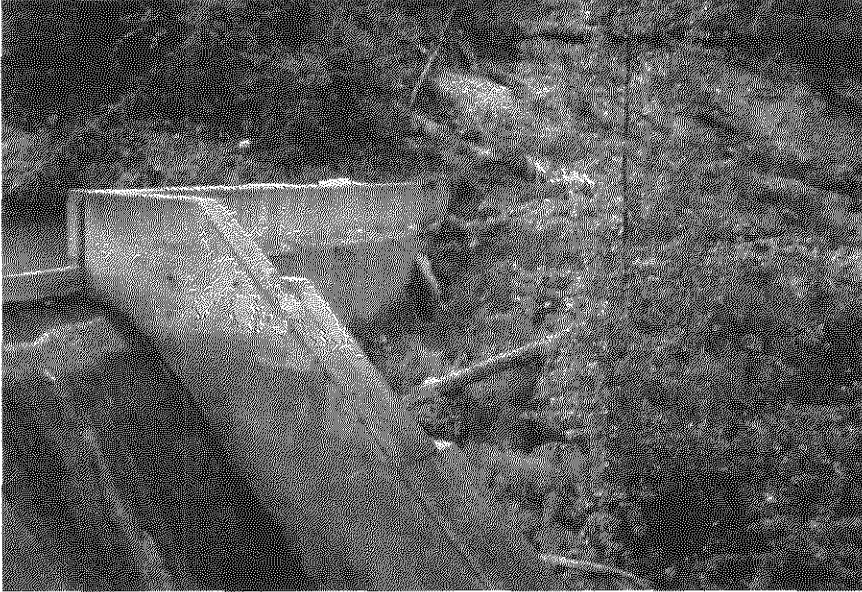
Photo 1, Coldspring Creek Dam

The dam appears to have been overtopped by flood flows at some time, resulting in erosion of the soils from the downstream face of the dam. **Photo 1** shows the exposed downstream face of the dam. A detailed stability assessment or review of the design of the dam to verify safety factors has not been undertaken at this time. However, the size of the trees and vegetation on the ground surface in this area tends to indicate that there is a degree of stability associated with the current situation. We recommend that the backfill along the downstream face of the dam be replaced.

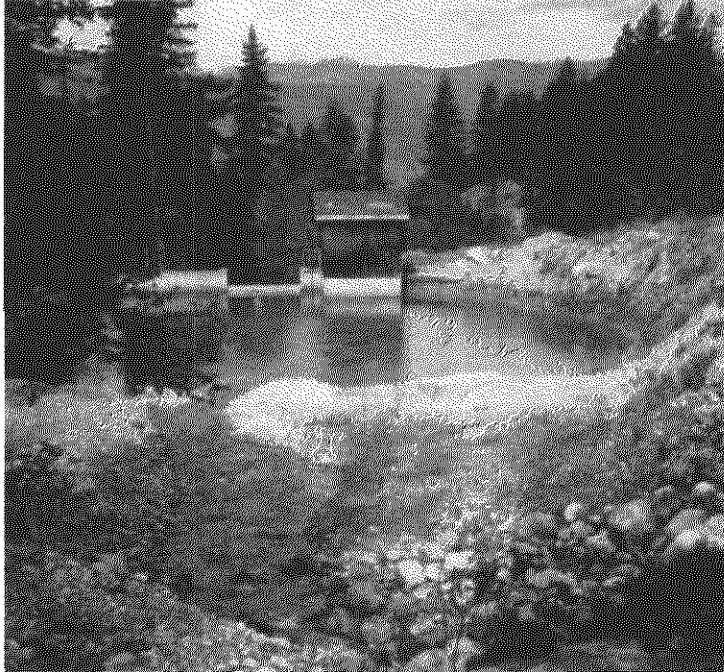
Photo 2, Coldspring Creek Reservoir

The reservoir has been dredged out recently, perhaps last year and there is capacity in the reservoir to receive and to contain a debris flow. The reservoir can be seen in **Photo 2**. We believe that the bank, on the right of the photo, is composed of material previously removed from the reservoir and can be excavated to provide more capacity within the reservoir. The upstream end of the reservoir has an amount of deposition which will require removal in future as more material accumulates. The removal of material would be a part of the ongoing maintenance program for the reservoir.

At this time we recommend only removal of material from the reservoir as part of a continuing maintenance program for the reservoir.

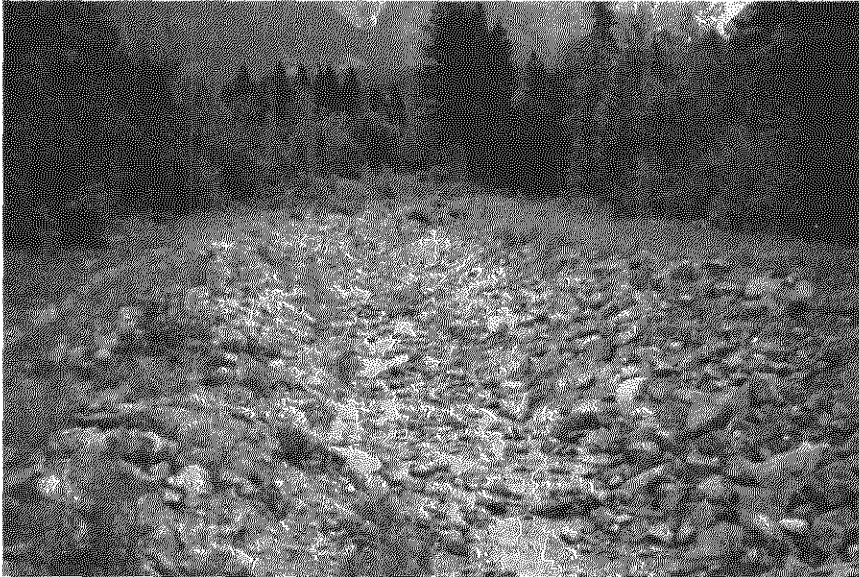
Photo 1, Coldspring Creek downstream of Highway 93

The channel appears to be stable functioning as it was designed. Along portions of the channel, there has been a placement of soil on the rip rap of the south bank. This soil and resulting grasses will not decrease the functionality of the channel. The condition of the channel can be seen in **Photo 1** and **Photo 2**.

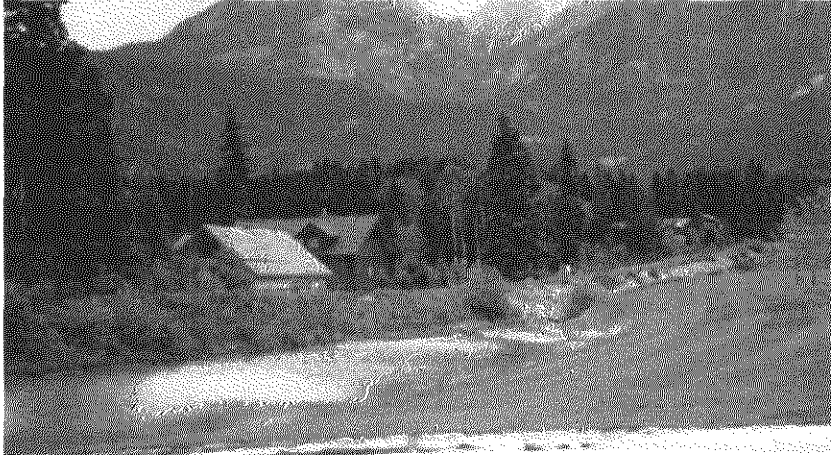
Photo 3, Coldspring Creek Debris Trap

The debris trap adjacent to the Columbia River is almost free of sediment and debris accumulation. **Photo 3** shows the general condition of this facility.

At this time we recommend only continued monitoring of this system which includes Coldspring Creek downstream of Highway 93 and the debris trap adjacent to the Columbia River.

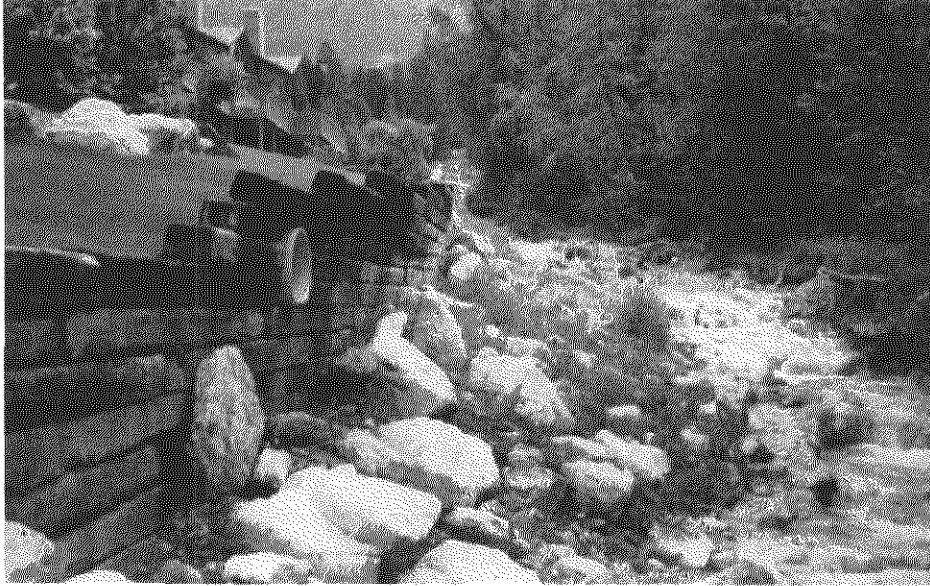
The second, and more problematic, occurrence has been the tilting of the retaining wall. We speculate that a combination of factors may have lead to the current situation. The watering of the lawns along the top of the wall could have provided the hydraulic pressures, which are acting to push the wall off of a vertical alignment. This may be combined with a poor drainage system or possibly a limited tieback system. A photo of the wall is shown below.

It can be seen that there is no visible evidence of movement along the bottom rails. The tilting seems to be limited to rails located above the storm sewer outlet.

At this time we recommend that the upper portions of the wall be restored to a vertical position. Further, an adequate drainage system should be placed behind the wall along with appropriate tiebacks.
