File: Fairmont Creek Dike

Re: Fairmont Creek - Flood Mitigation Works

FLOOD PROTECTION INSPECTION REPORT

DYKE: FAIRMONT CREEK

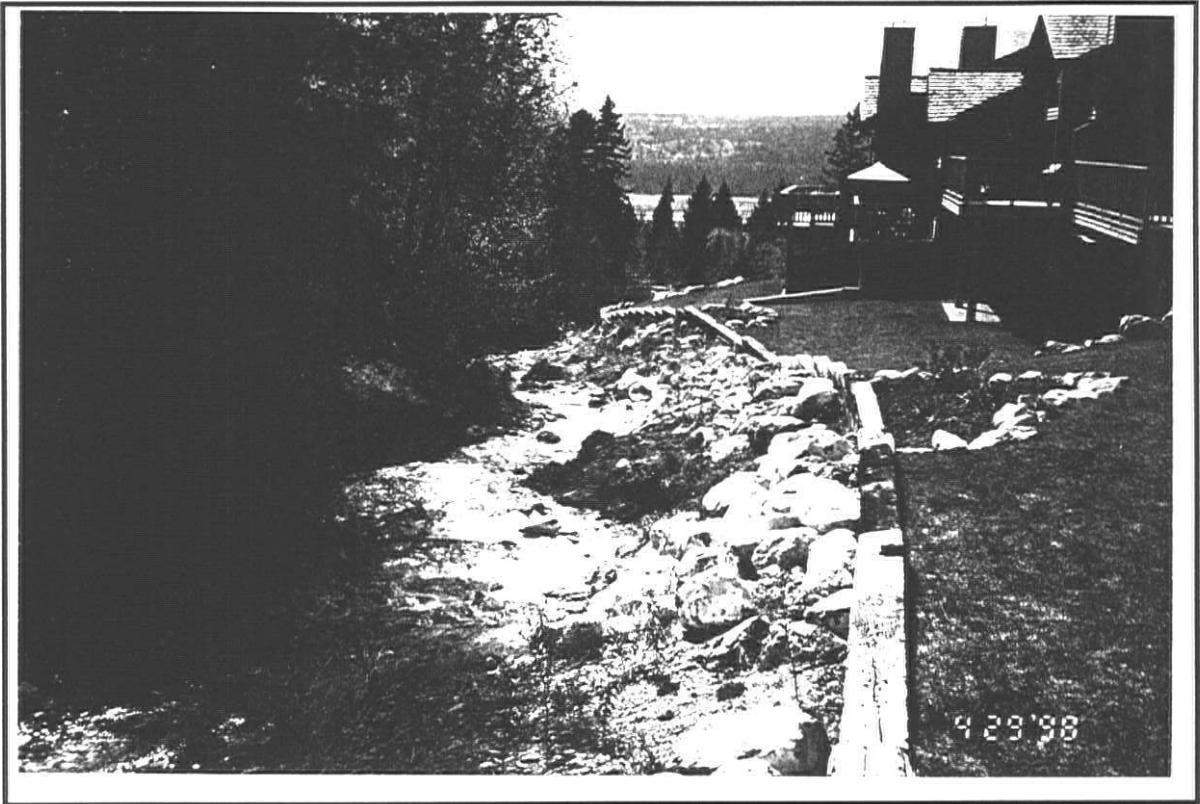
Photo #1

Standing at upper end of flood protection works looking downstream.

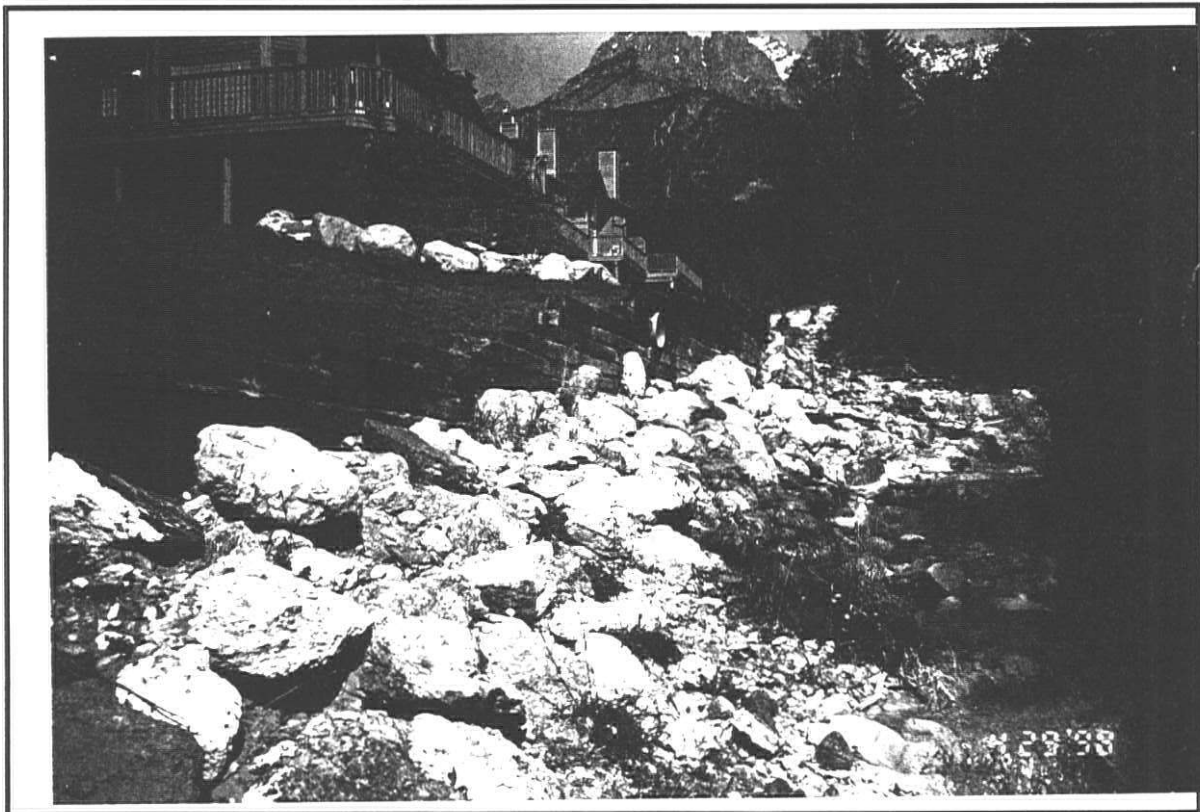
Photo #2

Standing at lower end of flood protection works looking upstream.
