## **Cold Spring Creek 2022 Annual Dike Inspection Report**

## **2022 Cold Spring Creek Dike Inspections**

An inspection was completed on May 3, 2022 and was conducted by Jim Maletta, ASCT., RDEK acting Water Resources Project Supervisor. All sections of the dike were found to be in good condition at that time and ready for freshet.

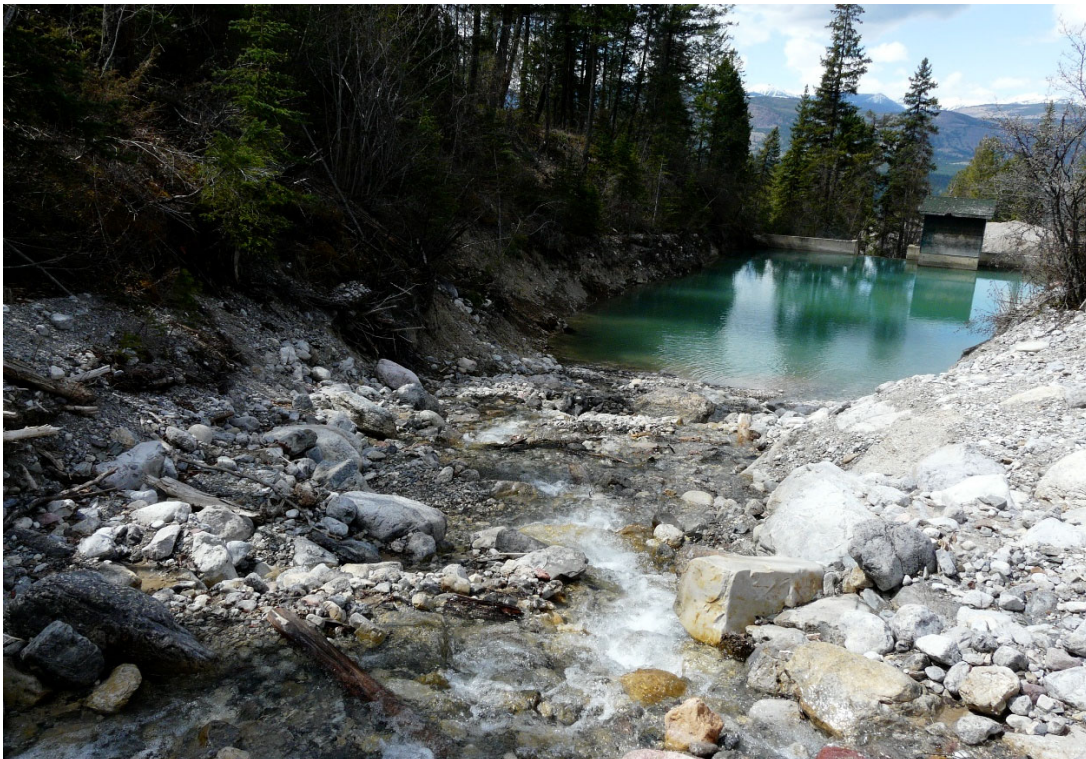
The dam and reservoir were in good condition during the May 5, 2021 inspection. During the May 24, 2021 event it was approximately 75% filled with debris. The debris was removed from the reservoir immediately after the May 24 event. A second intense rain event in mid July filled approximately 30% of the reservoir capacity with debris. The second event material was cleaned out shortly after the deposition occurred leaving the reservoir completely empty of debris. The dam was in good condition on the May 3, 2002 inspection date with some scour along the left bank which was very noticeable at the face of the dam. Meters of material would have to scour out before any issues would surface. FHSR has been advised of the observed conditions.

Photo 1: The reservoir conditions on May 3, 202

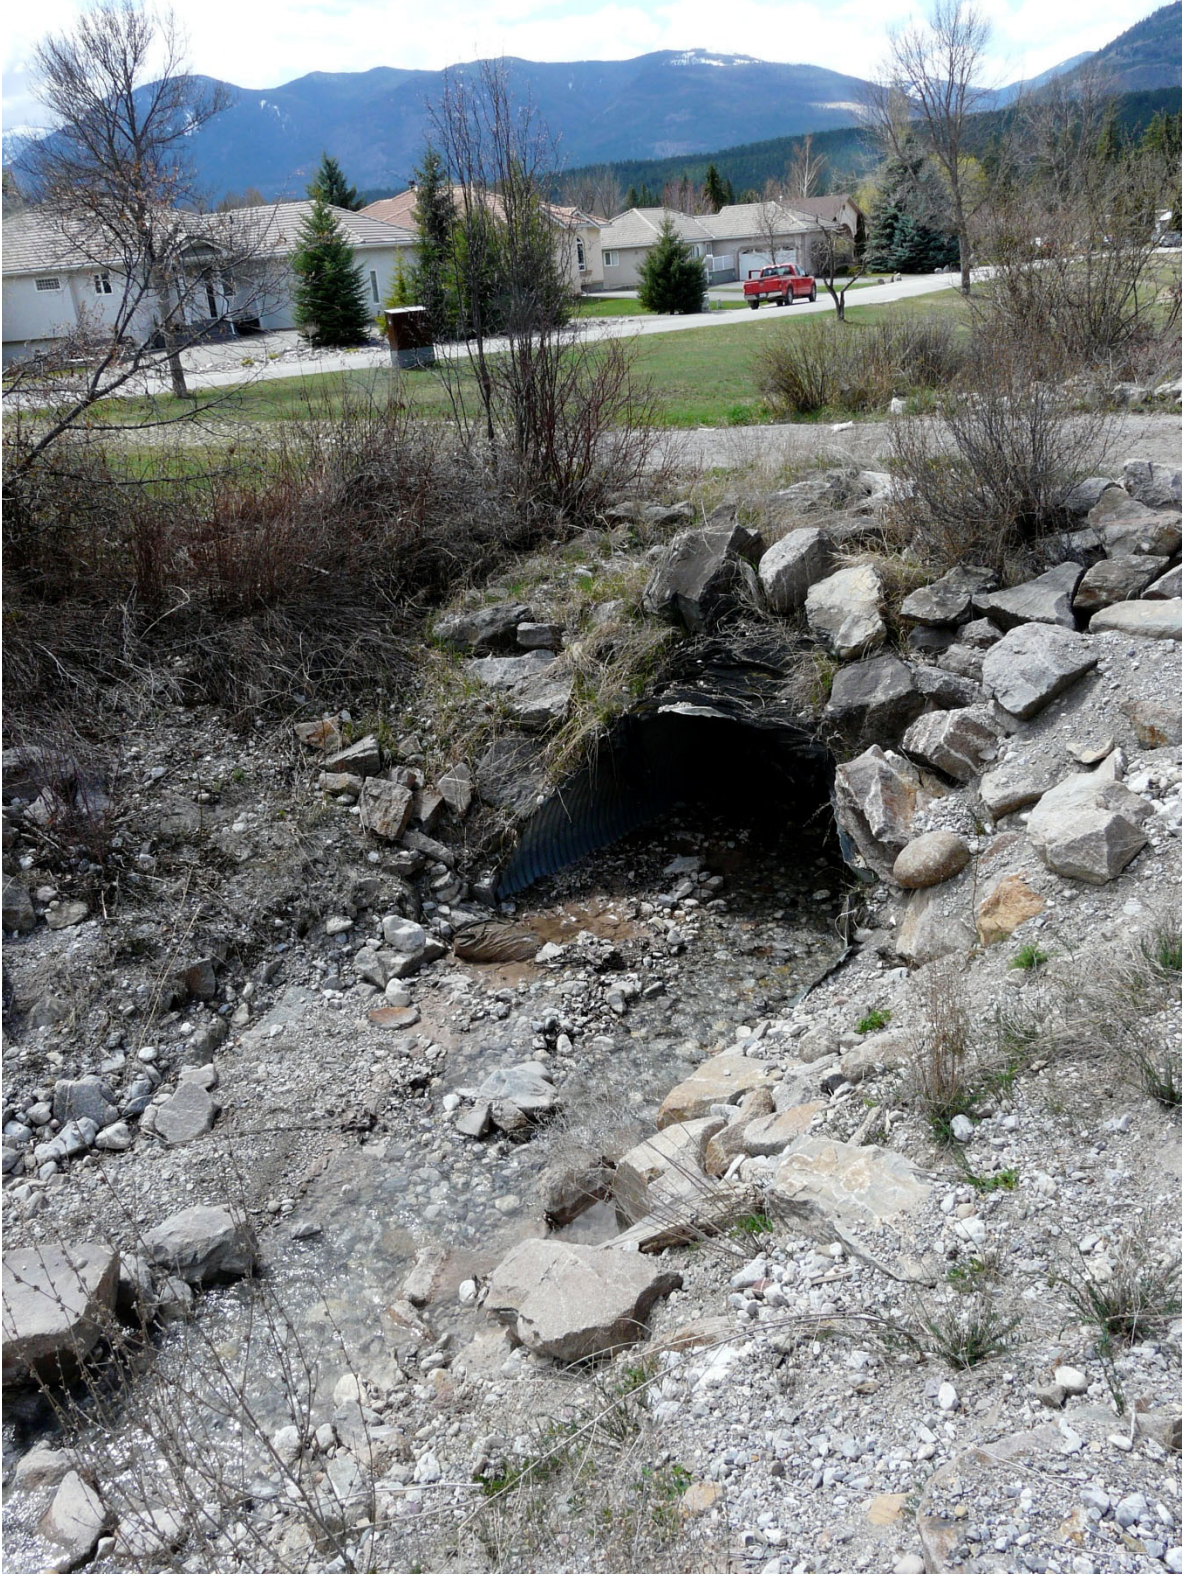
The last culvert along Cold Spring Creek before the lower debris trap is experiencing some very minor underflow piping. Sediment deposition in this culvert is common as the grade at the culvert inlet flattens out and sediment collects at the inlet and along the invert of the culvert length. The current condition of this culvert may reduce capacity in a high flow situation. Clearing granular sediment above, within and below the culvert should occur prior to the 2023 freshet. The channel at the outlet of the last culvert also has gravel deposition within it and has deposited granular material from the culvert outlet and has created a small fan at the debris trap inlet. The last culvert along Cold Spring Creek is part of the flood control works. It would be prudent to remove some material from the creek channel and fan when the culvert is cleaned out

Photo 2: Lowest Cold Spring Creek Culvert Inlet with Sediment Build Up

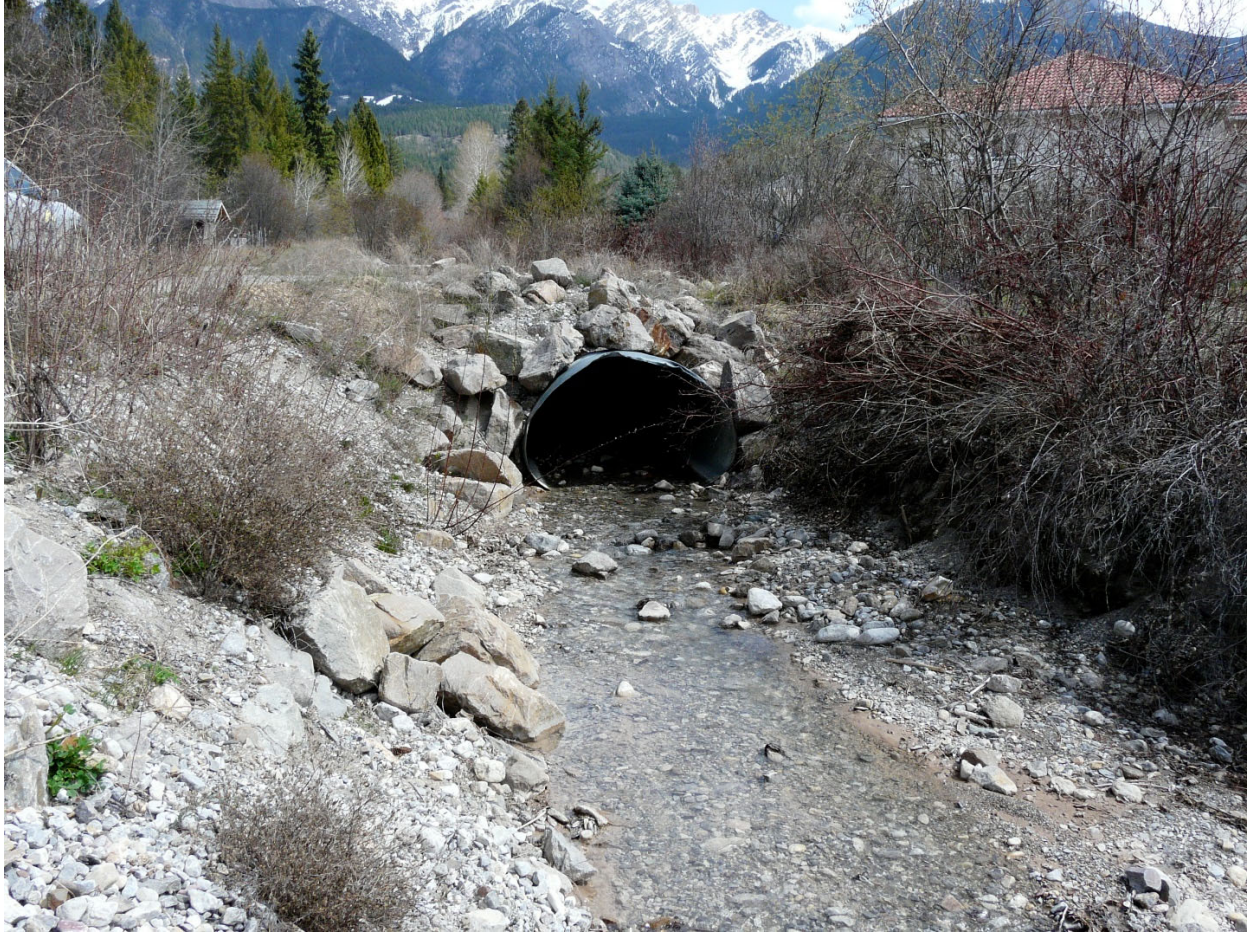
Photo 3: Lowest Cold Spring Creek culvert outlet showing gravel deposition throughout the culvert

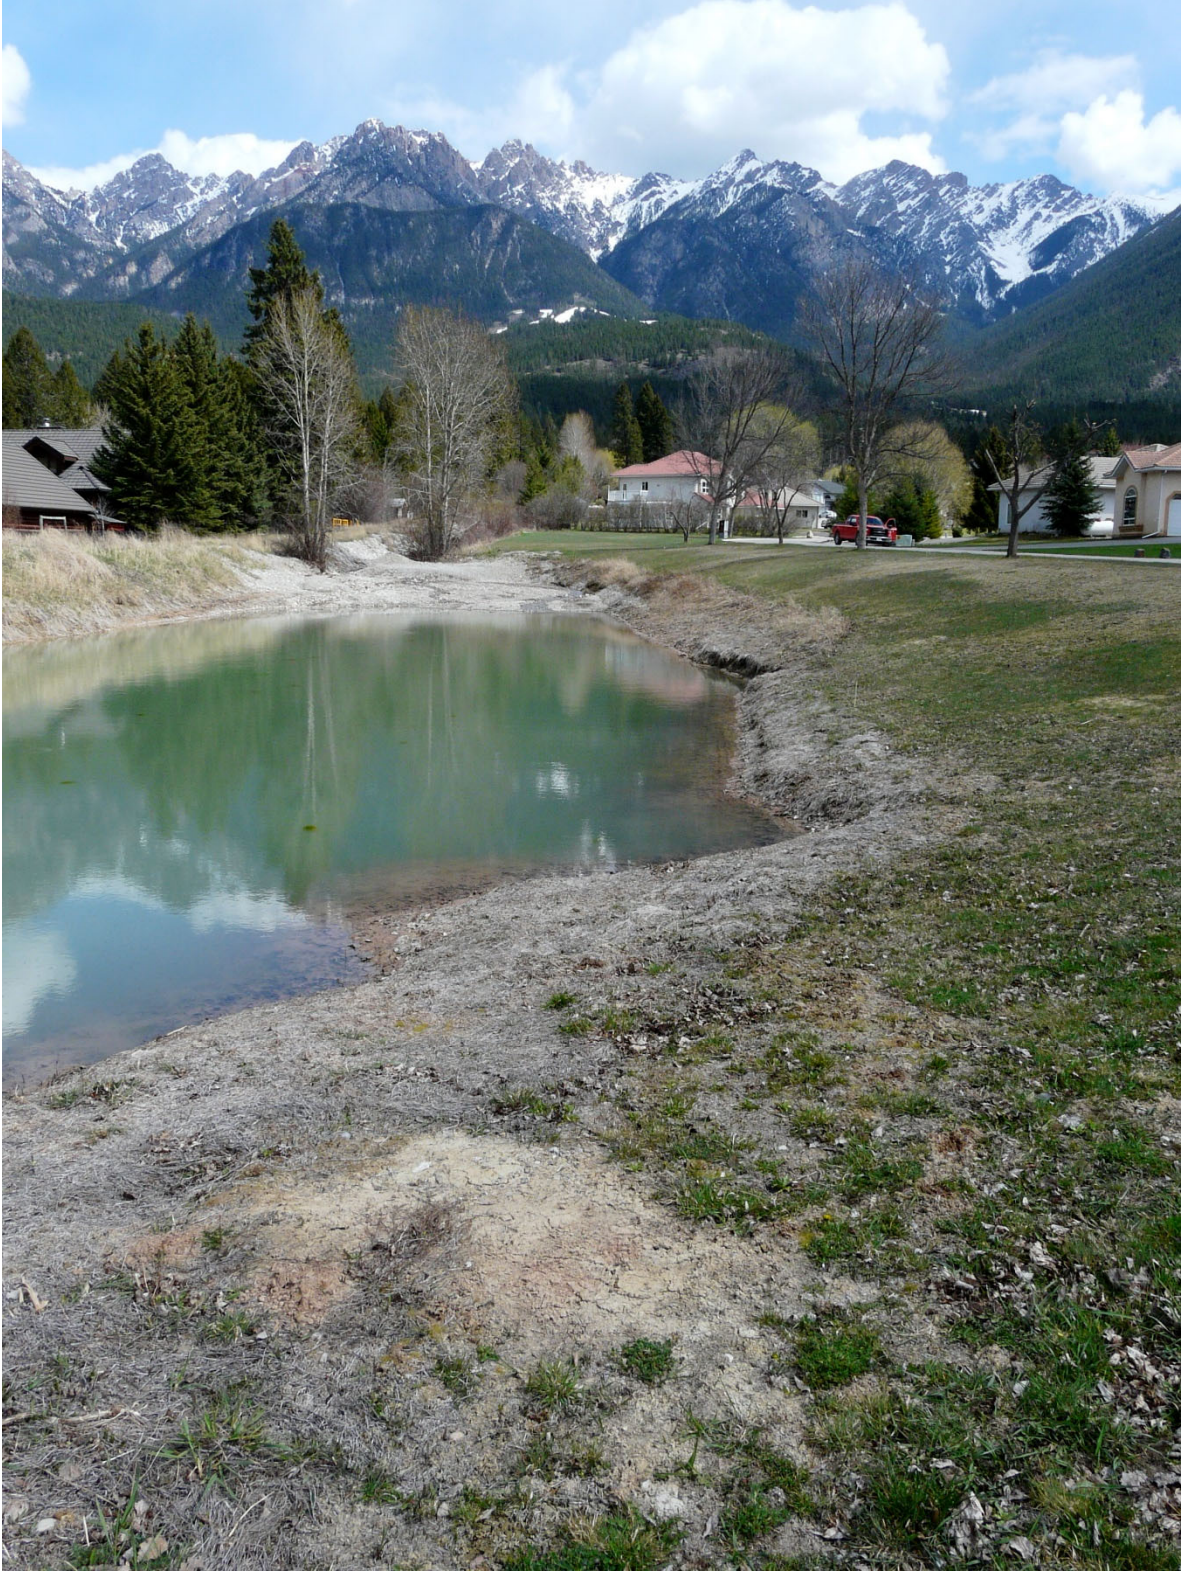
The bottom Cold Spring Creek debris trap has signs of migrating deposition at the inlet and siltation deposition near the outlet. The build up at the inlet and near the outlet are not significant but increasing. Minor capacity reduction of the debris trap is the result of the upper gravel and lower silt depositions. Plans to dredge the sediment near the outlet should occur within the next 5 years or if deposition increases due to high fines carryover from high water events possibly sooner. The debris trap inlet deposition should be inspected regularly in 2022 after high water events. High water events could impact gravel deposition at the trap inlet and should be inspected after each highwater event. A Water Act Section 11 application is required for material removal for non-emergency maintenance. Non -

Photo 4: Cold Spring Creek debris trap showing gravel deposition at the inlet

emergency maintenance occurs in the fish window in second half of August, so approvals need to be in place prior to the fish window maintenance period.

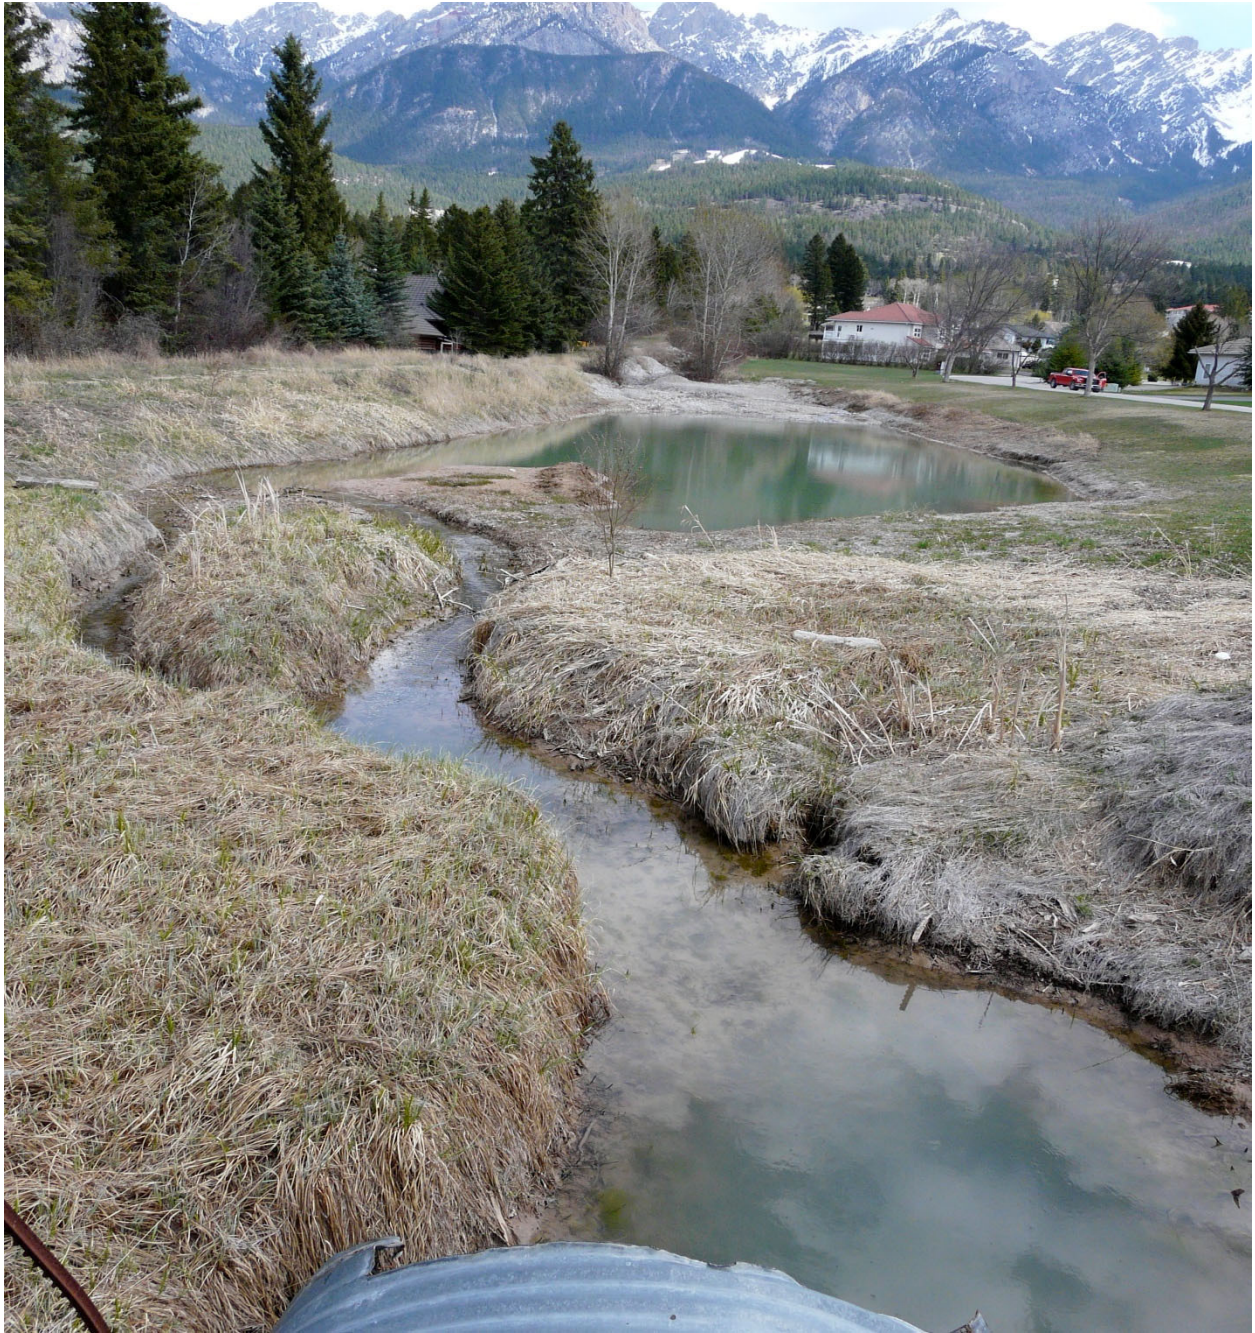
Photo 5: Cold Spring Creek outlet of debris trap showing siltation buildup up stream of the culvert
