Cold Spring Creek Dike Inspection Report

Water Course 1: Cold Spring Creek

GPS Number 330

The Dike was inspected on Friday May 20, 2011.

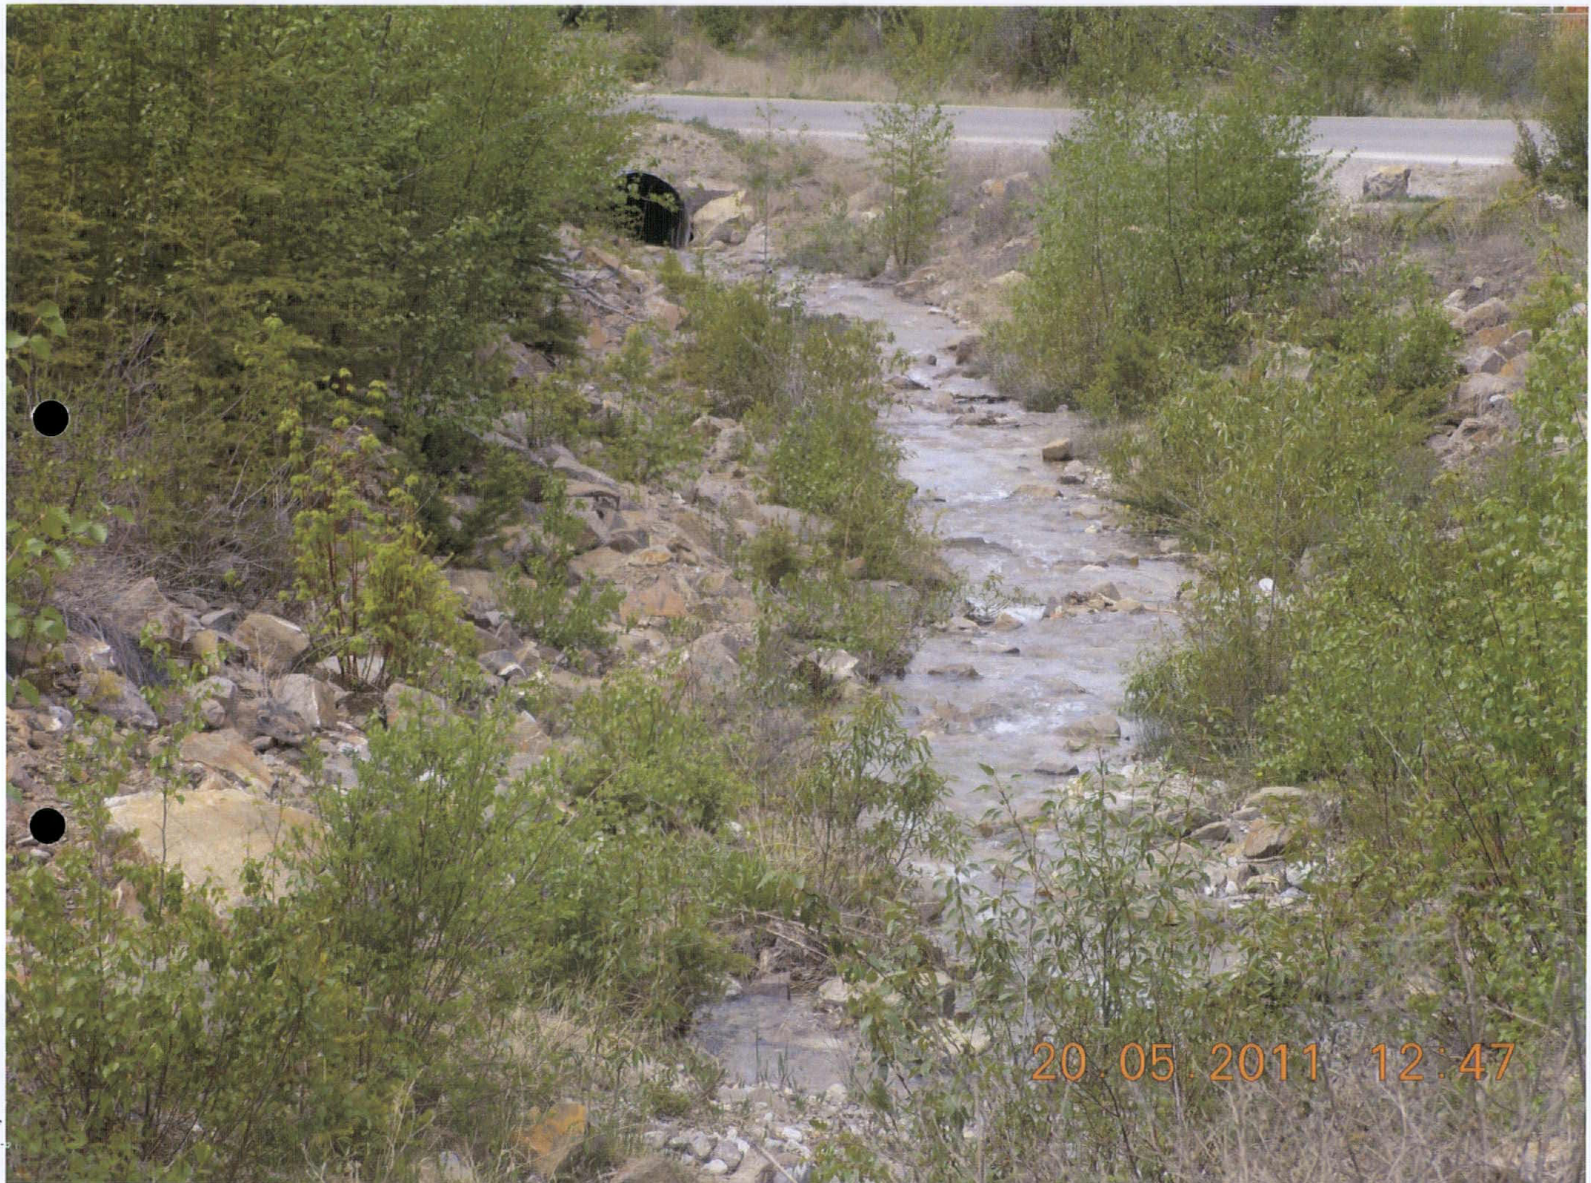
20.05.2011 12:47

The dike armoring is in good condition with no signs of erosion or high water over the past 12 months. The flow through the channel has increased this year over last year. Vegetation is present in the armoring of the dike and removal is planned for the fall of 2011 when minimal flow is likely. (please see attached photo)

Removal of vegetation within the armored portion of the dike scheduled for the fall of 2011.

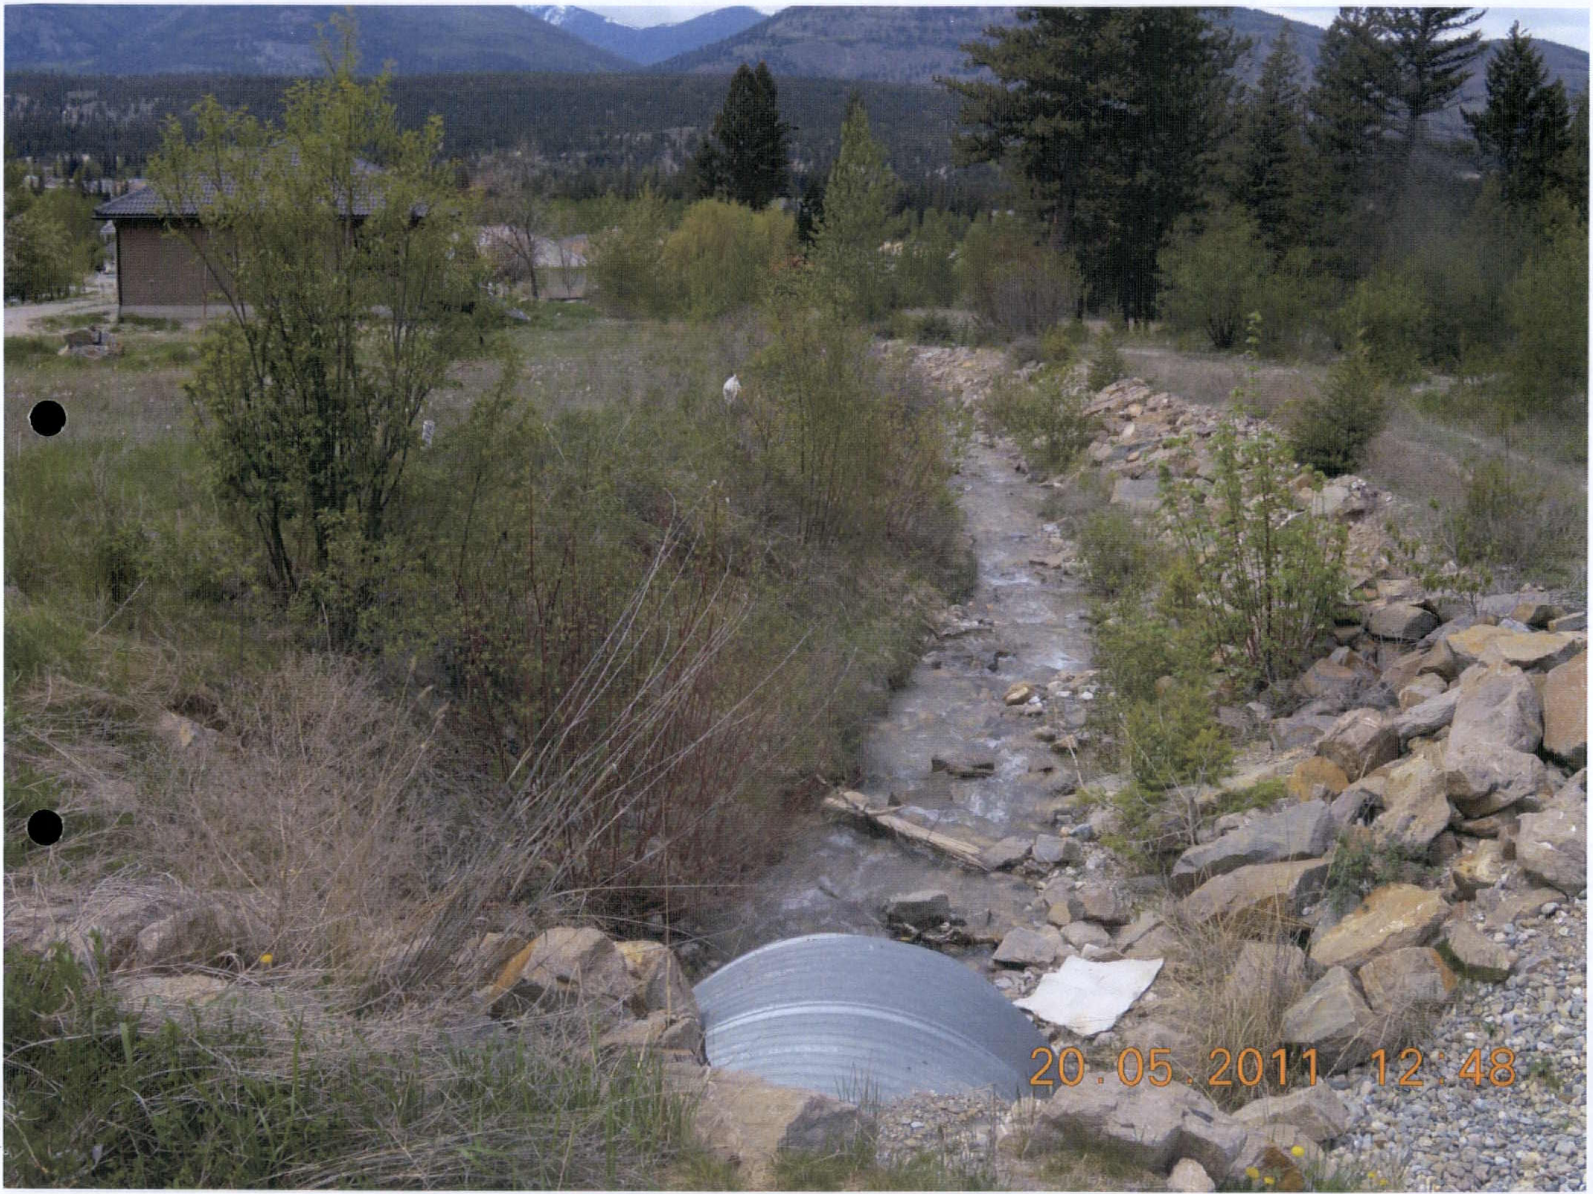
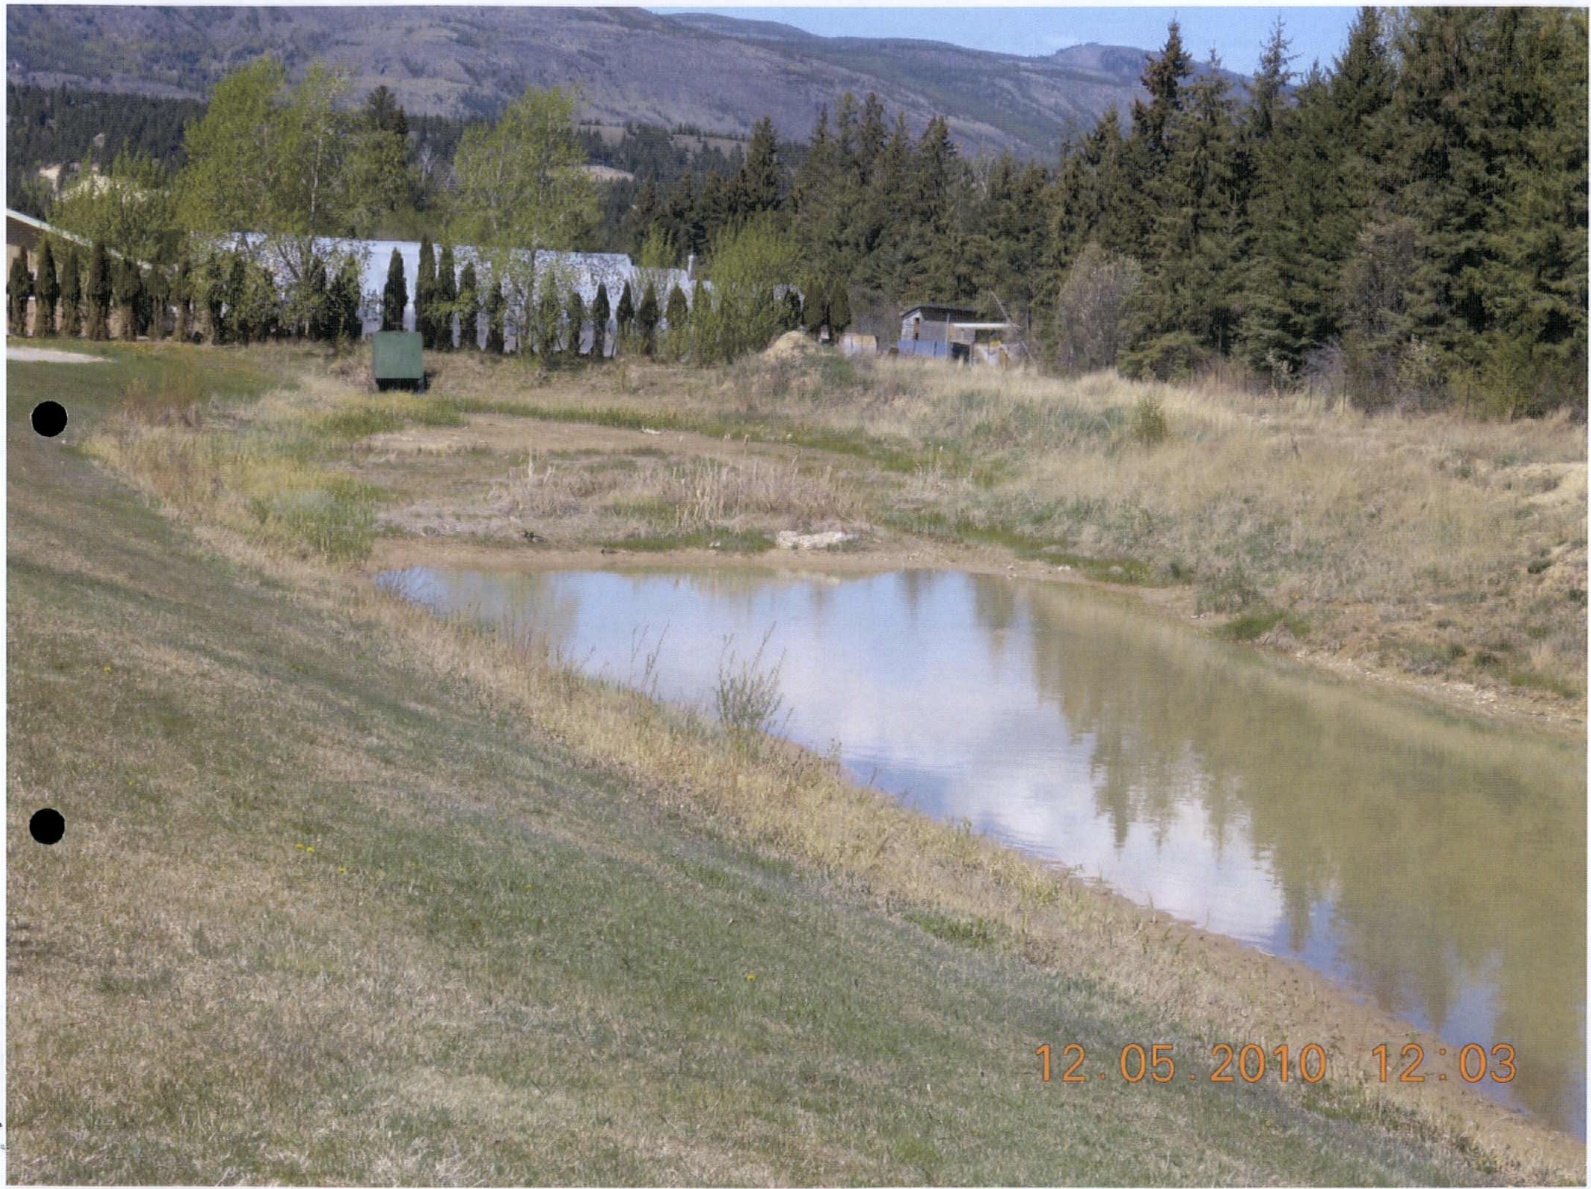
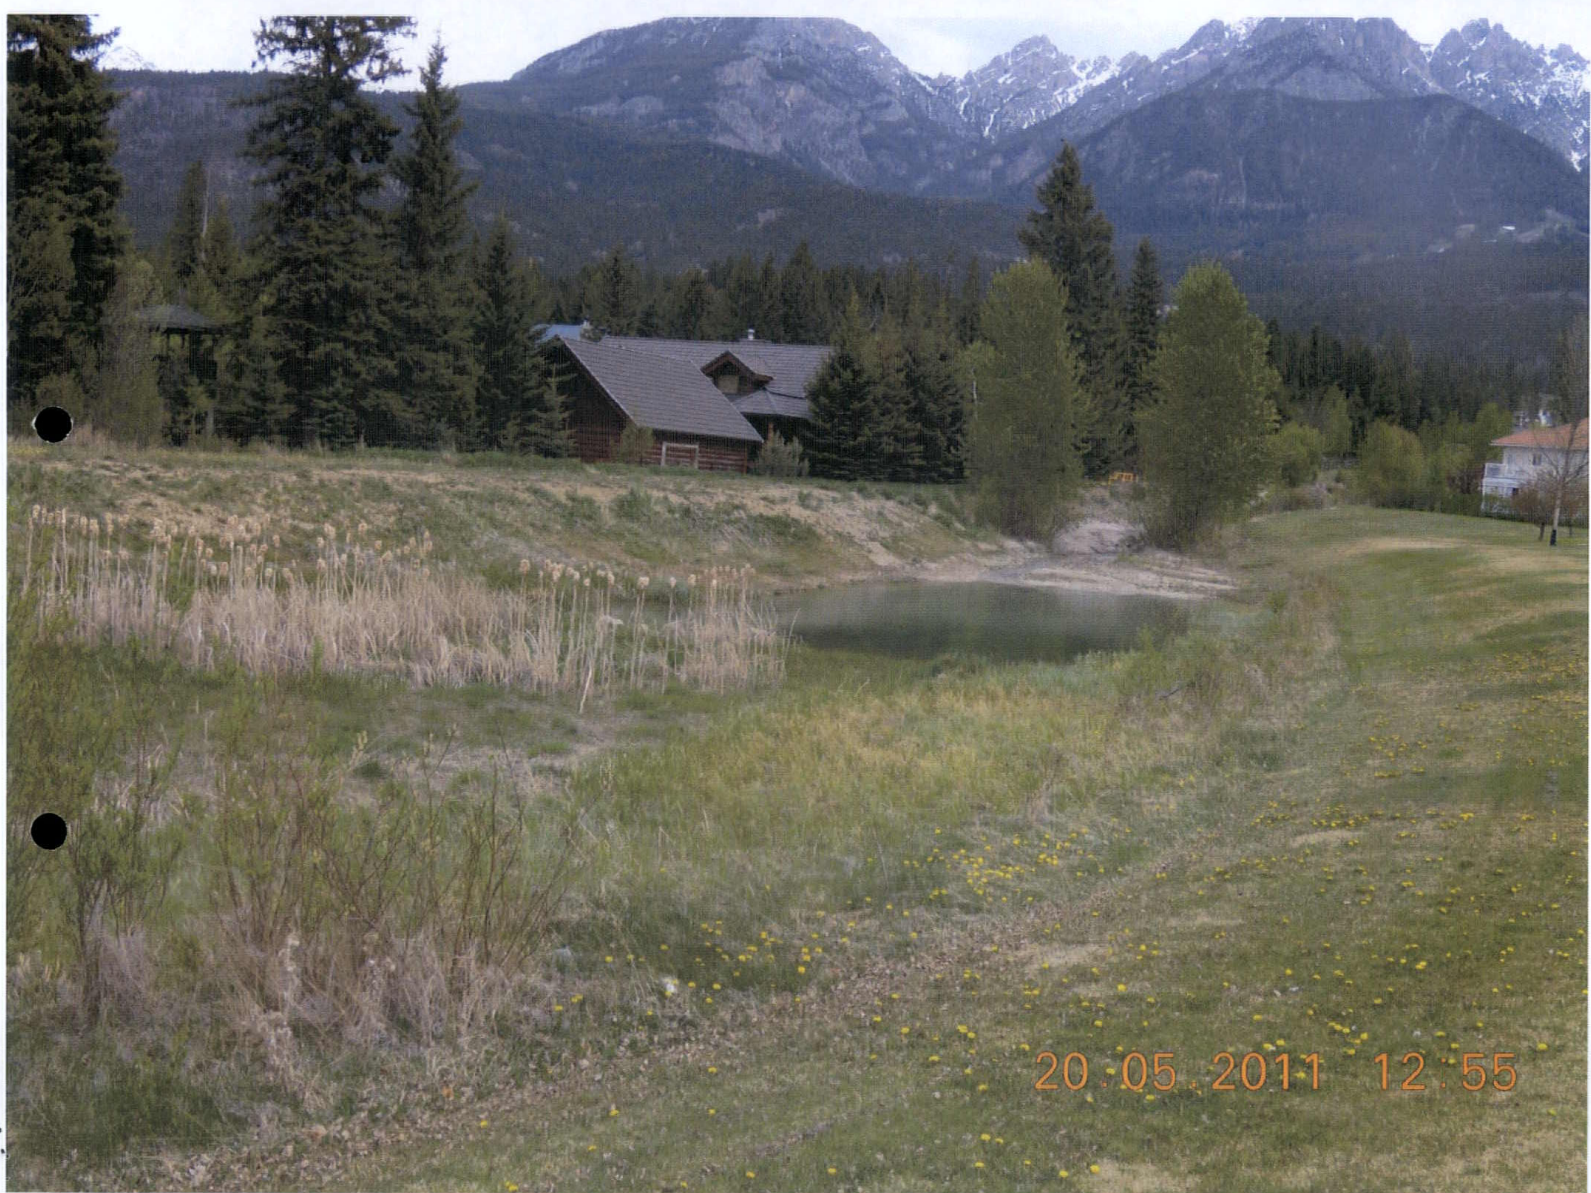
Removal of silt piles from private work executed approximately 5 years ago. This was along the banks of the deposition pond or stilling basin. The area was also graded and seeded for slope stabilization. (please see attached photos).
