Cold Spring Creek 2016 Annual Dike Inspection Report

April 20, 2016 Cold Spring Creek Dike Inspection

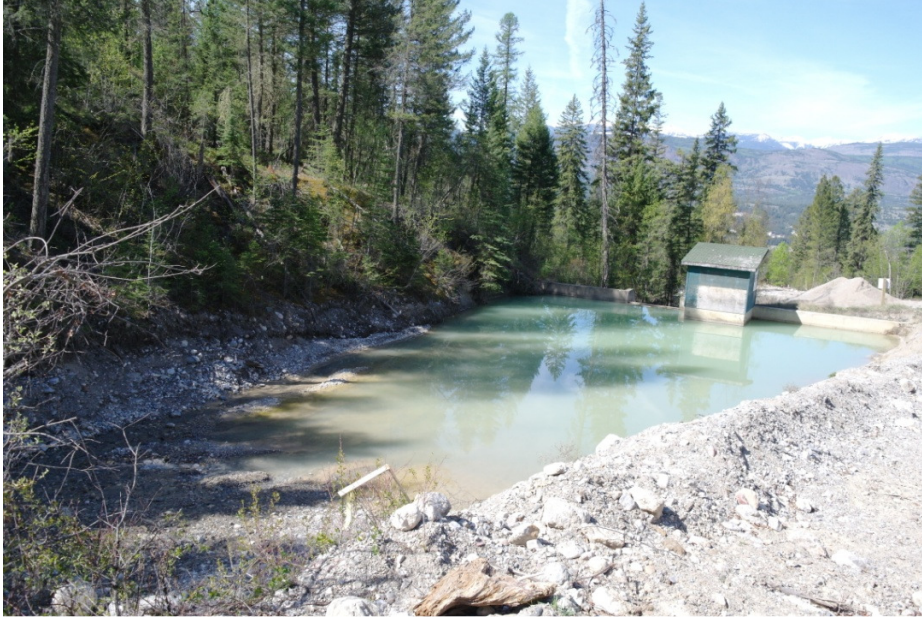
Photo 1: Cold Spring Creek Dam Reservoir, April 20, 2016. A small amount of material was removed from the reservoir by the contractor that was working just upstream of the dam.

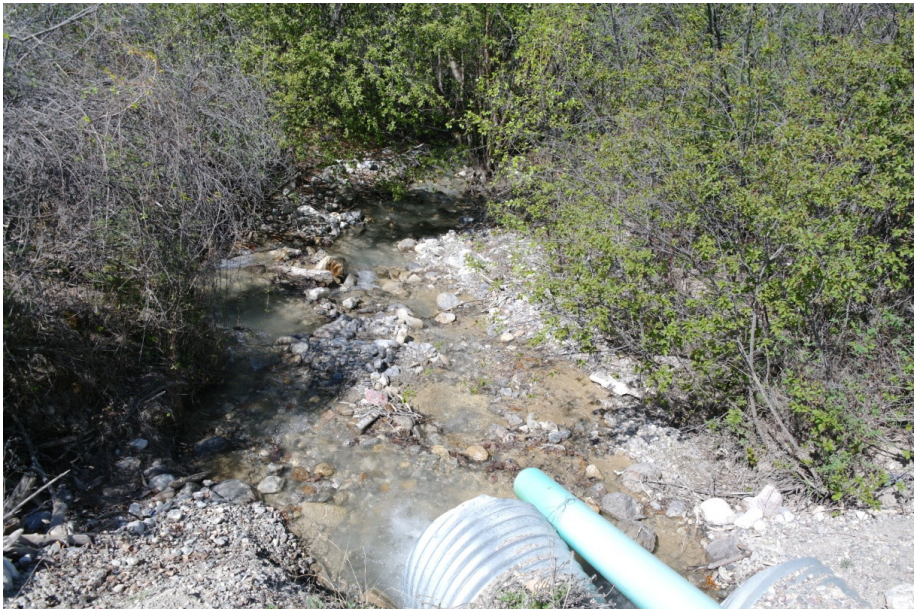
The water level at the time of the inspection was low and contained in the creek channel however the channel is infilled with debris material and does not have much capacity. Creek avulsion is possible in a moderately high water situation.

Photo 3: Cold Spring Creek between the dam and Highway 93/95, April 20, 2016.

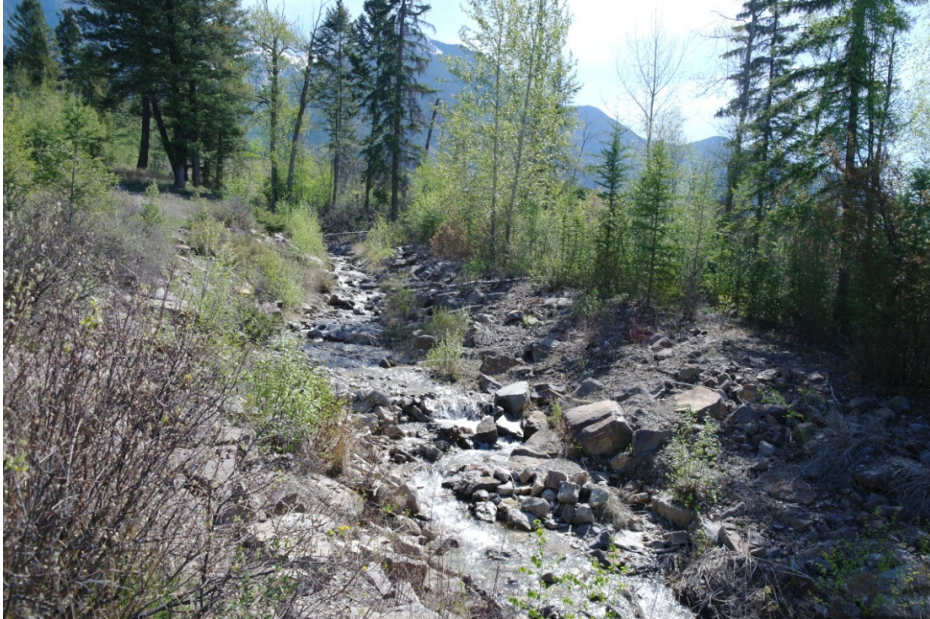
The channel from Highway 93/95 to the debris trap (dike/bank protected area) is in good condition. The complete bank protection works were brushed in 2012 which allows for ease of inspection of the rip rap lined banks and maintains the integrity of the works. Brushing is planned for 2017.

Photo 4: Cold Spring Creek below Highway 93/95, April 20, 2016.

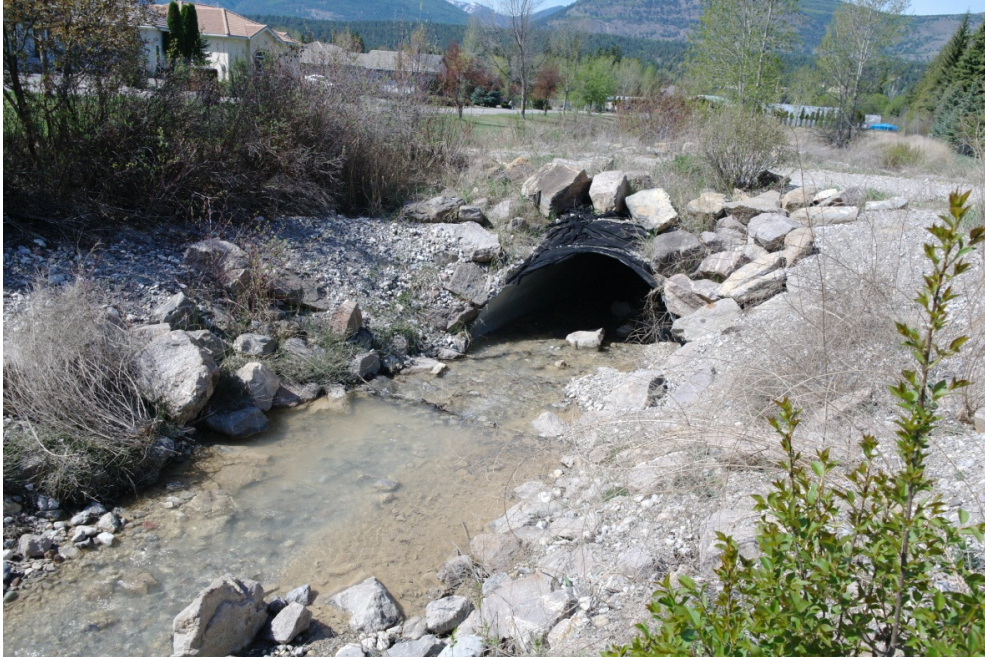
The last culvert along Cold Spring Creek before the lower debris trap is experiencing some very minor underflow piping, which is causing some very minor scour under the culvert. The situation is being monitored. The same culvert was approximately 30% filled with gravels and was cleaned out in August 2016.

Photo 5: Inlet of the culvert above the debris pond, April 20, 2016.

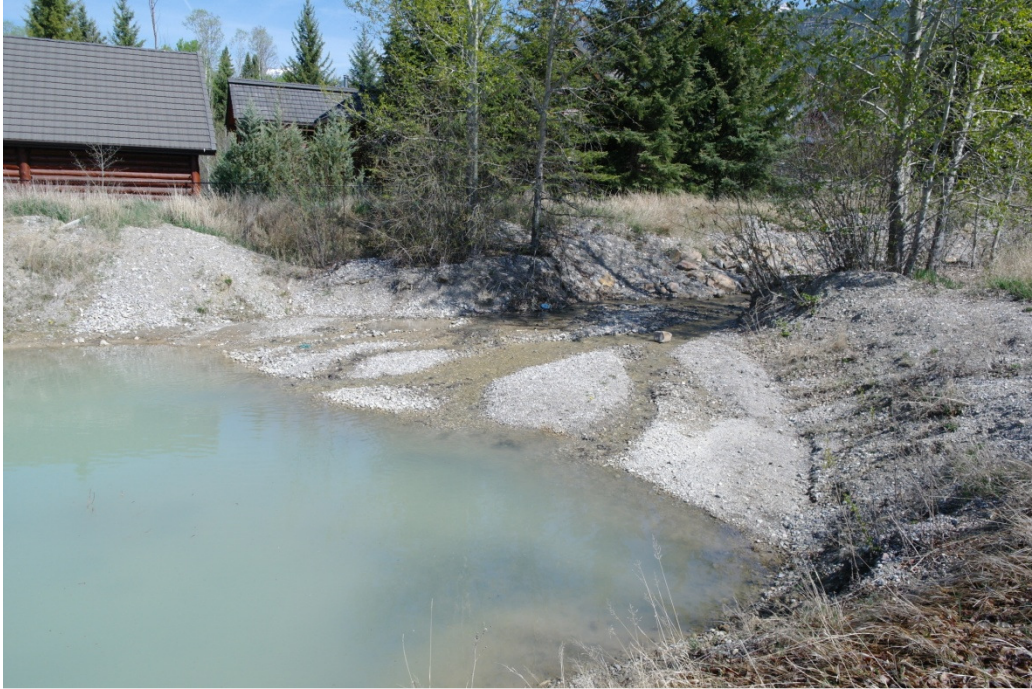
The upstream half of the debris trap was cleaned out in 2013. Some sediment and gravels had been deposited at the inlet to the pond since that time. The downstream half of the debris trap still had several years of sediment build up. The inlet to the pond and the lower half of the pond were both cleaned out in August 2016.

Photo 6: The inlet to the lower debris pond, April 20, 2016.

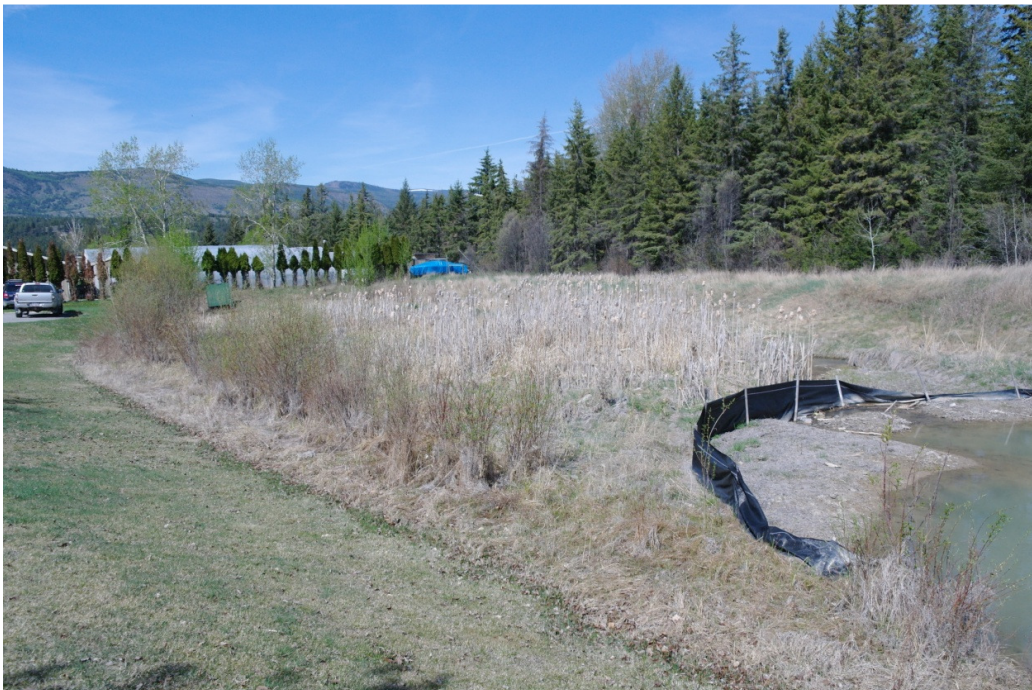
Photo 7: The sediment build up in the lower half of the debris pond, April 20, 2016.

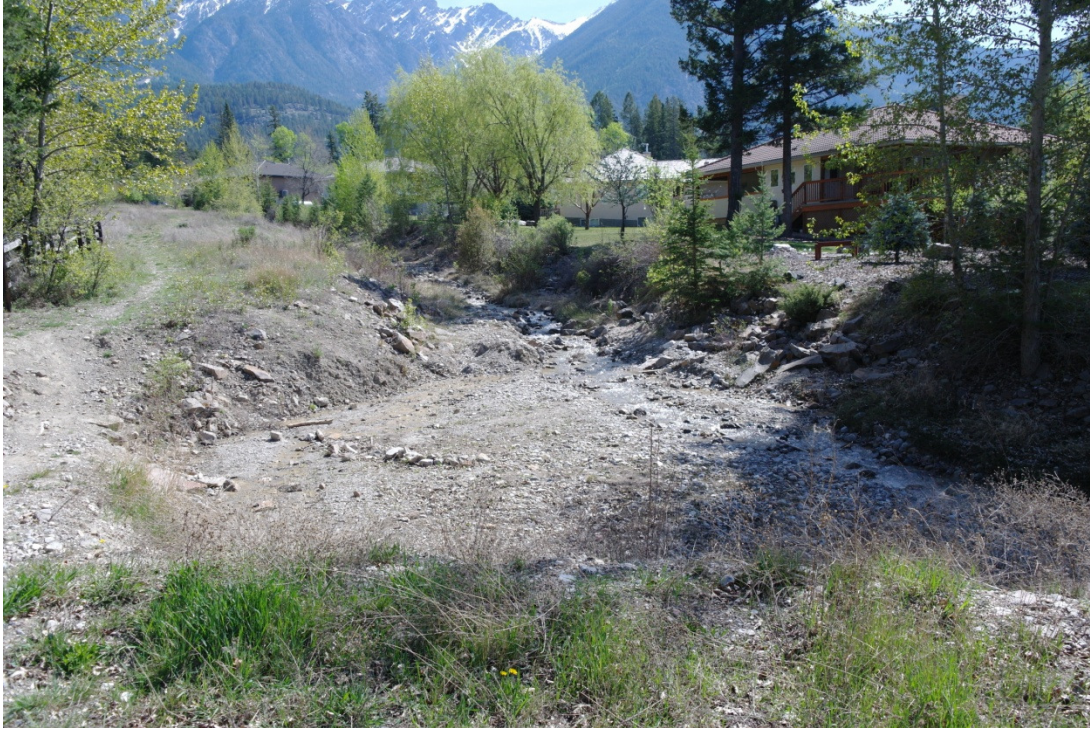
There is some minor material deposition in the mid-channel debris trap that should continue to be monitored.

Photo 8: The mid-channel debris trap, April 20, 2016.
