Cold Spring Creek Annual Dike Inspection

Introduction

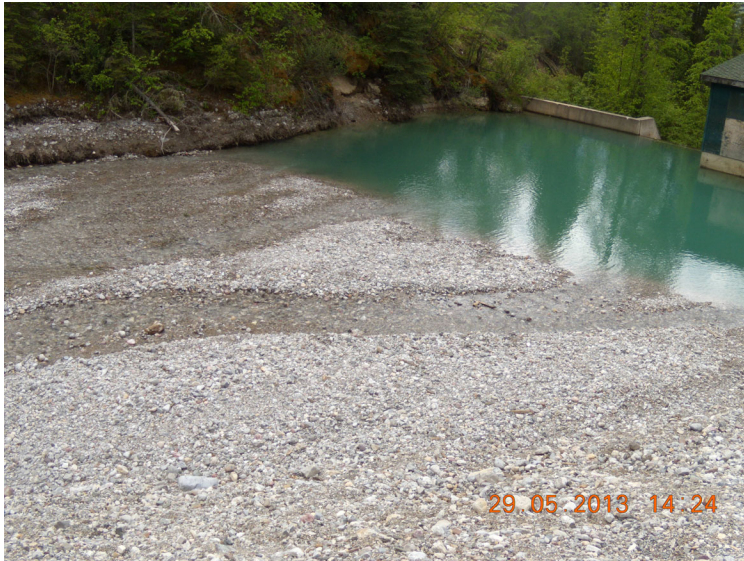
The upstream conditions above the dike/bank protection works were normal. The culvert inlet for the culvert under Fairmont Resort Road had the trunk end of a placed poplar tree partially blocking the inlet. No build up of material had occurred and a Fairmont Hotsprings Resort employee was advised of the issue. All other culverts were clear. The upstream dam which is owned by FHSR had some sediment infilling in the upstream section of the reservoir. FHSR has been advised of the infilling situation.

May 29, 2013 Reservoir Sediment Deposition

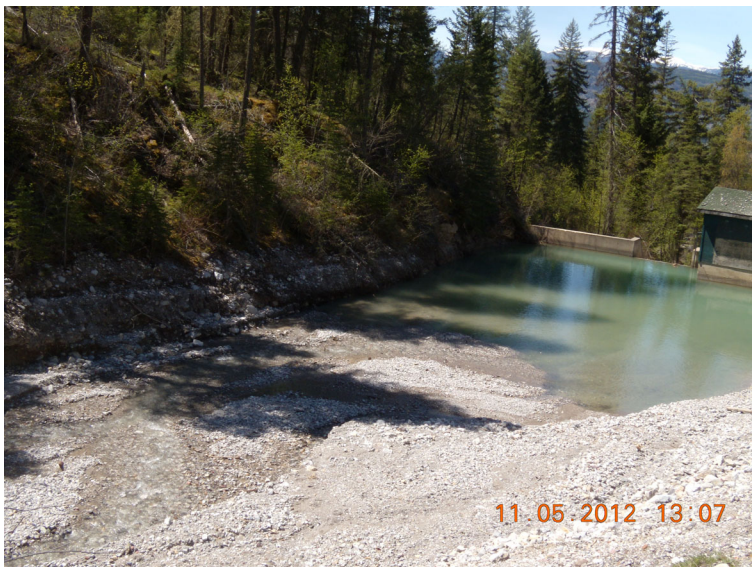
May 11, 2012 Reservoir Sediment Deposition

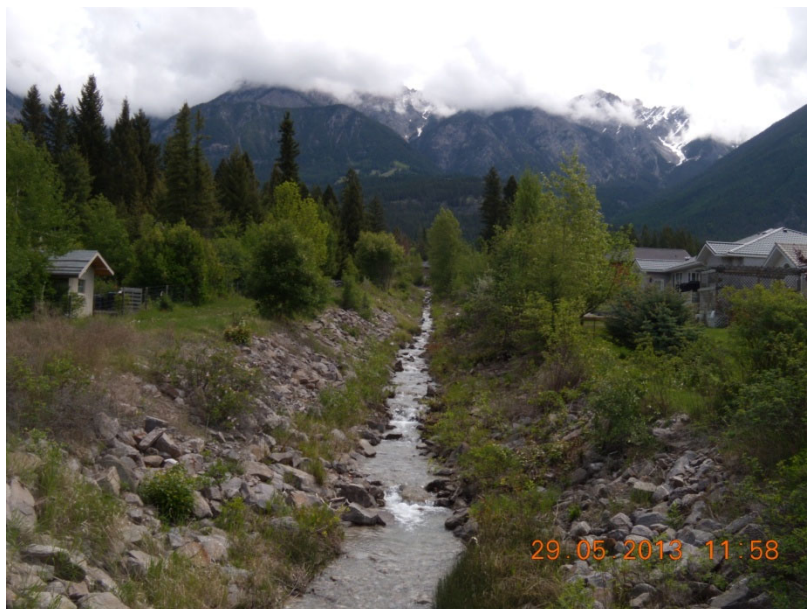
The channel from Highway 93/95 to the debris trap (dike/bank protected area) is in good condition. This section of creek channel was brushed in the fall of 2012 and allows for ease of inspection of the rip rap lined banks and maintains the integrity of the works.

2013 Brushed Channel

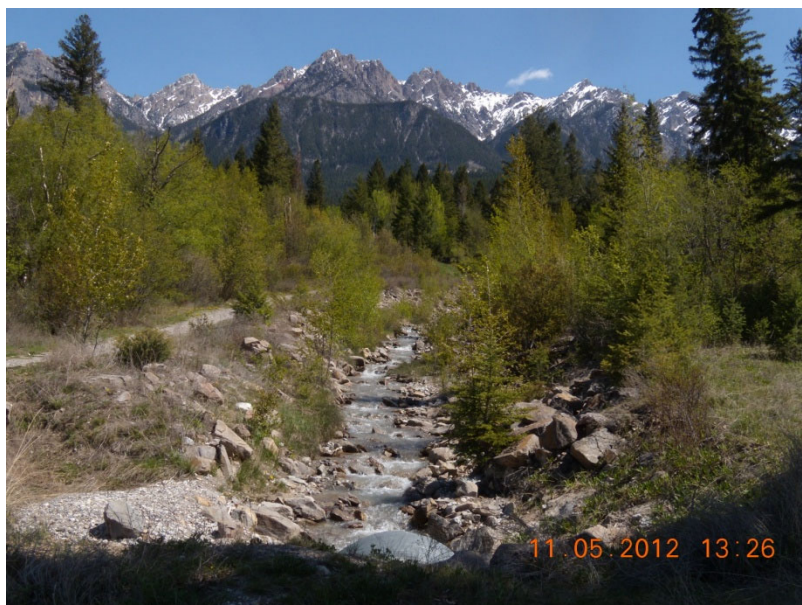
2012 Channel Pre-Brushing

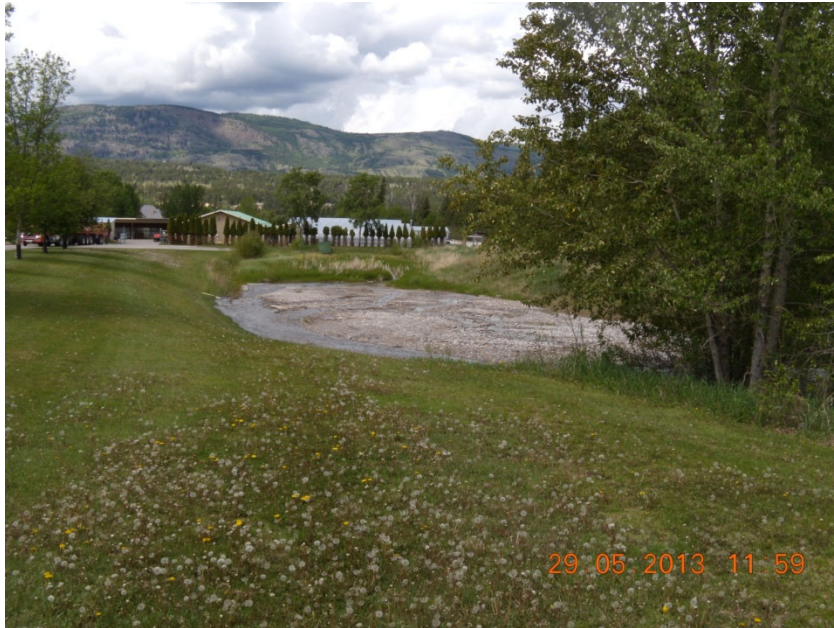
The debris trap on Cold Spring Creek has significantly infilled with sediment and is scheduled for removal this fall, when freshet flows have subsided and tourism activity is reduced.

Debris Trap Sediment Deposition

- Section 9 application for Works in and Around a Stream, June 2013
- Water license application for Cold Spring Creek, June 2013
- Debris trap sediment removal, fall of 2013
- Creek channel monitoring for vegetation removal, quarterly
- Commissioning of a Hazard and Risk Assessment for Cold Spring Creek tentatively scheduled for 2014 or 2015. Dependent on budget funds available

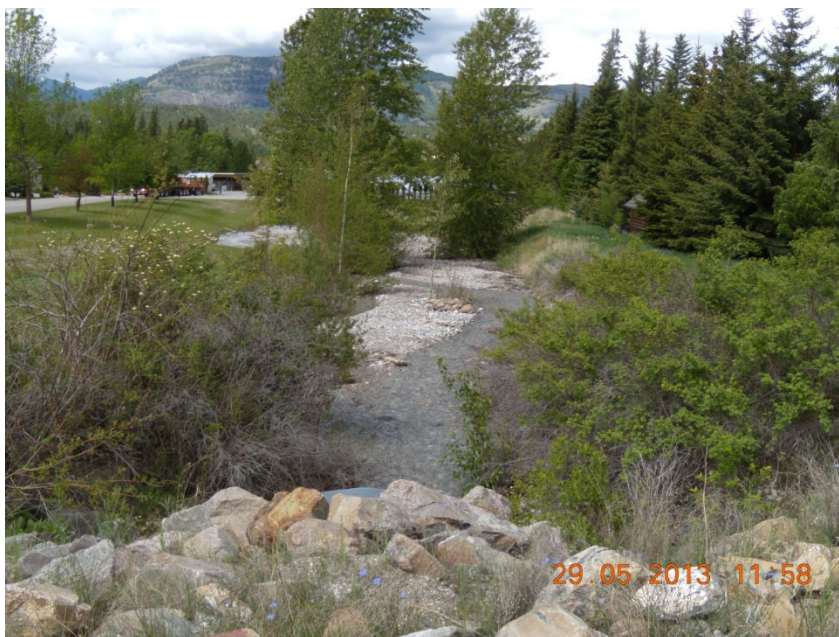
Debris Trap Sediment Migration into Cold Spring Creek Channel
