## Review of the Hosmer Fire Hall

November 8, 2024 | Project # 2451-31070-11

Prepared for the Regional District of East Kootenay | Prepared  
by McElhanney Ltd

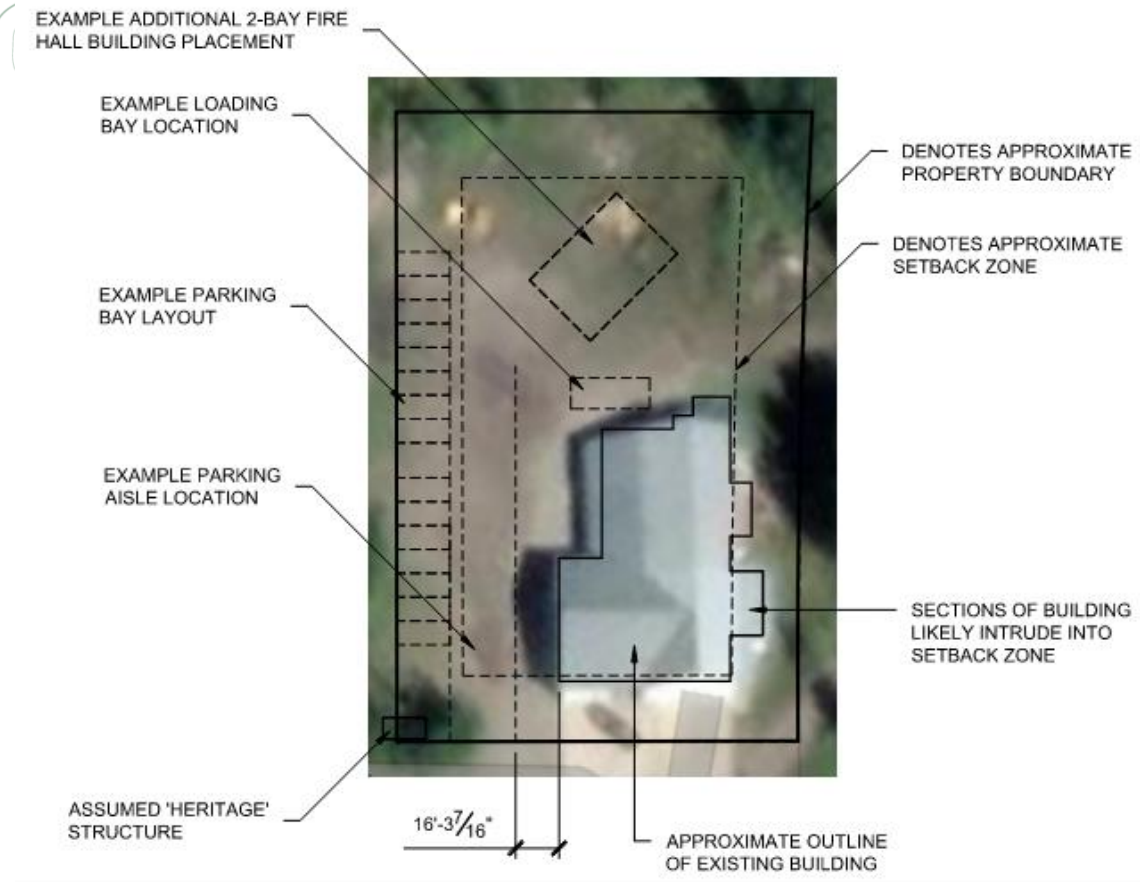
Figure 2 - Expansion options map

Given the above notes and the nature of the existing structure it is believed that opportunities for expansion of the existing fire hall are limited. The building cannot be added onto on the southern or eastern sides due to setback requirements. The location of the 'heritage foundation' and the required width of the aisle for parking access leaves very little space into which the building could expand in the western direction. And adding onto the northern end of the structure is of limited use as this is the community hall side of the building. The most effective option for providing increase fire hall capacity would be a separate new structure towards the north-western side of the property. However, this option presents its own challenges. Having the equipment, vehicles and crew of the fire hall split between separate buildings isn't practical. Additionally, due to the attached community hall, having to navigate people and vehicles present for the community hall may hinder the fire crew's ability to respond to an emergency from the new rear structure. Refer to Figure 2 for a site map with notes regarding these points.

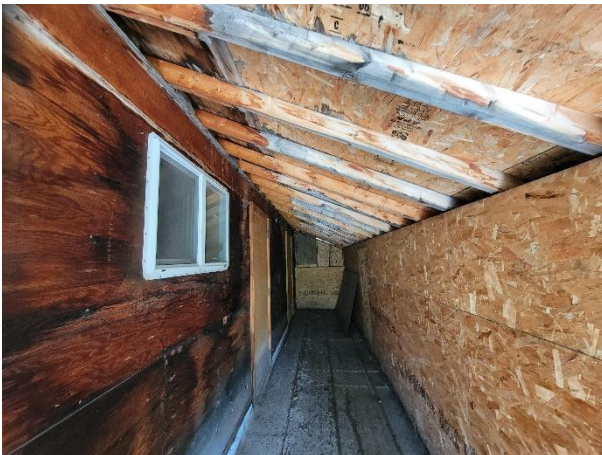
Overall, it was noted that, aside from apparent water damage to the roof over the attached office/storage room and stairway at the south-eastern corner of the building, the condition of the building structurally appeared to be acceptable. No significant damage or deterioration was noted, nor was noticeable deflection in any spanning structural members observed.

- As previously mentioned, significant water staining was noted on the roof framing over the landing of the south-eastern stairway.
- Review of the design drawings for the existing building found that the specified steel reinforcement (amount/spacing) in the footings, foundations and slabs-on-grade is, in some instances, less than modern code minimum standards. However, as no significant issues with the slabs or foundations were reported to McElhanney or observed, it appears that they are performing adequately at this time. As such it would be acceptable to leave them as is, without additional remedial work. Should their performance deteriorate in the future, replacement of some of these structural aspects may be required.

*Photo 3 - South-eastern entry way over office/storage addition. Water damage to roof framing*

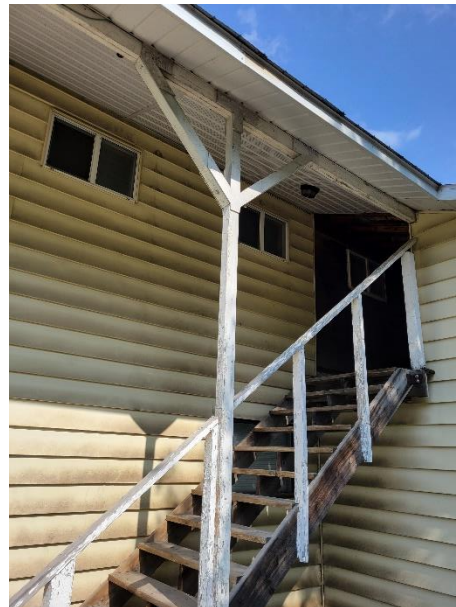
| Structural System | Part 4 – Post-disaster | | Part 4 – Normal Importance | | Part 9 | |
|---|---|---|---|---|---|---|
| S.E. Stairway Rafters | Fail | 341% | Fail | 277% | Fail | 203% |
| S.E. Stairway Beam | Fail | 208% | Fail | 171% | Fail | 127% |
| S.E. Stairway Posts | Fail | 309% | Fail | 254% | Fail | 190% |

The results above show that the framing of the roof over the south-eastern stairway is insufficient to meet BCBC requirements and that the north-eastern patio rafters and community hall posts would only be acceptable under Part 9 loading. Were the existing fire hall to remain in use and need to be brought up to current building code requirements, it is expected that some elements of the structure would require reinforcing or replacement.

- The framing of the guardrail/handrail on the south-eastern stairway does not meet BCBC or WorkSafeBC requirements.
- The drawings for the original building, first firehall addition and kitchen addition all indicate the foundation to be a thickened edge slab on grade with the base of the foundation 18" below grade. Typically, in this area, the required depth of footings below grade for frost protection is 48". The drawings for the kitchen show insulation being added to protect the footings, however it is shown vertically and only extending down to 2ft below grade, which would be inadequate to provide proper frost protection.

*Photo 4 - South-eastern stairway roof beams, posts and guardrail require replacement.*

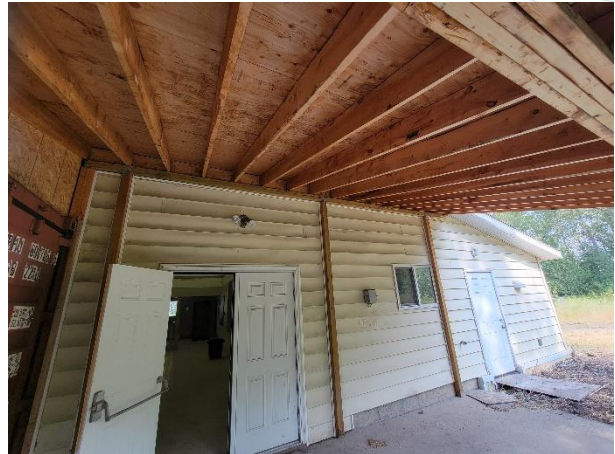
| Structural System | Part 4 – Post-disaster | | Part 4 – Normal Importance | | Part 9 | |
|---|---|---|---|---|---|---|
| N.E. Patio Rafters | Fail | 141% | Fail | 115% | Pass | 69% |

*Photo 6 - North-eastern patio roof framing*

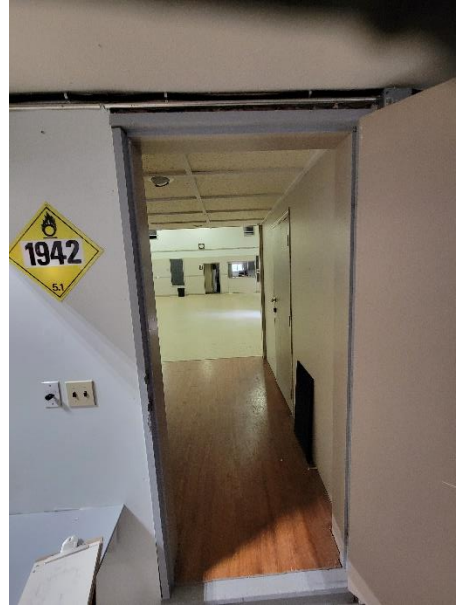
In reviewing the wall between the two occupancies we found no evidence of the wall being fire rated. The drawings for the original addition do mention a double layer of drywall but does not specify Type X (fire resistant) gypsum board. The drawings for the newer addition also make no mention of fire separation design of the walls. There is a single door between the community hall and fire hall, however, it appears to be a standard, non-fire rated door and does not feature an automatic closer.

*Photo 14 - Access door between fire hall and community hall is not fire rated*

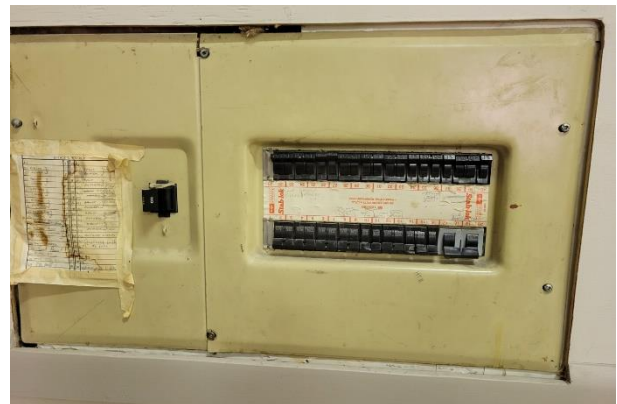
*Photo 24 - Panel A*

- In Area A of the building, Panel A appears to be part of the original building installation in 1983. This panel is an older Stab-Lok panel from Federal Pacific, which has known issues of breakers being unable to trip during an electrical incident, resulting in electrical fires. The panel interior was also found to be in very poor condition, with animal droppings and debris found inside. Considering the age, condition, and model of the panel, it is recommended that this panel be replaced with a new 100A panel. Should the smaller panel be installed, the corresponding 150A feeder breaker from the main 200A panel will also need to be downsized to 100A.

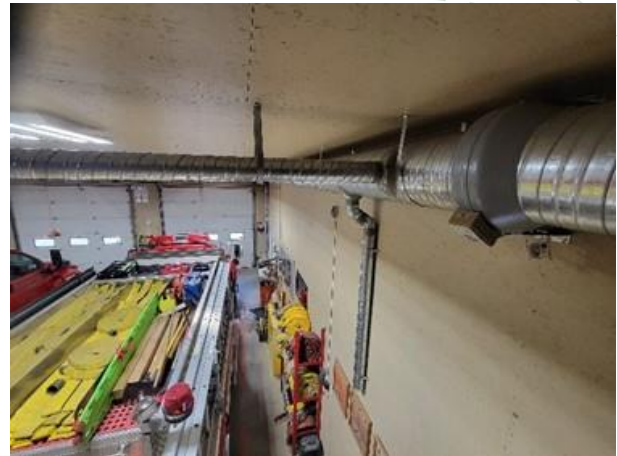
Photo 26 - Truck bay existing ventilation

- The Truck Bays currently utilize an exhaust system comprising 4-inch round open-ended ducts that descend from a 12-inch main exhaust duct positioned at a high level within the facility. These smaller ducts extend downwards to approximately 7 feet 6 inches above the floor, aiming to extract contaminants from the breathing zone. The main exhaust duct is connected to a 12-inch exhaust fan, specifically the Continental Fan Manufacturing Model Number AXC300B-ES. This fan has an exhaust capacity of 970 CFM (cubic feet per minute) and is controlled manually via a wall switch. Additionally, there is a Honeywell Gas Detection System, Model Number E3SARSCO, intended to monitor hazardous gas levels and automate the exhaust system's operation. However, it was observed that this gas detection system was disabled at the time of inspection, which poses significant safety risks. Heating within the Truck Bays is provided by gas-fired unit heaters that supply warmth but do not contribute to air quality management.

- The existing exhaust configuration will not adequately remove harmful gases such as carbon monoxide (CO) and nitrogen dioxide (NO<sub>2</sub>), which are prevalent in vehicle exhaust. The 4-inch ducts are insufficient in diameter to handle the volume of contaminants produced, and their positioning will not effectively capture fumes at the source. The disabled gas detection system eliminates a critical safety feature designed to alert personnel and automatically activate ventilation in the presence of hazardous gases. It is imperative to reactivate or replace the gas detection system to ensure continuous monitoring and protection of occupants. Upgrading the exhaust system to meet current standards is also recommended to enhance air quality and comply with occupational safety regulations.

- Control Systems - Automatic Operation: The makeup air unit should automatically increase to high speed when the vehicle fume extraction system is engaged or if gas monitoring detects hazardous levels such as activation at gas concentrations exceeding 0.1 PPM for NO<sub>2</sub> or 35 PPM for CO. In the event of elevated gas levels, the system enters a purge mode where the makeup air unit operates at high speed and the exhaust fan and fume exhaust system are both initiated, and an alarm is triggered to alert occupants.

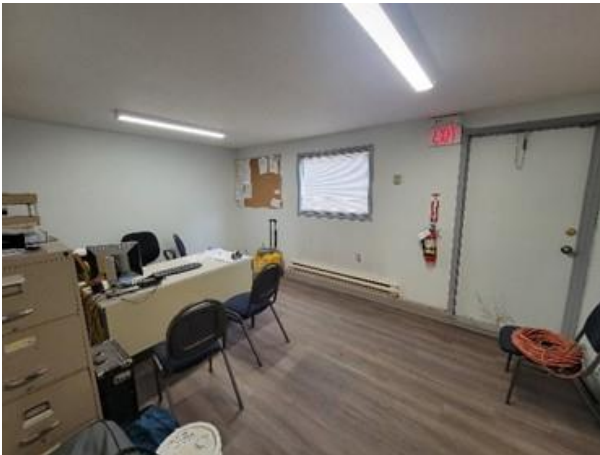
Photo 27 - Office existing conditions

- The Office area lacks an HVAC system for ventilation. Heating is provided by electric baseboard heaters, which do not facilitate air exchange.
  - Install a Small HRV System: A 25 CFM HRV unit is sufficient for the office space.
  - Purpose: This system will provide continuous ventilation, diluting indoor pollutants and maintaining air quality conducive to occupant health and productivity.
