Fairmont Creek 2016 Annual Dike Inspection Report

April 20, 2016 Fairmont Creek Dike Inspection

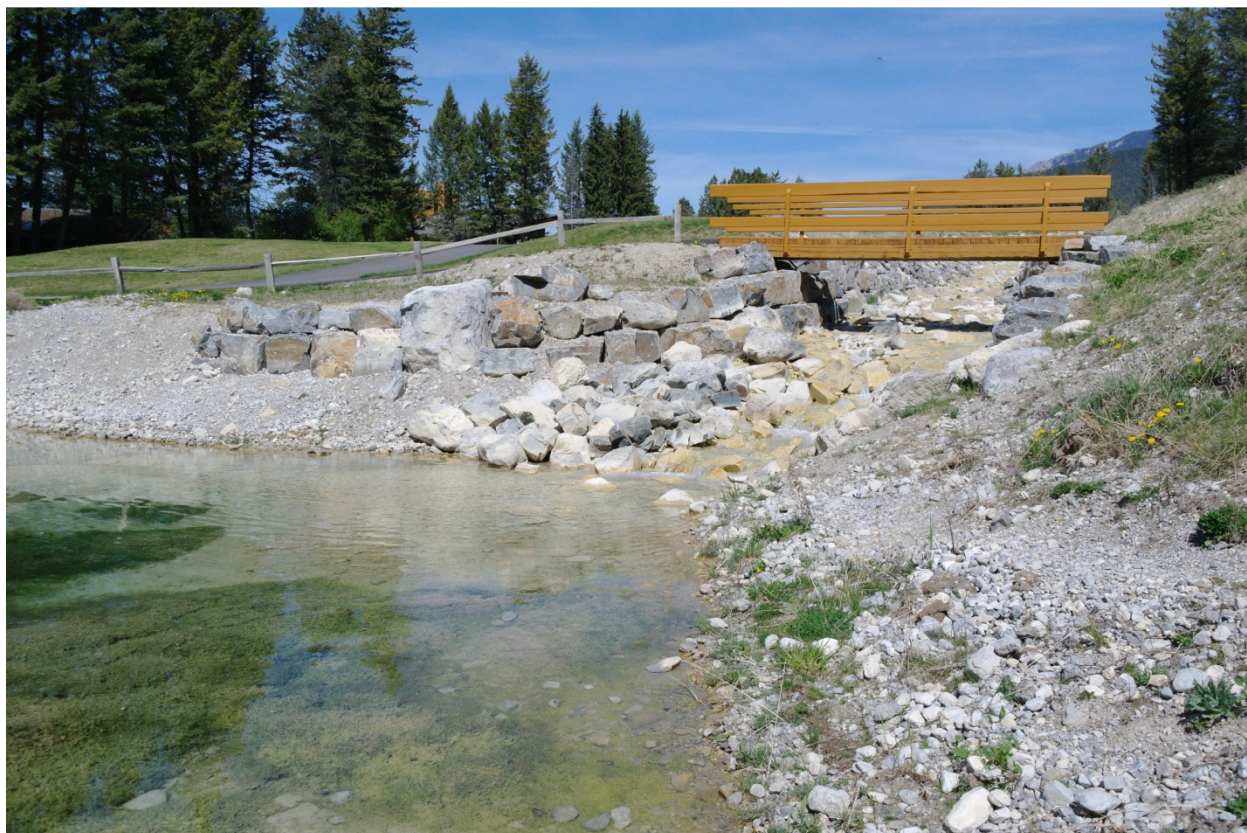
Photo 1: Downstream extent of the dike and bank protection works at the entrance to the debris pond.

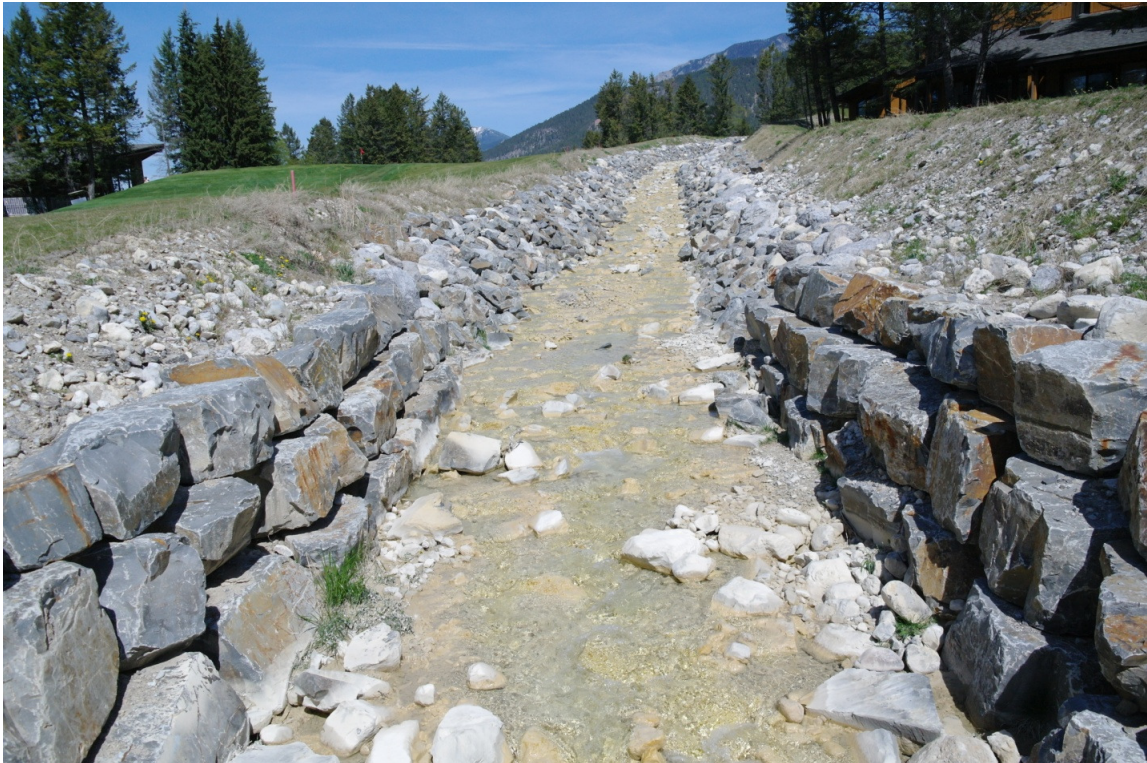
Photo 2: Looking upstream from the pedestrian bridge on the previous photo.

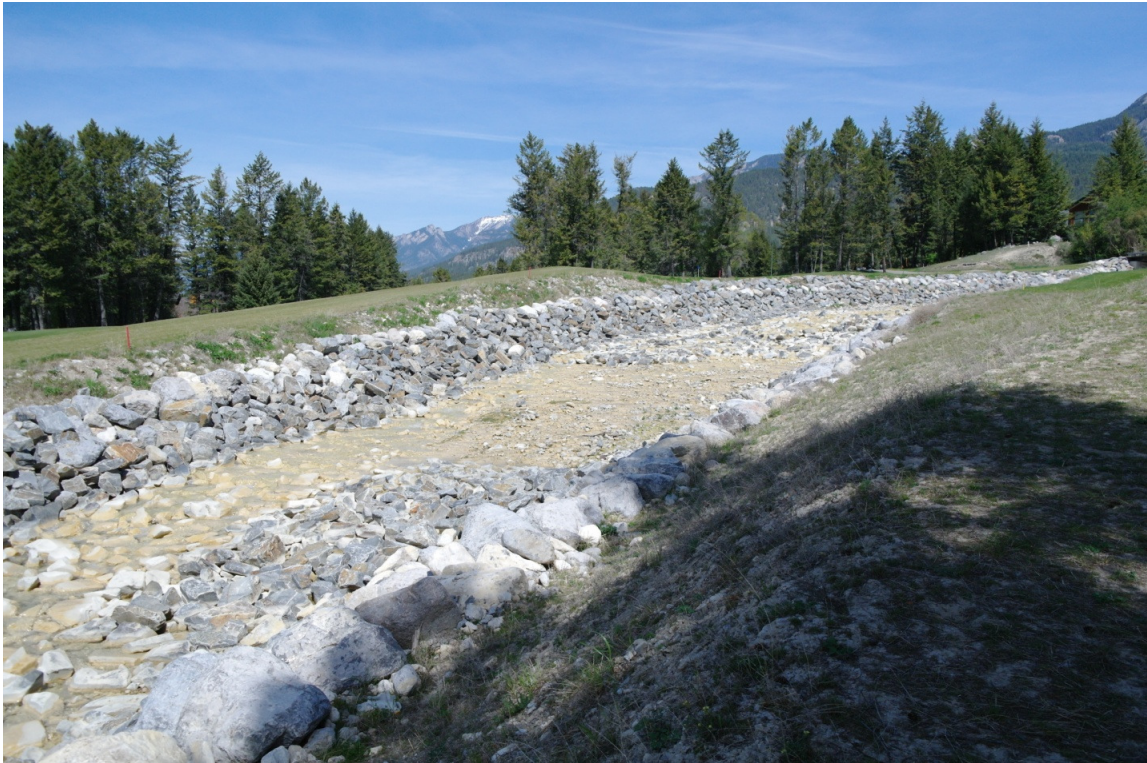
Photo 3: Photo of the widened section of the channel looking upstream.

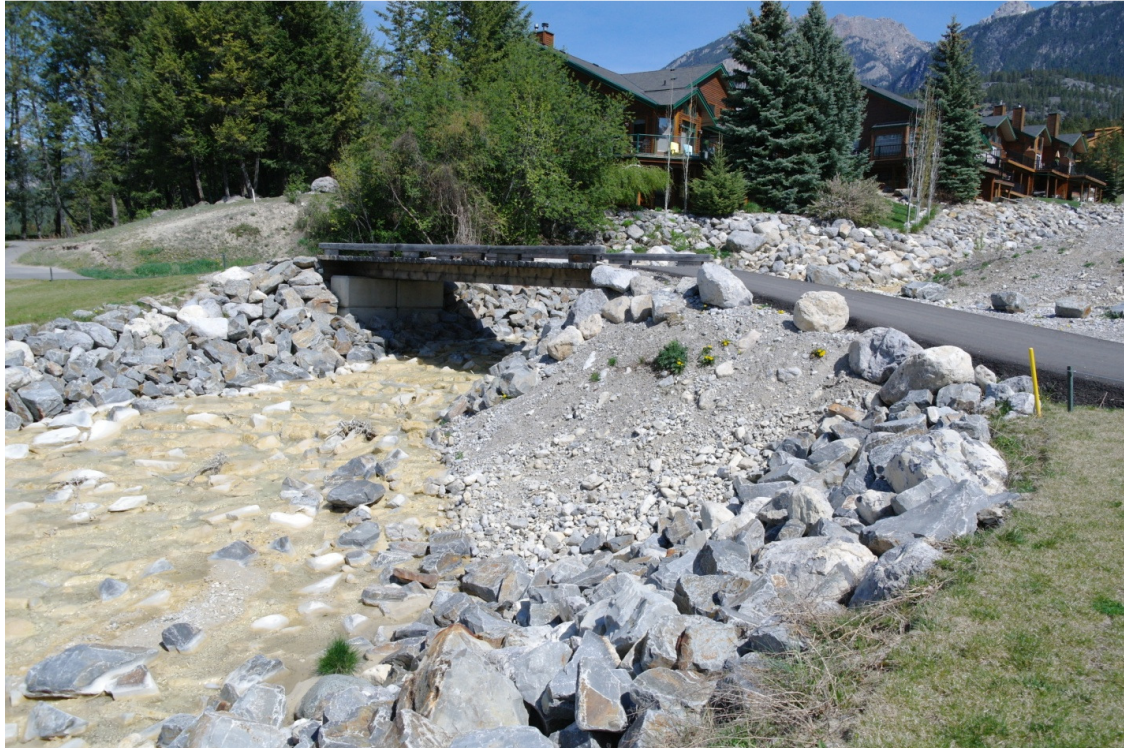
Photo 4: Cart Path Bridge at the upstream end of the golf course section of the channel.

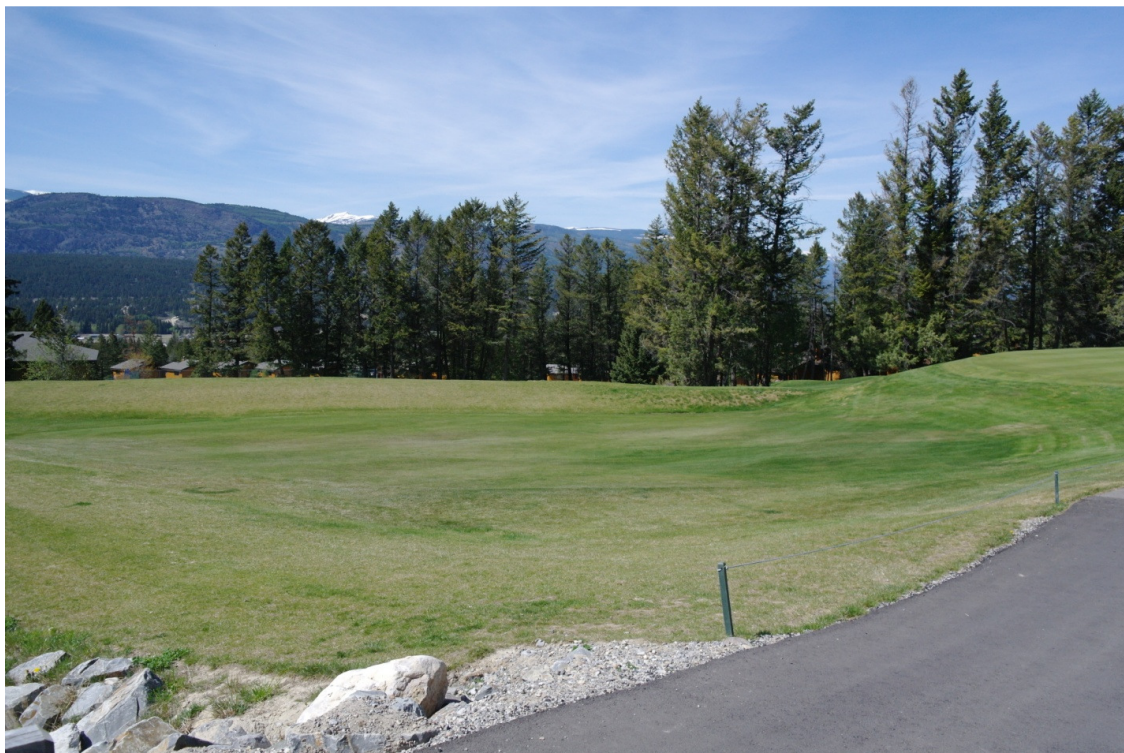
Photo 5: Right bank berm. Picture taken from the cart path bridge.

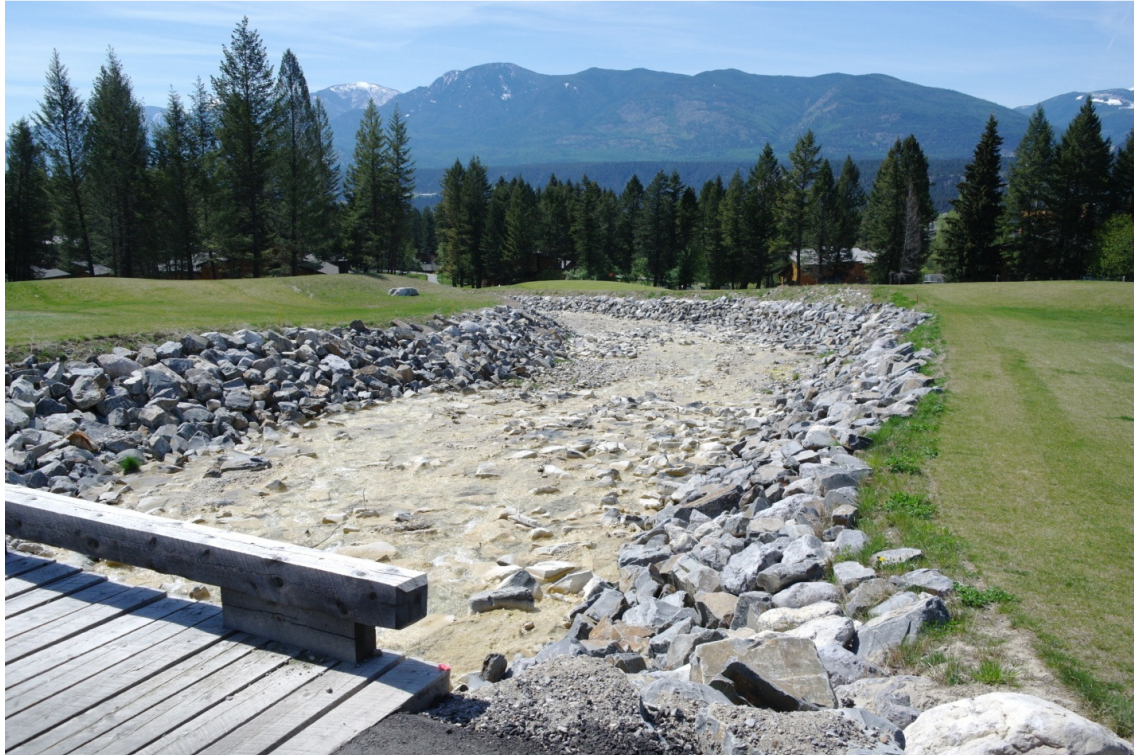
Photo 6: Left bank berm and widened channel. Picture taken from the cart path bridge.

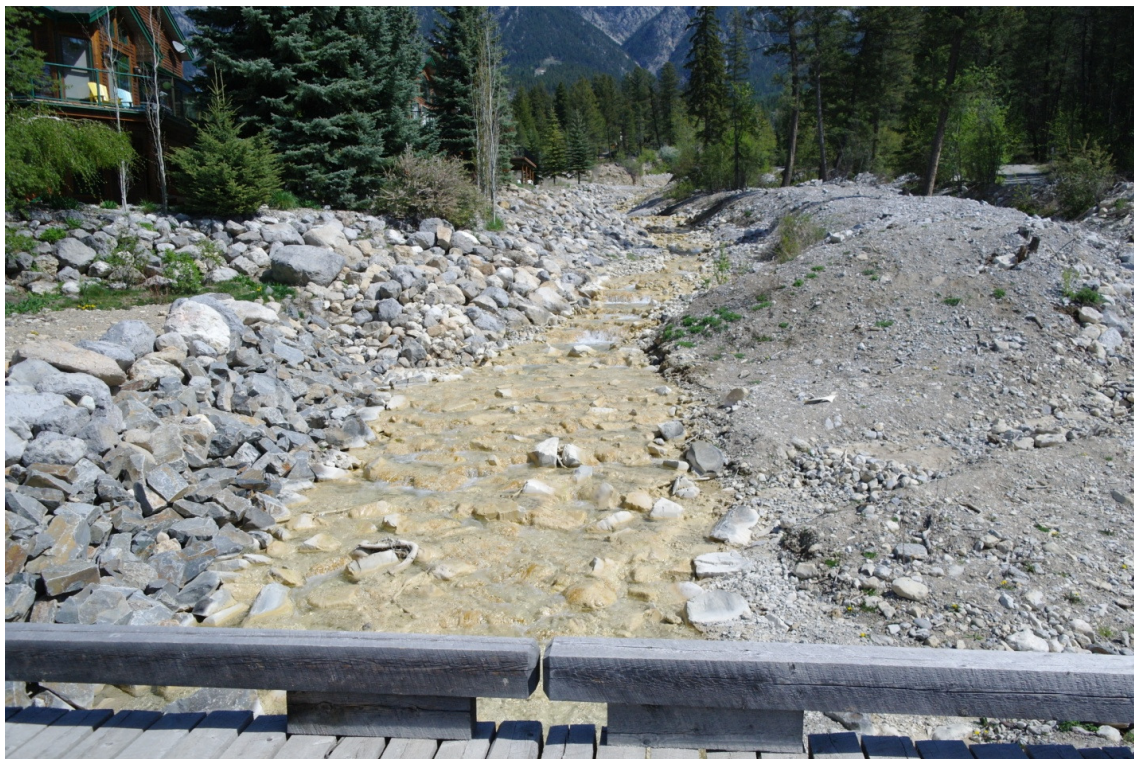
Photo 7: Tie in of Phase 1 to the DFA repairs upstream of the cart path bridge.

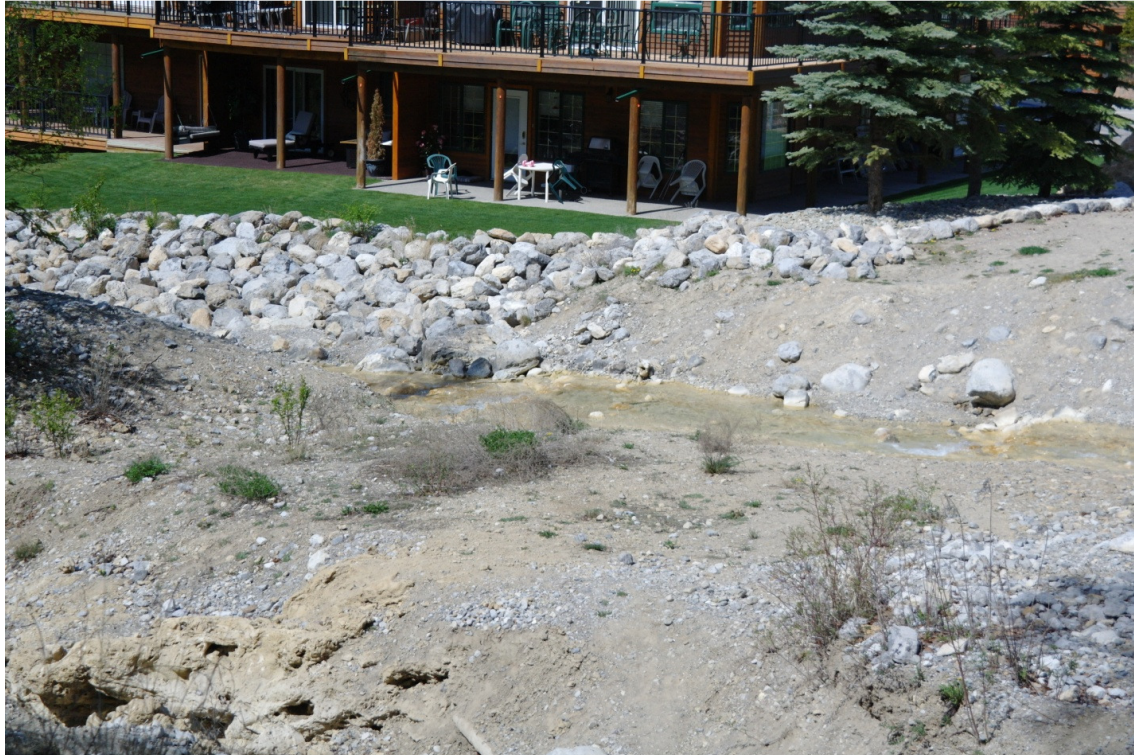
Photo 8: Upstream extent of the DFA works and bank protection.
