Fairmont Creek Debris Basins May 31, 2020 Flood Assessment

Final Report

Dale Muir, P. Eng.
Principal Engineer
June 24, 2020
NHC Ref no. 3005607

Regional District of East Kootenay

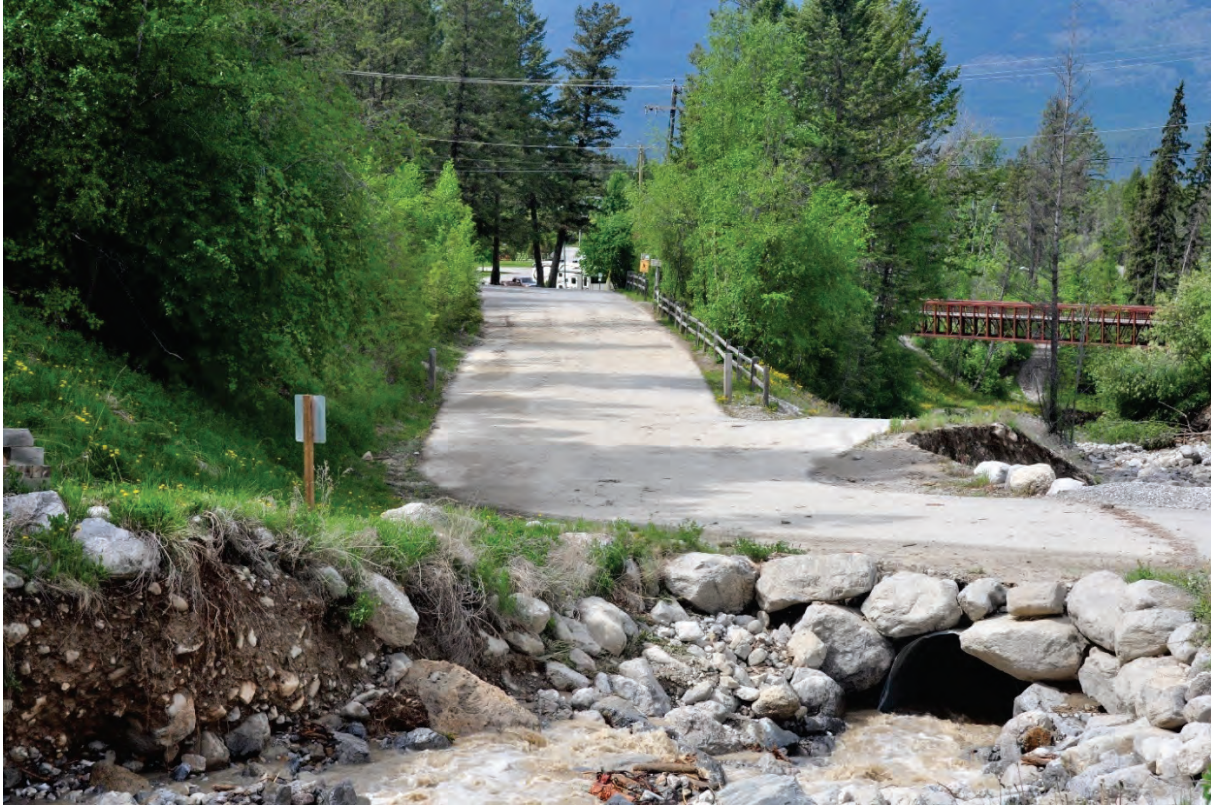
Photo 2.1 Upstream most 6' diameter culvert under Fairmont Resort Road that was overtopped and the downstream flooded area during the event. Debris line and mud covered pavement are visible in the photo.

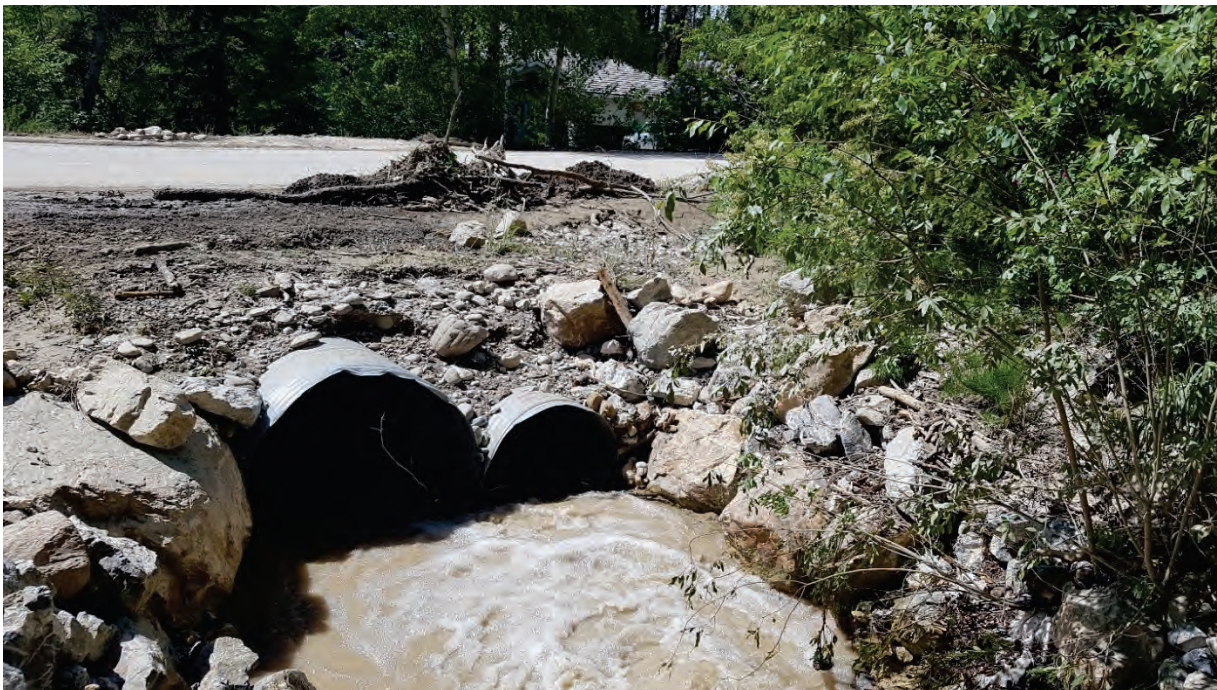
The Columbia River Road crossing consists of a 1200 mm (4') and a 900 mm (3') diameter culvert. This crossing was overtopped during the flood event (Photo 2-2). The culvert outlet is perched with a free flowing drop. Given the condition of the culverts it is likely that this crossing could pass approximately 3 m³/s. As such the flood flow is interpreted to be greater than 3 m³/s.

Photo 2.2 Columbia River Road crossing on Fairmont Creek that was overtopped during flood event.

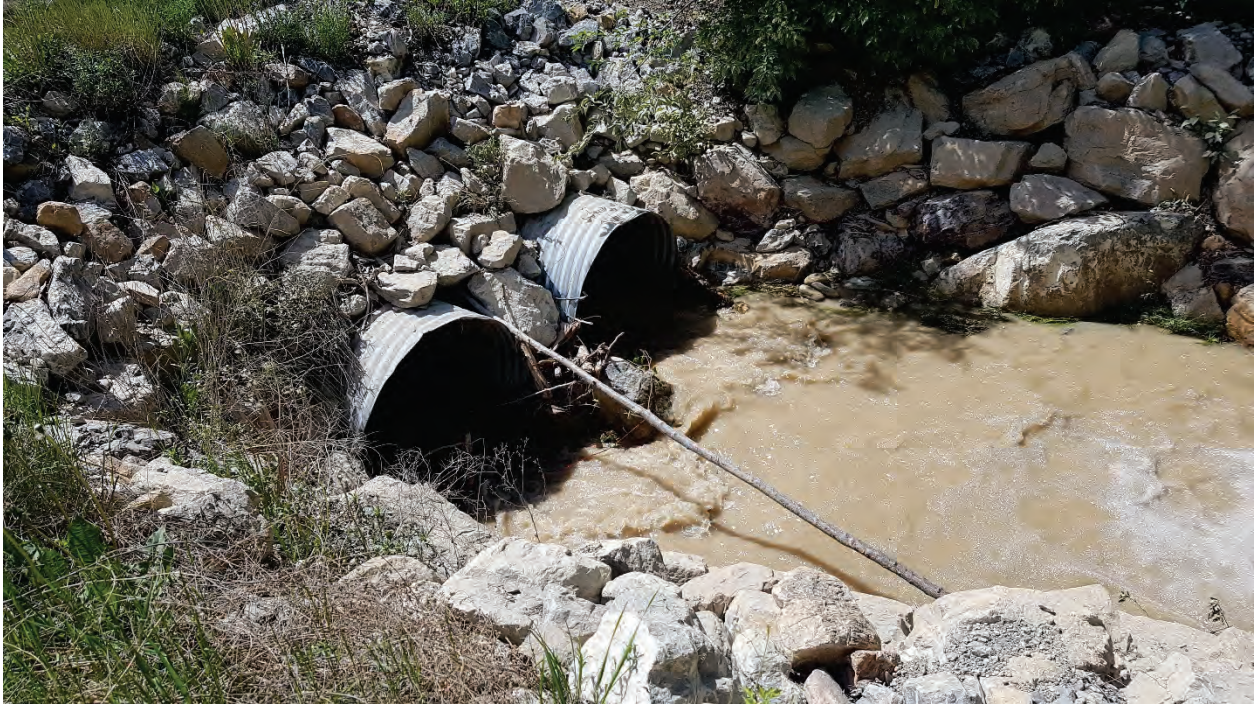
Photo 2.3 Fairmont Creek Road culvert on Fairmont Creek. This road crossing was not overtopped and a debris line can be seen about 0.3 m above the culvert.

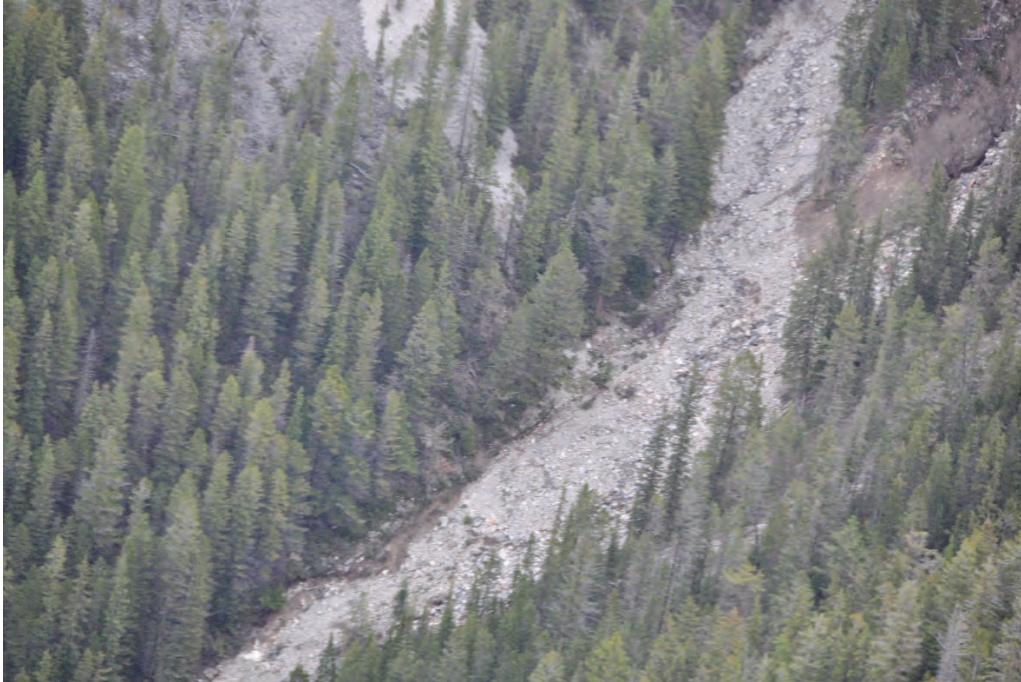
Photo 3.1 Sediment tracks and debris 300 m upstream of the ski hill water intake on the north tributary of Fairmont Creek. A debris flow deposit in the forest is visible in the top center of the image while extensive deposits of sediment in the two main channels are also visible.

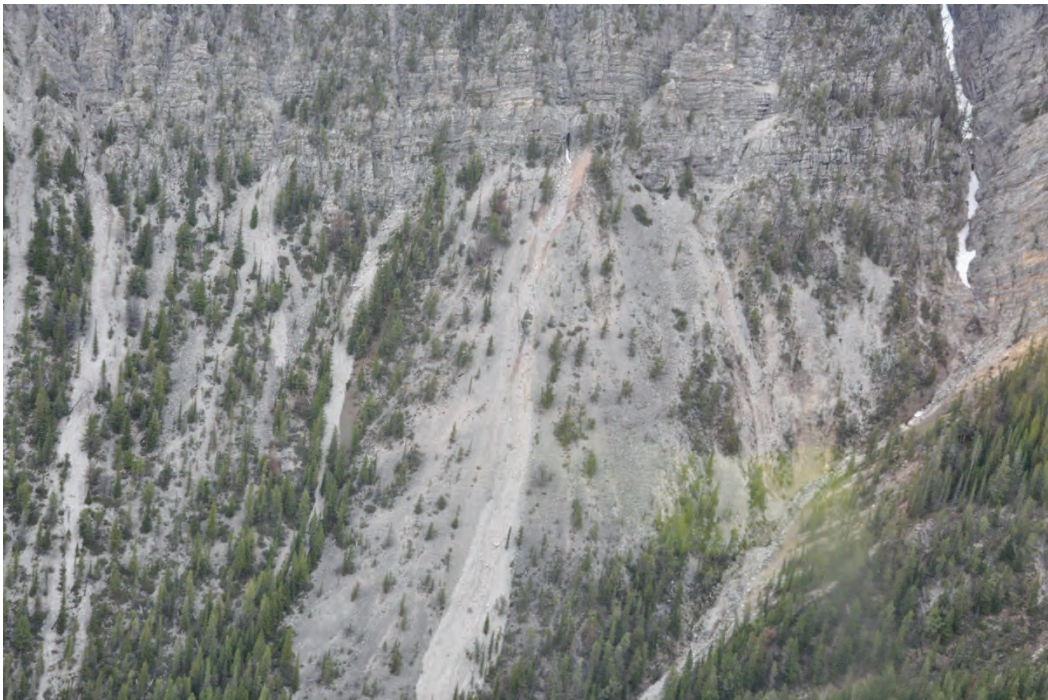
Photo 3.2 Initiation and deposition zone of debris flow in north tributary watershed. Many similar features can be identified throughout the watershed.

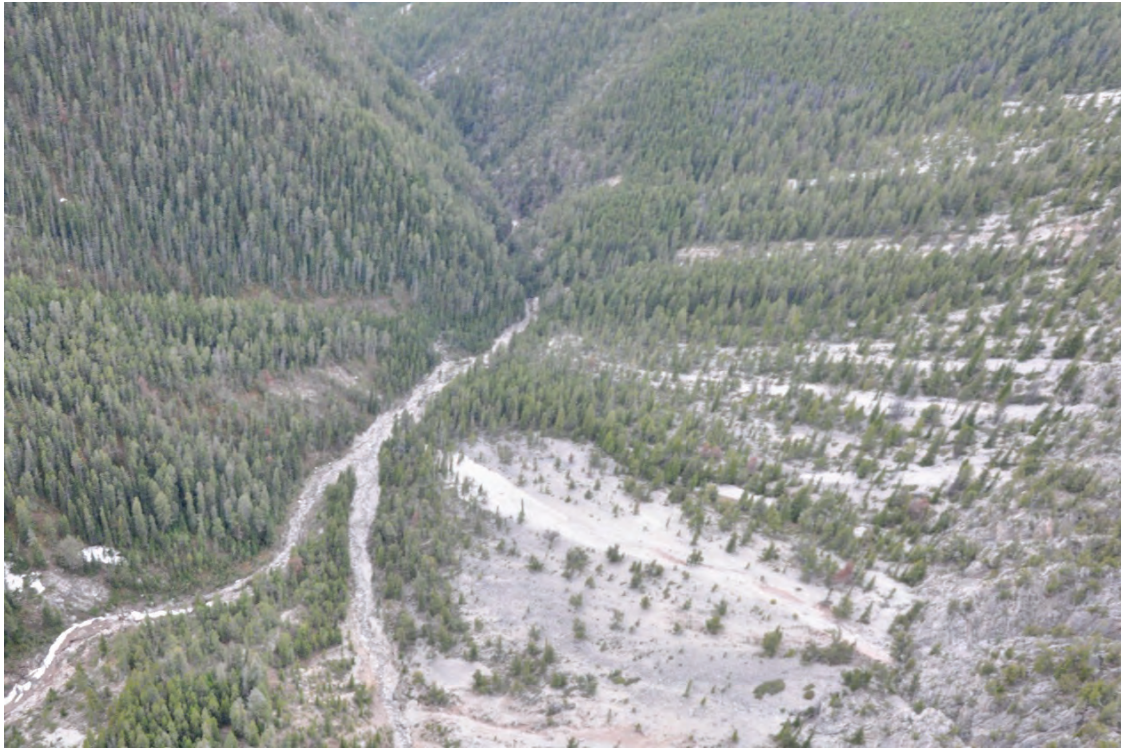
Photo 3.3 View looking down north tributary. Relatively low gradient section of channel before incised canyon helps prevent debris flows from travelling further down valley.

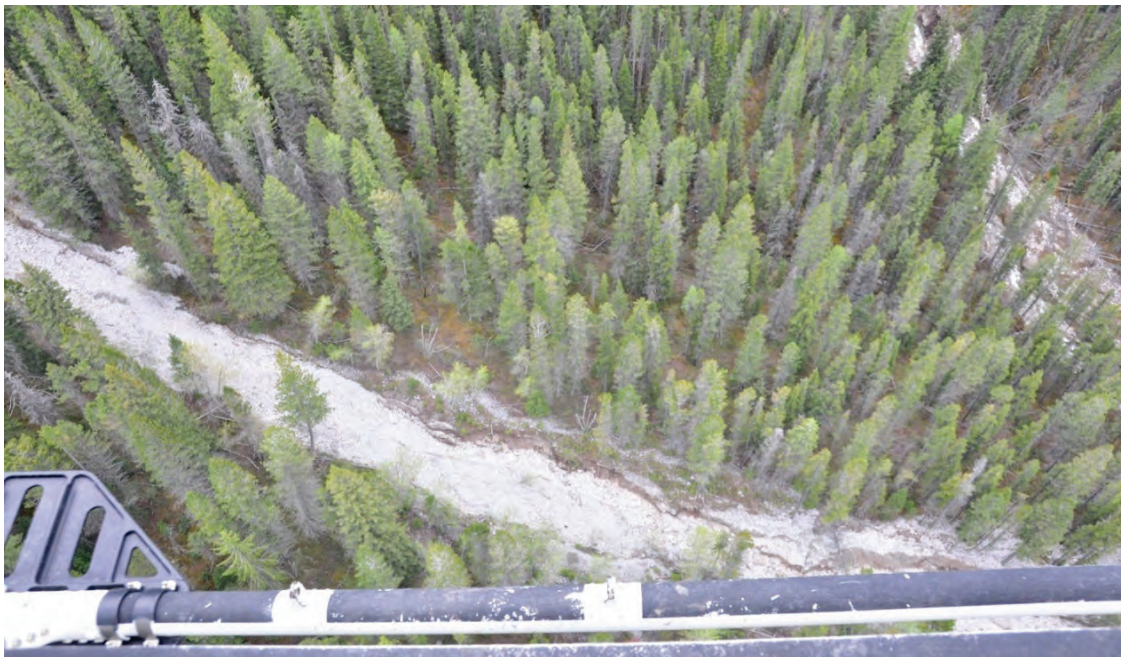
Photo 3.4 Fairmont Creek middle tributary just upstream of confluence with southern main channel. Debris flow deposits fill the channel in some sections of the middle tributary.

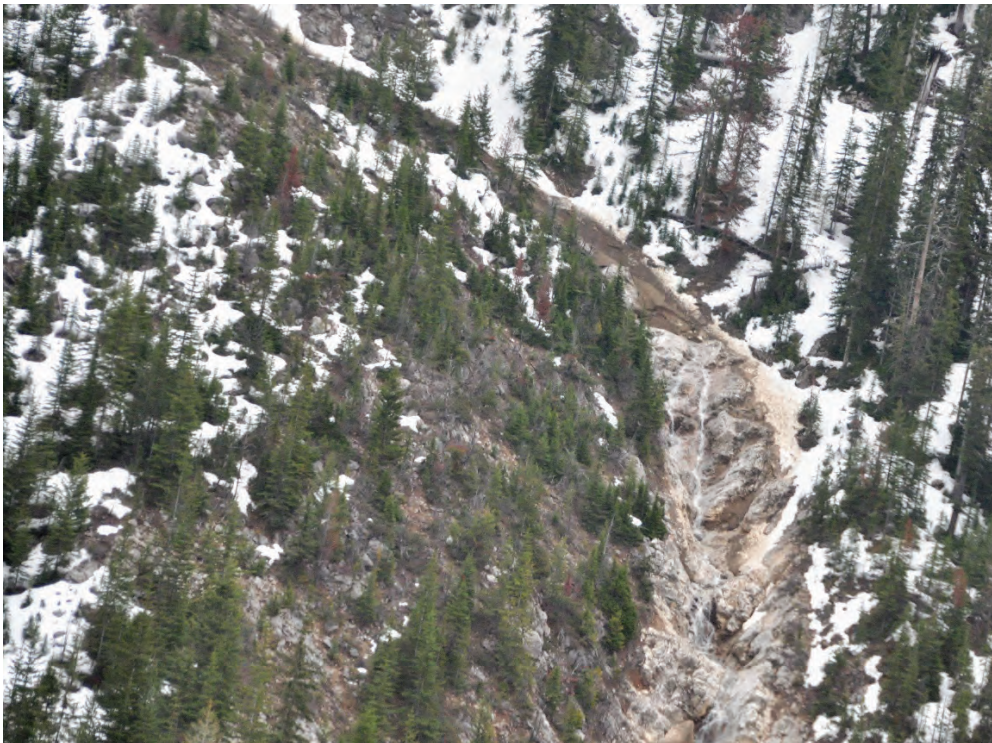
Photo 3.6 Debris flow over snow pack and then onto bedrock channel in southern most tributary of Fairmont Creek.

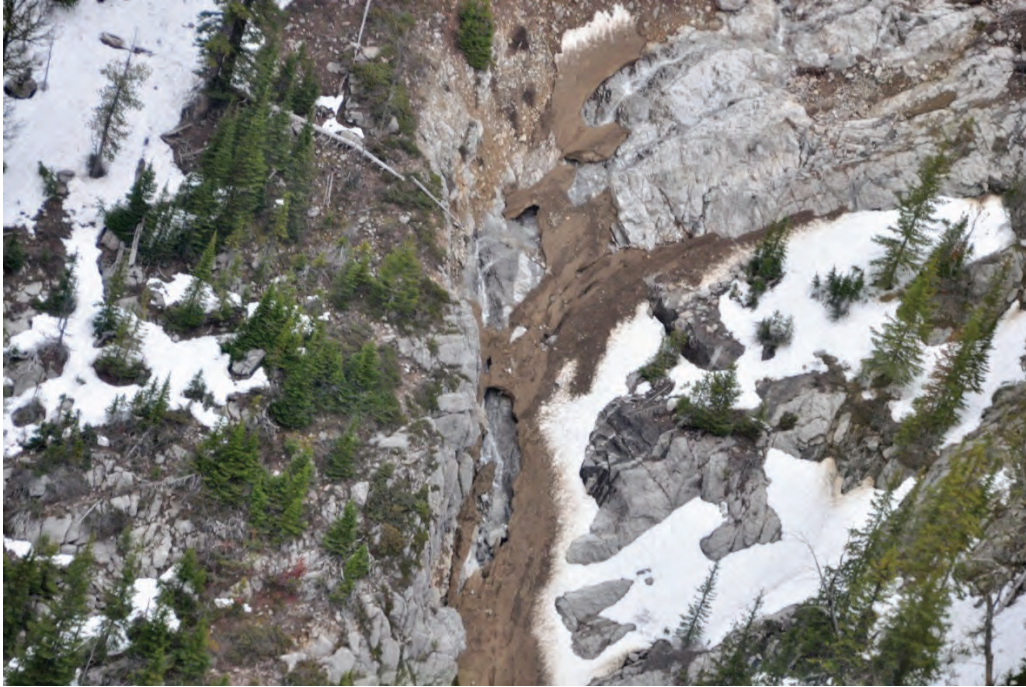
Photo 3.7 Debris flow sediments that travelled over snow in the southern most main channel of Fairmont creek

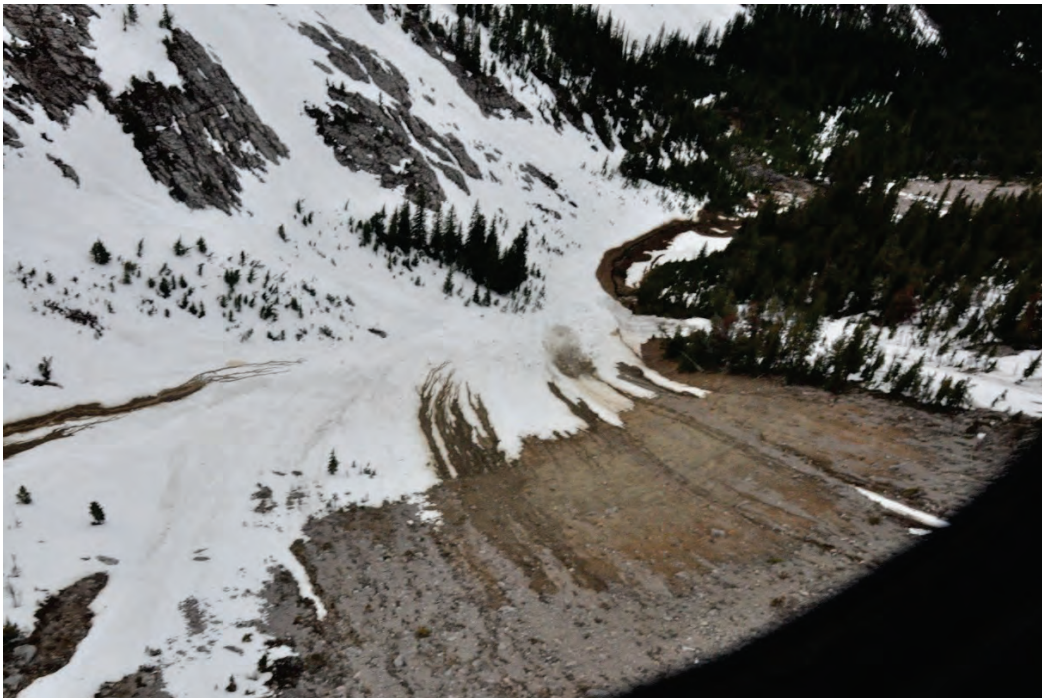
Photo 3.8 Hillslope raveling and shallow slope failures near the top of the southern most tributary of Fairmont Creek. Some of these failures appear to have transitioned to a debris flow or mud flow and travelled over the snow and down valley. Rapid snowmelt in days before the rain event would have helped saturate these soils.

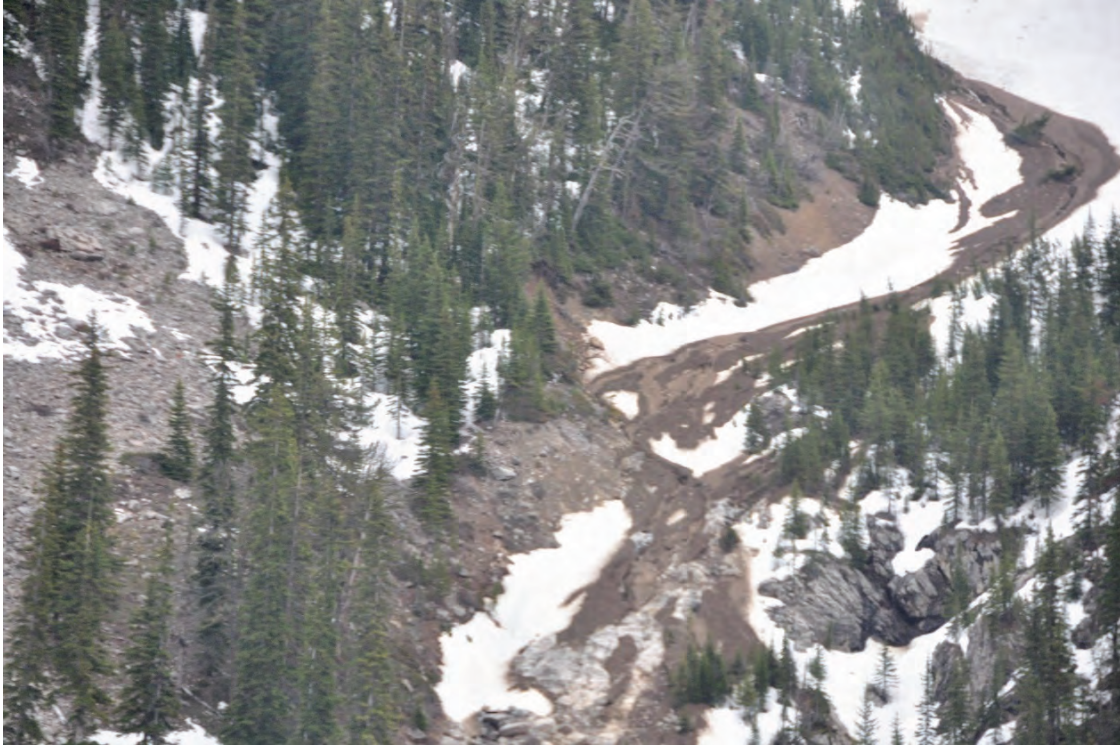
Photo 3.9 Mud flow passing over snow in southern most basin of Fairmont Creek.

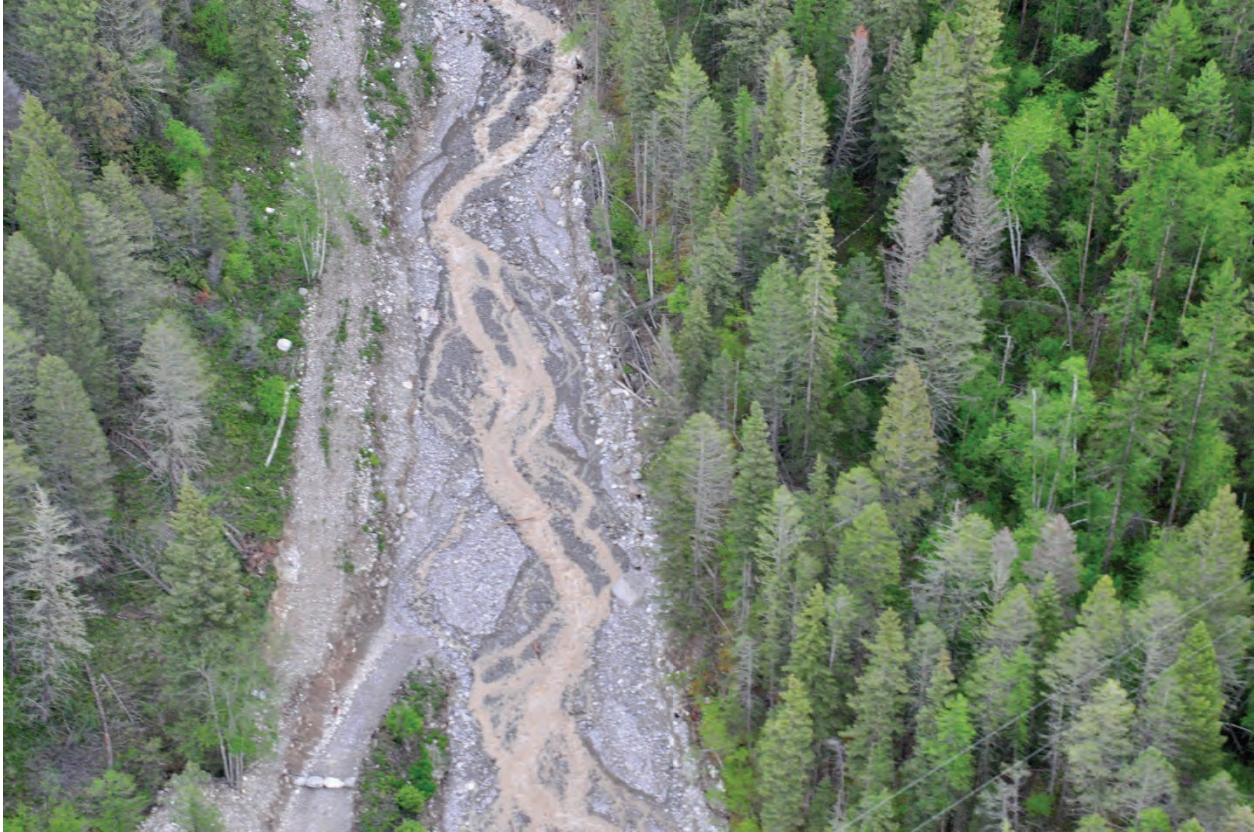
Photo 3.13 Fairmont Creek filled with sediment. Flow is from top of image to bottom. Upstream most containment weir (weir # 1) is under a few meters of sediment and located in bottom portion of the image. Downstream most zipline is visible in the image.

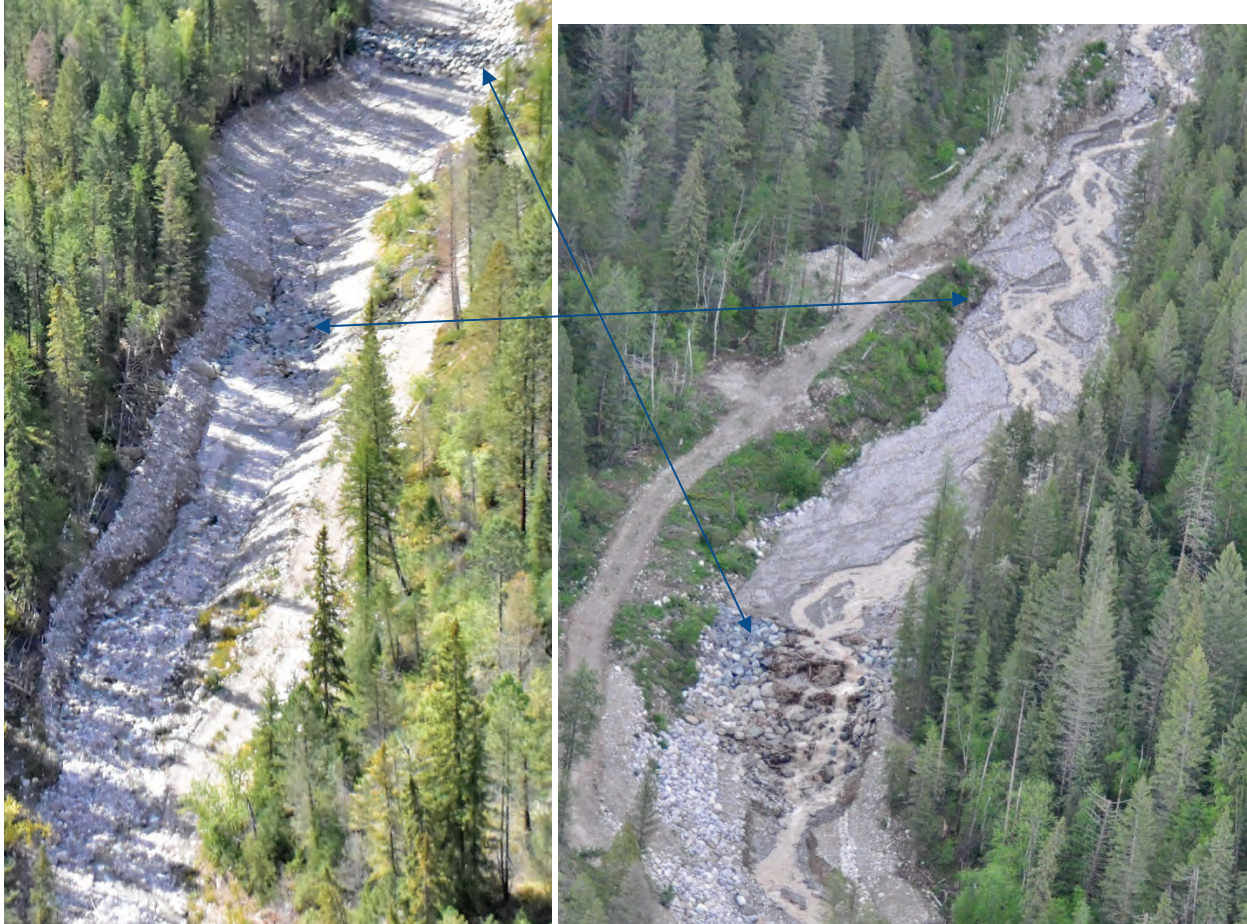
Photo 3.14 2019-09-17 (left) and 2020-06-01 (right) photos of containment weir # 1 and # 2. 2019 photo taken looking downstream while 2020 taken looking upstream. Arrows link containment weirs.

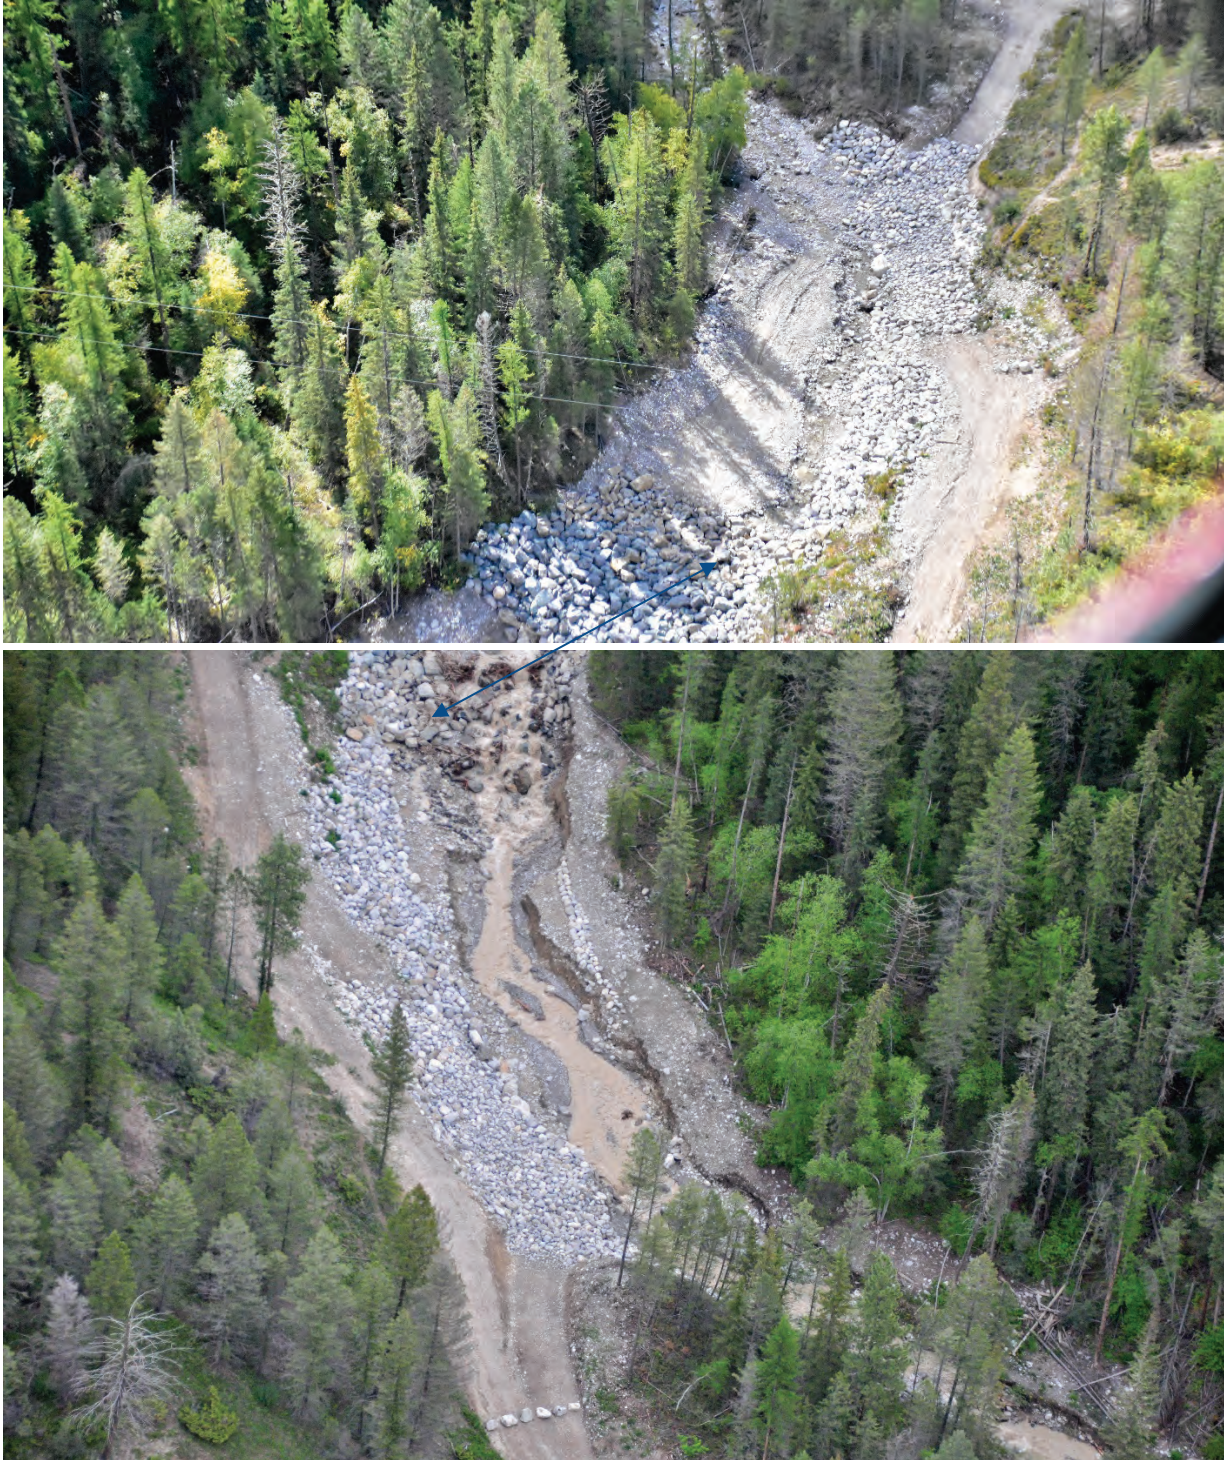
Photo 3.16 Top photo indicates the area downstream of the second debris containment weir in 2019, viewed looking downstream. The bottom photo shows the same area after then 2020 event looking upstream. The arrow links the common weir.

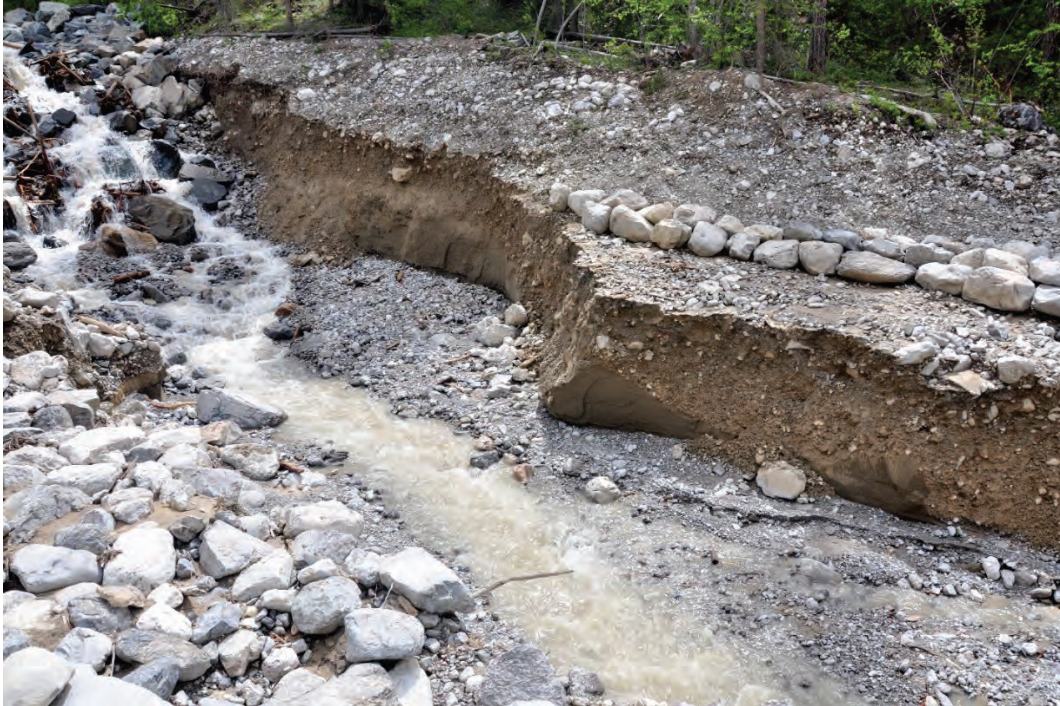
Photo 3.17 Incised stream channel at downstream limit of containment weir # 2. This section of channel needs grade control added and the banks protected to prevent additional channel migration and sediment removal.

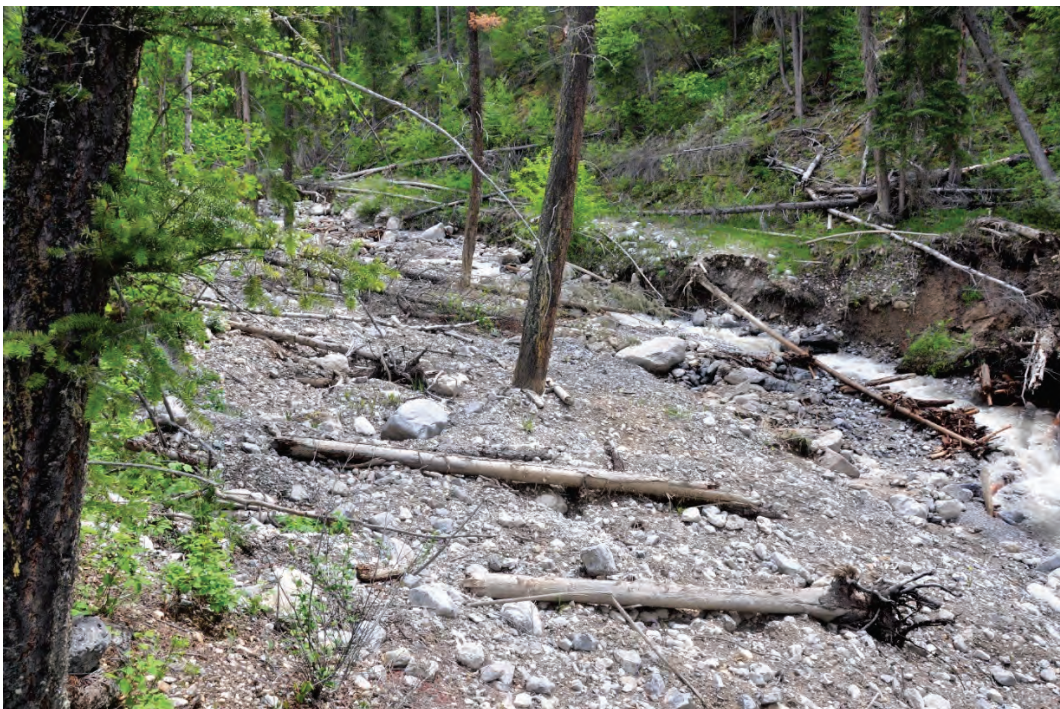
Photo 3.18 Fairmont Creek downstream of containment weir # 2. Horizontally aligned logs are placed on top of 2012 sediment deposition and illustrate that the May 2020 event only activated a fraction of the channel in this area.

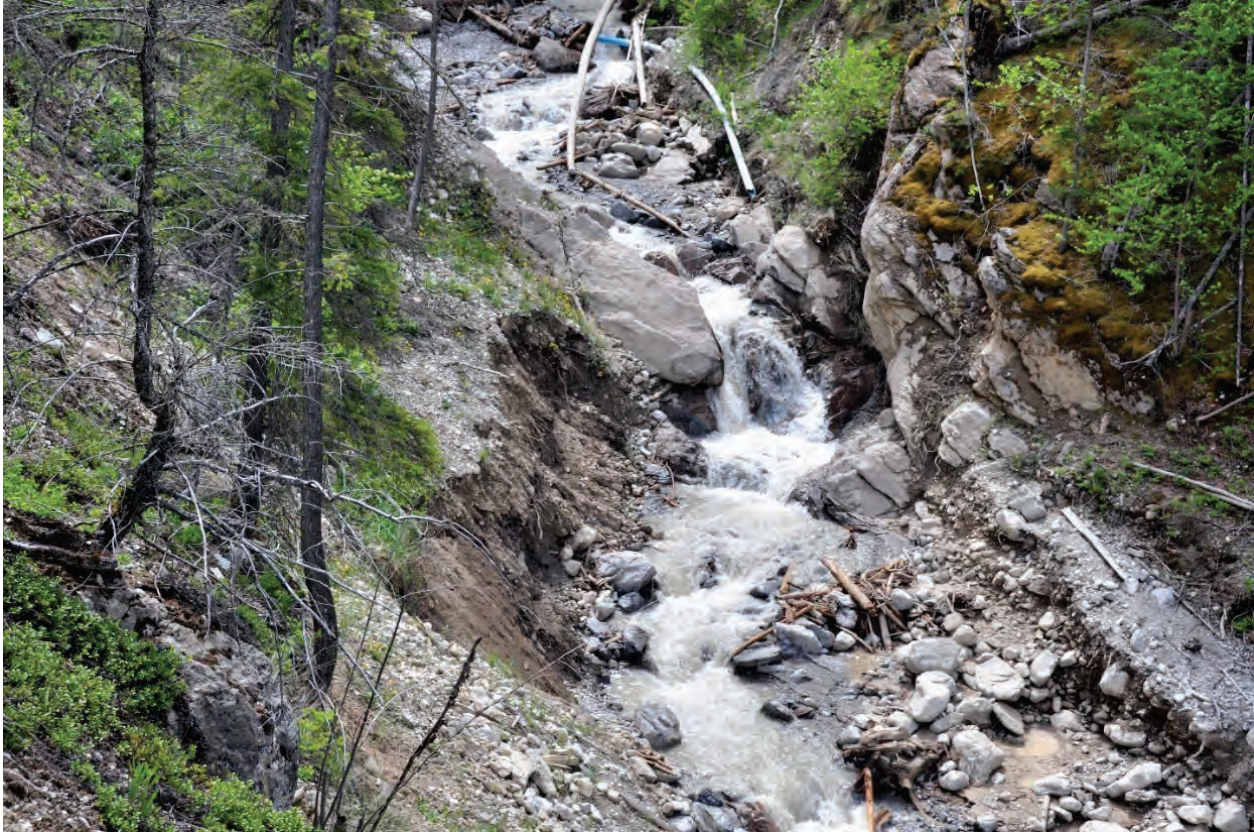
Photo 3.19 Bedrock constricted and bedrock grade controlled portion of Fairmont Creek between weir # 2 and weir # 3. Small slope failures from most recent event are visible, as well as perched terraces from 2012 event.

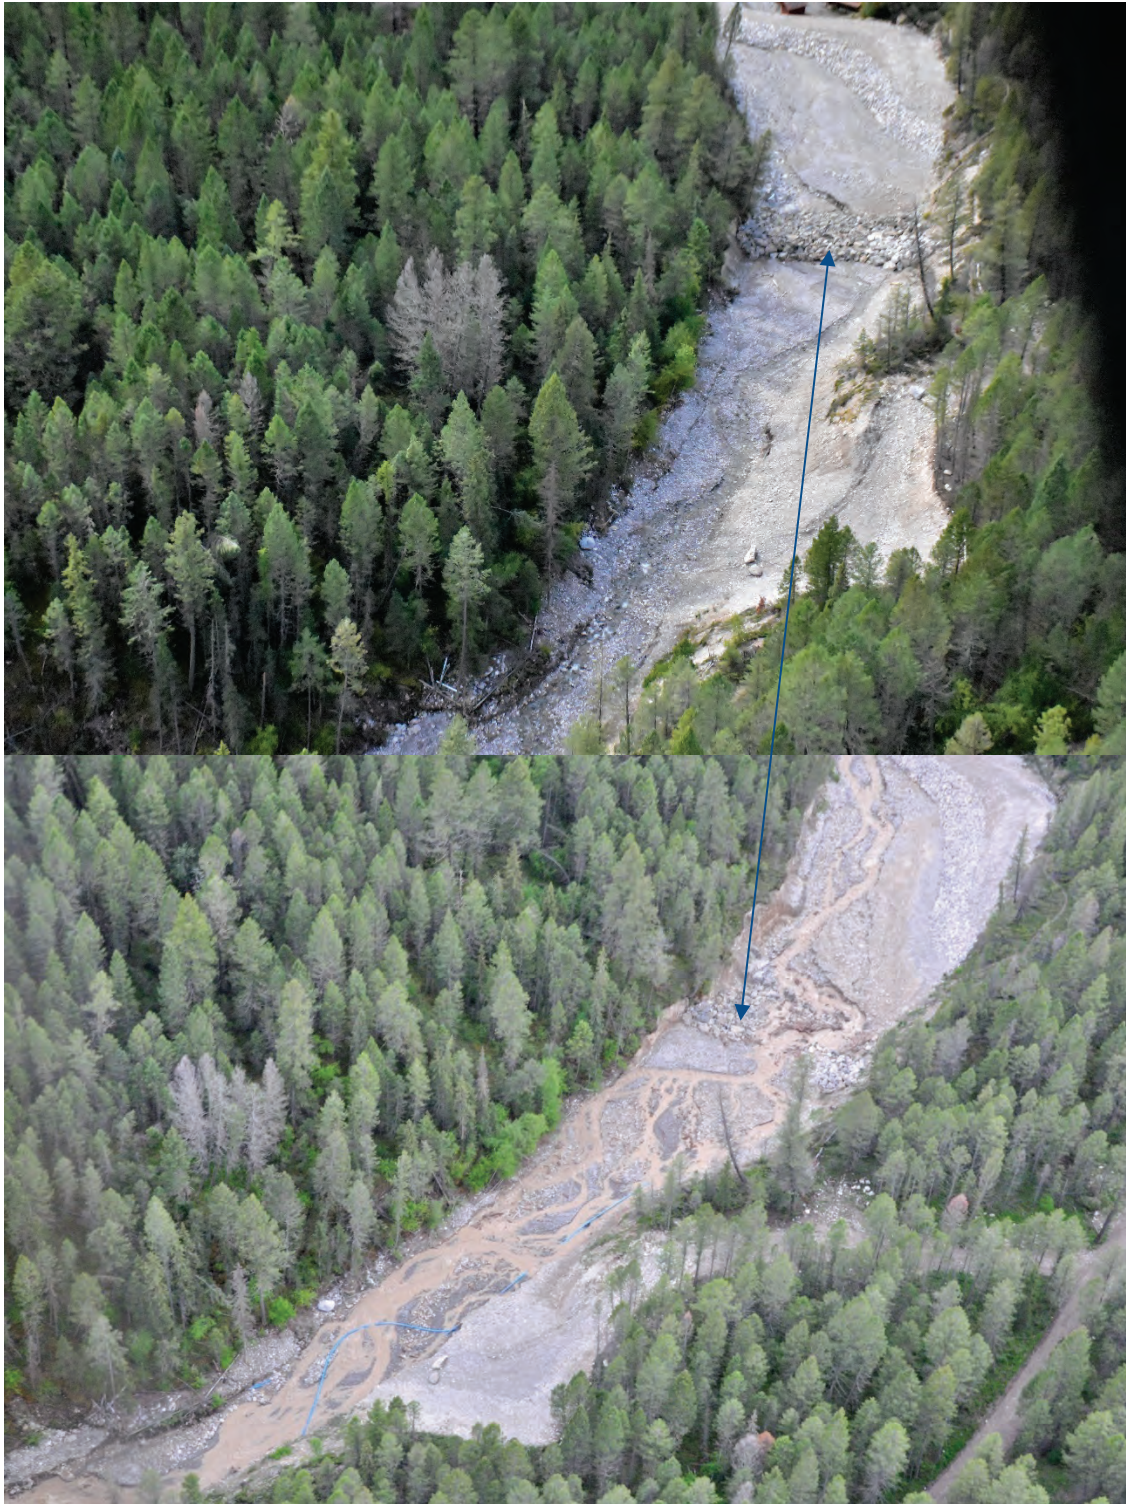
Photo 3.20 Sediment containment weir # 3 on September 17 2019 (top) and June 1 2020 (bottom). Flow from bottom of image to the top. Blue pipe is located in area where sediment accumulated upstream of weir.

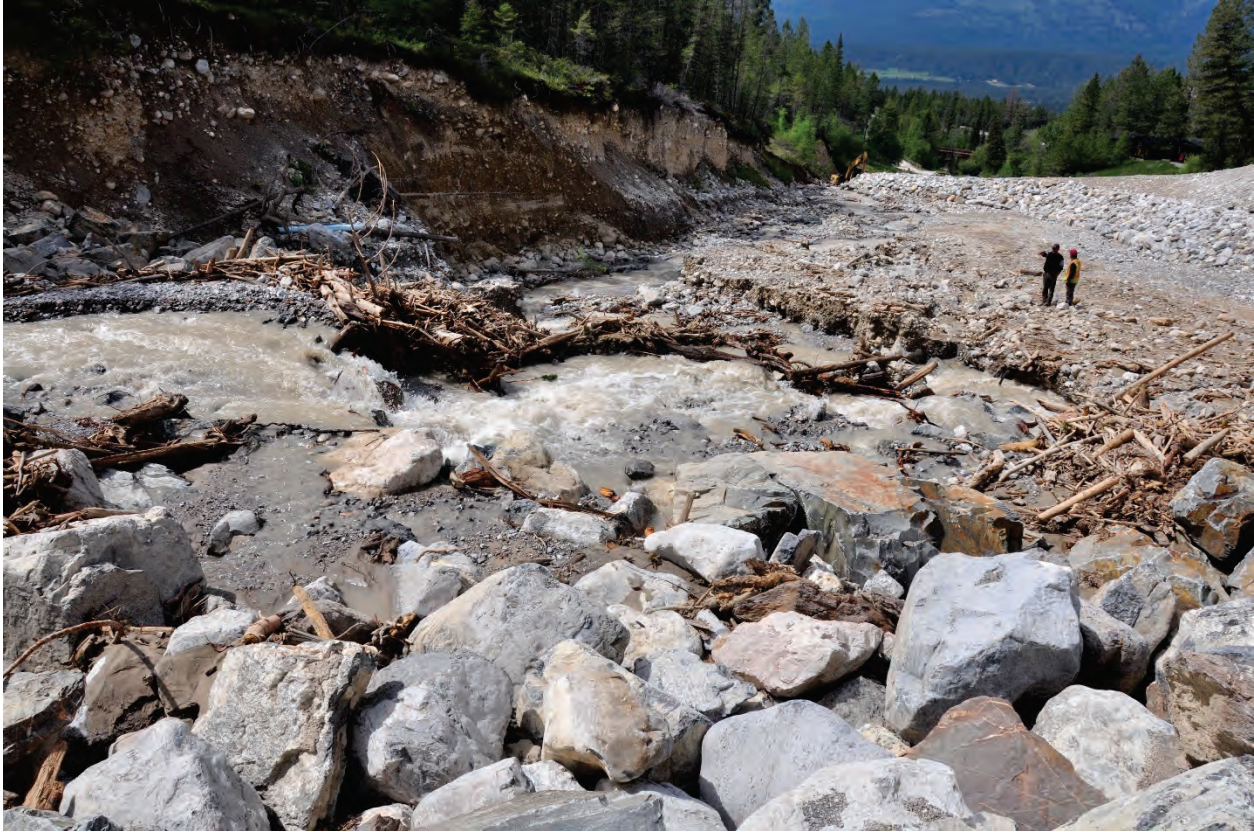
Photo 3.21 Sediment and debris that has passed overtop of weir # 3 is illustrated in foreground while scoured bed downstream of weir # 3 is also visible.

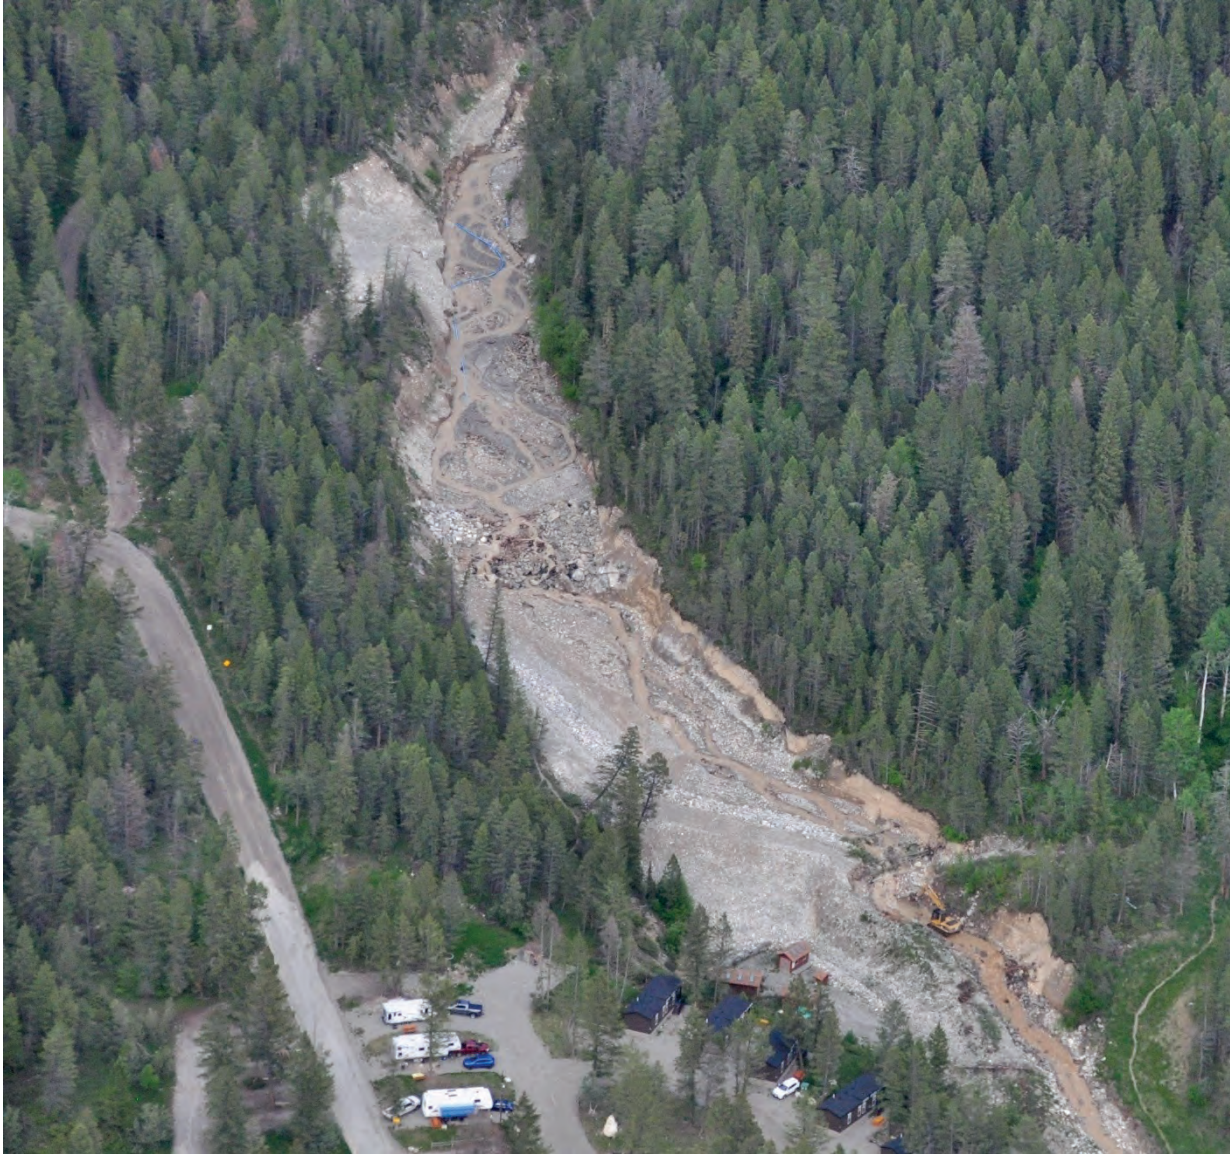
Photo 3.22 June 1 2020 helicopter photo of containment weir # 3 filled with sediment as well as degraded channel adjacent to hot spring intake buildings. The excavator working in the channel had just started to access the channel and repair the eroded bank upstream and to the left of where it is positioned in the image.

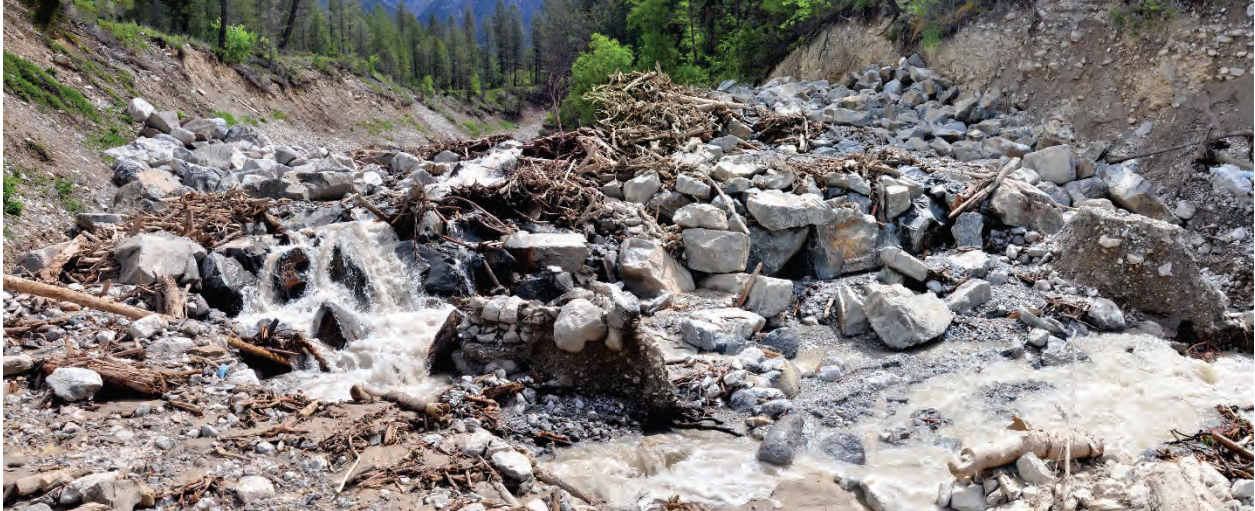
Photo 3.23 Downstream toe of containment weir # 3 showing limited scour after May 2020 event.

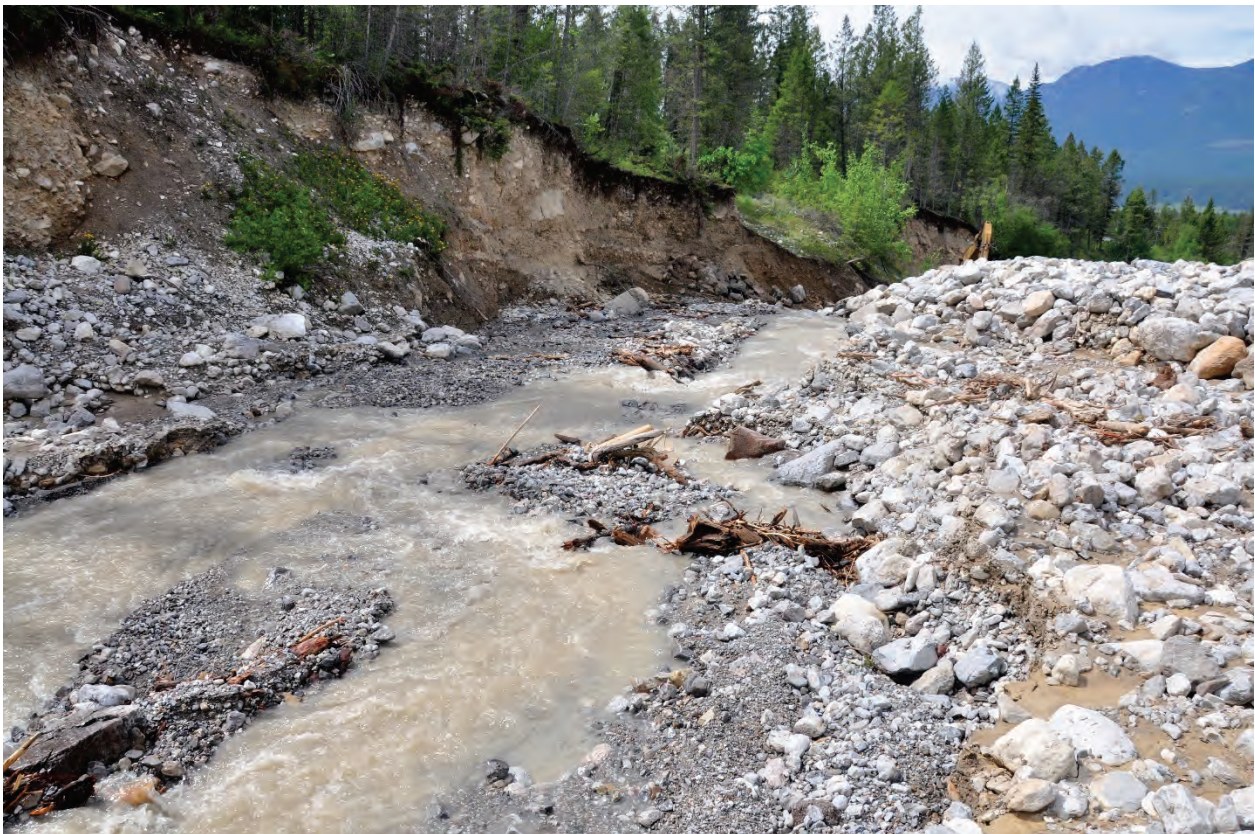
Photo 3.24 Degraded channel downstream of containment weir # 3 upstream of end of 2018 riprap placement. Hot spring intake buildings are over the berm to the right of the image.

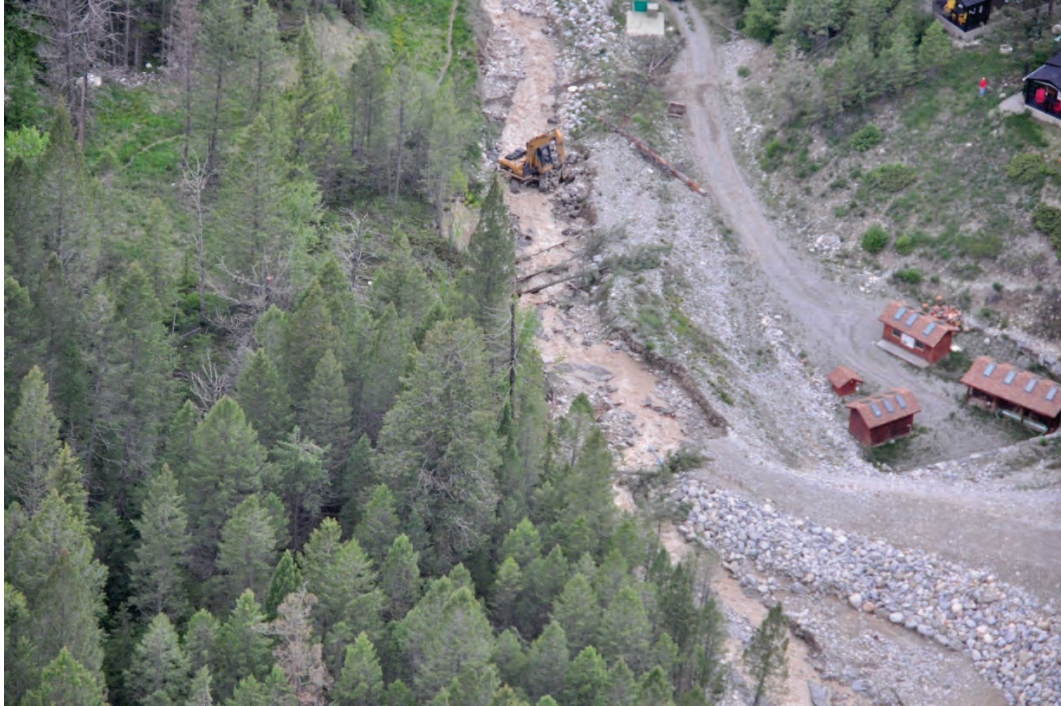
Photo 3.25 Bank erosion adjacent to hot springs intake huts immediately downstream of the downstream limit of the 2018 riprap placement as seen on the evening of June 1, 2020.
