Fairmont Creek Debris Basins May 31, 2020 Flood Assessment

Final Report

Dale Muir, P. Eng.
Principal Engineer
June 24, 2020
NHC Ref no. 3005607

Regional District of East Kootenay

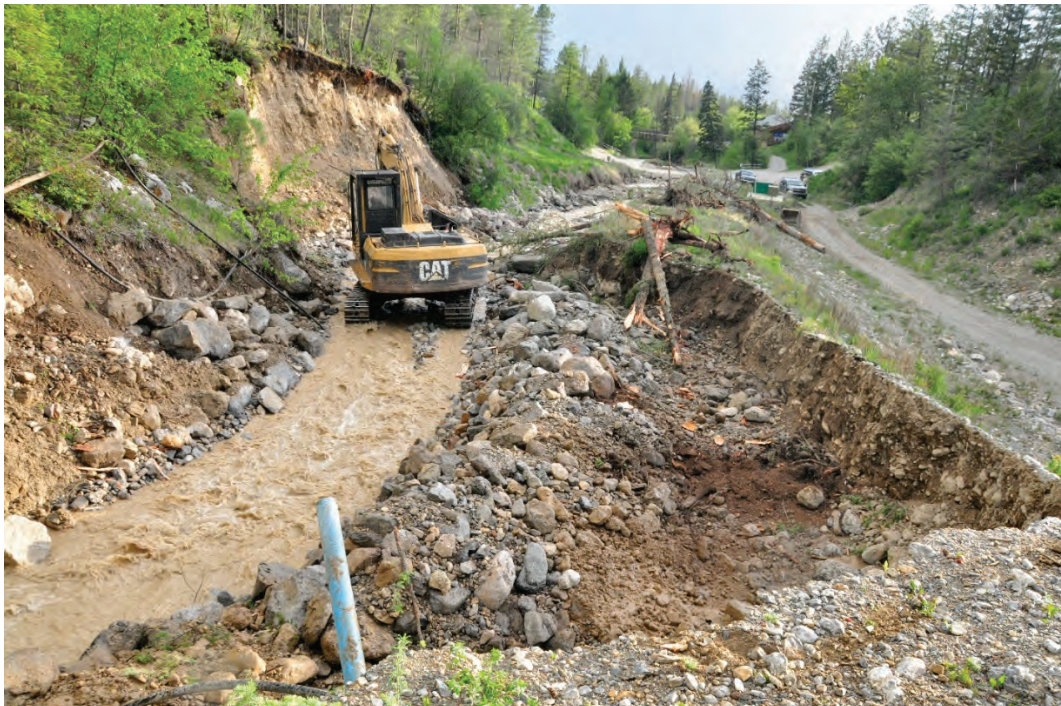
Photo 3.26 Evening of June 1, 2020 photo of eroded berm after initial re-alignment of channel by the excavator in the preceding hour. The small amount of remaining bank that separated the creek from the hot springs intake building is visible on image right and was about 1 m tall and 1.5 m wide.

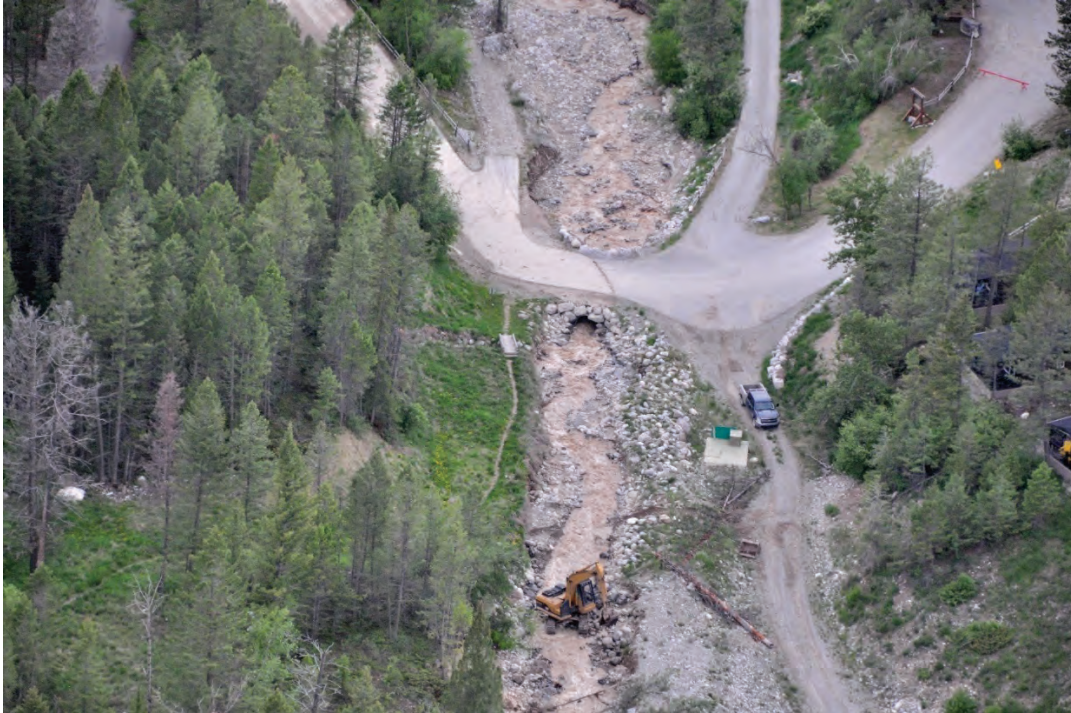
Photo 3.27 Upstream most 4' culvert viewed looking downstream. Creek overtopped road and debris line is visible crossing roadway on a diagonal.

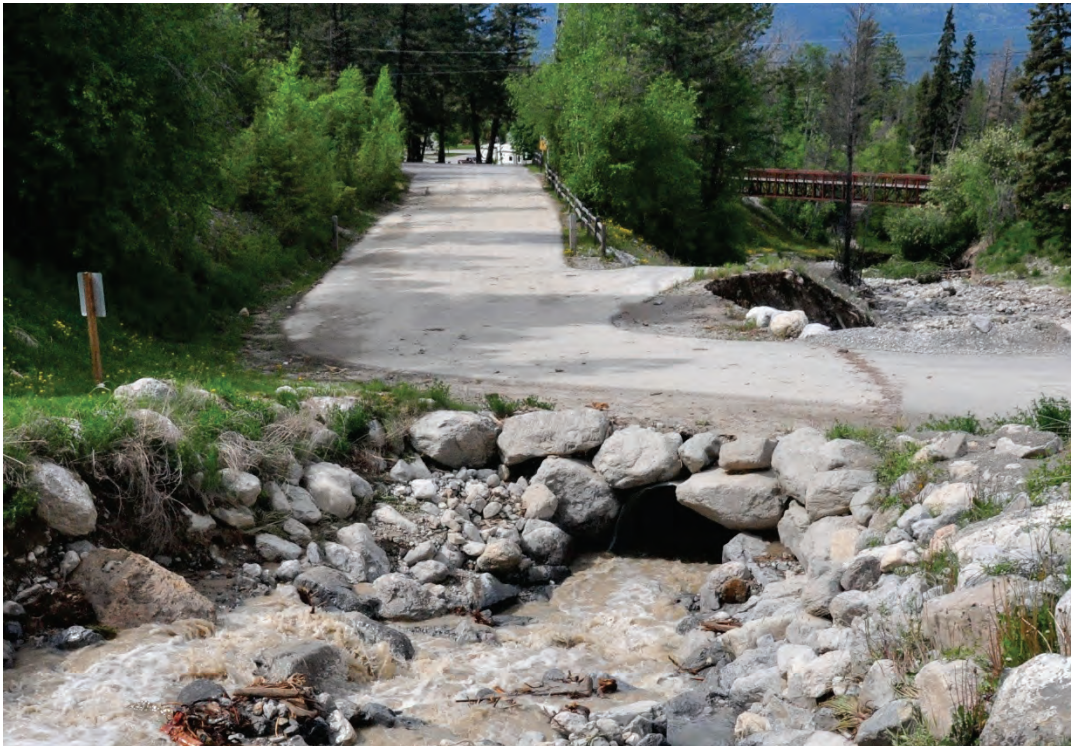
Photo 3.28 Four foot diameter culvert and road that was overtopped.

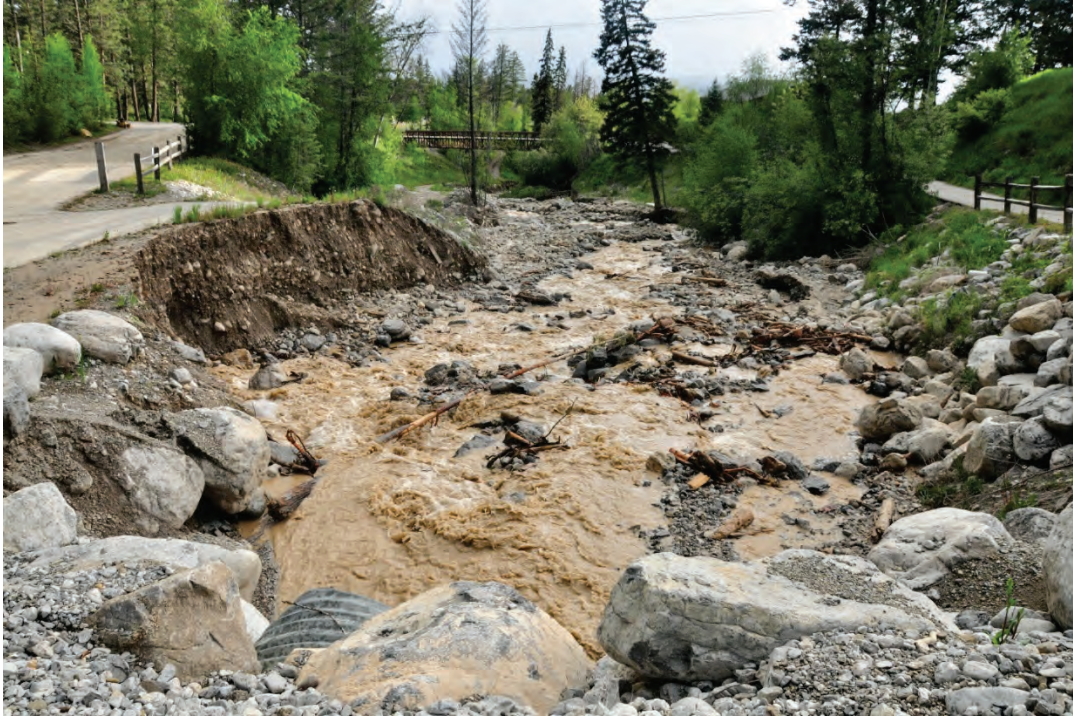
Photo 3.29 Bank erosion downstream of upstream most 4' culvert.

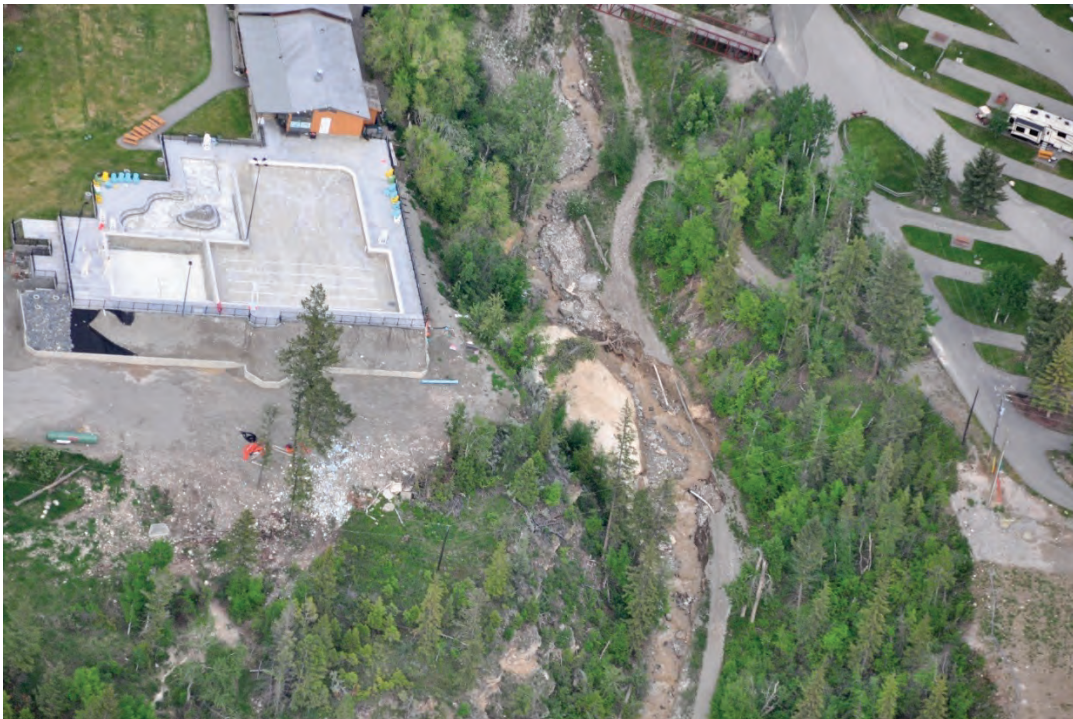
Photo 3.30 Fairmont Hot Springs pools and mineral rich water discharge point (light colored uniform textured deposit). Golf course irrigation pipe can be seen hanging in the air where the roadway has been eroded.

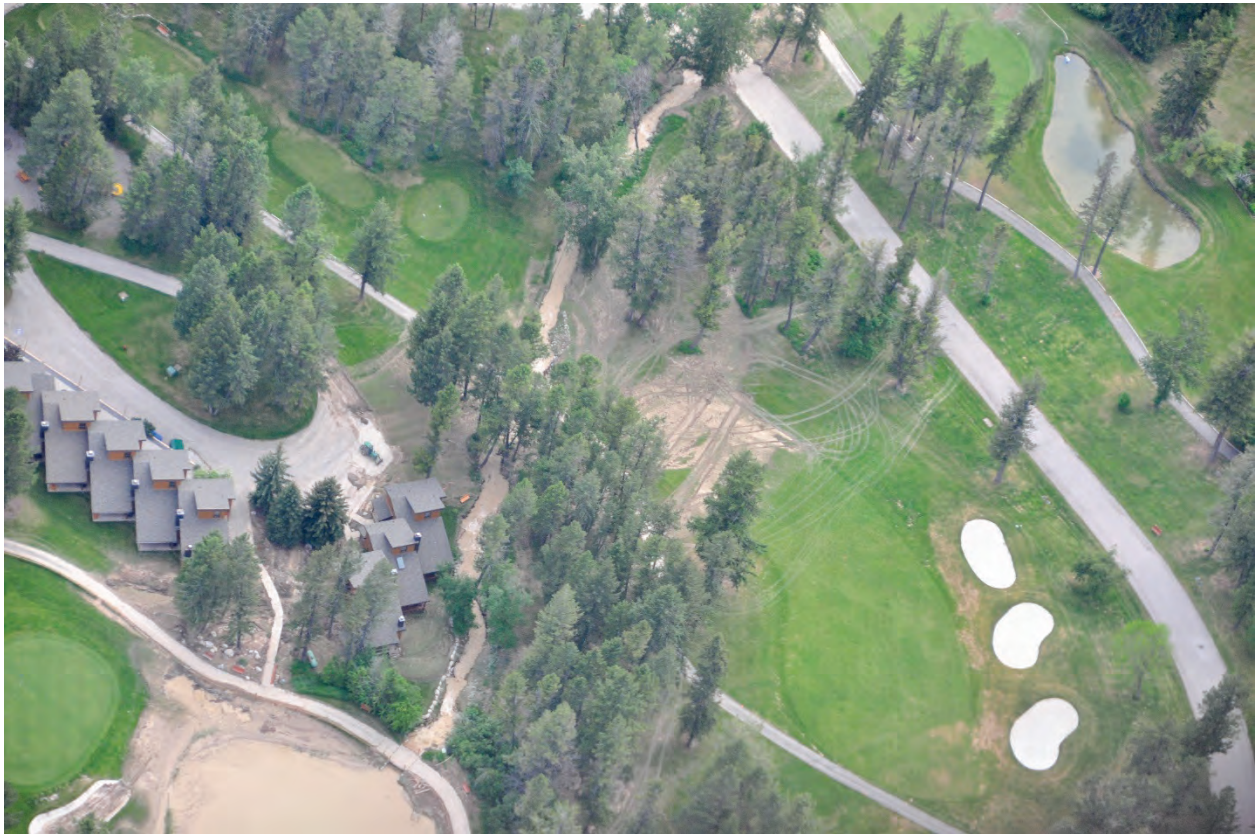
Photo 3.31 Golf course sediment containment pond and area downstream that experienced clearwater flooding. Flood waters went overtop of the paved golf course road.

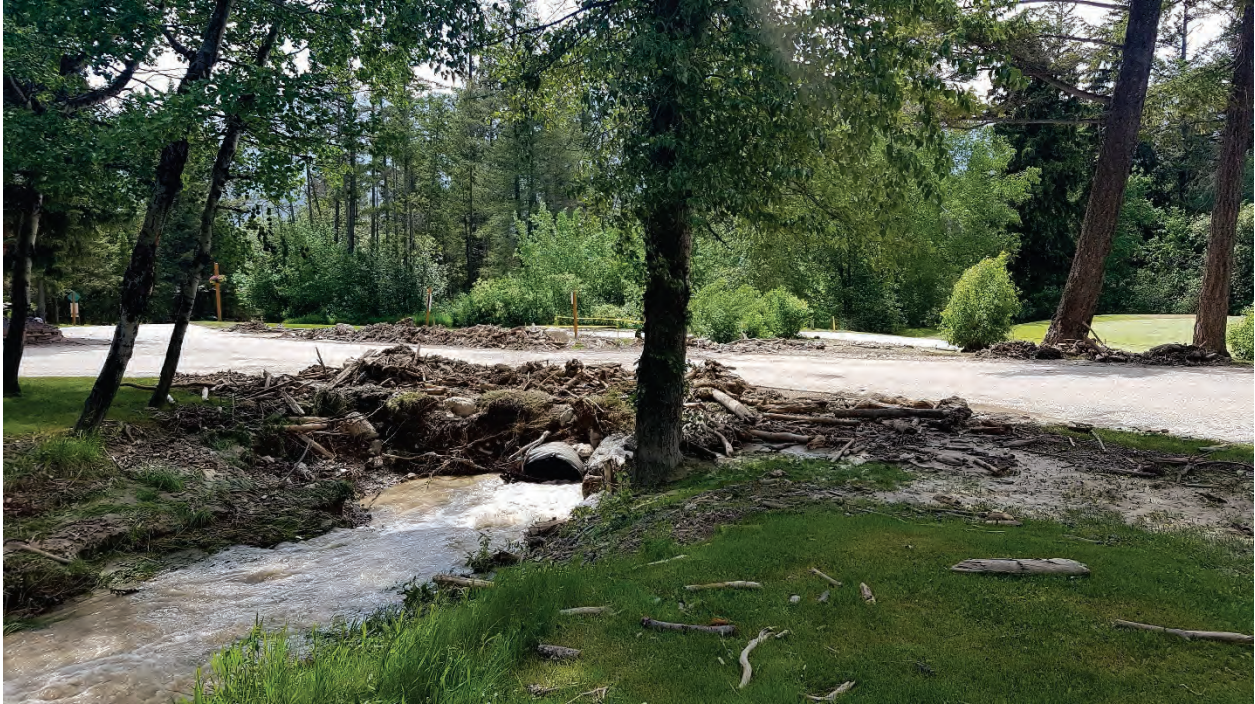
Photo 3.32 Culvert that was overwhelmed during the flood event that is located 250 m downstream of the golf course pond on road providing access to Fairmont Mountainside Vacation Villas.

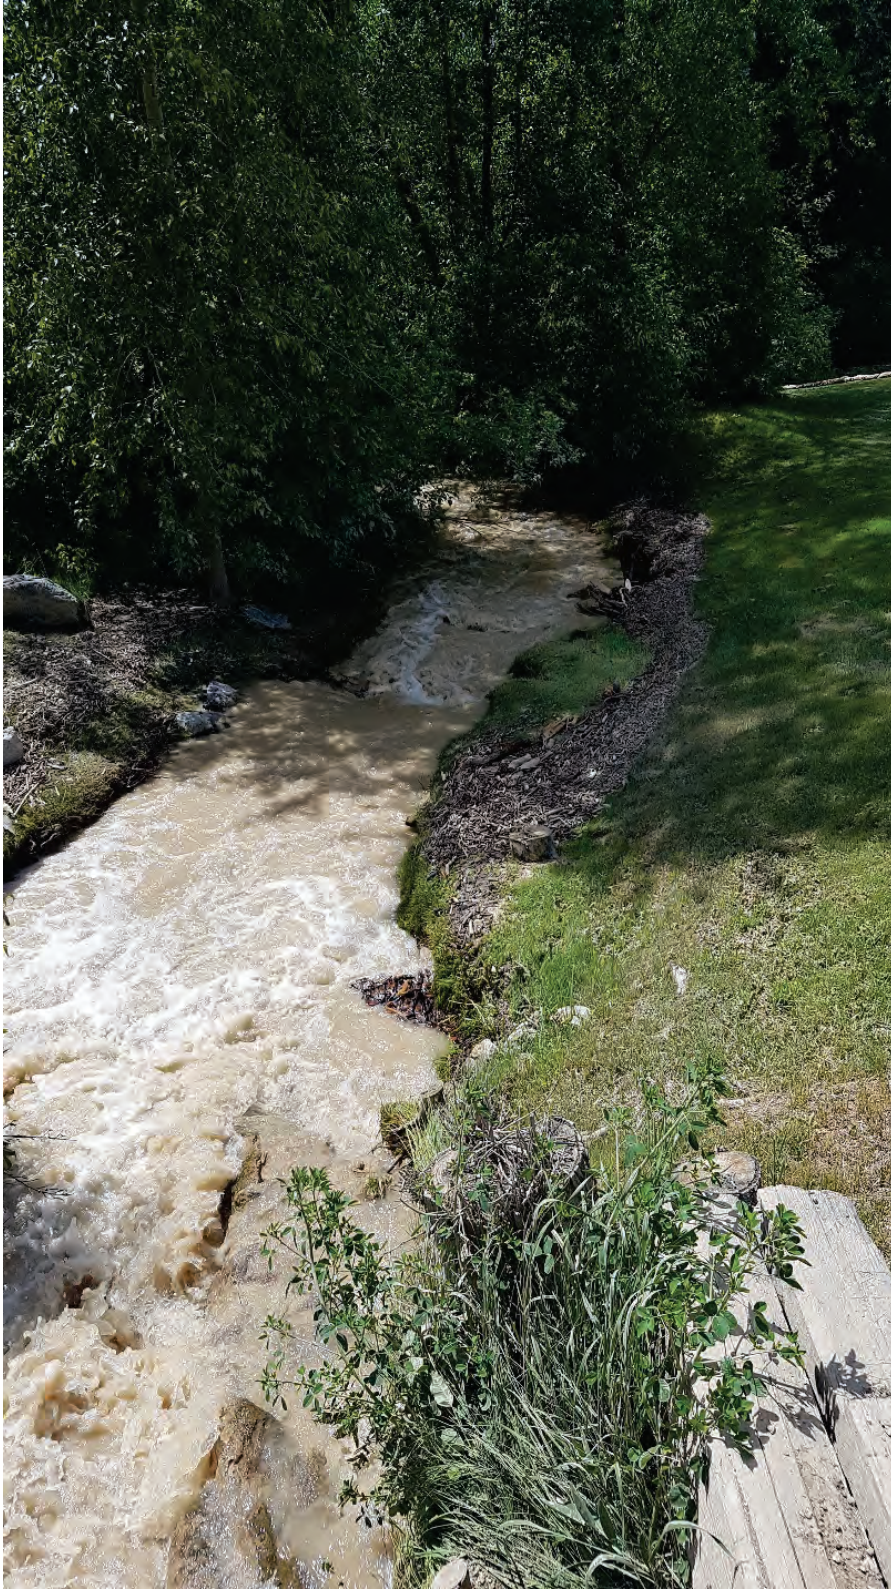
Photo 3.33 Lower Fairmont Creek illustrating a section of channel that experience over bank flooding leading into a forested portion of the reach.

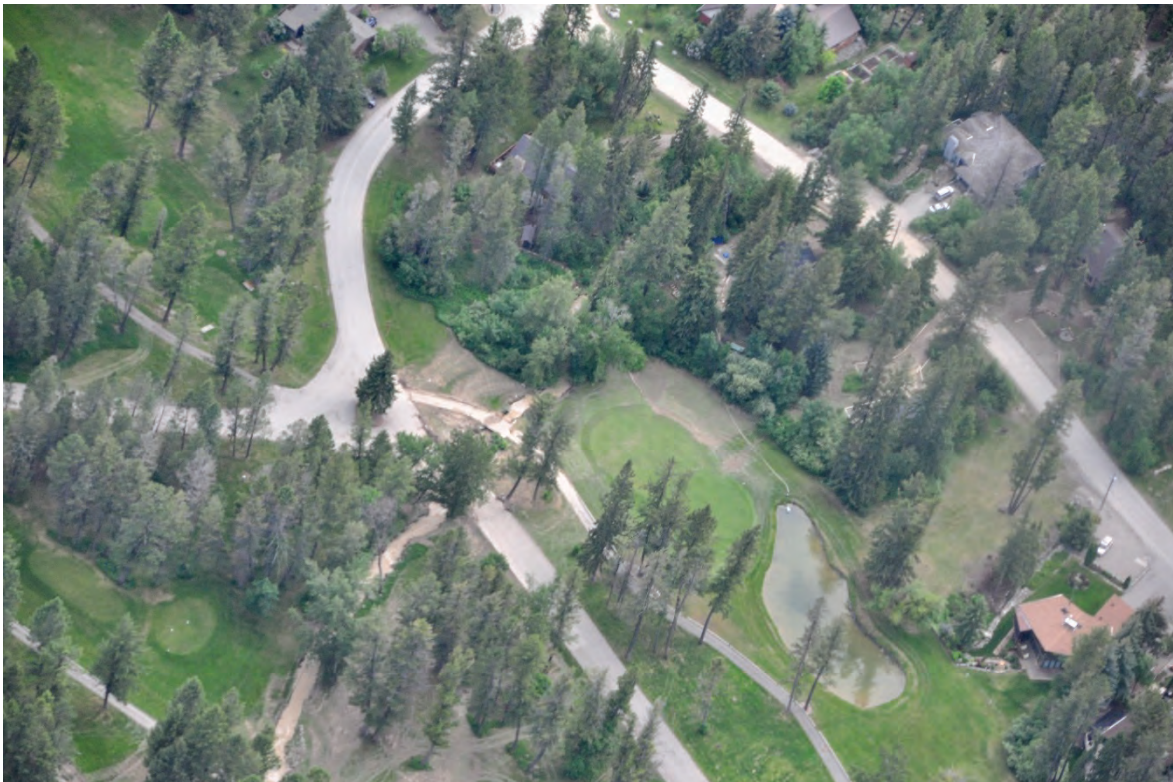
Photo 3.35 Aerial image of Fairmont Creek downstream of golf course sediment containment pond. Roadway in image center and top of image were overtopped during the event.

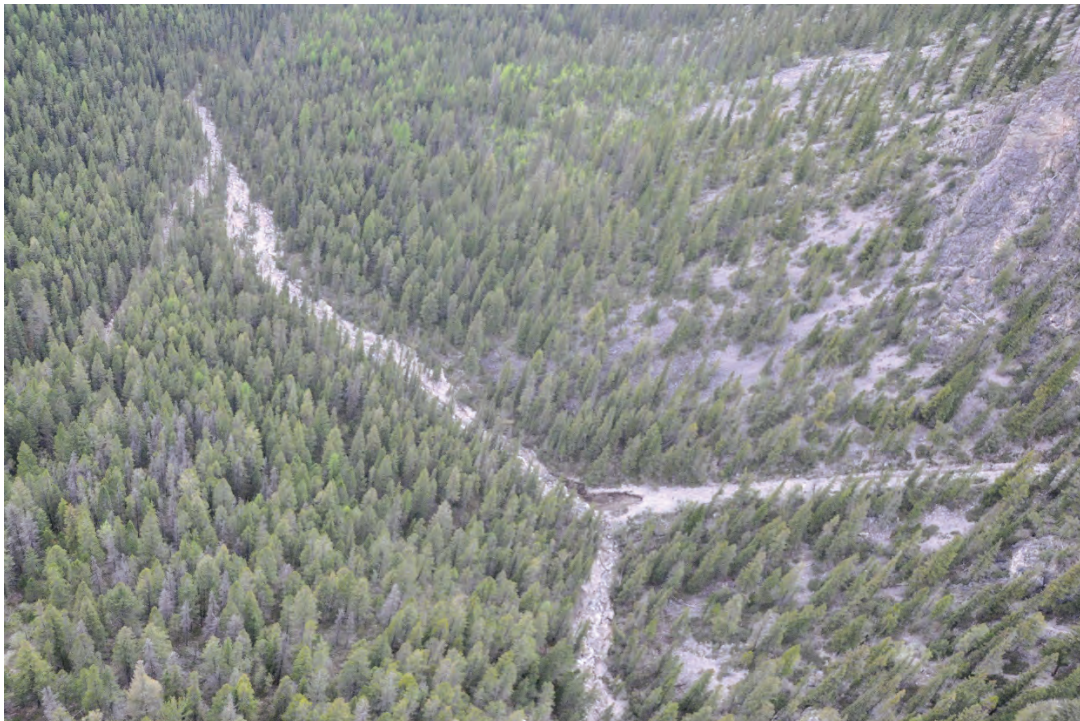
Photo 3.36 Major debris flow system on Cold Spring Creek located 5.7 km upstream from the dam can be seen on image right. The toe of the deposit has been scoured by river flows.

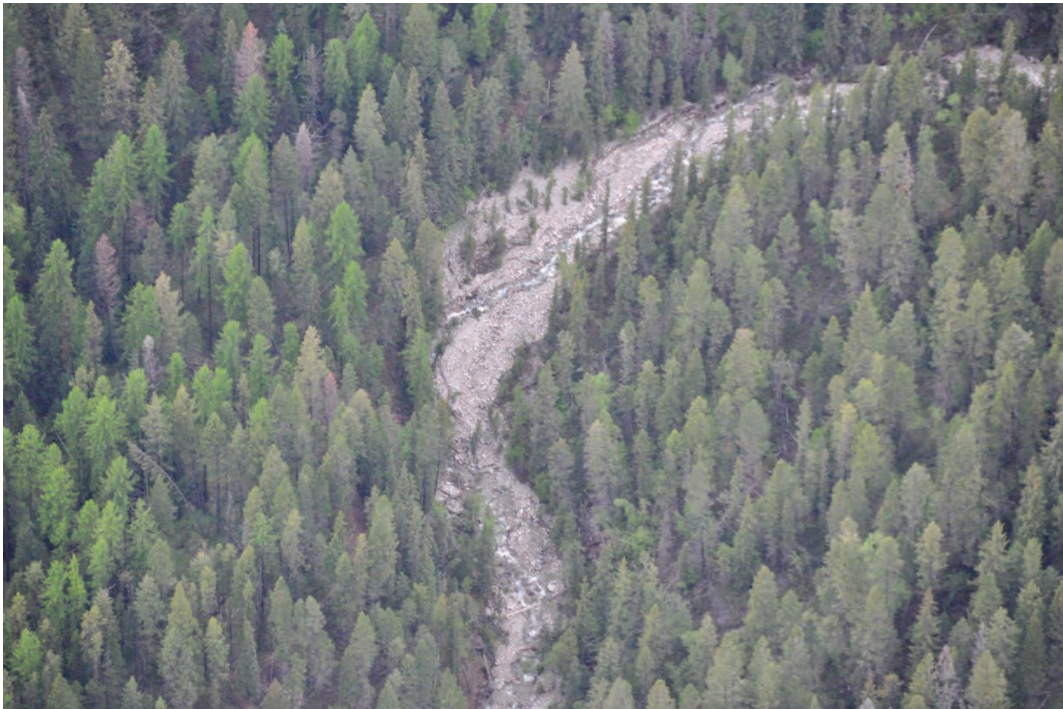
Photo 3.38 Cold Spring Creek 4 km upstream from dam. Extensive deposits of freshly mobilized sediment are visible.

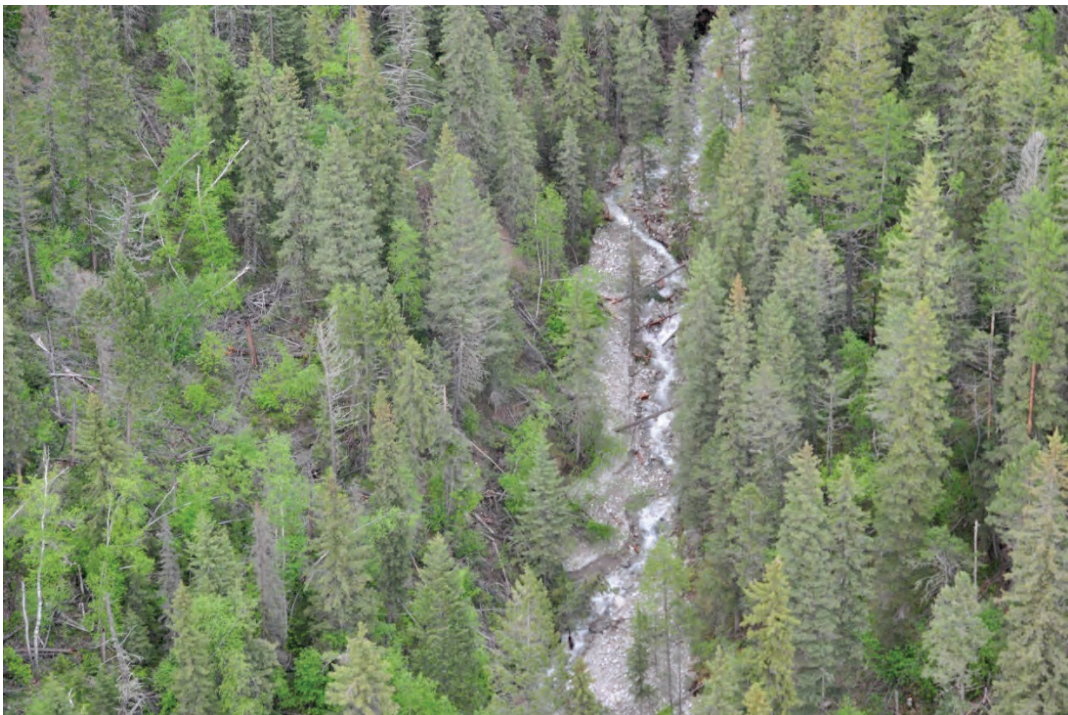
Photo 3.40 Cold Spring Creek 2.2 km upstream of the dam. Thick deposits of alluvial sediment can be seen filling the valley.

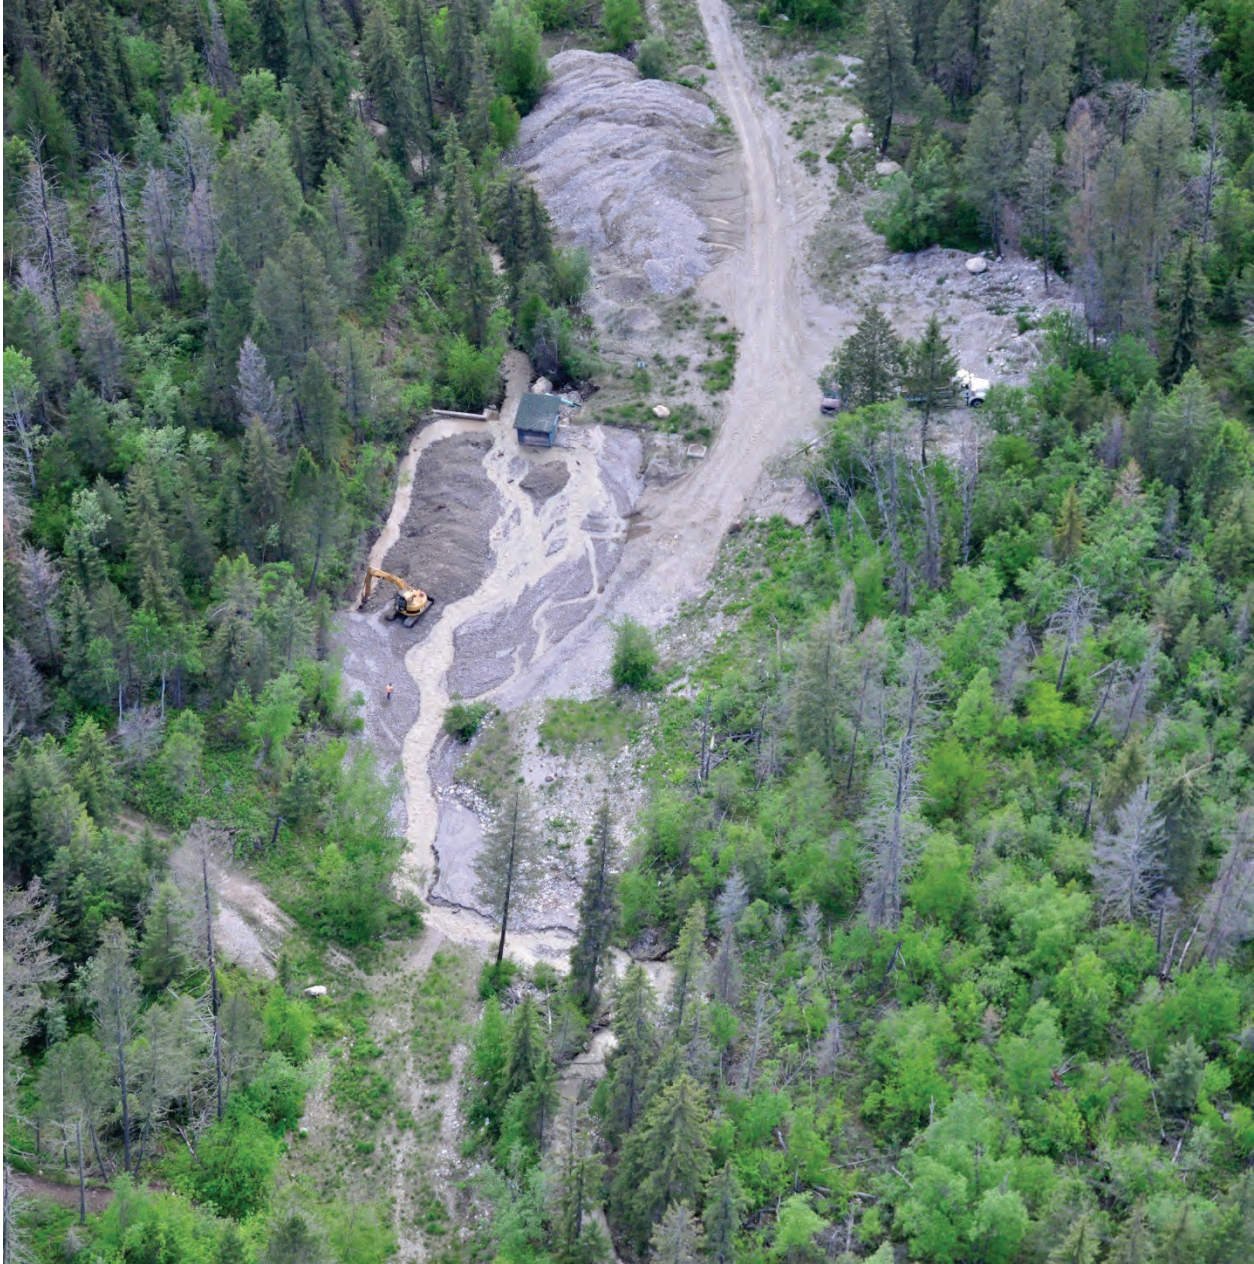
Photo 3.42 Sediment deposited in dam on Cold Spring Creek.

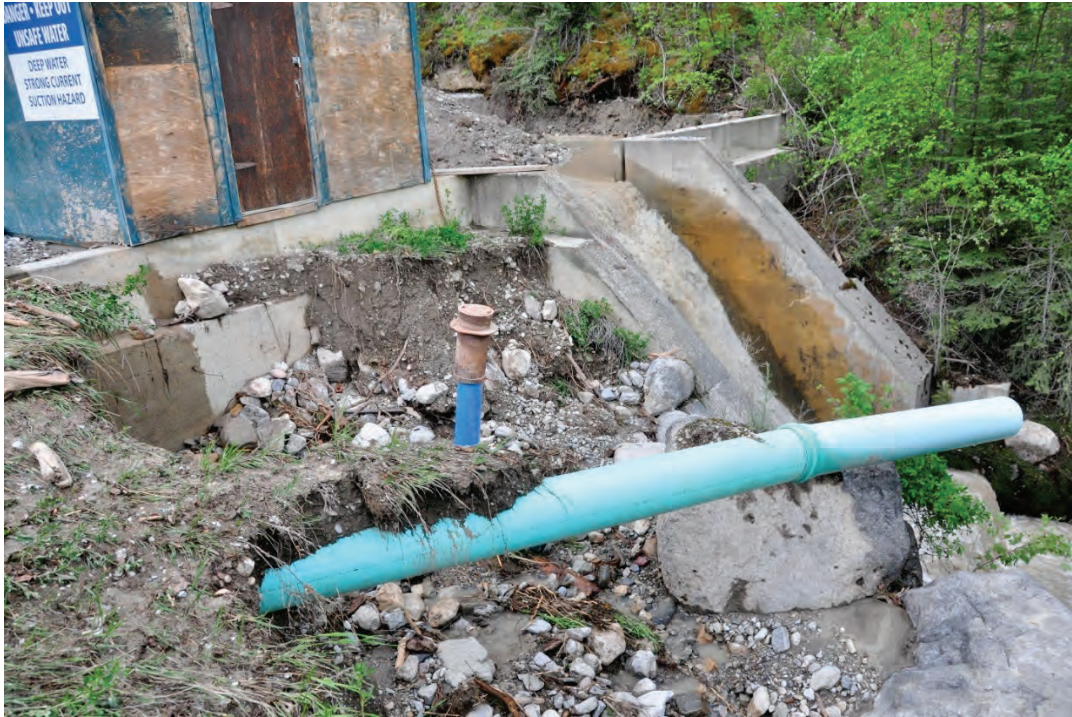
Photo 3.43 Downstream face of dam showing path of water to right side of spillway and resulting scour.

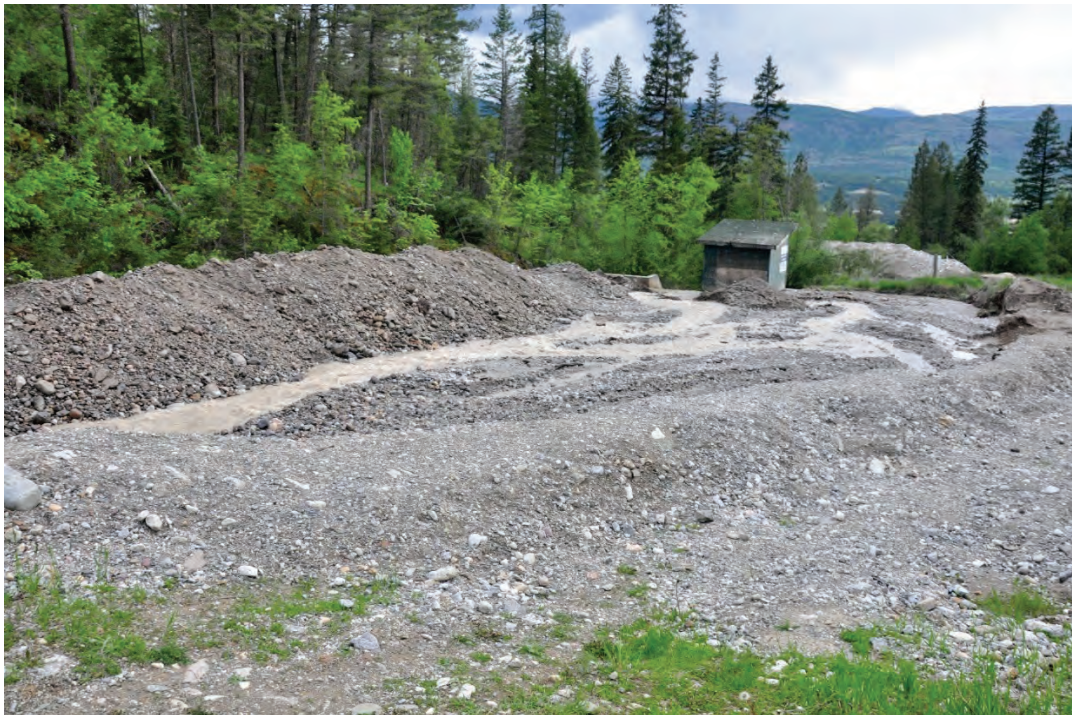
Photo 3.44 View looking downstream into dam headpond which has become filled with sediment. Note the presence of a abutment on river left at the crest of the dam but no evidence of a abutment on river right as the creek bed has aggraded and is above the abutment wall.

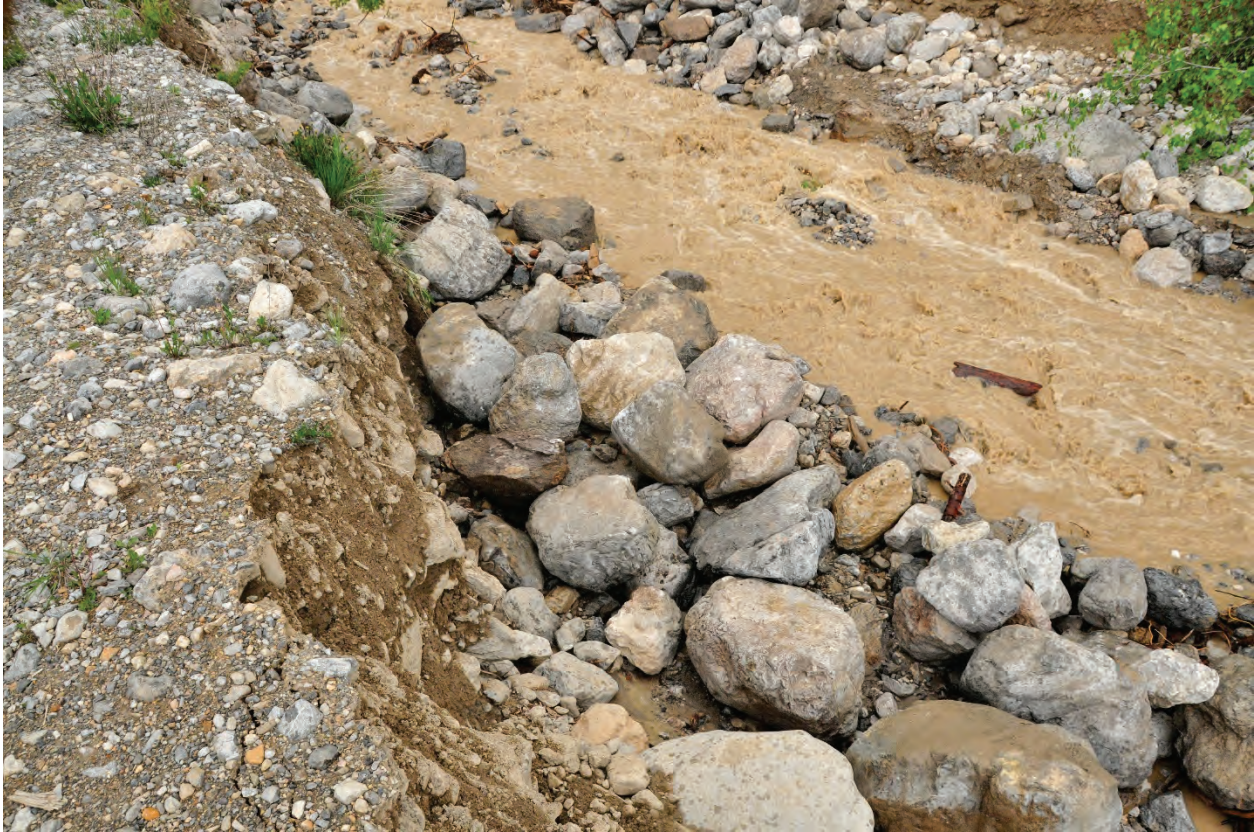
Photo 5.2 Section of berm upstream of first culvert along Fairmont Creek that experienced bank erosion and needs the bank protection rebuilt to prevent the creek from eroding through the berm and flowing down the hot spring intake access road.

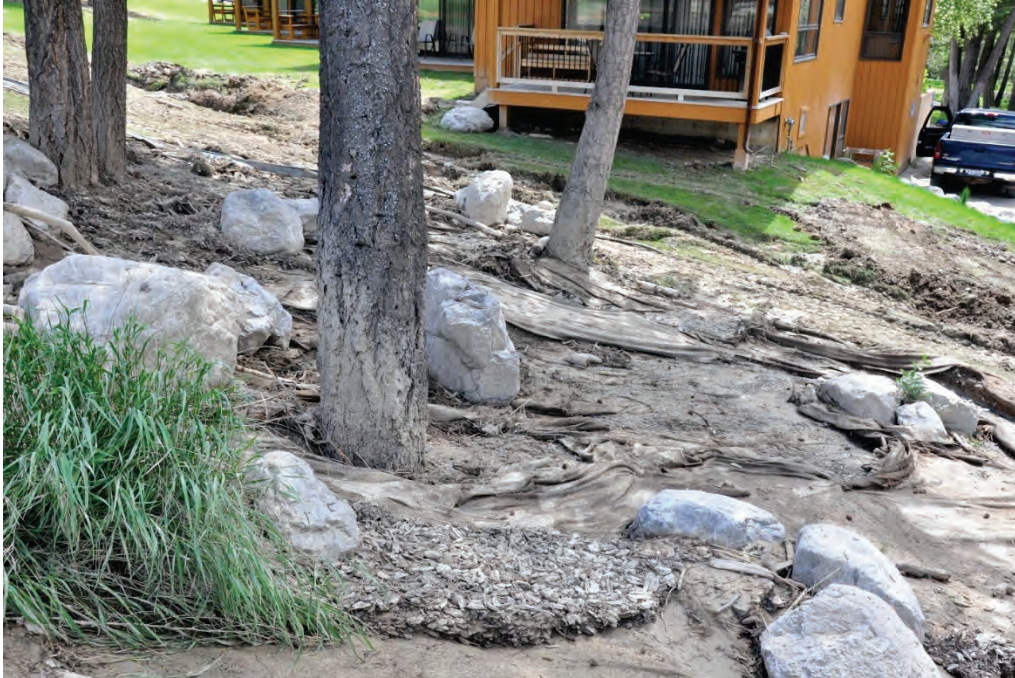
Photo 6.1 Eroded soils downslope from golf cart road that was overtopped when water levels in the golf course pond sediment trap were raised.

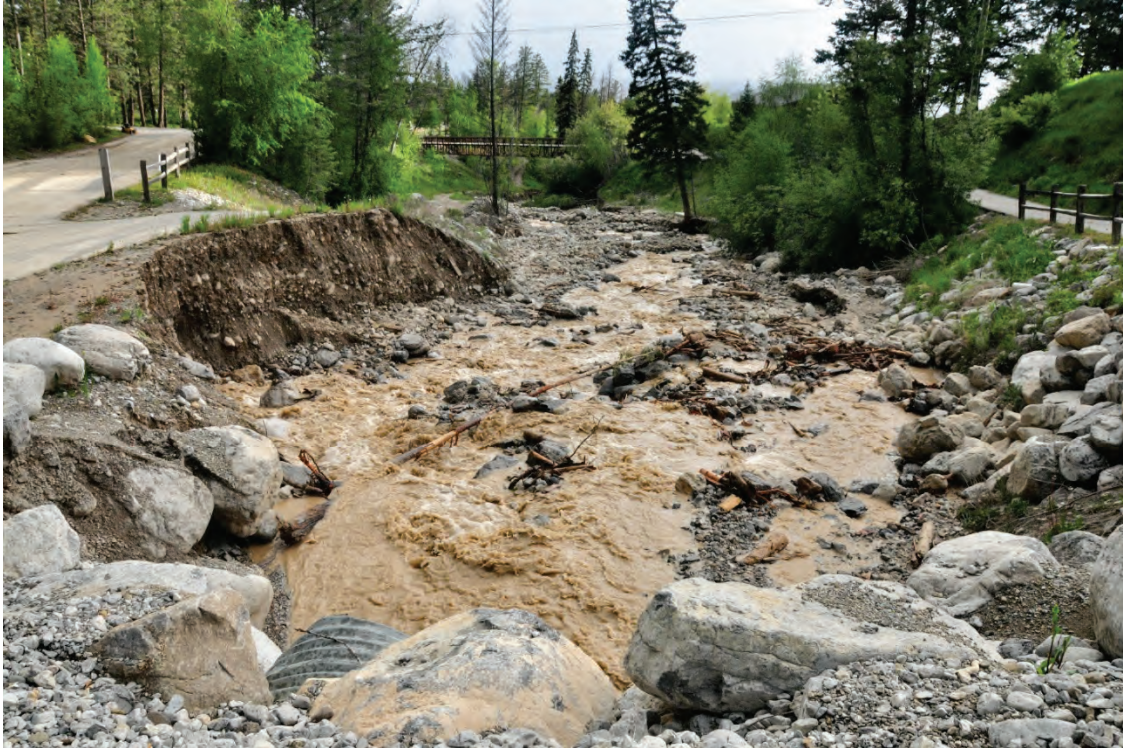
Photo 6.7 Middle portion of Fairmont Creek that would benefit from both bank protection and grade control structures.

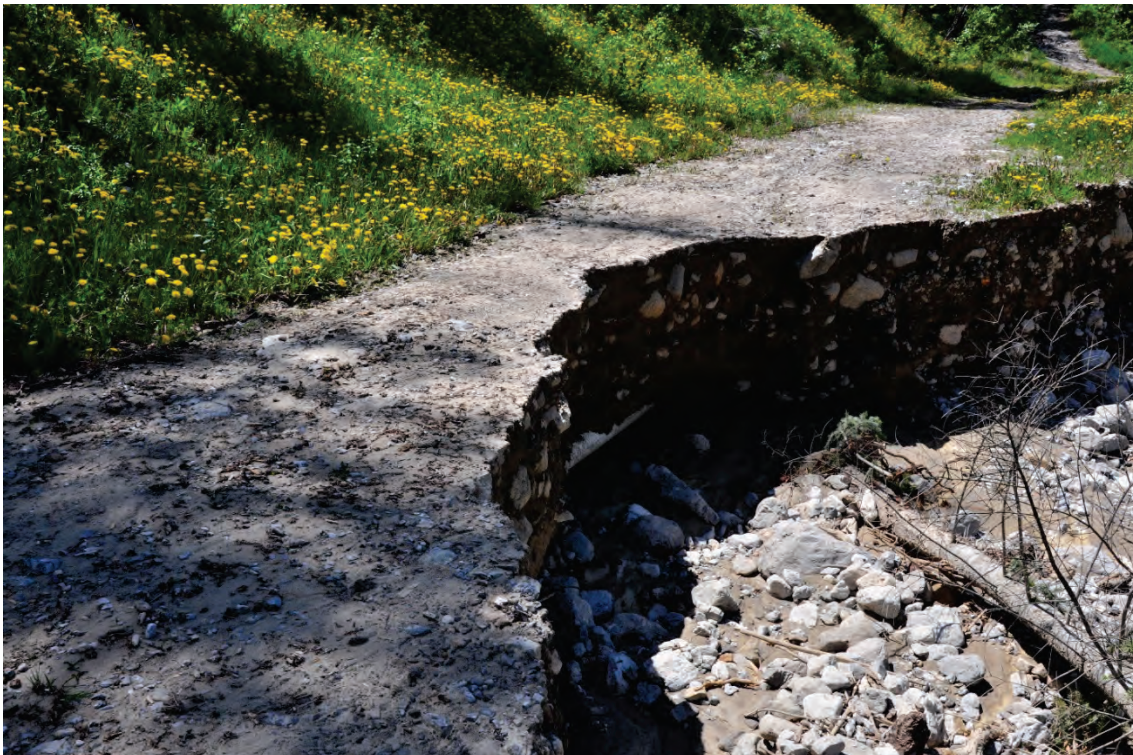
Photo 6.8 Section of access road that was washed out and exposed irrigation waterline.

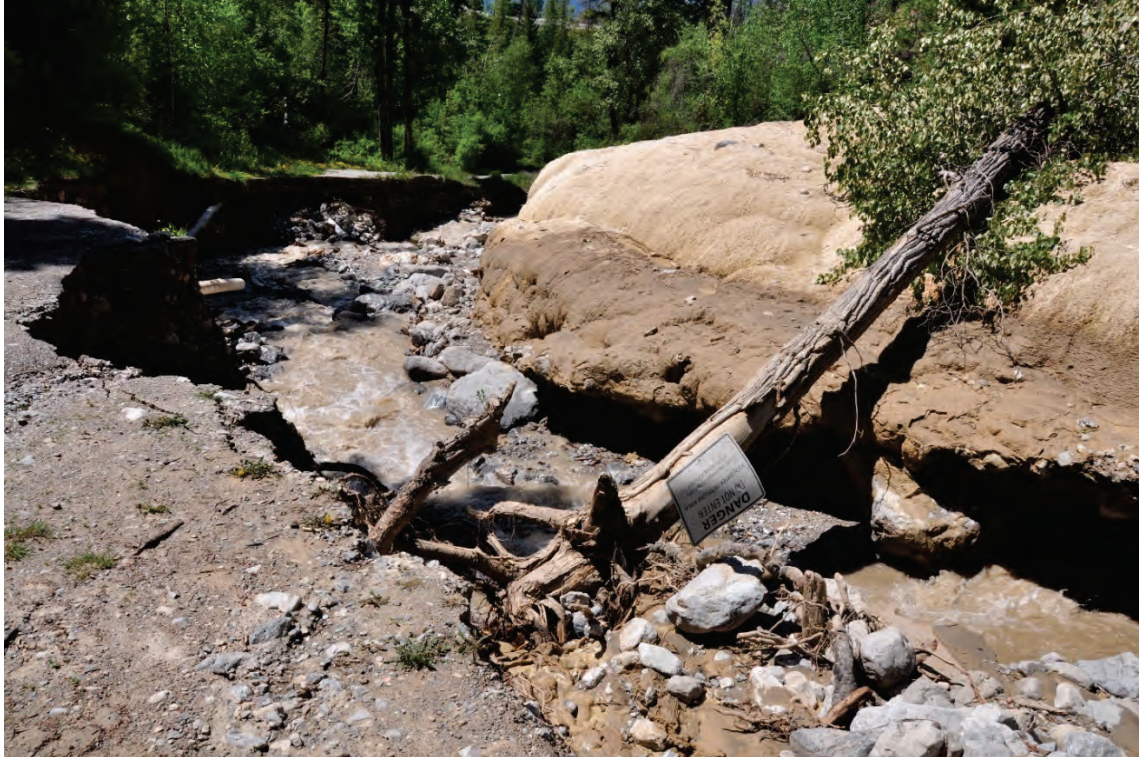
Photo 6.9 Limestone deposit in historic channel that has now directed flow south and eroded the bank.

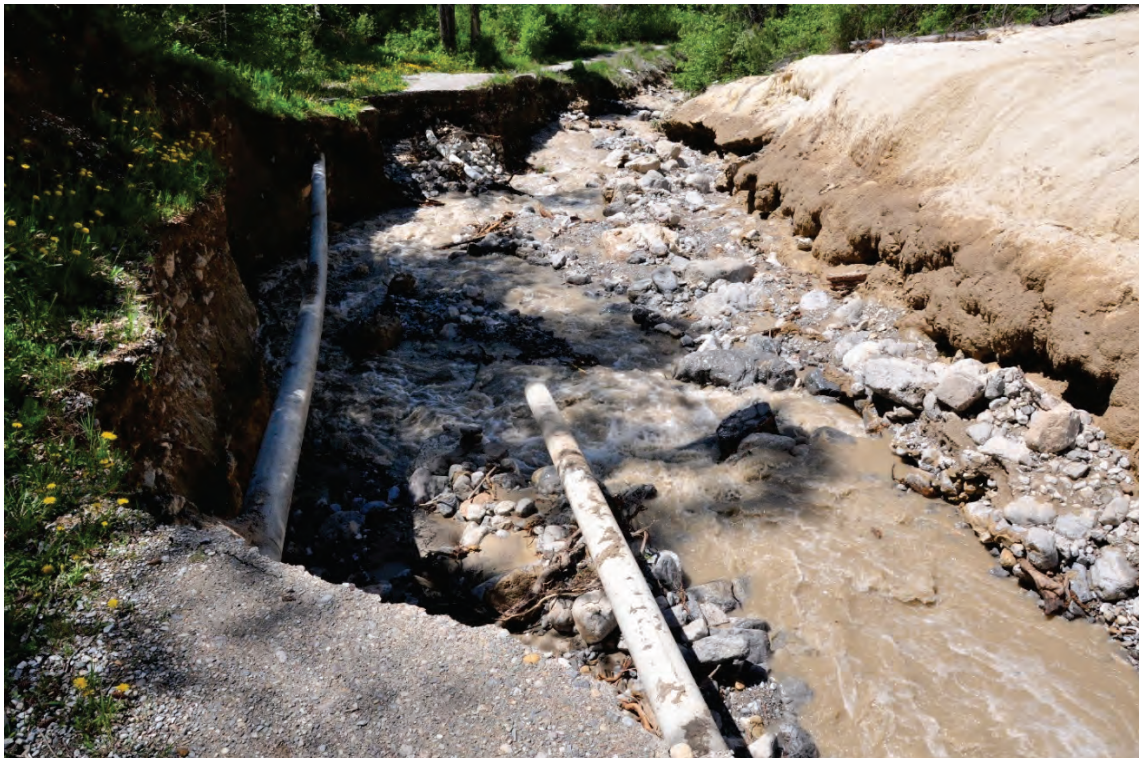
Photo 6.10 One of two extended suspended section of golf course irrigation waterline.

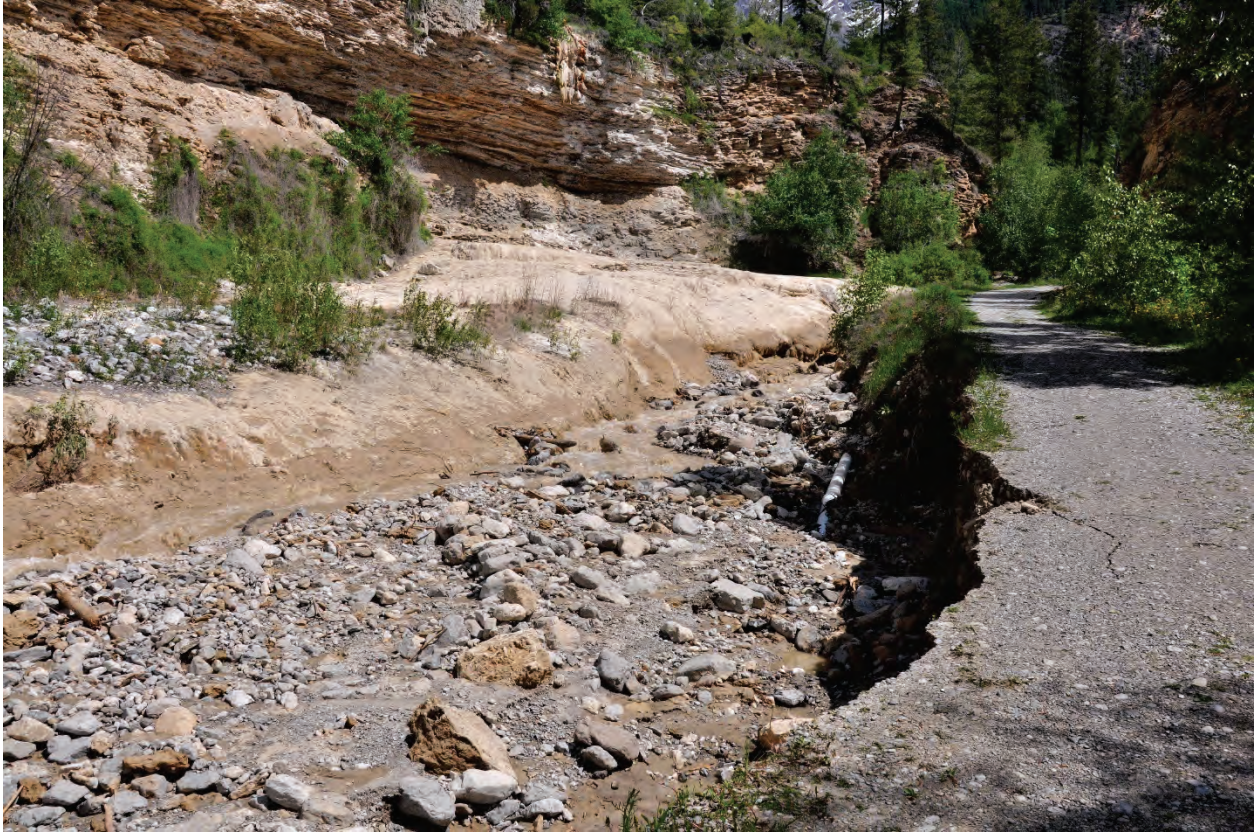
Photo 6.11 Limestone sediment accumulation on right bank (image left) of the creek and eroding bank on left bank of the creek with exposed irrigation water line.
