Fairmont Creek Dike Inspection Report

Water Course 1: Fairmont Creek

GPS Number 52

The Dike was inspected on Friday May 20, 2011.

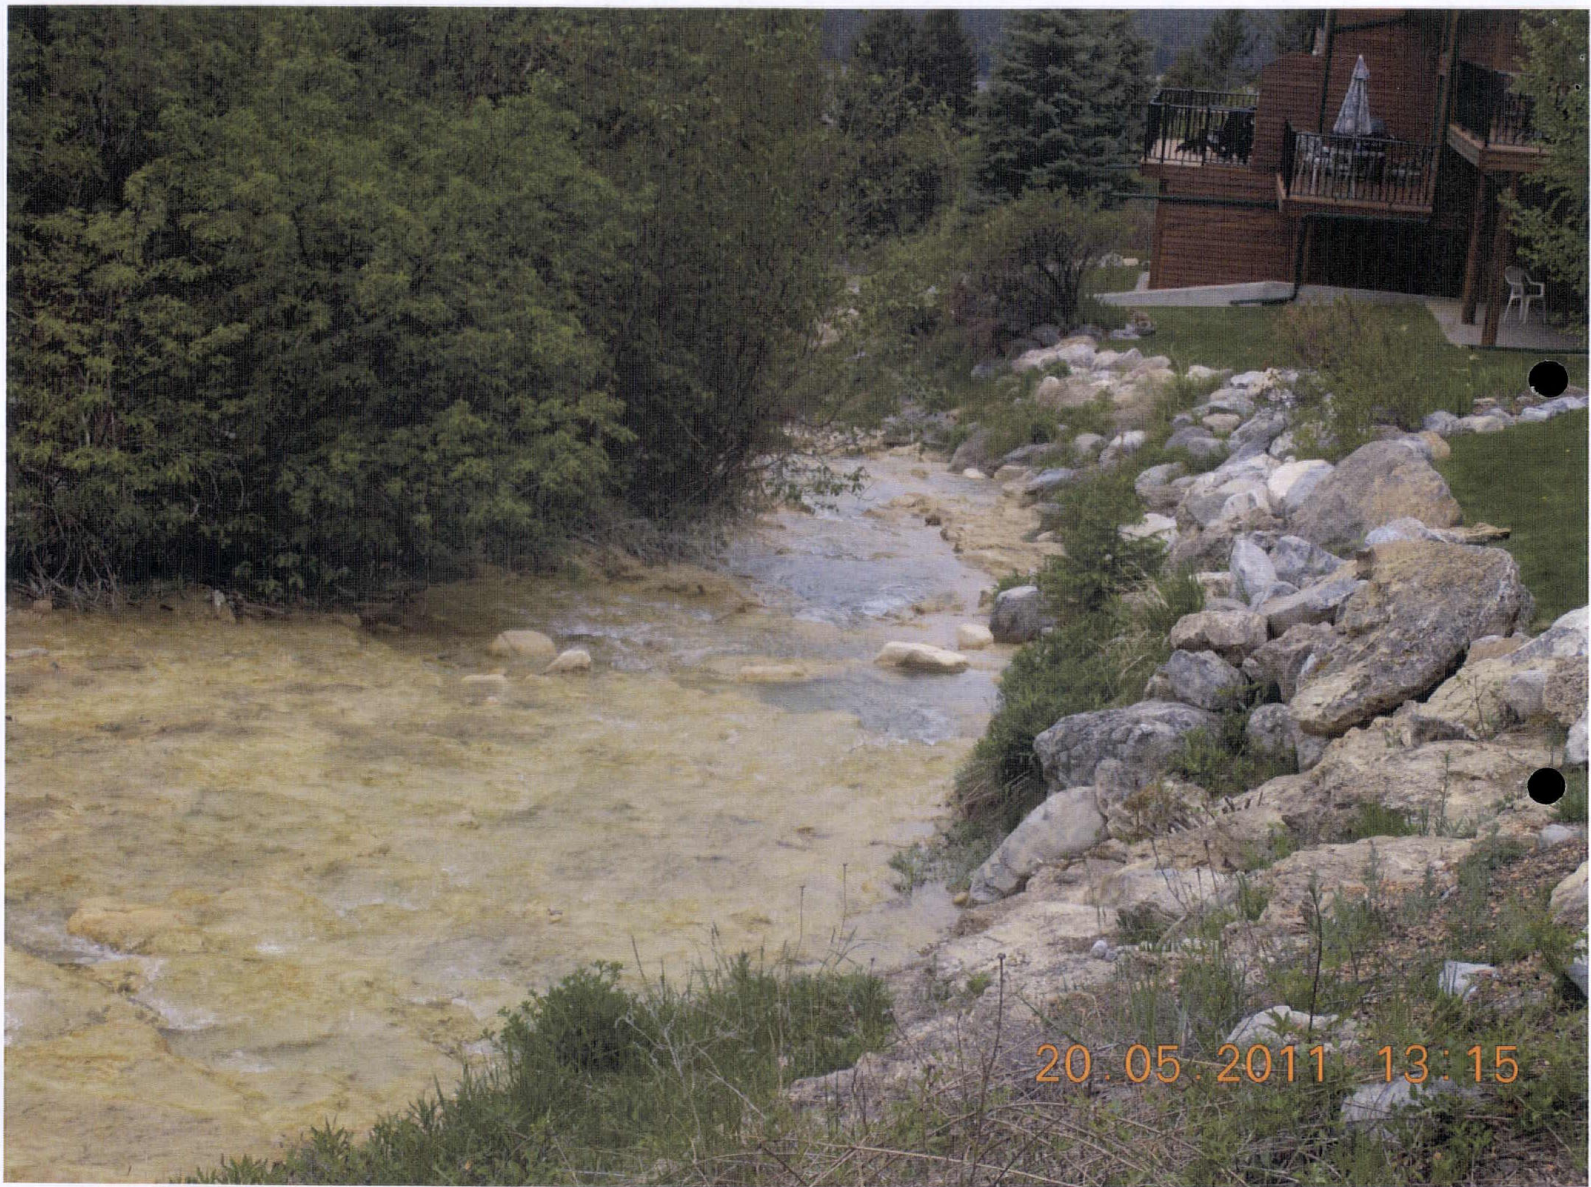
The upstream conditions were normal, normal amounts of debris existed upstream of the dike armoring. (Please see attached photo)
