## Fairmont Creek 2022 Annual Dike Inspection Report

## **Fairmont Creek 2022 Dike Inspections**

The 2022 Fairmont Creek Dike inspection was completed on May 3, 2022 by Acting Water Resources Project Supervisor, Jim Maletta, AScT. on May 3, 2022. Conditions at the time of the inspection were warm, mostly sunny and approximately 24 ° C. Creek flow and water clarity were low and very clear, typical for pre-freshet flow volume and turbidity. The high elevation of the Fairmont Creek drainage still had snow from the mountain peak to above mid elevation levels. The Fairmont Creek Dike inspection will be from highest creek debris trap to the confluence of Fairmont Creek and receiving waters at the Columbia River.

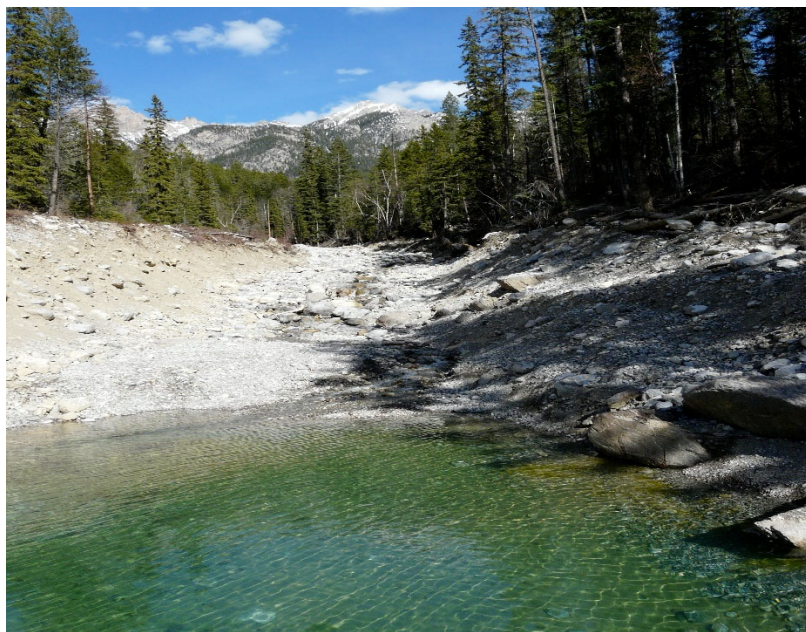
Debris trap 1 was in excellent condition with a minor amount of granular sediment in the very upper section. The upstream and downstream slopes were in excellent condition with a small amount of woody debris present. The visible channel above debris trap 1 is in good condition. Debris trap 1 has almost 100% of design capacity available for debris containment at the time of the inspection. Photos below show debris trap 1 inlet, upstream weir slope and downstream weir slope.

Photo 1a: Debris Trap 1 Inlet of Fairmont Creek May 3, 2022

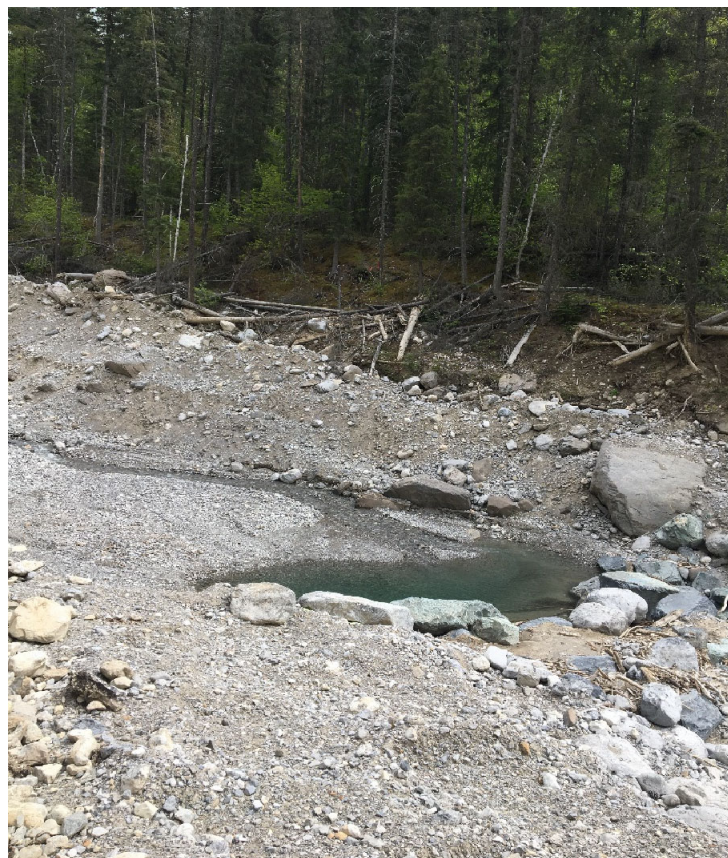
Photo 1b: Debris Trap 1 Inlet May 31, 2022

Photo comparison for sediment deposition between May 3 and May 31, 2022. Snow melt within the Fairmont Creek drainage area is still in process.

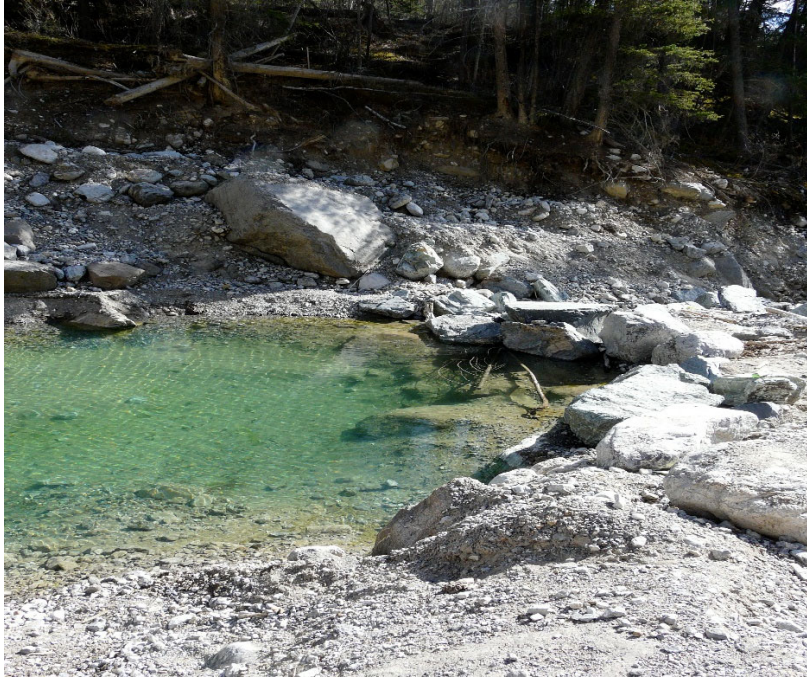
Photo 2: Debris Trap 1 Upstream slope of Weir 1

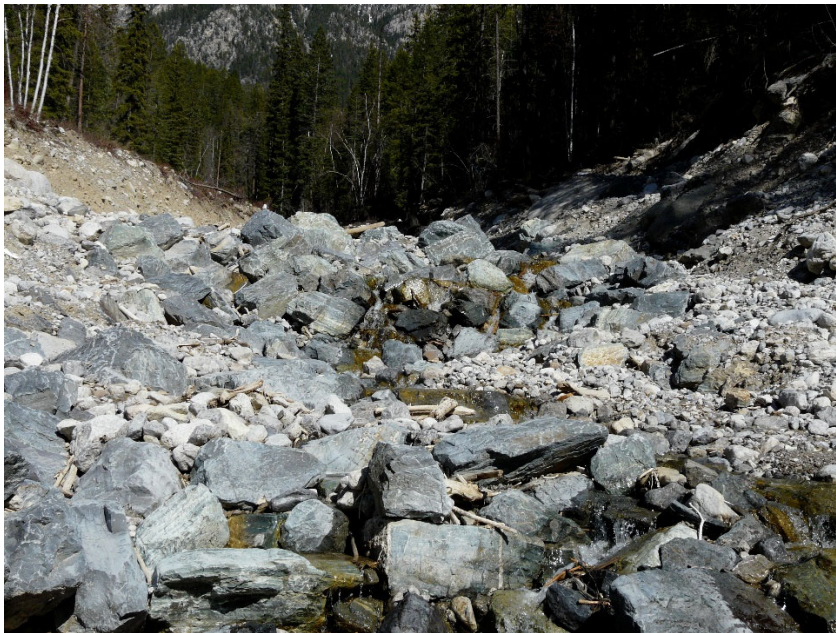
Photo 3: Debris Trap 1, Downstream Slope Looking Upstream

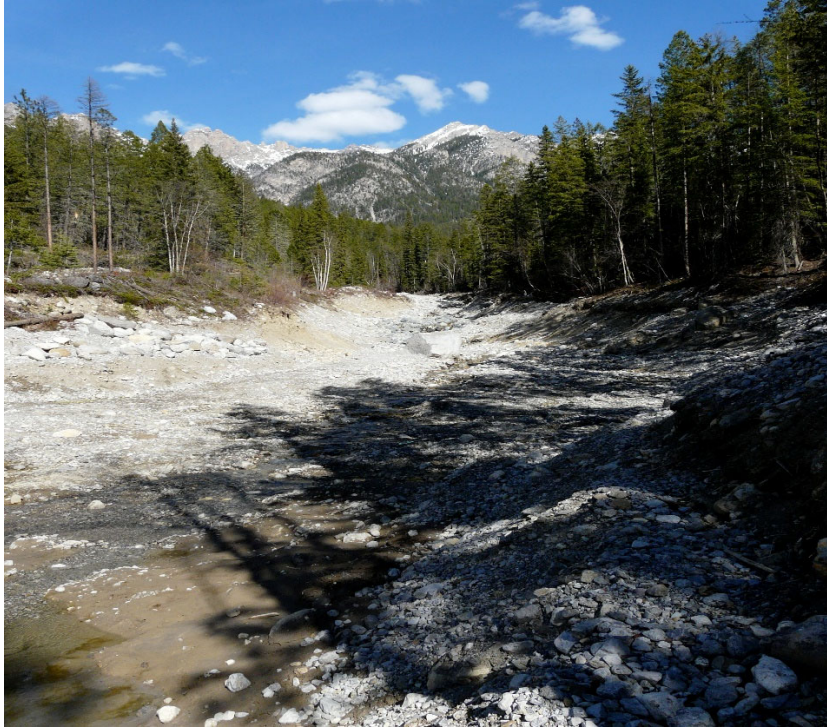
The channel between Debris Trap 1 and Debris Trap 2 is in good condition. Some minor indications of scour exist on the left bank looking downstream, likely from when the creek channel migrated to the left bank.

Photo 4: Channel between Debris Trap 1 and Debris Trap 2

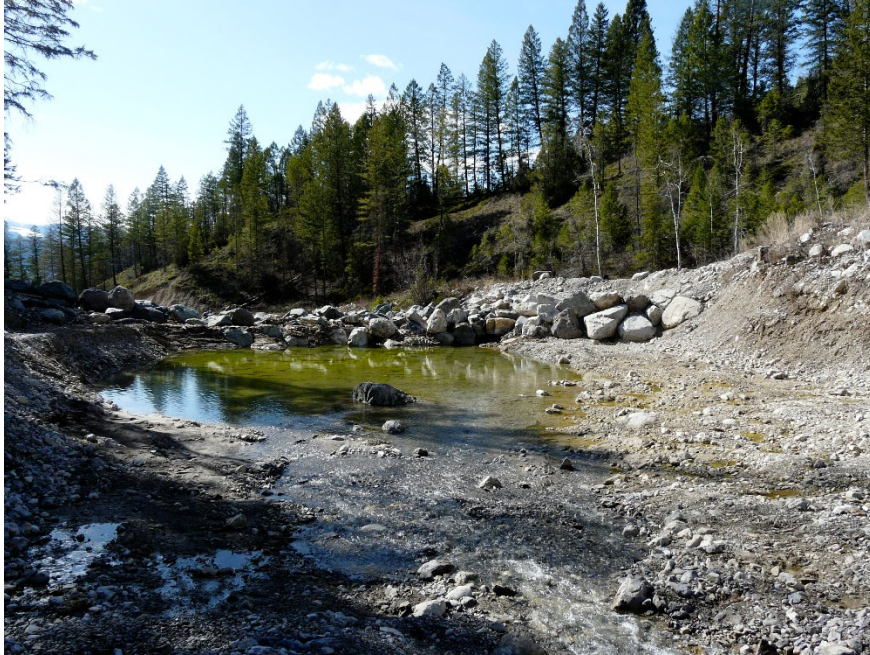
Debris Trap 2 is in good condition. Capacity for transmitted material is essentially 100% as minimal material has entered the Debris Trap 2. The upstream and downstream slopes of the weir are in excellent condition. The downstream slope of the weir has a small to moderate amount of smaller woody debris present.

Photo 5: Debris Trap 2 View from Upper Section & US Slope of Weir

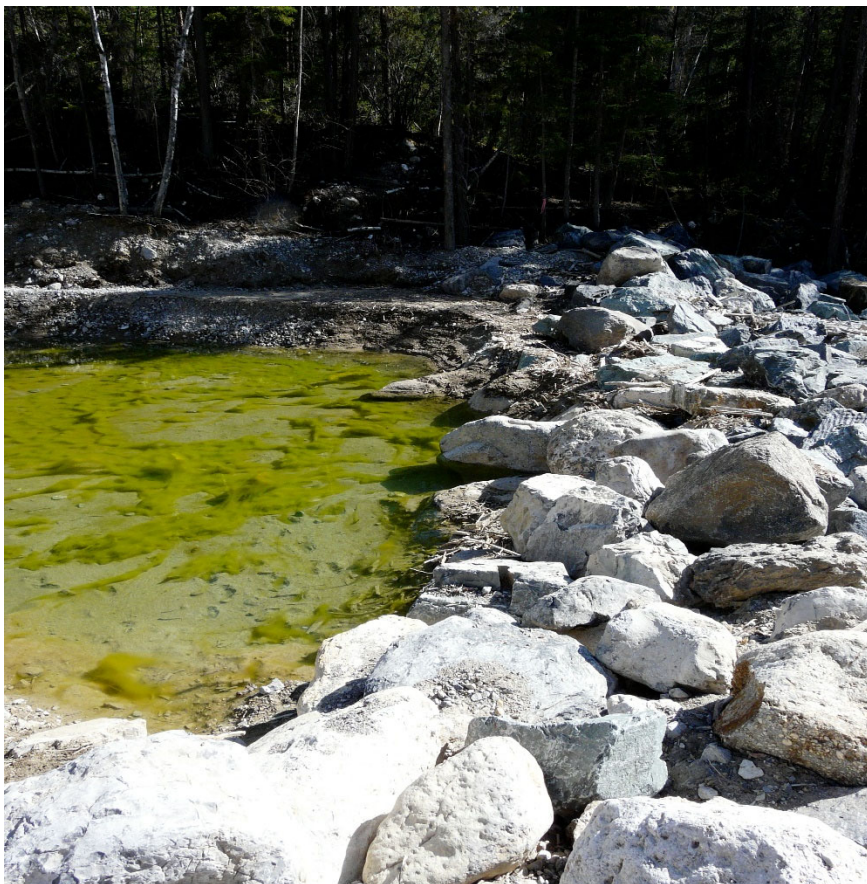
Photo 6: Debris Trap 2 US Slope of Weir

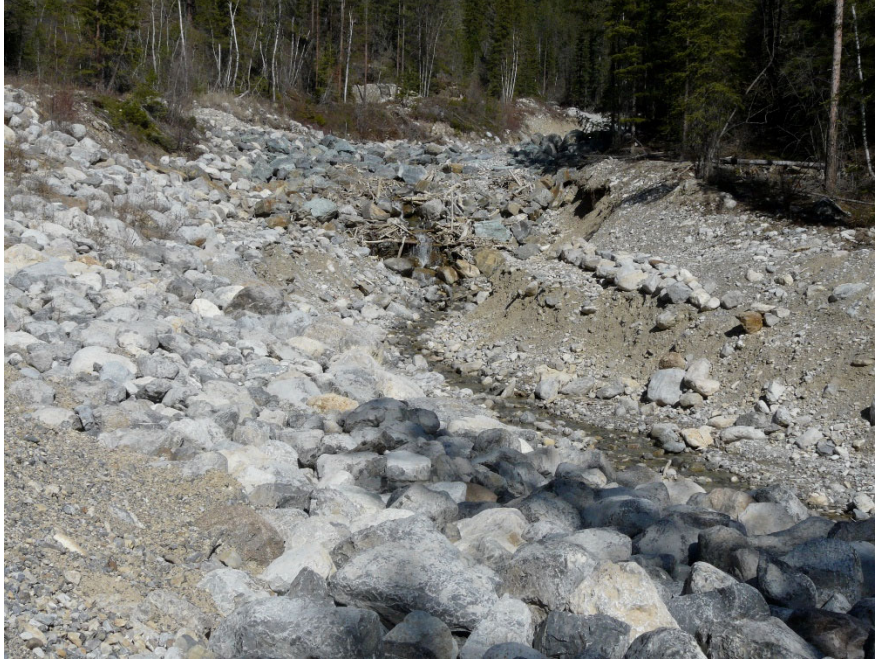
Photo 7: Debris Trap 2 DS Slope

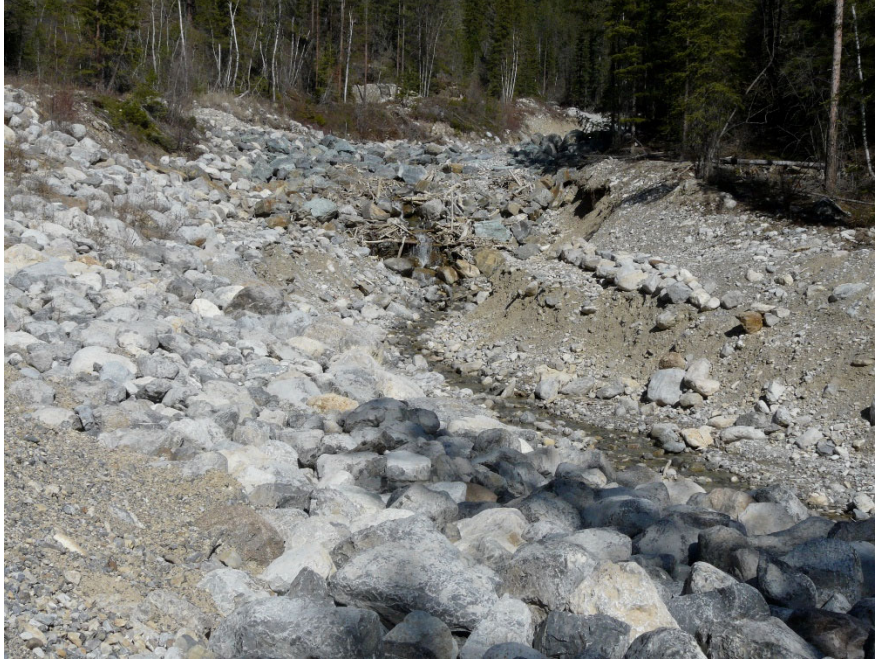
- Significant scour issues along the left bank. High water events could easily mobilize material along left bank and transmit it further down stream.
- Long logs or woody debris is present throughout the narrow long section of channel between debris trap 2 and debris trap 3. Water Stewardship has been advised through a request to buck up the logs into short lengths so they could flush through the Fairmont Creek channel. Water Stewardship should advise if this is water license maintenance, or if a Section 11 application is required

Photo 8: Woody debris on DS Slope of Weir 2, Left bank scour

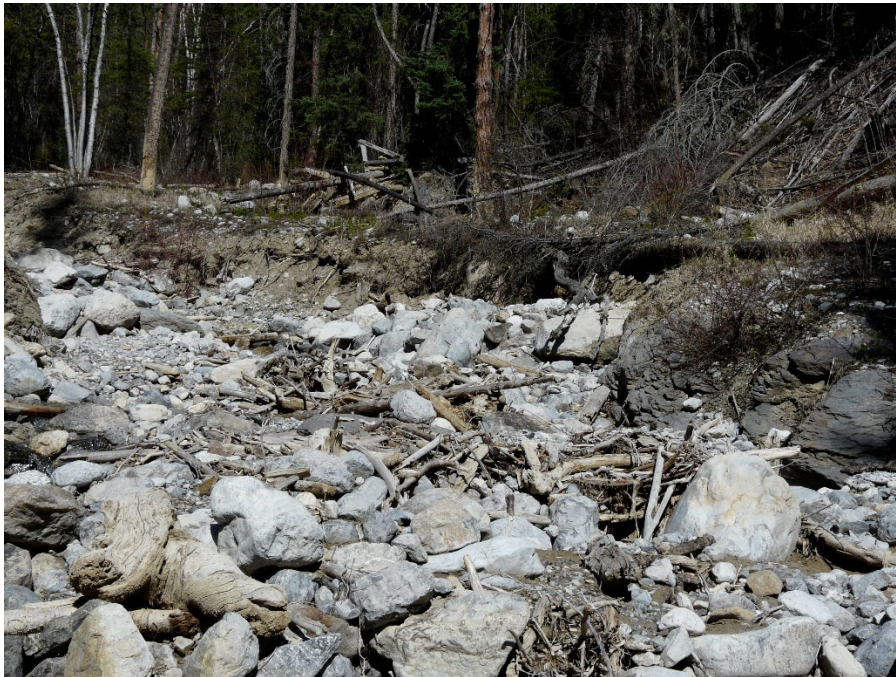
Photo 9: Left Bank Scour and Woody Debris within Fairmont Creek Channel

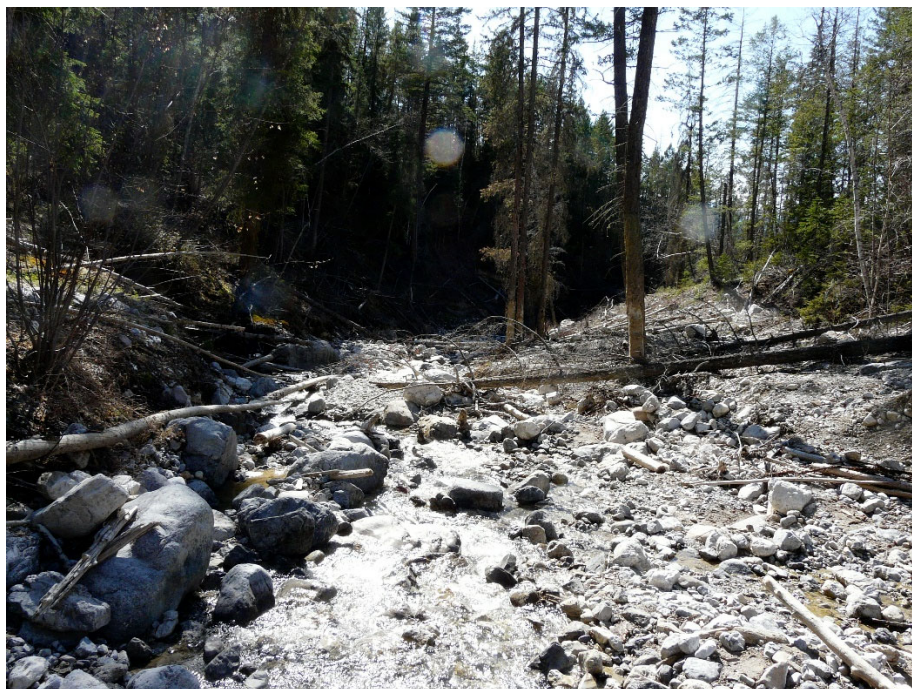
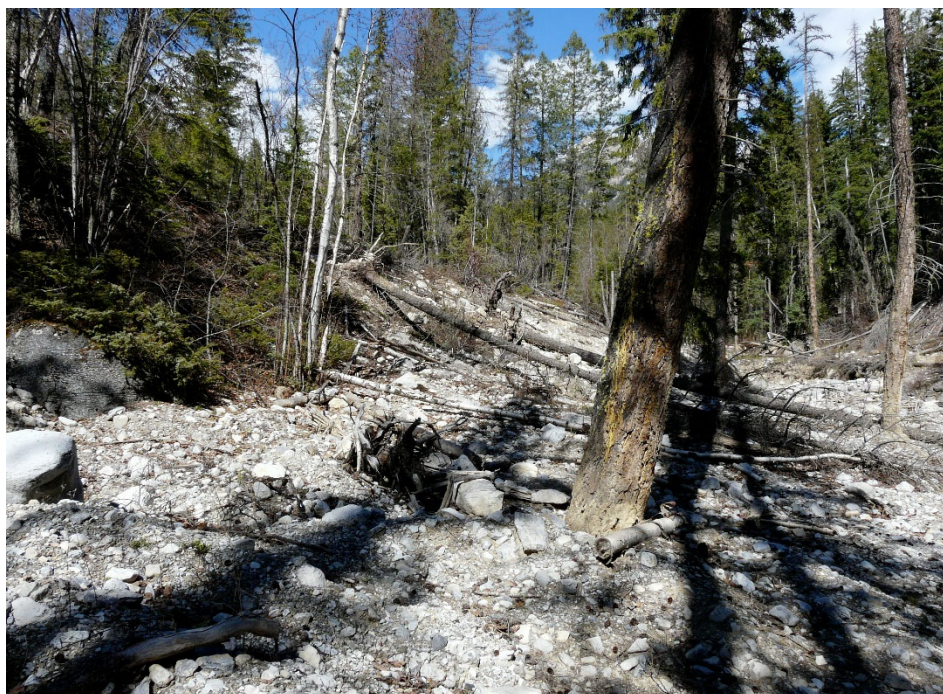
Photo 10a: Logs and Woody Debris within Fairmont Creek Channel

Photo 10b: Logs and Woody Debris within Fairmont Creek Channel

Photos 10a and 10b are both from the section of Fairmont Creek channel between debris trap 2 and debris trap 3. There is a large amount of logs and woody debris in this reach of Fairmont Creek.

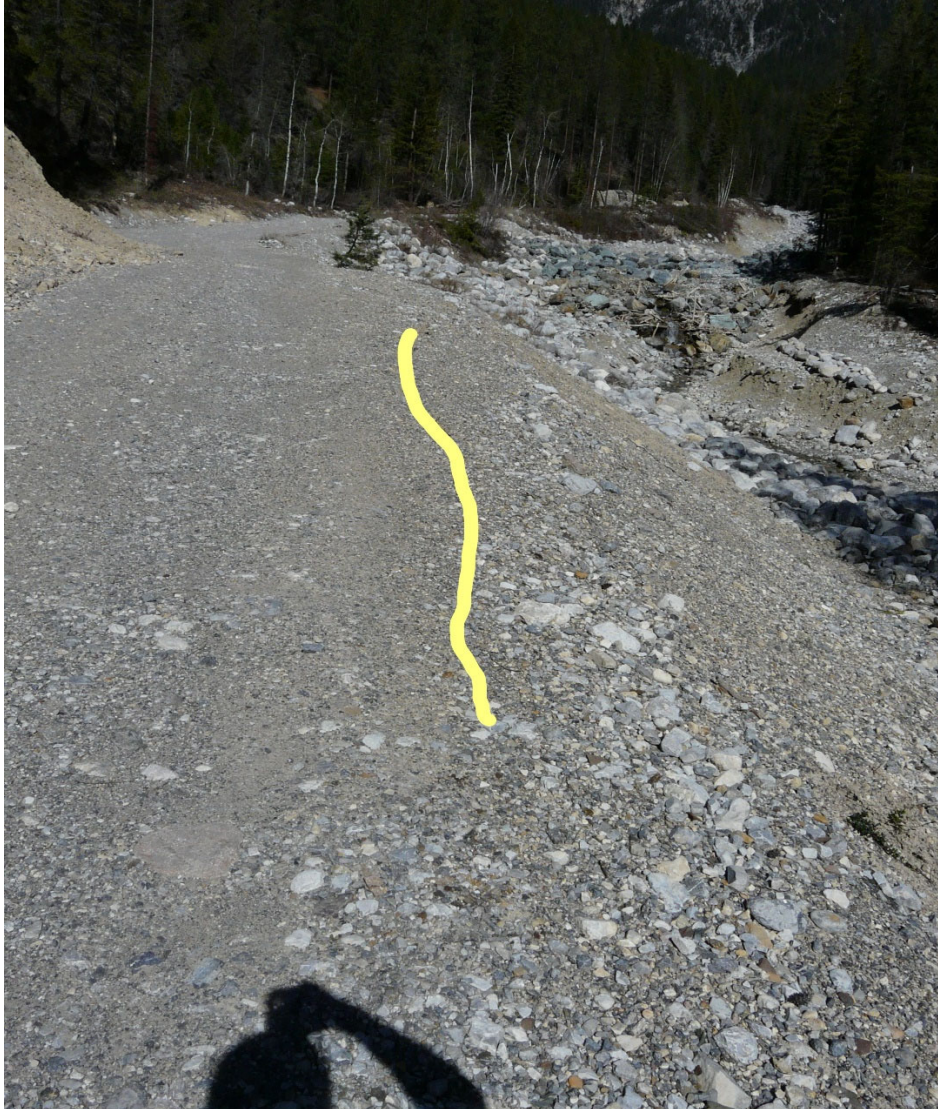
- Haul road tension crack. The haul Road just downhill of trap 2 entry road has a tension crack in it. The crack has increased in size since late July 2021. This may not currently be an issue but intense rain events prior to the next use could impact the integrity of the road. For safety reasons any contractor, consultant, or inspector using the debris trap haul road should know about the issue before driving the haul road.

Photo 11: Tension Crack on Fairmont Creek Debris Trap Access Road

The tension crack is located just above the wooded bank with pull out parking area as the road enters a fill section. The tension crack is near the road edge and should be inspected regularly. The crack should be inspected before driving along that section of haul road and definitely before any heavy equipment accesses the site and hauls material along the road.

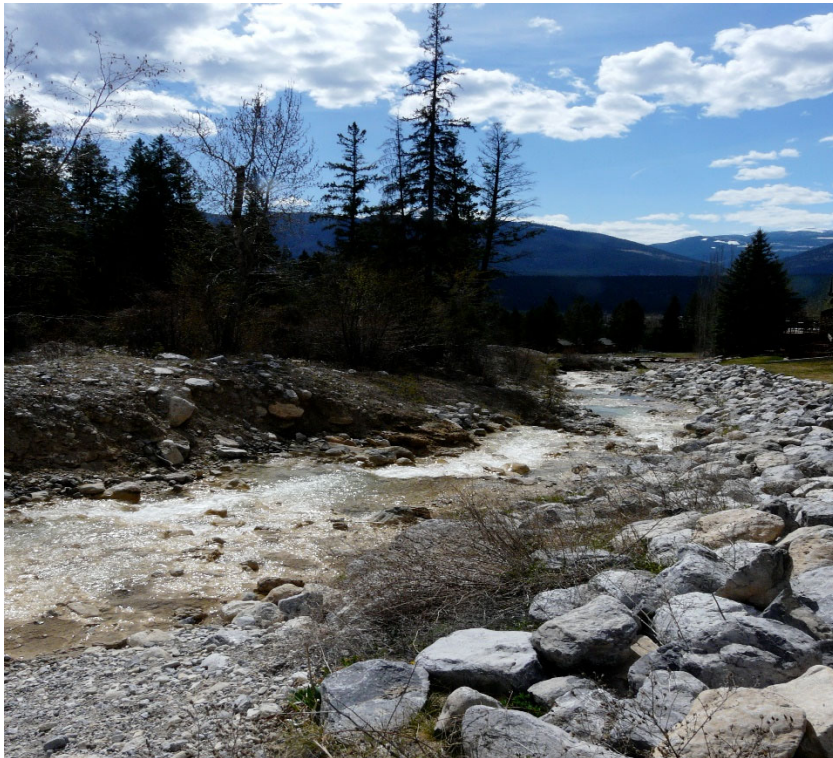
Photo 12: Marble Canyon Works

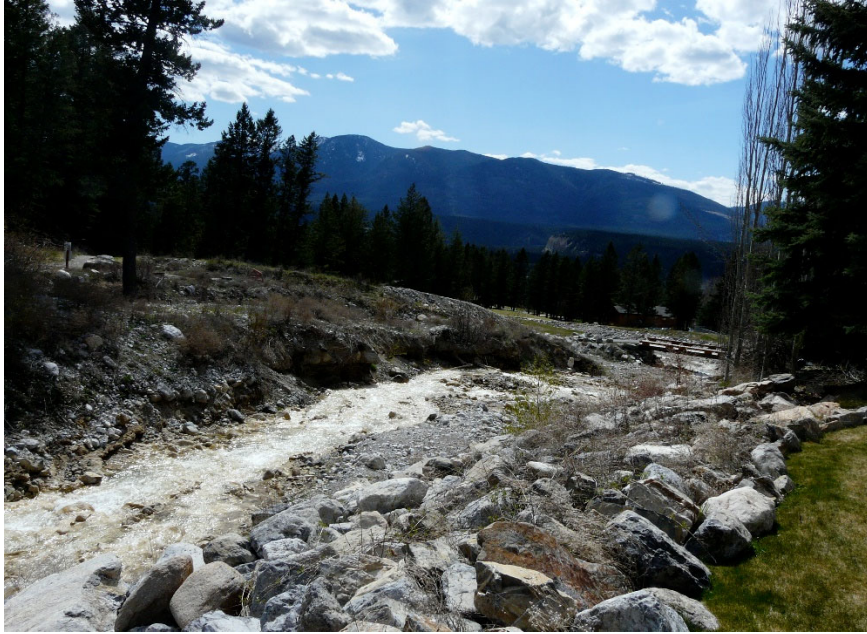
The bank protection works in the Marble Canyon section of Fairmont Creek are in good condition. Some small amount of brush exists in a couple of locations but has no impact on the function of the revetment. Along the unprotected left bank of the creek in the lower portion of the Marble Canyon works bank scour is occurring. This does not affect the works, however, the scoured material would likely end up in the Hole 12 pond as sediment deposition from high water events.

Photo 12: Left Bank Scour Locations Along Lower Area of Marble Canyon Section

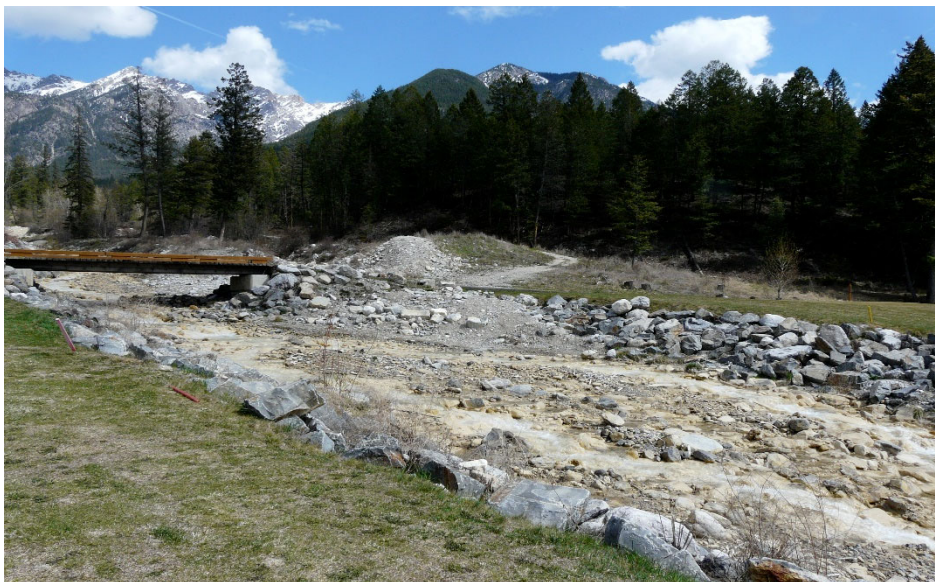
Fairmont Creek works between Marble Canyon and hole 12 debris trap/golf course pond is in very good condition. The tufa layer has re-established within the creek channel. Two small areas have reduced bank protection, possibly from clean up efforts. The upper location is on the left side just below the hole 16 golf cart bridge (possible equipment access point) and the lower bank exposure is on the right side just at the creek bend above the pond. Neither location is a current concern.

Photo 13: Left Bank Exposed Area Below Hole 16 Bridge. Possible equipment entry point

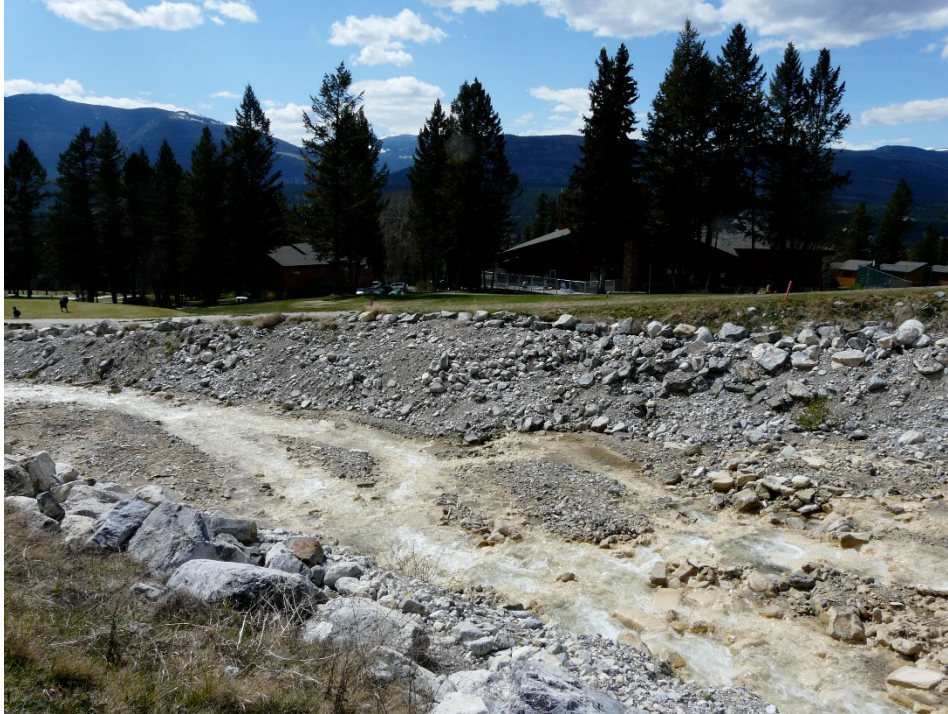
Photo 14: Exposed Bank Protection at Bend on Fairmont Creek Above Hole 12 Debris Trap

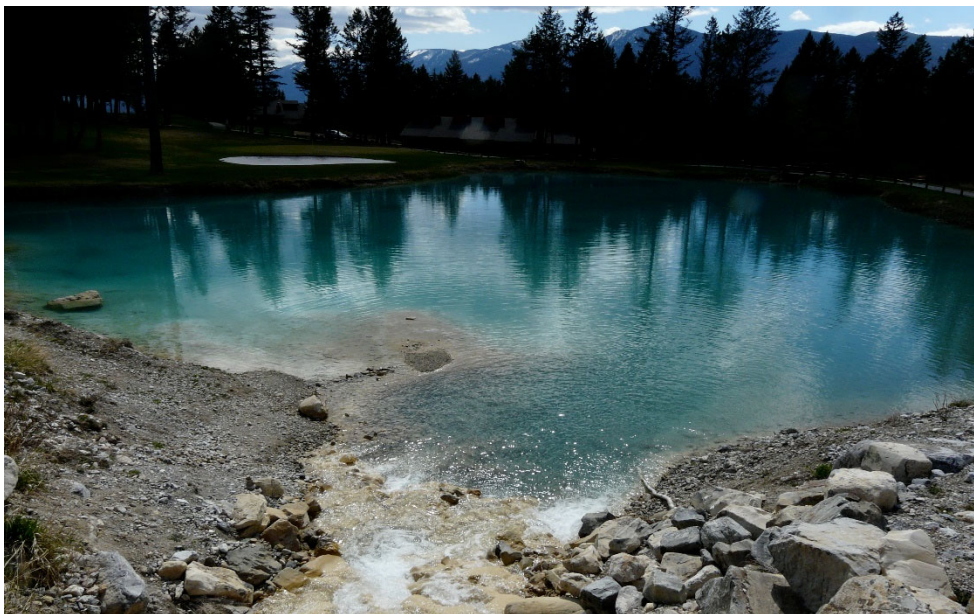
The hole 12 debris trap/golf course pond is generally in very good condition with some silt/sediment build up on the left side beginning at the inlet and heading downstream. FHSR and the RDEK have discussed removal of the silt sediment in the fall of 2022.

Photo 15a: Hole 12 Pond Inlet with Sediment Build Up (May 3, 2022)

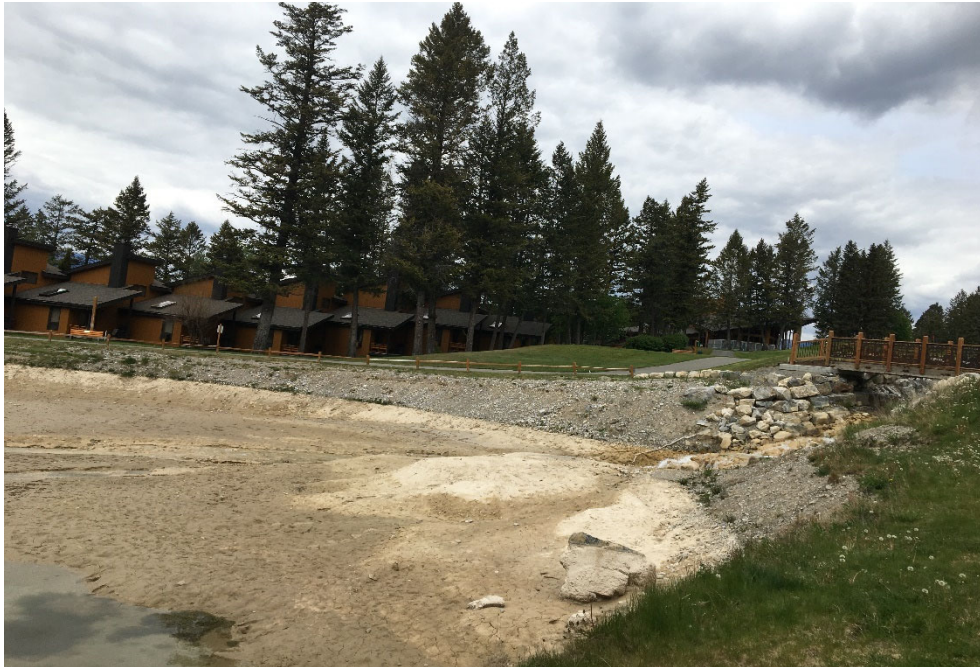
Photo 15b: Hole 12 Pond With Underflow Discharge in Effect. Sediment Build Up Very Evident on Left Side of Pond Inlet

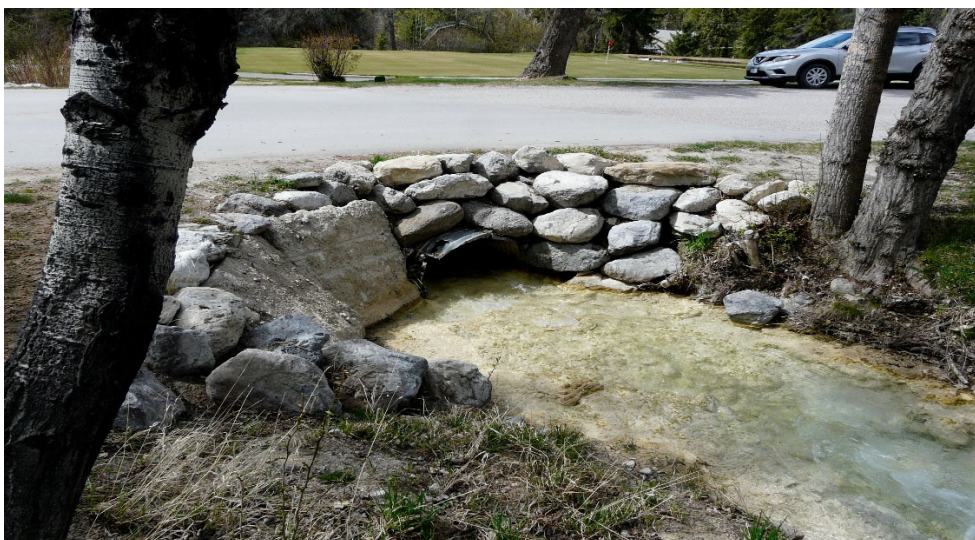
The channel from the discharge at hole 12 debris trap/golf course pond to the Columbia River is generally in good condition apart from 2 culverts on FHSR Villas and golf course and 2 culverts on public roadways. The culverts have partially infilled, and a tufa layer has built up over the sediment within the culverts. The infilling has reduced transmittance capacity of the culverts. FHSR and MoTI has been made aware of the current condition of the culverts impacted by infilling.

Photo 16: First Culvert DS of Hole 12 Debris Trap/Pond Outlet, Inlet Obstruction Present FHSR Culvert

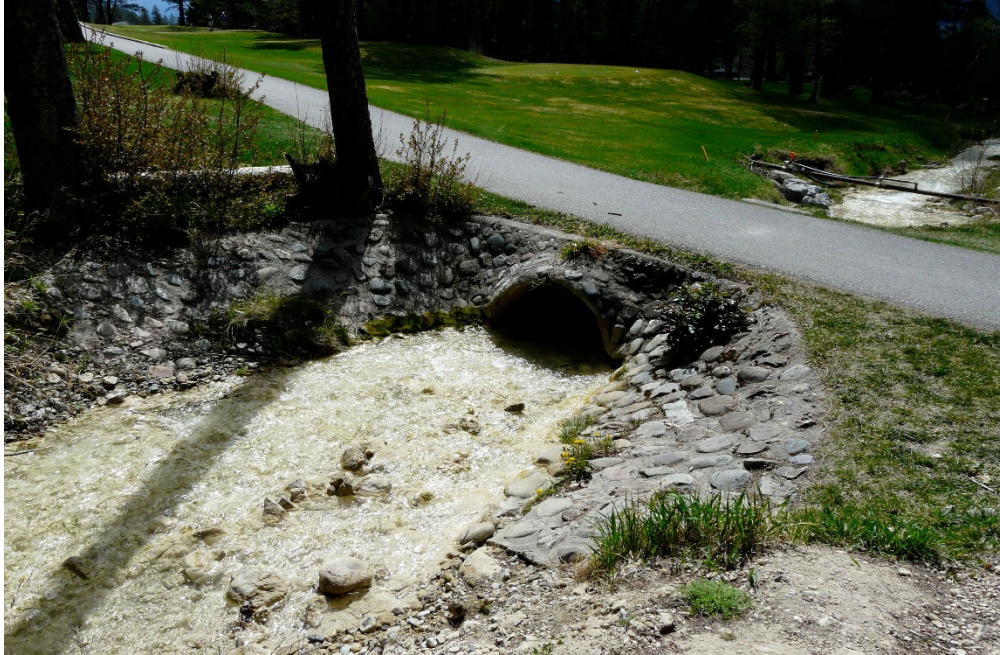
Photo 17: Second Culvert Downstream of Hole 12 Debris Trap/Pond, Inlet Obstruction Present FHSR Culvert

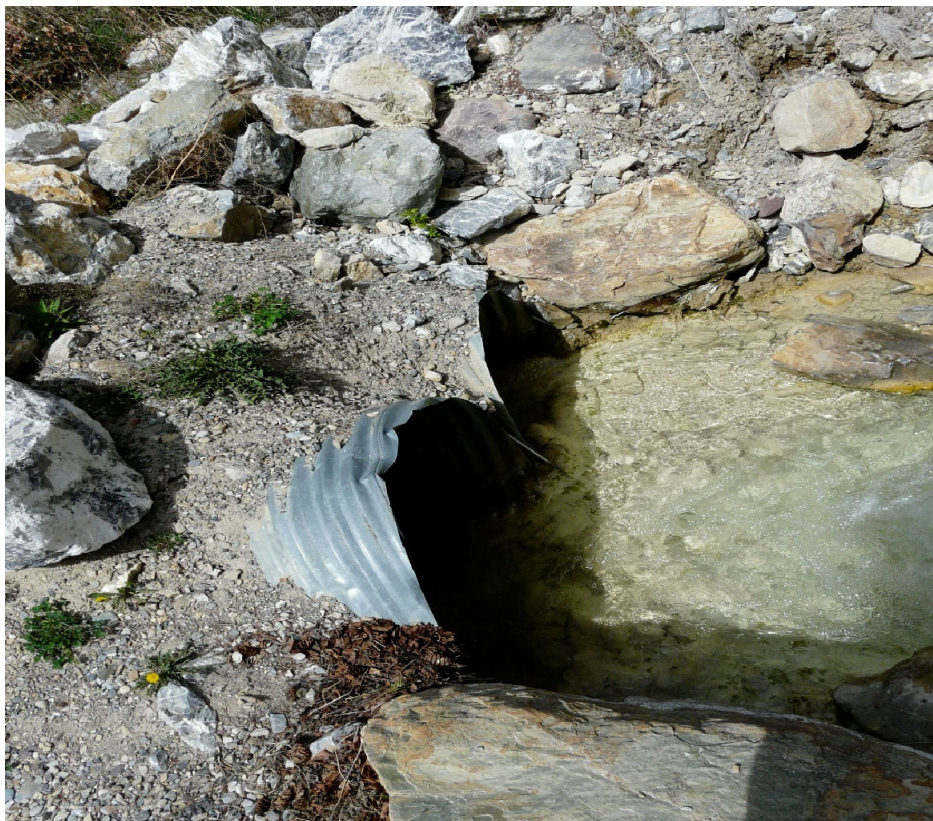
Photo 18: MoTI Culvert Infilling

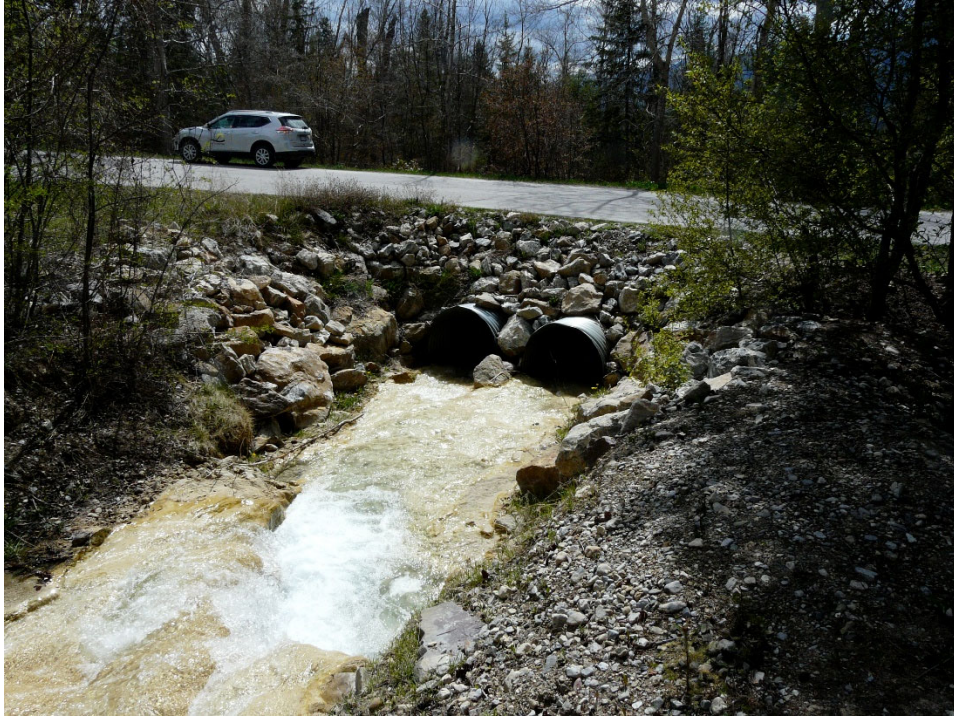
Photo 18: MoTI Culvert Infilling, Last Culvert Along Fairmont Creek Before the Columbia River
