2012 Fairmont Creek Inspection Report

Water Course 2: Fairmont Creek

GPS Number 52

The dike was inspected on Friday May 11, 2012

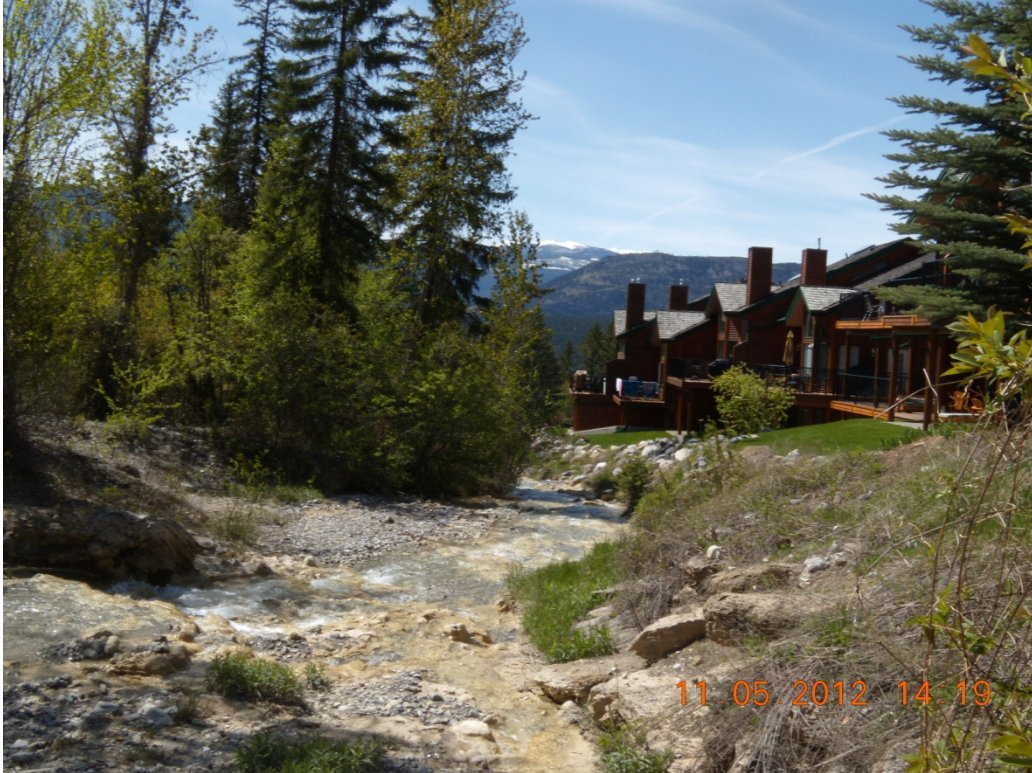
Fairmont Creek Flow above Armoured Works

The upstream conditions for Fairmont Creek were normal, limited debris existed within the creek channel.

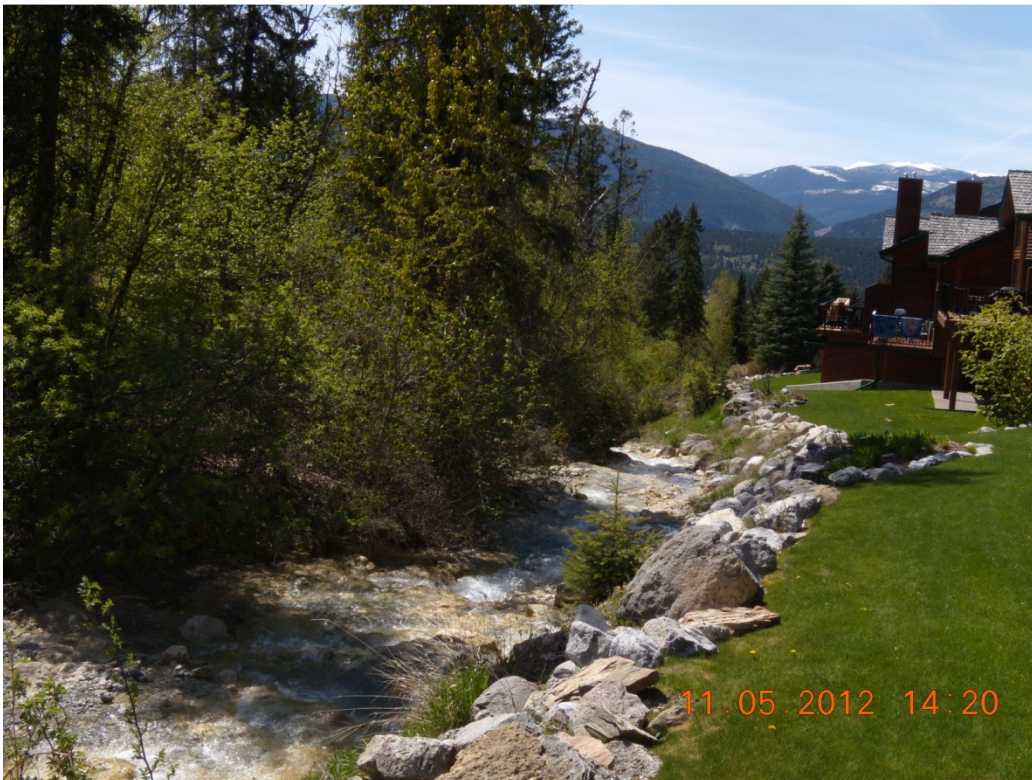
Top Section of Armouring

The dike armouring is in good condition with no signs of erosion or high water over the past 12 months. The flow through the channel is similar to last year. Some vegetation is present in the armouring of the dike and removal of the brush is scheduled for the fall of 2012. The brushing was originally scheduled to be removed in the fall of 2011, but due to RDEK personnel availability the vegetation removal was postponed to 2012. (please see attached photos)

Removal of vegetation from the dike armouring is scheduled for the fall of 2012.
