Re: Fairmont Hot Springs Resort Area,
Flood Protection Works Inspection

RE: Flood Protection Works Inspection – Fairmont Creek

RE: Flood Protection Works Inspection – Coldspring Creek Downstream of Highway 93

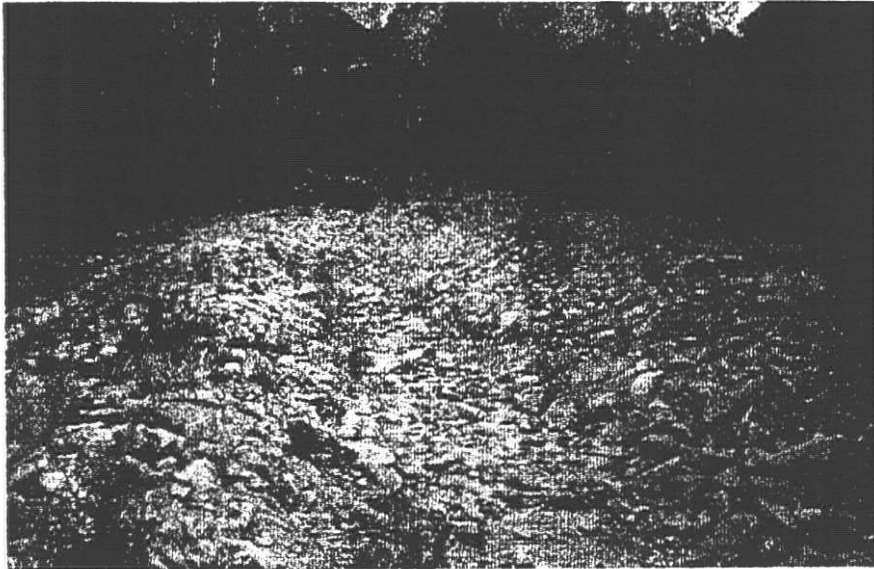
The channel appears to be stable functioning as it was designed. Along portions of the channel, there has been a placement of soil on the rip rap of the south bank. This soil and resulting grasses will not decrease the functionality of the channel. The condition of the channel can be seen in **Photo 1** and **Photo 2**.

Photo 1, Coldspring Creek downstream of Highway 93

At this time we recommend only continued monitoring of this system which includes Coldspring Creek downstream of Highway 93 and the debris trap adjacent to the Columbia River.

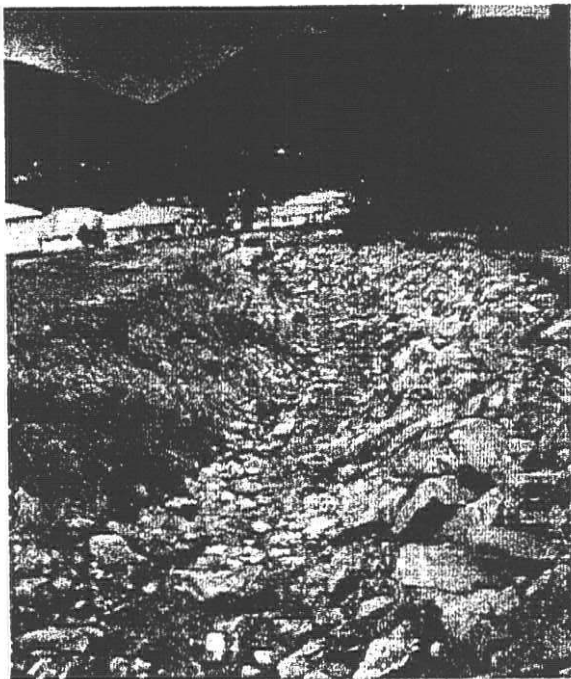
Photo 2, Coldspring Creek at Riverside Golf Course

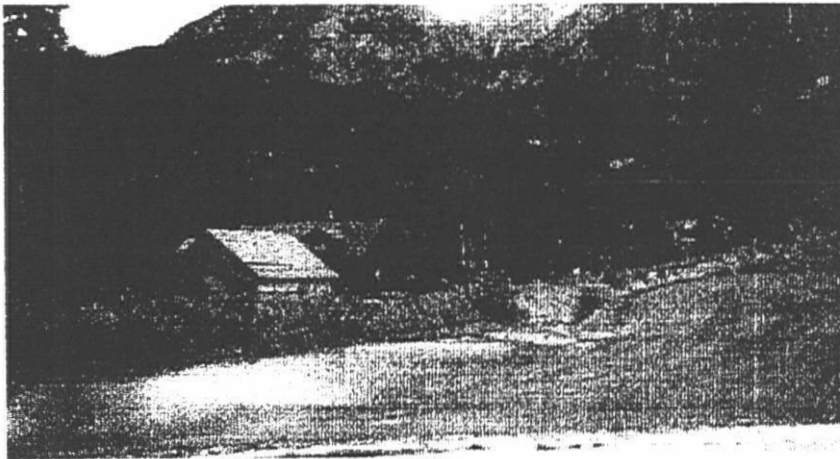
The debris trap adjacent to the Columbia River is almost free of sediment and debris accumulation. **Photo 3** shows the general condition of this facility.

Photo 3, Coldspring Creek Debris Trap
