Cold Spring Creek 2019 Annual Dike Inspection Report

May 8, 2019 Cold Spring Creek Dike Inspection

August 21, 2019 Cold Spring Creek Dike Inspection

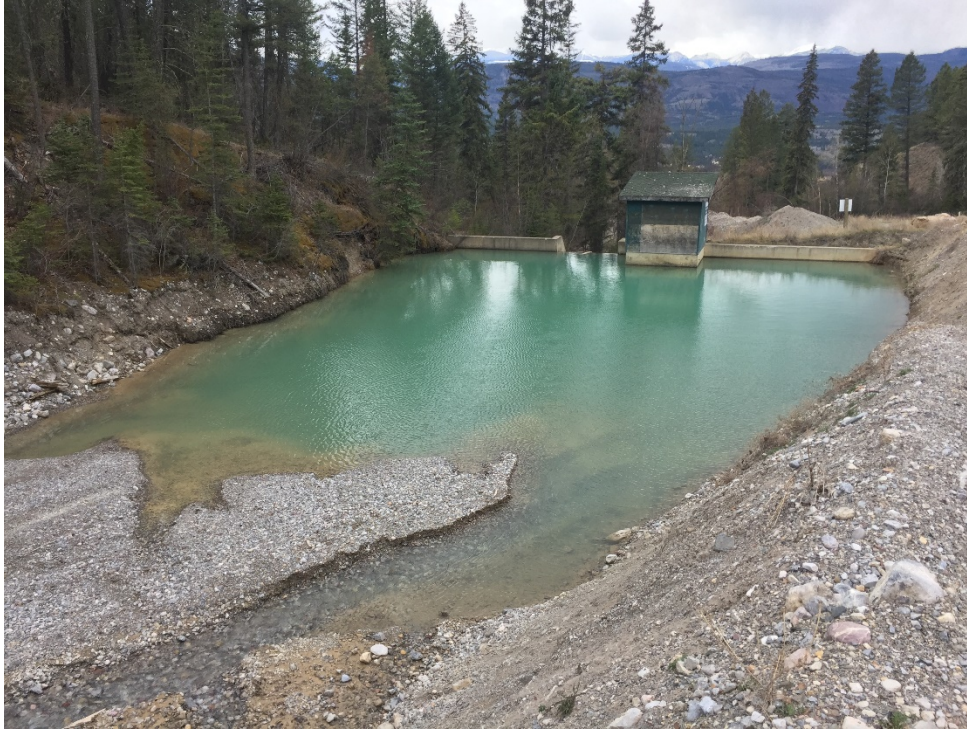
The Cold Spring Creek Dam Reservoir is in good condition. The dam is owned and operated by the Fairmont Hot Springs Resort. A small amount of material was removed from the reservoir in late 2015/early 2016 by the contractor that was working just upstream of the dam. The dam was cleaned out again in May 2017 after a small debris flow event that completely filled the reservoir with debris flow material.

Photo 1: Cold Spring Creek Dam Reservoir, May 1, 2019.

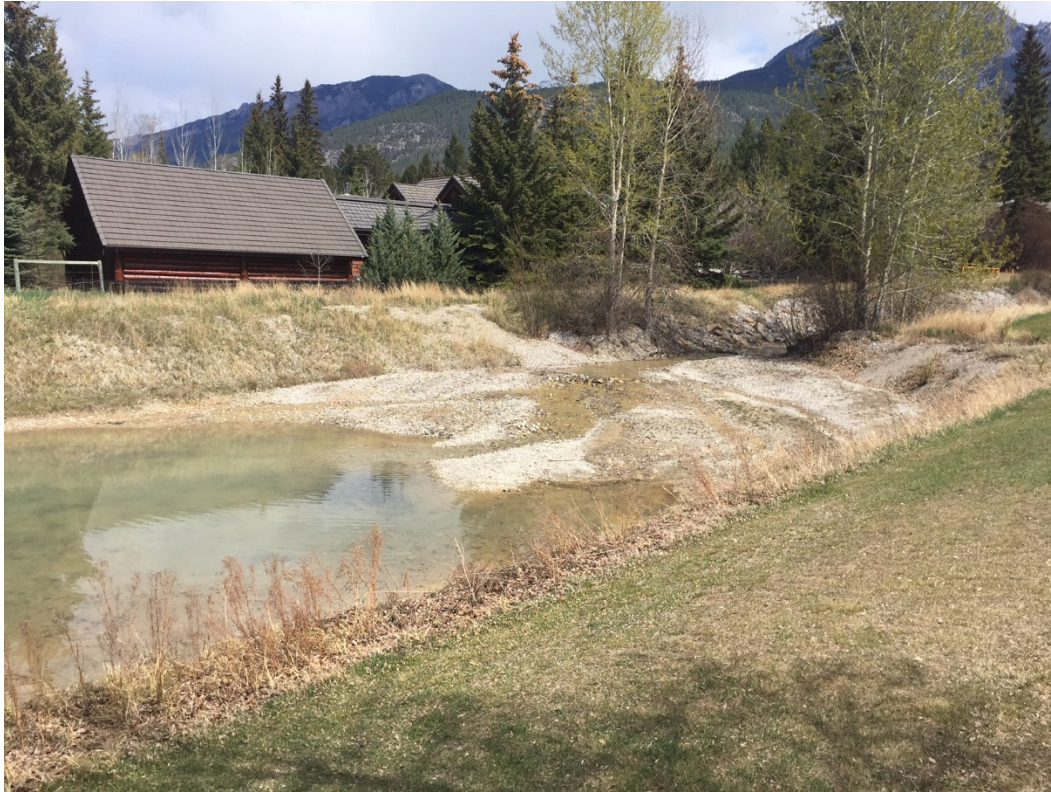
Photo 2: The inlet to the lower debris pond, May 8, 2019.

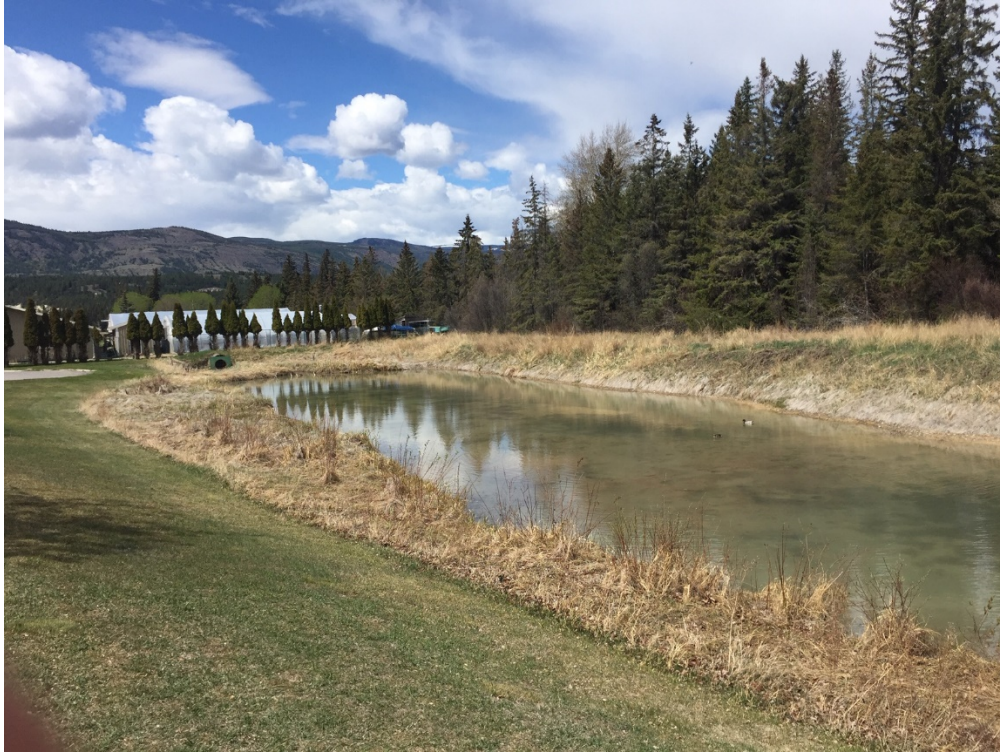
Photo 3: The lower half of the debris pond, May 8, 2019.

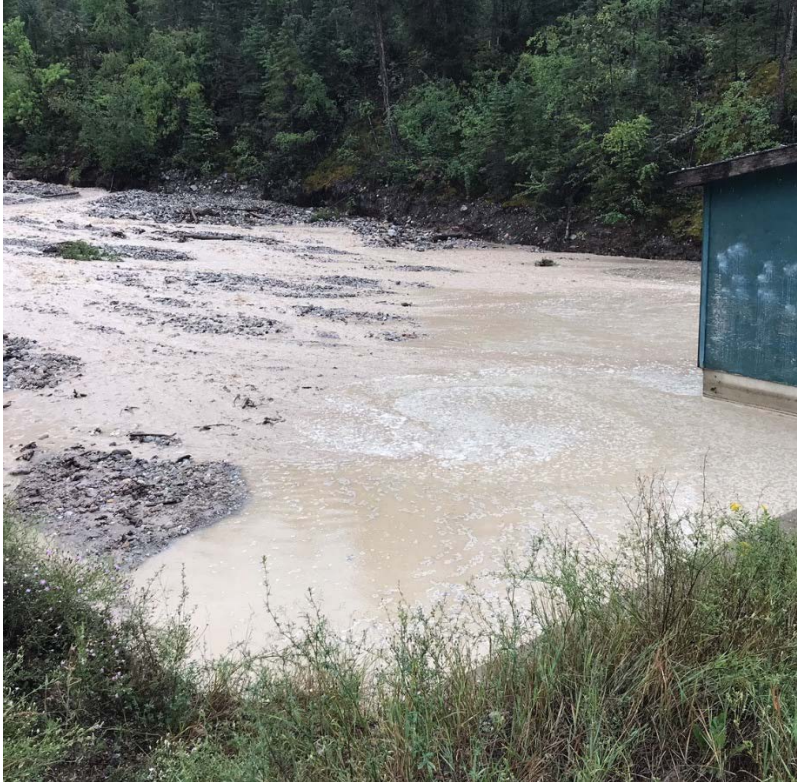
Photo 4: Cold Spring Creek Dam reservoir immediately after the August 12, 2019 event.

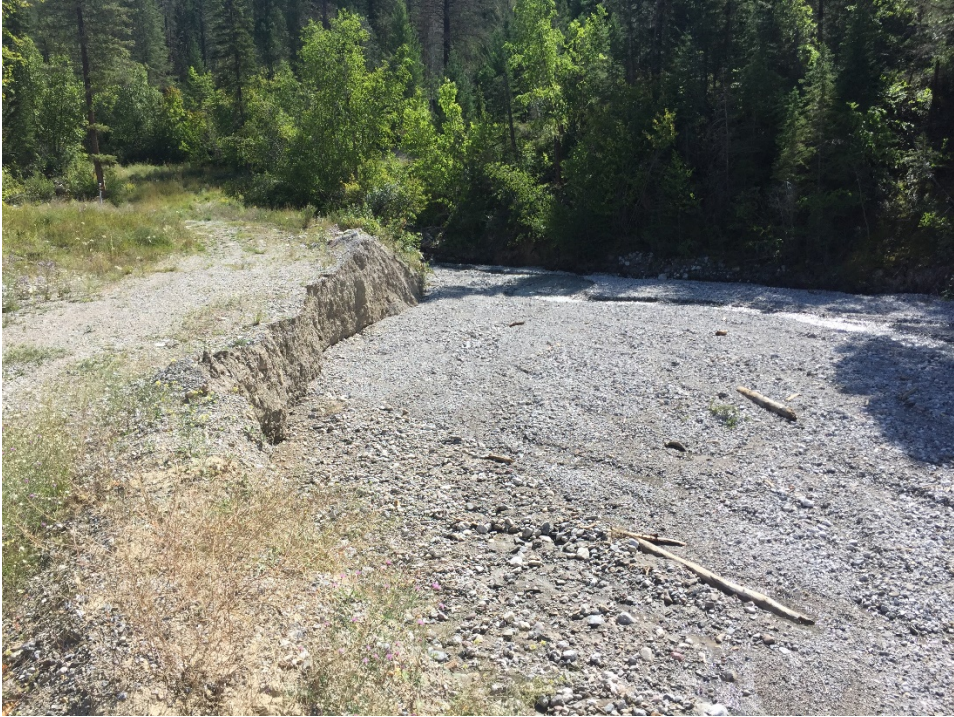
Photo 5: Cold Spring Creek Dam reservoir on August 21, 2019.

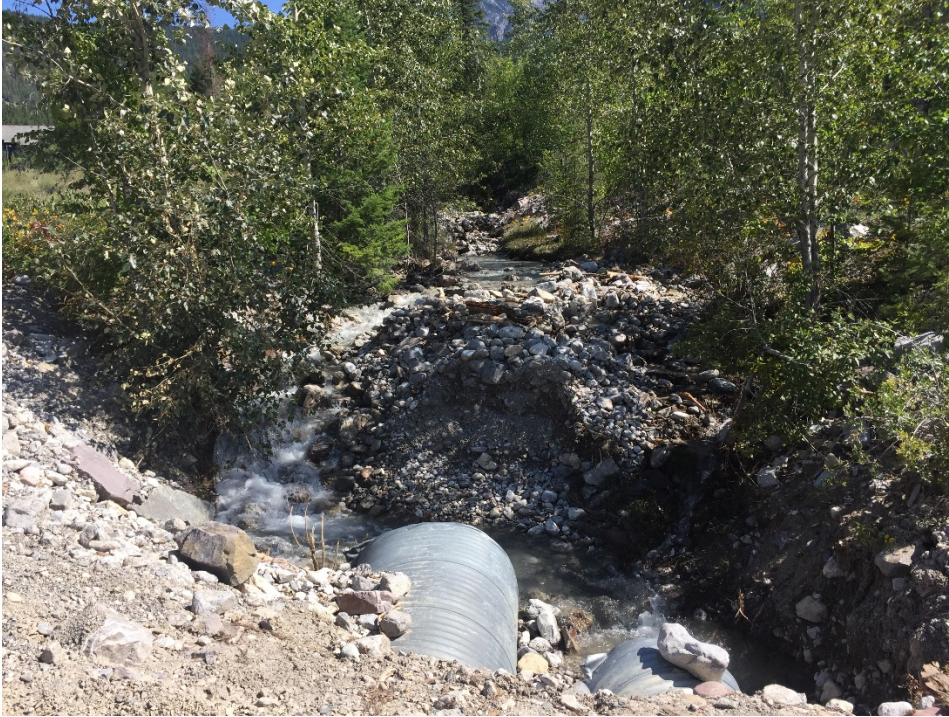
Photo 6: Culvert at the crossing of Fairway Dr looking upstream. The culvert was plugged and debris was removed as an emergency measure to restore flow.

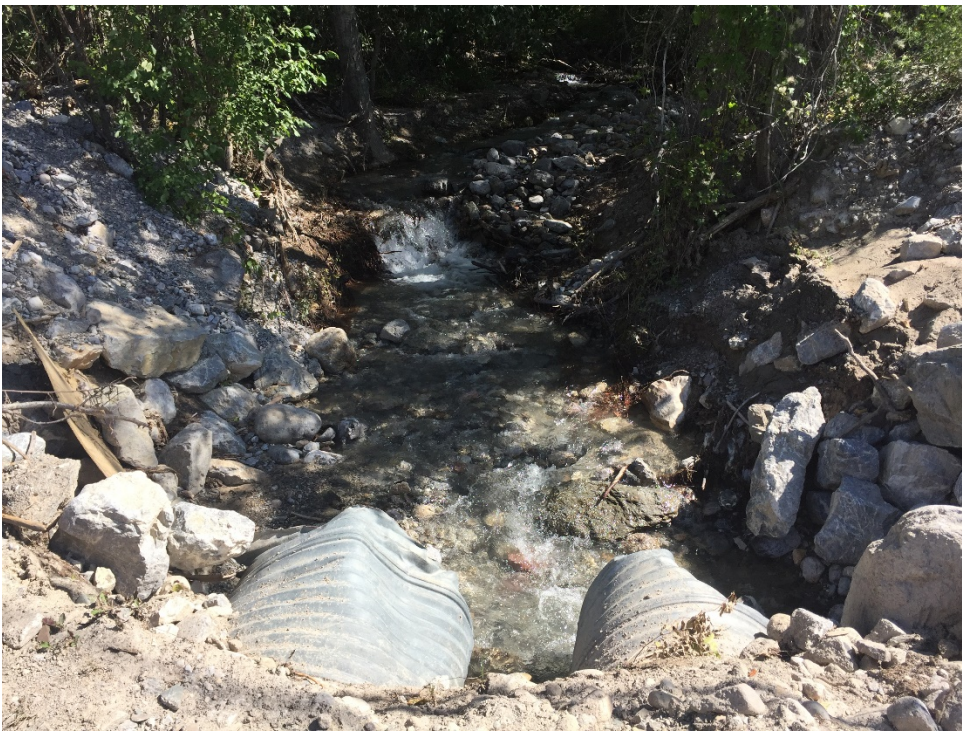
Photo 7: Culvert at the crossing of Hot Springs Road looking upstream. The culverts were plugged and debris was removed as an emergency measure to restore flow.

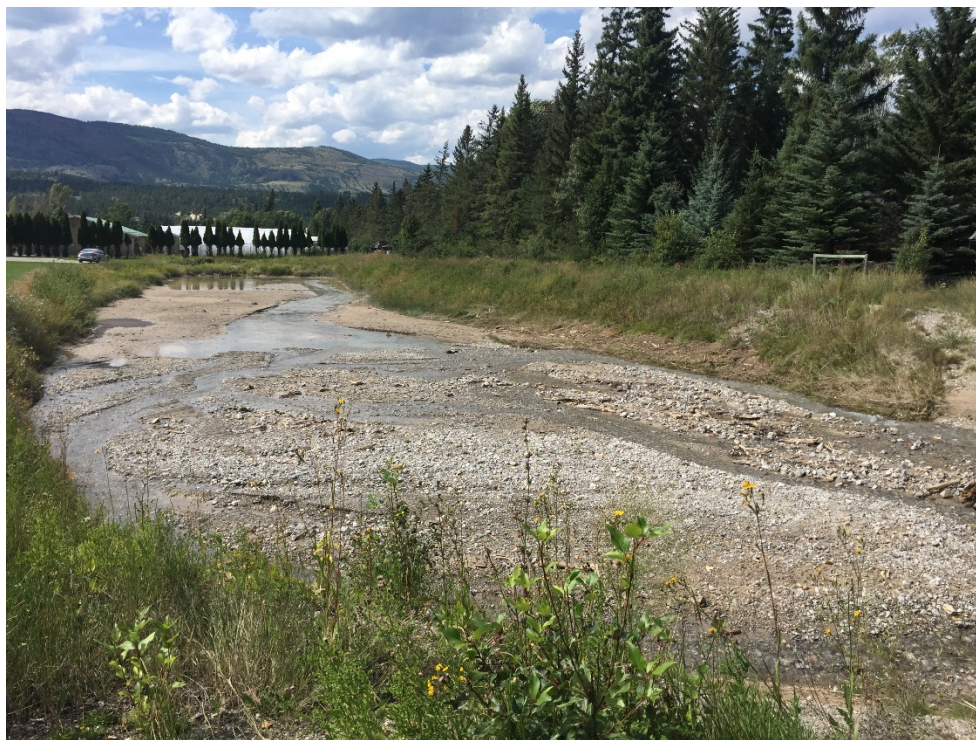
Photo 8: Cold Spring Creek lower debris trap.

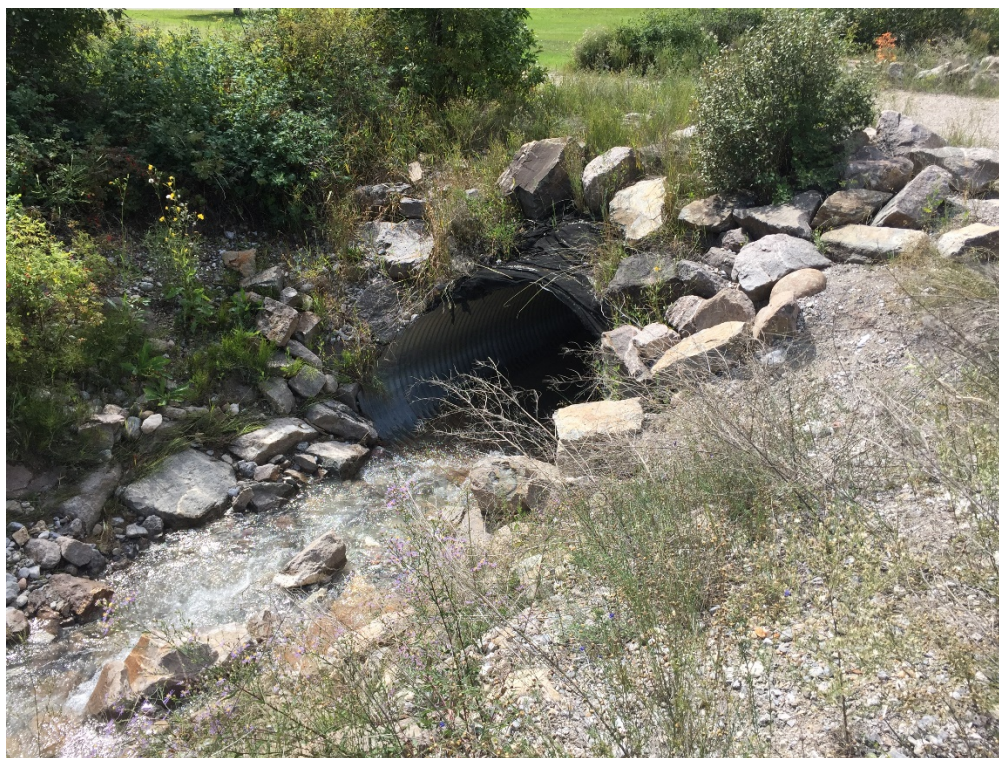
The last culvert along Cold Spring Creek before the lower debris trap is experiencing some very minor underflow piping. The situation is being monitored. The same culvert was approximately 30% filled with gravels and was cleaned out in August 2016.

Photo 9: Culvert just upstream of the lower debris trap. The culvert is in good condition with very minor piping that is being monitored.

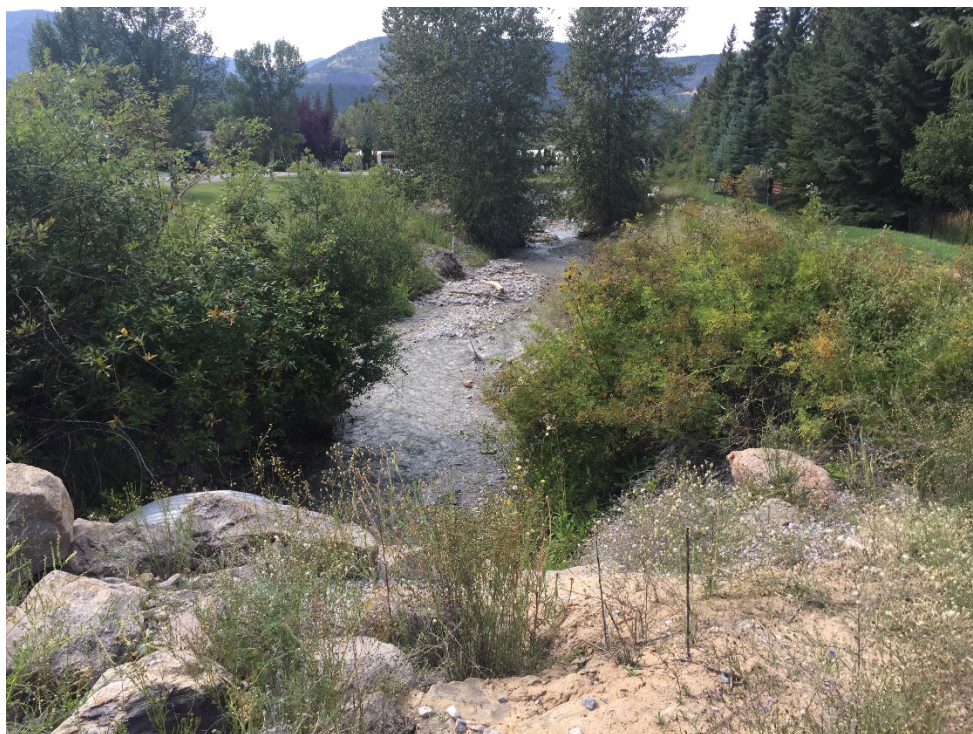
Photo 10: Facing downstream from the culvert in Photo 9 towards the lower debris trap. Very minor gravel deposition in the channel.

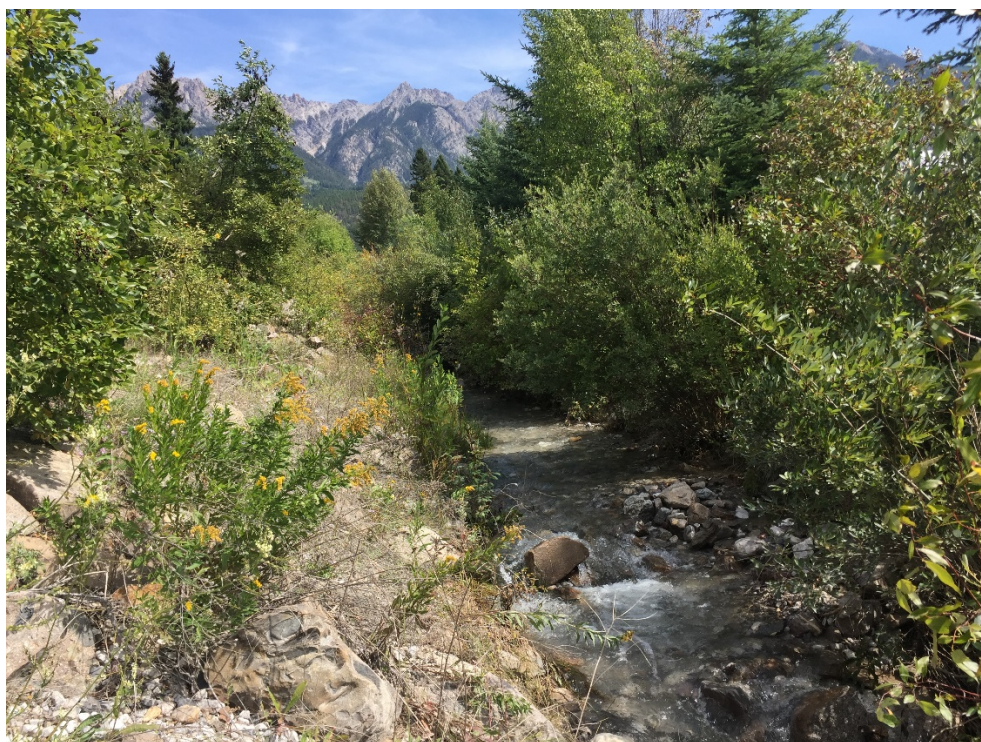
Photo 11: Facing upstream from the culvert in Photo 9. Vegetation management is required and will be completed in 2020.

At this time, the RDEK is planning to complete vegetation removal along the lower sections of the creek in 2020.

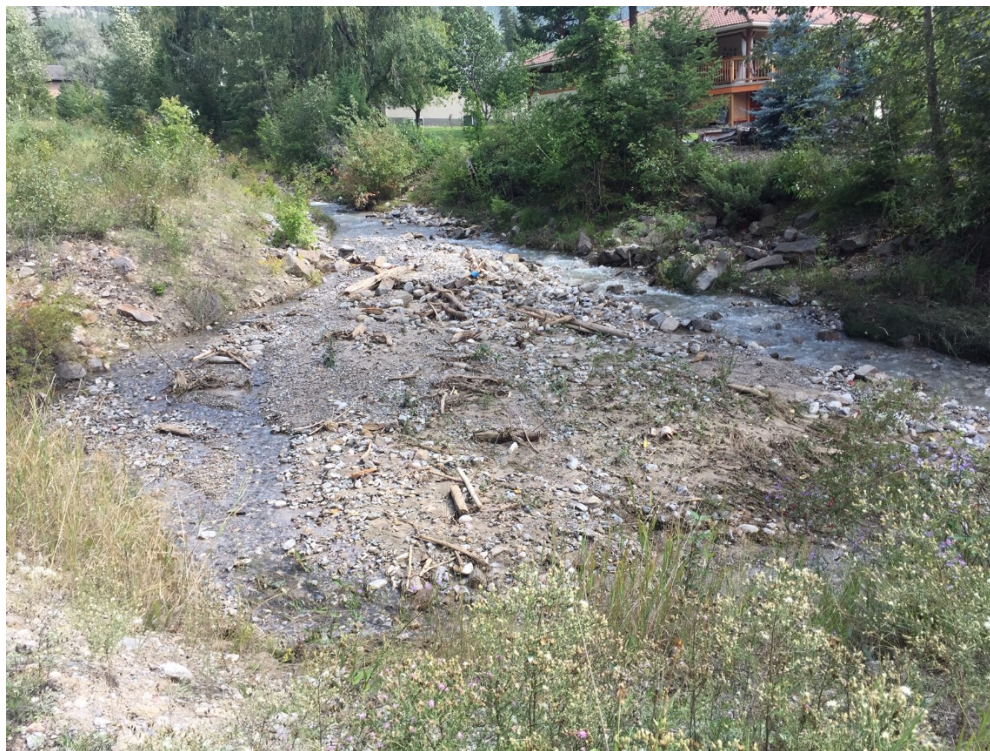
Photo 12: Small debris trap has some woody debris and minor debris flood deposition.

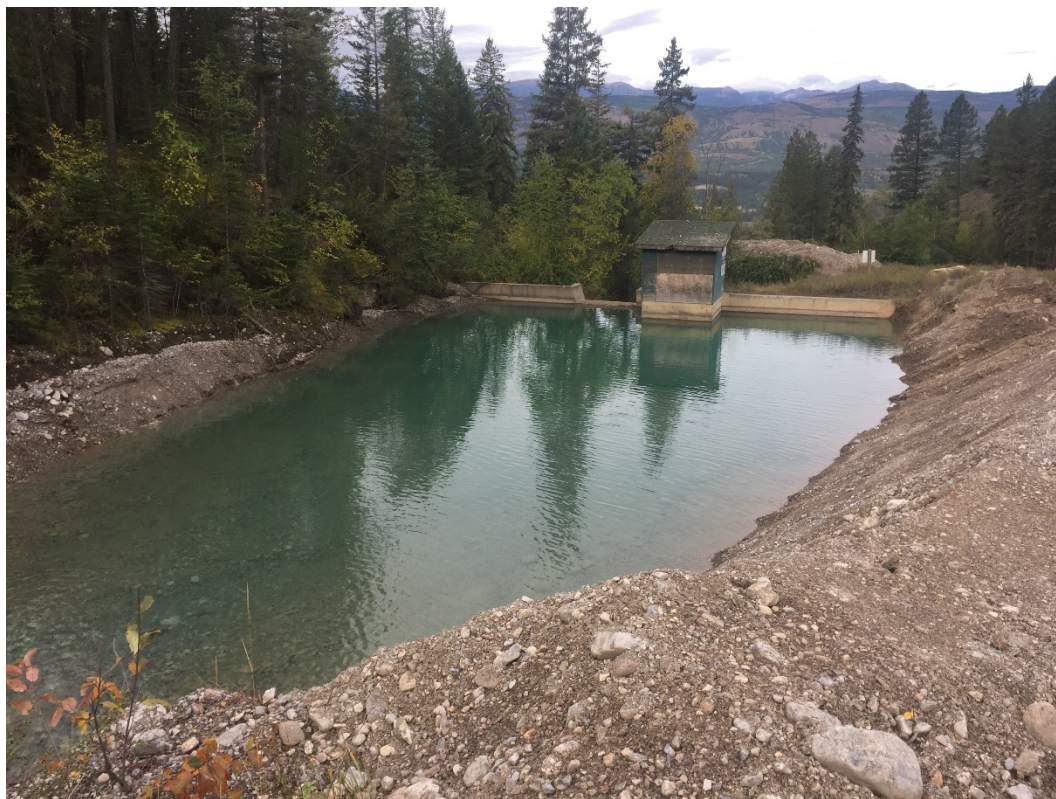
Photo 13: Cold Spring Creek Dam reservoir. Photo taken September 18, 2019.

A significant amount of maintenance was completed in 2019, all in response to the August debris flood. The Cold Spring Creek Dam reservoir was cleaned out by Cody McKersie Contracting in September 2019 under the supervision of the Fairmont Hot Spring Resort and the remaining work was completed in November and December, 2019 by Ralph Stewart Contracting under the supervision of the RDEK. The RDEK supervised instream works were authorized under Section 11.

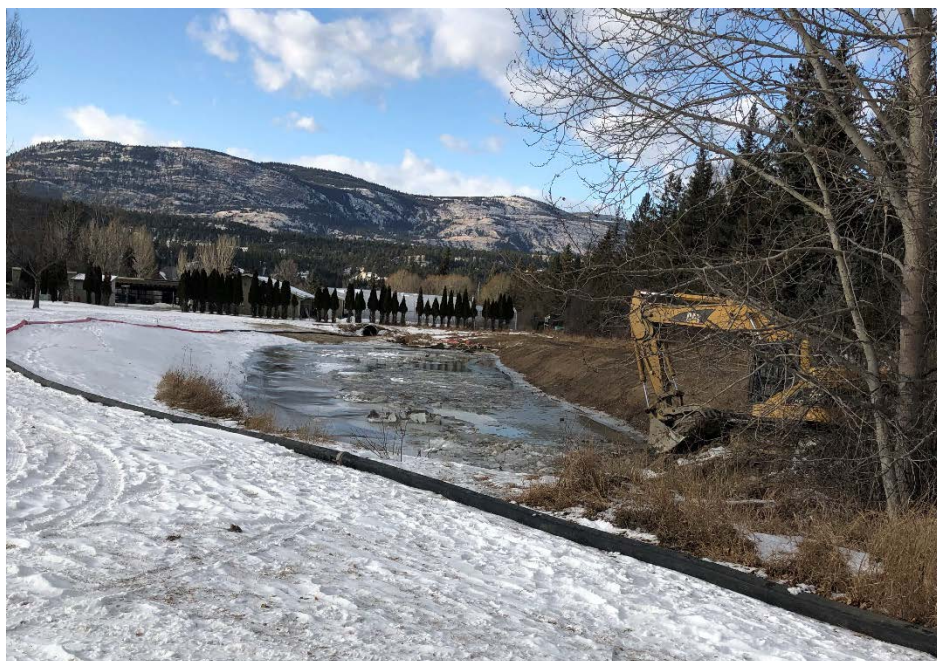
Photo 14: Cold Spring Creek lower debris trap. Photo taken December 19, 2019.
