Cold Spring Creek 2017 Annual Dike Inspection Report

May 4, 2017 Cold Spring Creek Dike Inspection

The dike/bank protection works were inspected on May 4, 2017 by Kara Zandbergen, RDEK Engineering Technician.

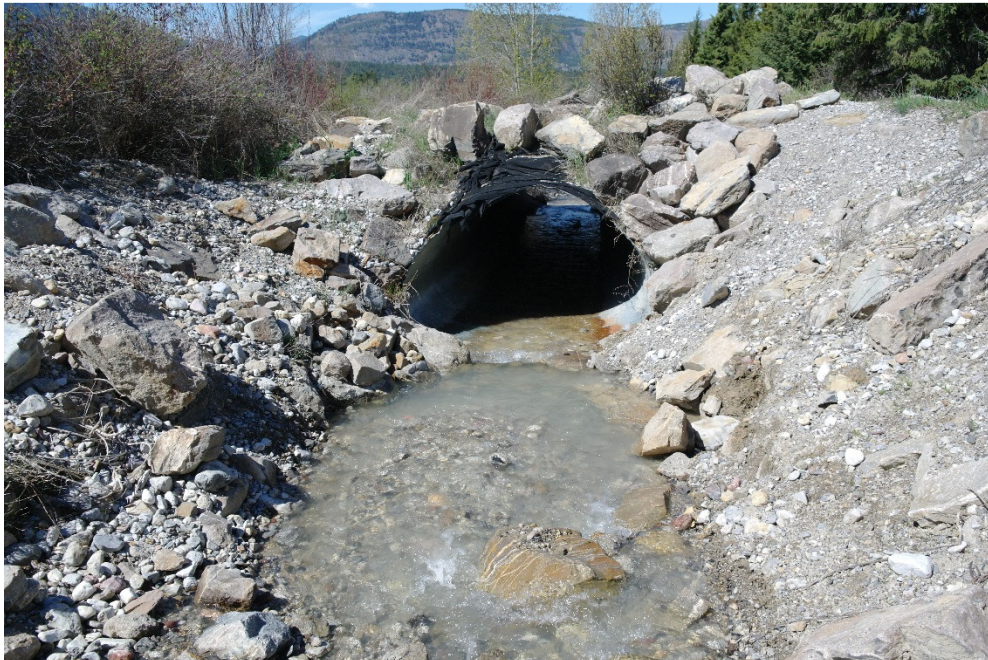
The last culvert along Cold Spring Creek before the lower debris trap is experiencing some very minor underflow piping. The situation is being monitored. The same culvert was approximately 30% filled with gravels and was cleaned out in August 2016.

Photo 1: Inlet of the culvert above the debris pond, May 4, 2017.

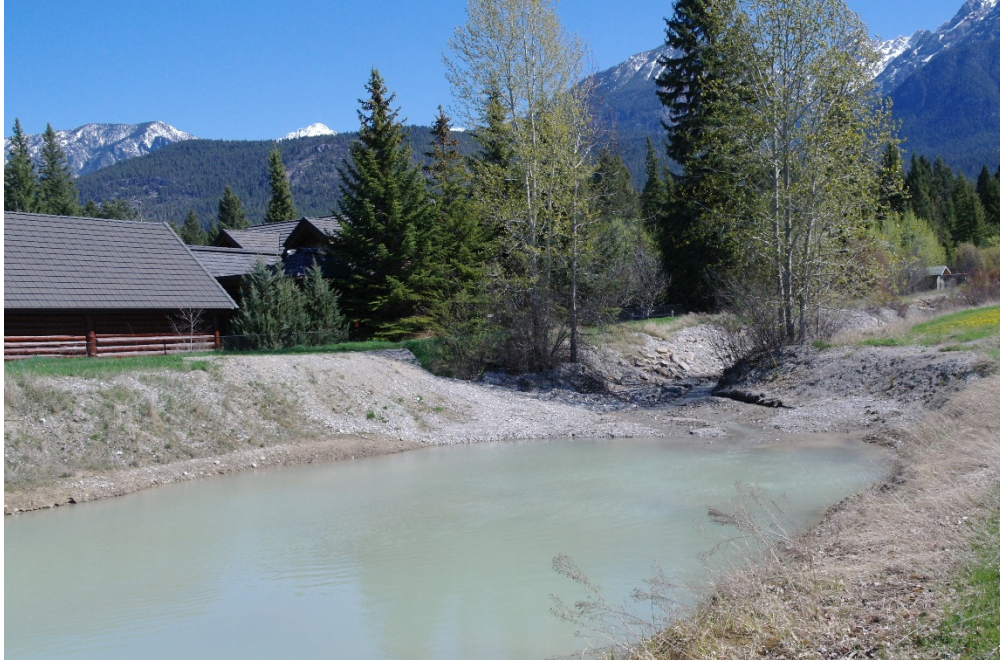
The upstream half of the debris trap was cleaned out in 2013. Some sediment and gravels had been deposited at the inlet to the pond since that time. The downstream half of the debris trap still had

several years of sediment build up. The inlet to the pond and the lower half of the pond were both cleaned out in August 2016.

Photo 2: The inlet to the lower debris pond, May 4, 2017.

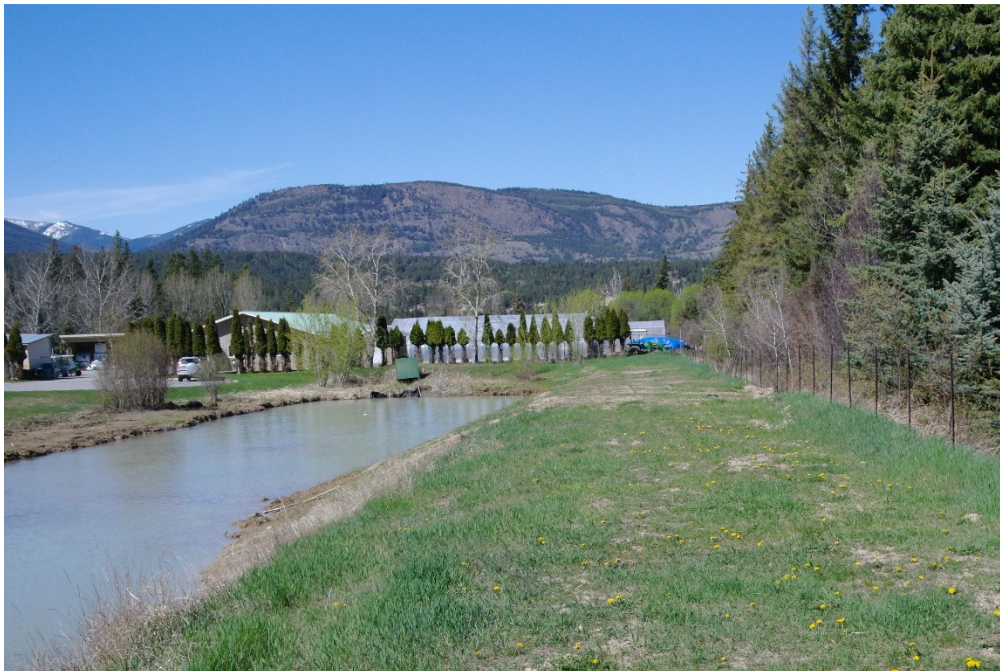
Photo 3: The lower half of the debris pond, May 4, 2017.

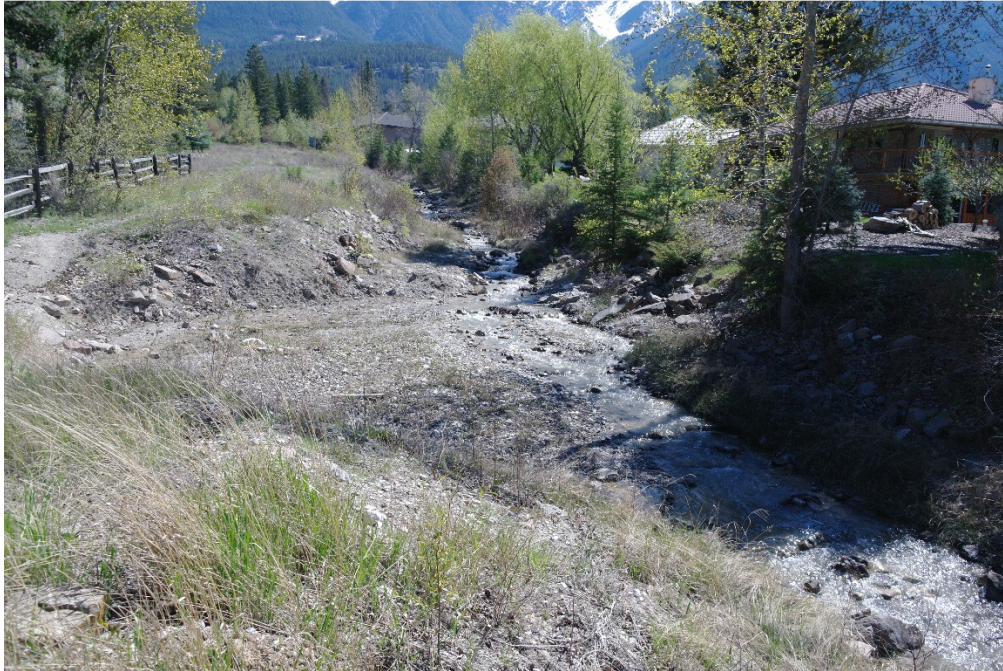
There is some minor material deposition in the mid-channel debris trap that should continue to be monitored.

Photo 4: The mid-channel debris trap, May 4, 2017.

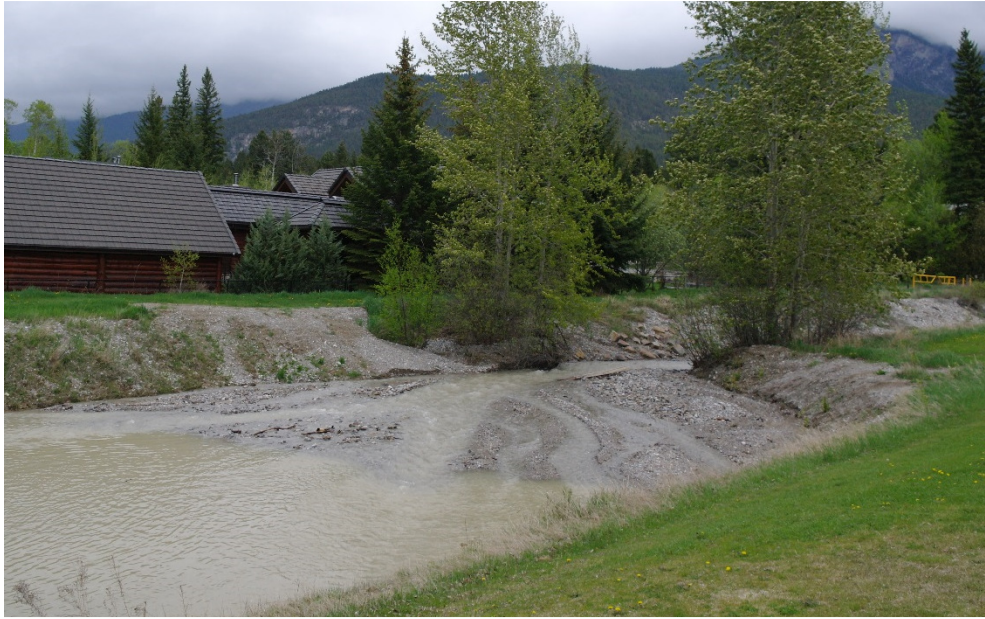
A small amount of debris came down Cold Spring Creek on May 12, 2017. The Cold Spring Creek Dam Reservoir was filled with debris and a small amount of debris was deposited at the mouth of the lower debris trap. A very minor amount of debris was deposited in the creek channel between the reservoir and the debris trap.

Photo 5: Material deposited at the entrance to the lower debris trap. Photo taken May 12, 2017.

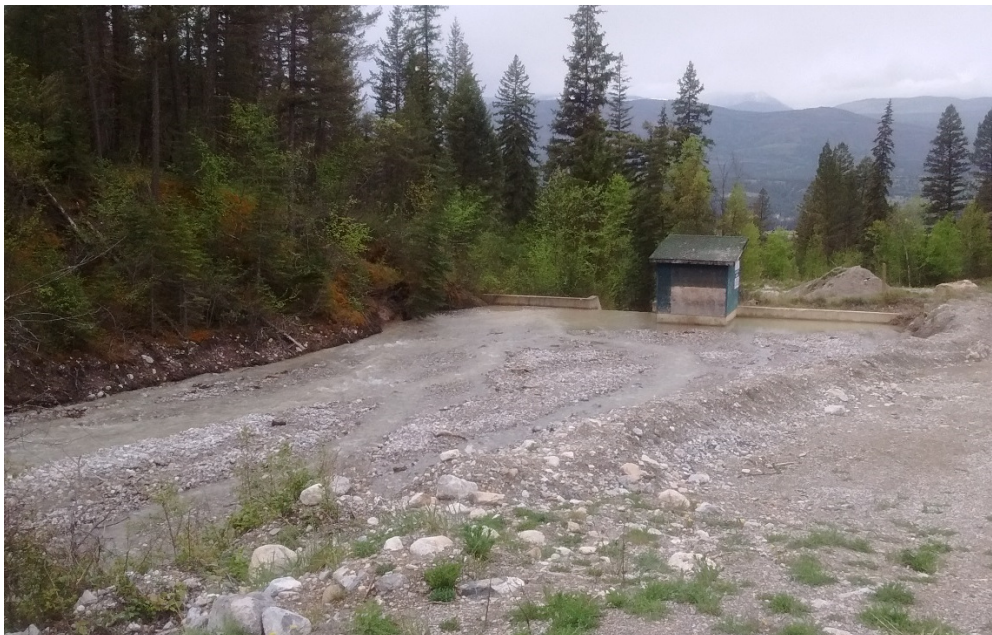
Photo 6: The Cold Spring Creek Reservoir was completely filled in by debris. Photo taken May 12, 2017.
