DECEMBER 3, 2020

# MAY 31 FAIRMONT DEBRIS FLOOD EVENT

Kara Zandbergen, RDEK Engineering Technician

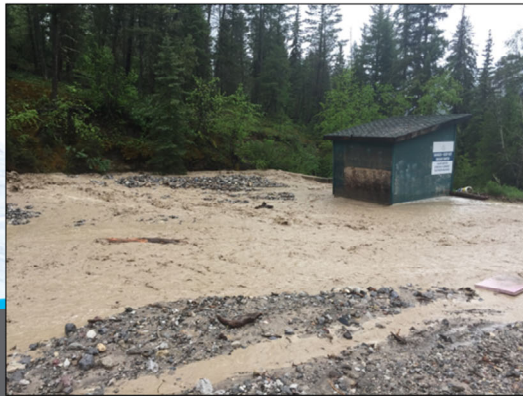
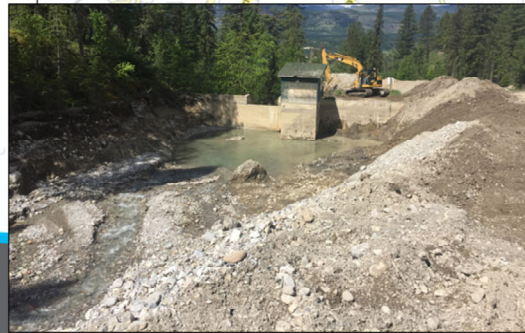
## 1. Reservoir – 3,600 m<sup>3</sup>

The reservoir site is the uppermost debris containment location on Cold Spring Creek and is currently the only containment site upstream of the community. It is marked on the map with a "1". Restoring capacity at this location was a high priority as it is the only debris containment location upstream of the community and this work was completed very early in the response. Approximately 3,600 cubic meters of material was removed from the reservoir. To make that volume more understandable, if we assume 9 cubic meters per truckload, that is 400 dump truck loads of material.

The picture on the left shows the full reservoir on May 31 and the picture on the right shows the cleaned reservoir.

This work was considered response.

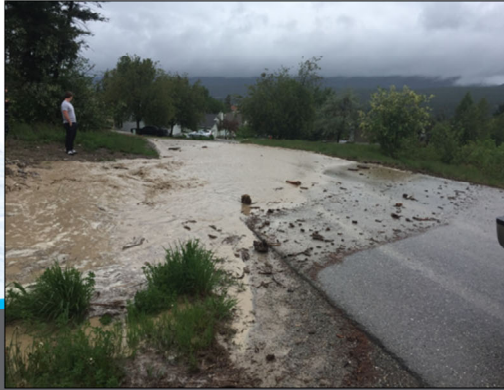
## 2. Culverts

Because we were able to contain the debris so effectively, the biggest impact to the residents and community on both creeks were the culverts that were blocked, unable to pass the flows and overtopped the roads. There were four locations on Cold Spring creek represented by the “2” on the map where the creek overtopped the roads. The culverts were addressed immediately with assistance from local contractors and the Resort.

This was considered response.

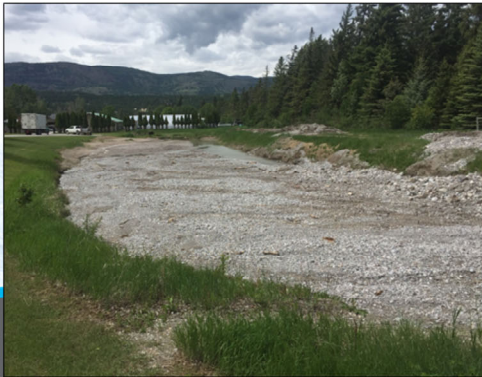
- 3. Lower Channel
- 4. Lower Debris Trap – 2,500 m<sup>3</sup>

The next sites on Cold Spring Creek were damage to the armoring on the lower channel and some infilling of small debris traps (3 on the map) and the lower debris trap (4 on the map) that was completely filled with material.

The repair of damage to the armoring in the channel was completed right away in anticipation of high flows and the material removal in the channel and pond was completed in late fall.

Both were considered recovery.

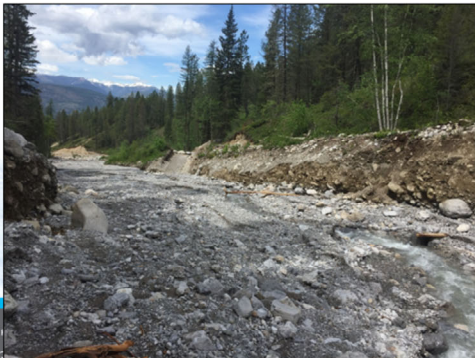
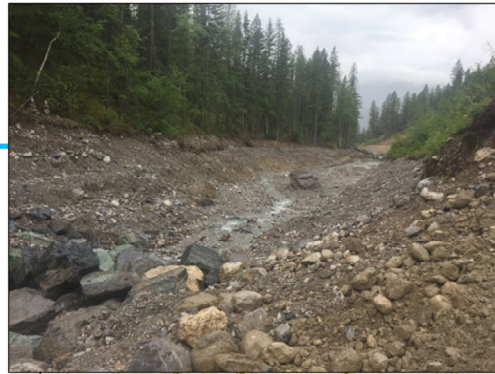
### 5. Upper Traps – 18,000 m<sup>3</sup>

Moving over to Fairmont Creek, there are three large weirs and debris containment basins upstream of the resort and community. The three basins are marked by the 5's on the map (the right-hand "5" indicates basins 1 and 2) and contained a total debris volume of approximately 18,000 cubic meters, all of which has been removed.

The picture on the left was taken upstream of the uppermost weir which is located roughly where you see the access road coming down. This weir was buried under about 2 meters of debris. The pic on the right is taken from weir 1 looking towards weir 2 in the distance and shows the cleaned basin. A tremendous amount of material was removed from this site.

The removal of 10,000 cubic meters of debris from the upper two basins was considered response and the remainder was considered recovery.

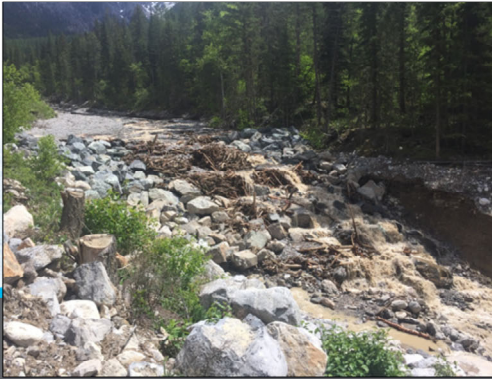
## 6. Weir 2 Scour

There was scour downstream of Weir 2 that needs to be repaired. This is shown in the lower picture and is marked by the 6 on the map.

This work will be completed in 2021 and will be considered recovery.

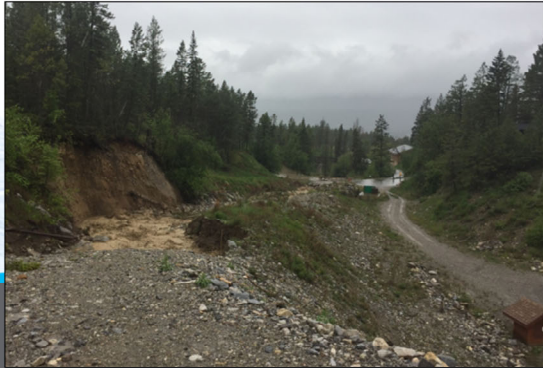
- 7. Damage to Berm
- 8. Fairmont Ridge Channel – 1,240 m<sup>3</sup>

The berm marked with a 7 upstream of the resort and community was damaged as shown in the lower picture. This was a high priority site and was repaired very early in the response. The picture on the right shows the repaired bank. This was considered response.

The Fairmont Ridge site is marked by an 8. There was bank erosion and channel infilling and the site was considered high priority as a second highwater event could have forced the creek out of the channel. Approximately 1,200 cubic meters was removed and the bank was repaired. This was considered response.

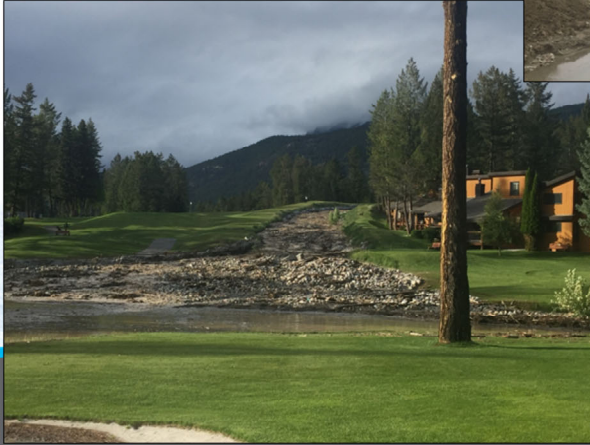
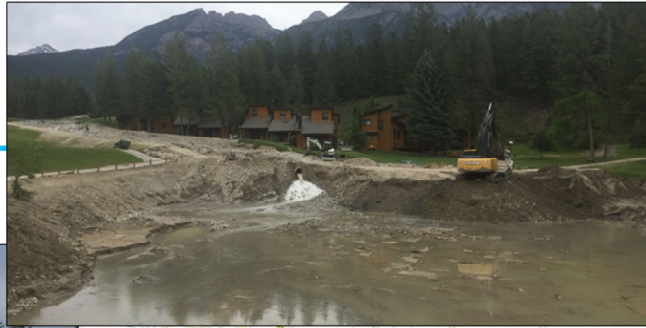
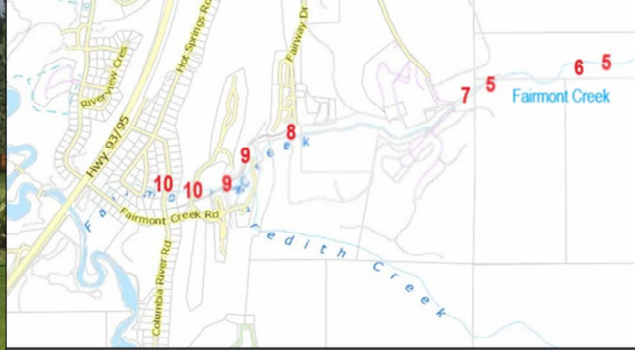
### 9. Golf Course Channel and Hole 12 Pond – 12,000 m<sup>3</sup>

The armoured and bermed channel through the golf course and the pond (marked with 9's) captured approximately 12,000 cubic meters of debris. This was a high priority site and was actioned very early in the response. The removal of the debris from the channel and part of the pond excavation was covered under response and the remainder is considered recovery.

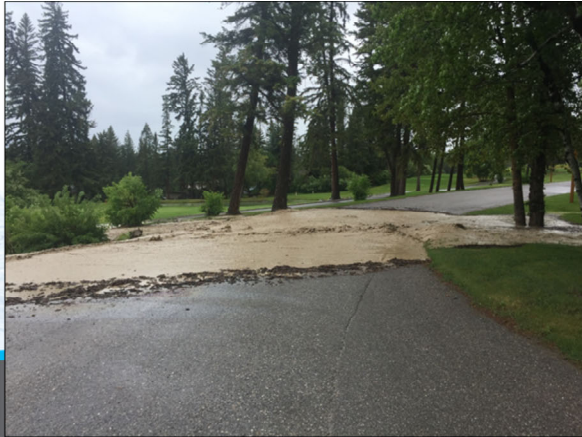
## 10. Culverts

The two trouble culvert locations on Fairmont Creek are marked with 10's. Similar to the culverts on Cold Spring, the culverts were addressed immediately with assistance from local contractors, the Resort and the Mountainside Villas. There were properties impacted by these overflowing culverts – mostly yards but there was damage to a garage foundation.
