**Alpine Projects Ltd.**  
**7410 Lynch Rd Fernie, BC. V0B 1M5**  
**Phone: (250)423-8540**  
**e-mail: [alpineprojectsltd@gmail.com](mailto:alpineprojectsltd@gmail.com)**

**To: RDEK**  
**Attn: Christina Carbrej**  
**From: Mark Paul Koeman ROWP # OW-0790**  
**Date: Nov. 12th, 2024**  
**Pages: 7**

**This report is for the evaluation done Nov. 11th, 2024, at the Hosmer Fire and Community Hall in Hosmer, BC done on the onsite wastewater treatment system (septic). The original septic filing was dated April/May , 1983 with the system as build layout appearing to be correct.**

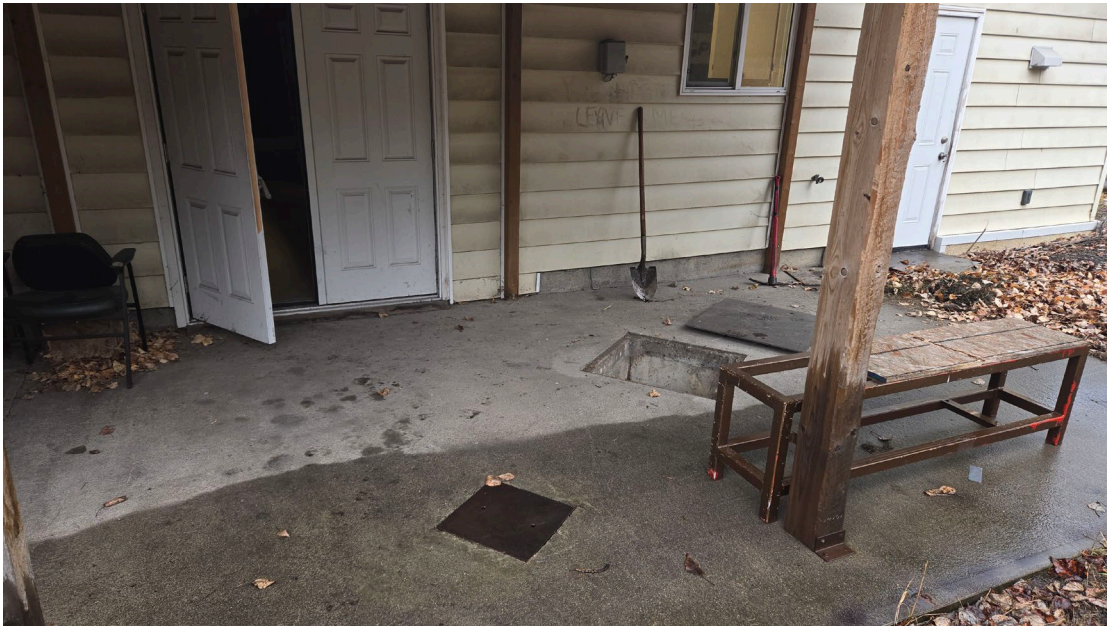
The back patio area of the hall.

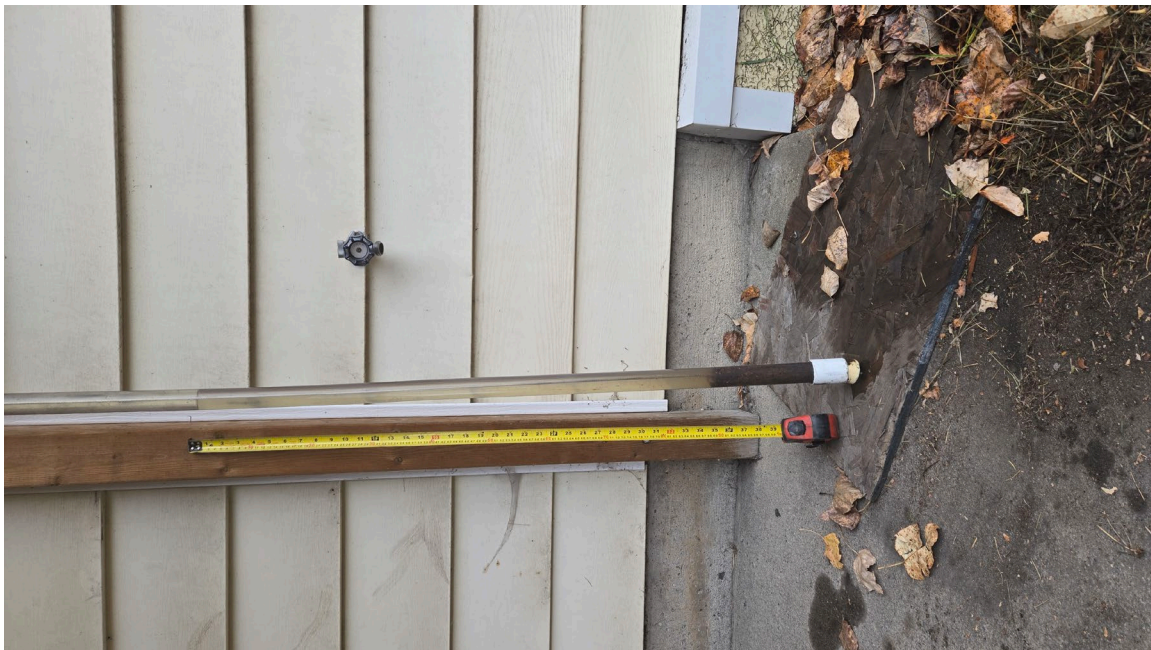
**The tank lid is located about 12" below the concrete patio under the larger steel plate lid with the heavy concrete access lid centred 80" from the concrete building foundation. The tank appeared to be good condition and has minimal corrosion for its age. The tank contained about 7" of sludge on the bottom and 1" scum at the surface. A pump-out is not needed at this time.**

Your tank lid locations are under the steel covers under your lean-to roof at the back of the hall. The main tank steel lid is to the side for access in this picture.

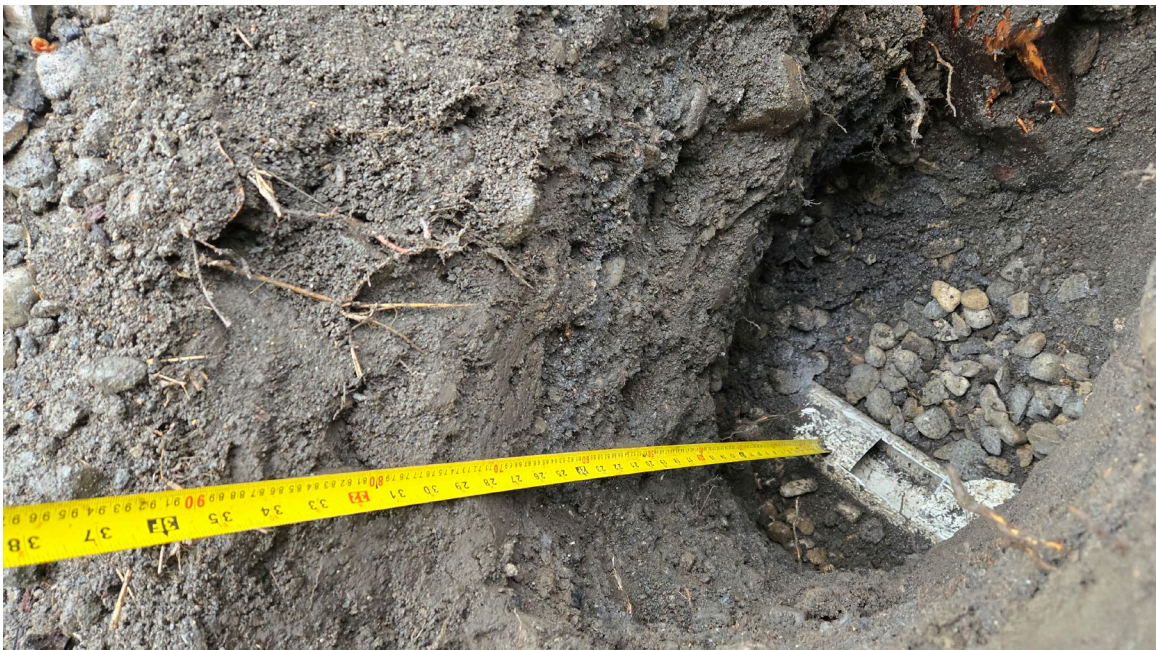
**The distribution box is under the concrete slab at the back of the hall about 30cm North of the Southern lean-to post and not directly accessible. The location was checked using a locator put through the piping. The lateral pipe farther from the building was slightly higher than the closer line point loading where most of the liquid drains in 1 location instead of going down the whole pipe. The other line was not accessed as it would not see much for flows based on the distribution box layout.**

The distribution box is about 30cm in front of the post and the lateral closest to the building follows the roof drip line along the C can and goes under the shovel handle seen in the background by the dirt pile. Note the line goes under the building.

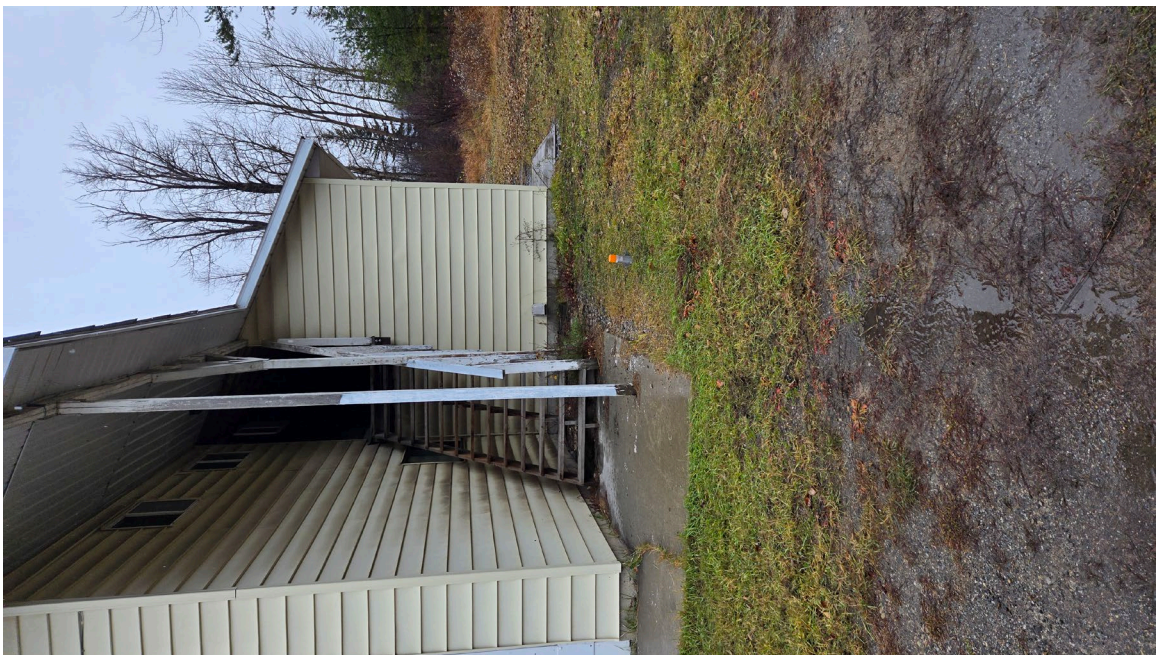
The end of the lateral is just to the right of the orange lid on the paint can.

The lengthwise view.

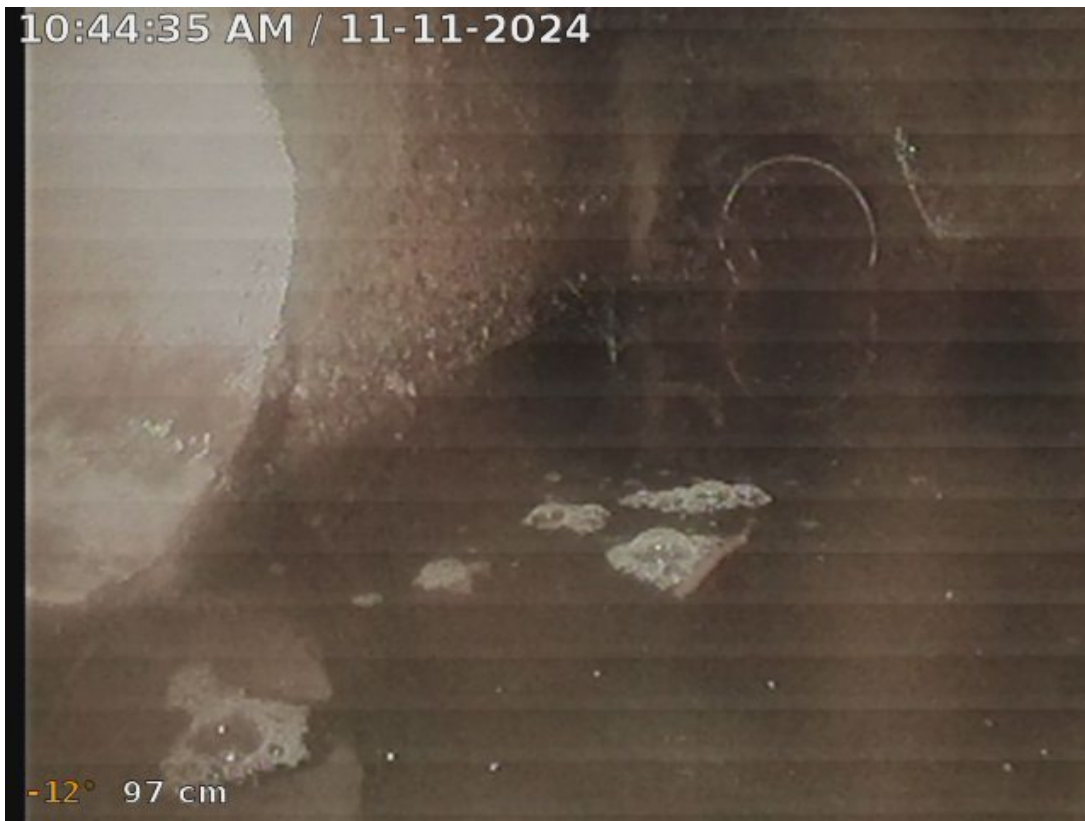
The inside of the distribution box coming in from the tank pipe. The far pipe is the lateral that was accessed and as you can see, the bottom is in the liquid. The pipe on the left would be going to the other lateral and is higher than the liquid and as such does not receive any unless there is a very high flow rate. The laterals should be evened out with levelers to have the flows evenly distributed.

- 1. The distribution box is not accessible to be able to install levelers to spread the flows out to a large portion of the field area.**
- 2. The sagging pipe near the distribution box should be leveled to help the liquid flow further down the pipe and avoid point loading.**
- 3. The lean-to should have a gutter added to direct the extra rainwater away from the field area.**
- 4. The sewer drain field piping goes under the addition and that is against sewerage and building codes. The building is probably a slab on grade with-out a full frost depth footing as otherwise the septic piping would have been cut short.**

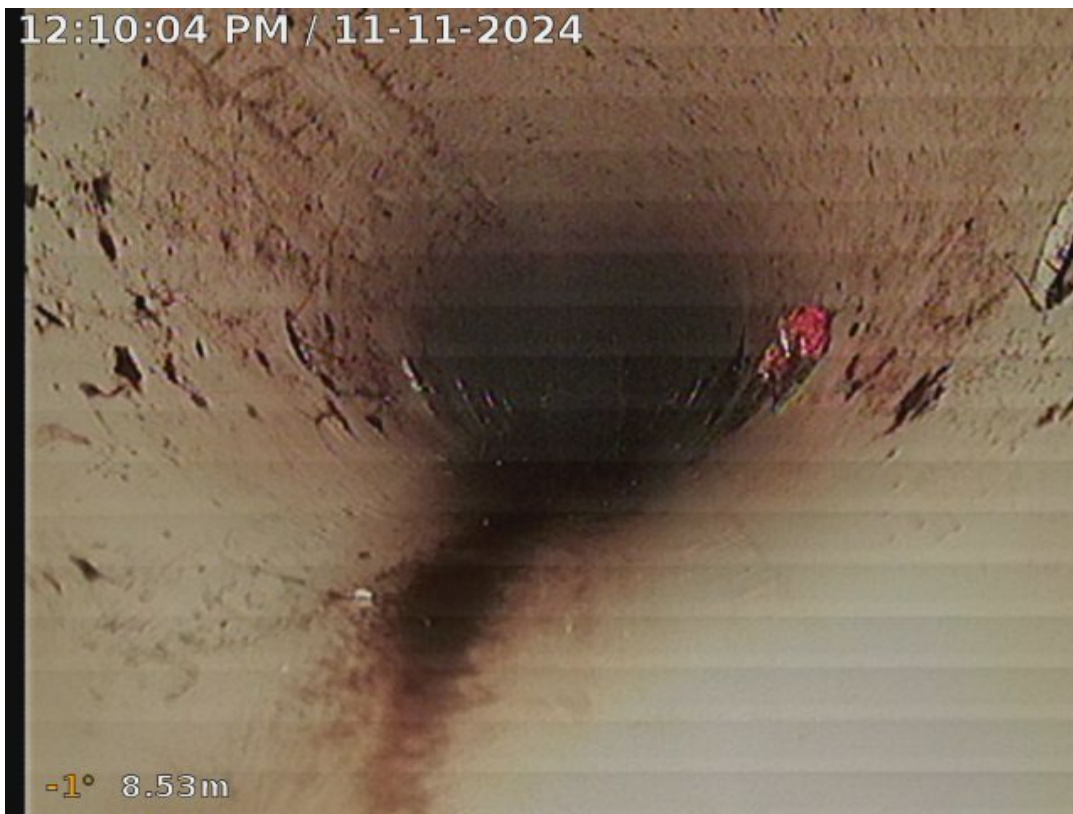
The inside of the lateral, with the drain holes seen, shows very little usage at about 3m from the distribution box. This is likely due to the pipe having sagged near the distribution box and the liquid draining out through the holes at that location.
