October 21, 2013

Regional District of East Kootenay
#19 – 24 Ave. South
Cranbrook, BC
VIC 3H8

RE: Overview-Level Hazard Assessment of Cold Spring Creek (2013)

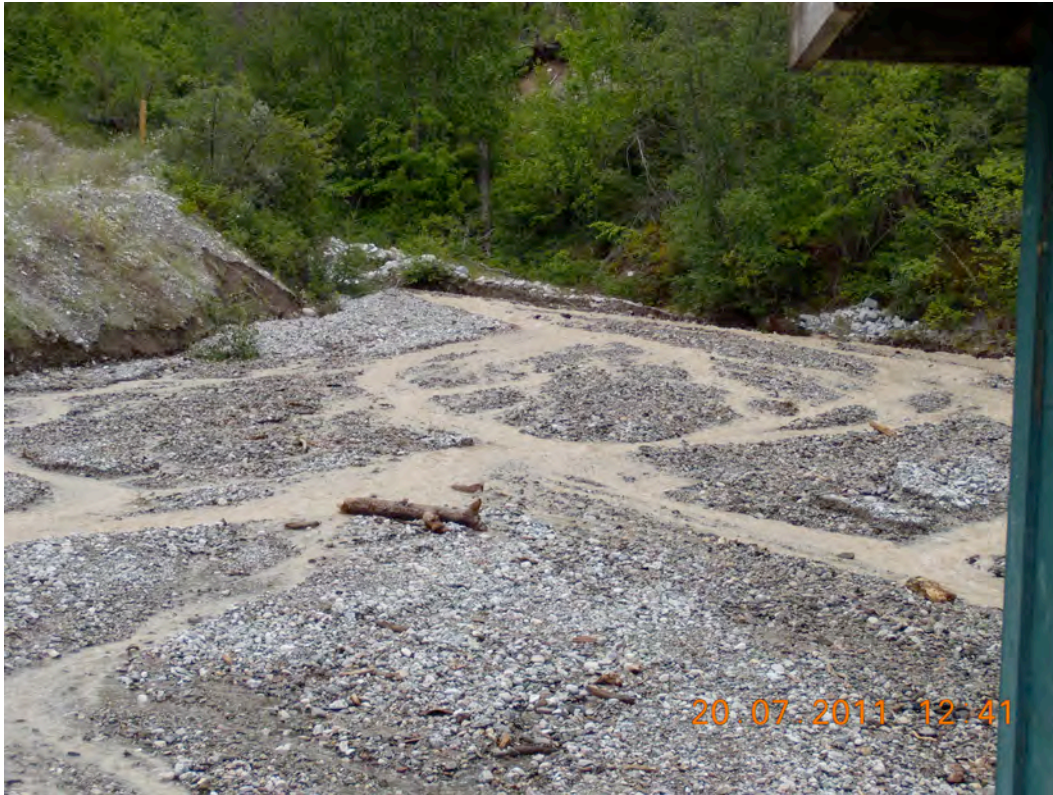
Prior to this year, Cold Spring Creek experienced significant sedimentation associated with a flood event in July 2011. Observations by RDEK personnel in 2011 indicated that the event caused infilling of the Cold Spring Dam reservoir (Photo 1), partial infilling of

Photo 1: Sediment infilling of Cold Spring Dam reservoir after flood event in 2011 (photo from RDEK)

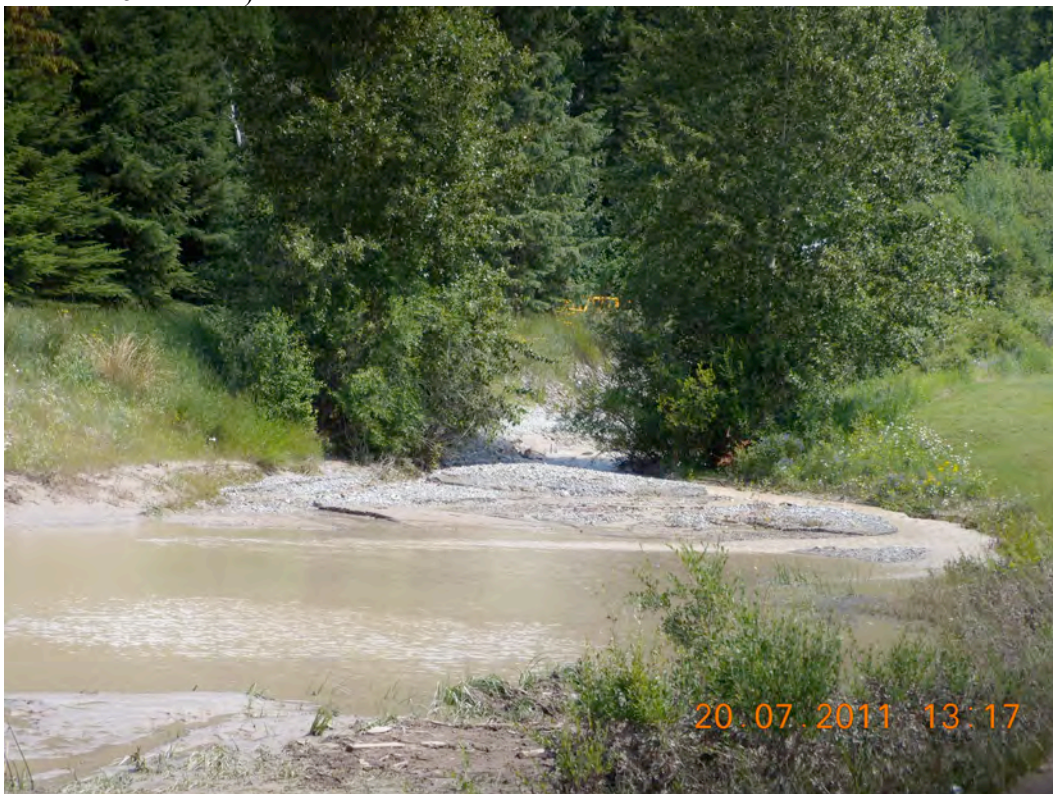
the lower debris trap (Photo 2), and led to reconstruction of the FHSR water intake structure (Photo 3). (J. Maletta, RDEK, *personal communication*)

Photo 2: Sediment infilling of lower debris trap on Cold Spring Creek after flood event in 2011 (photo from RDEK)

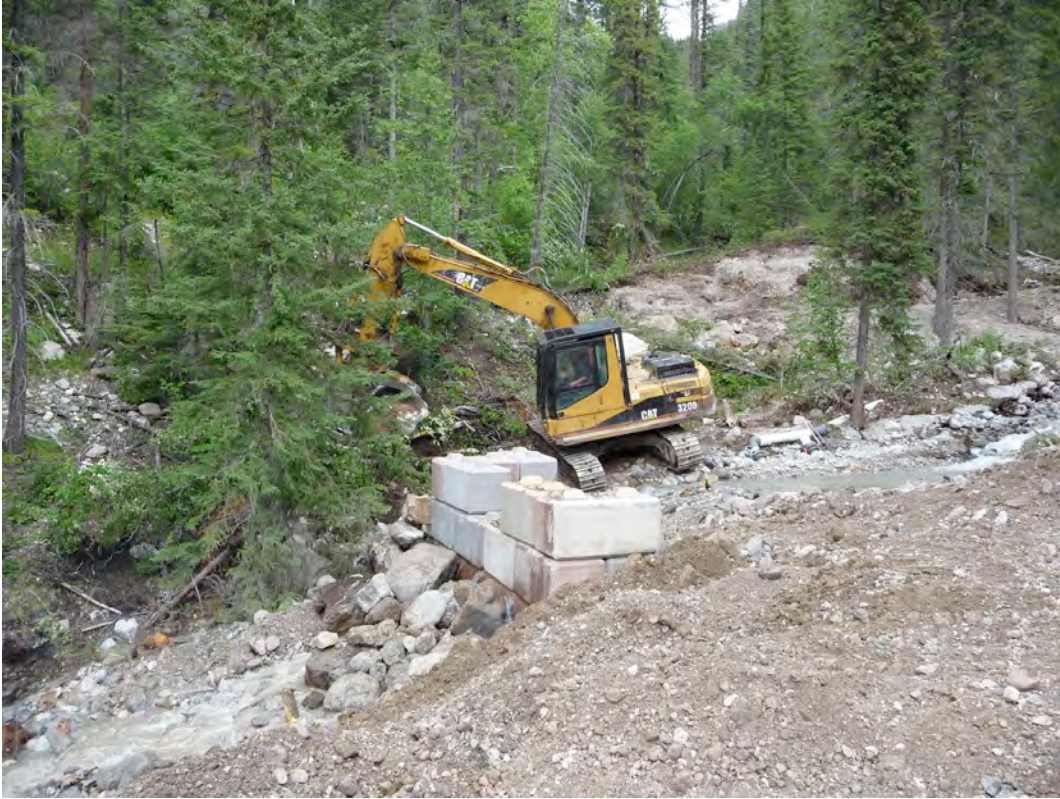
Photo 3: Reconstruction of water intake on Cold Spring Creek after 2011 event (exact date of photo unknown) (photo from RDEK)

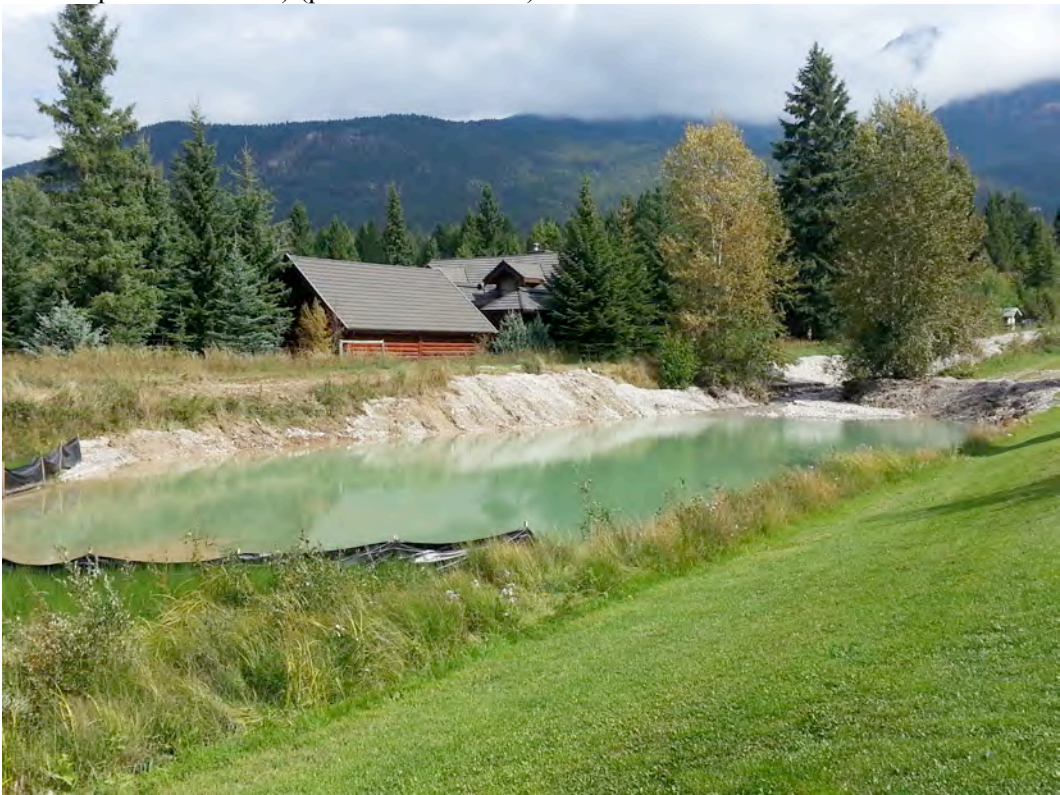
lower debris trap on Cold Spring Creek after the recently accumulated sediment was excavated.

Photo 4: Lower debris trap after sediment removal in 2013 (photo from RDEK)

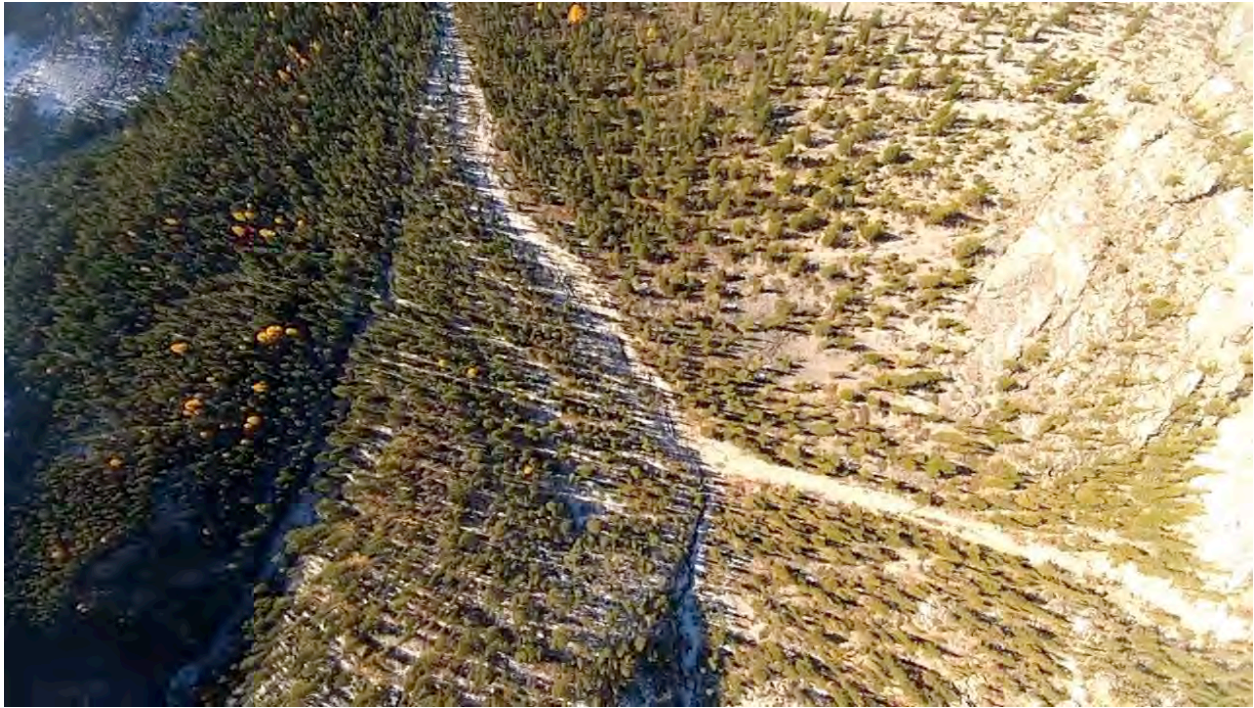
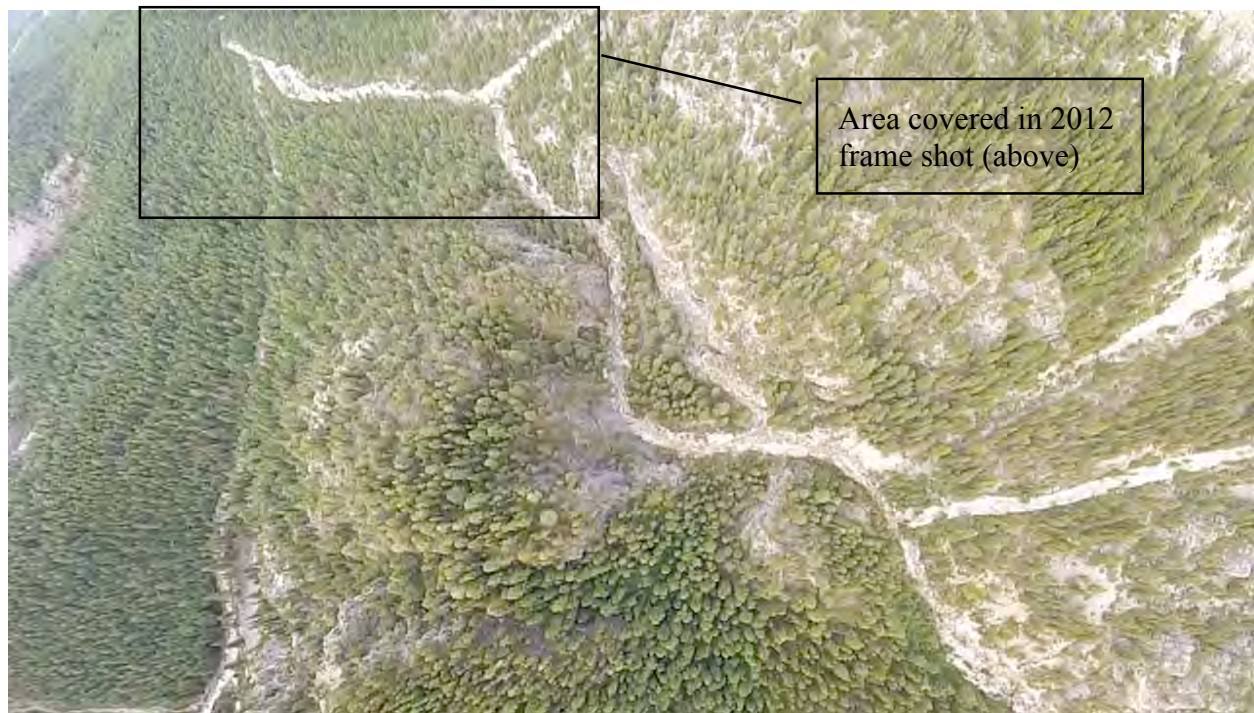
Project: Overview-Level Hazard Assessment of Cold Spring Creek (2013)	
Date: October 21, 2013	Title: Headwater Tributaries
Scale: n.t.s.	Figure No.: 2

The aerial reconnaissance identified recent instability along several headwater tributaries, including several tributaries with abundant sediment load. Where the headwater tributaries converge on the mainstem channel, Cold Spring Creek appears to be wider. It is judged that the headwater tributaries are active, and significant, sources of sediment and debris to the mainstem channel.

October 2012 Confluence of Headwater Tributaries

July 2013 Confluence of Headwater Tributaries – Noticeably increased sediment load

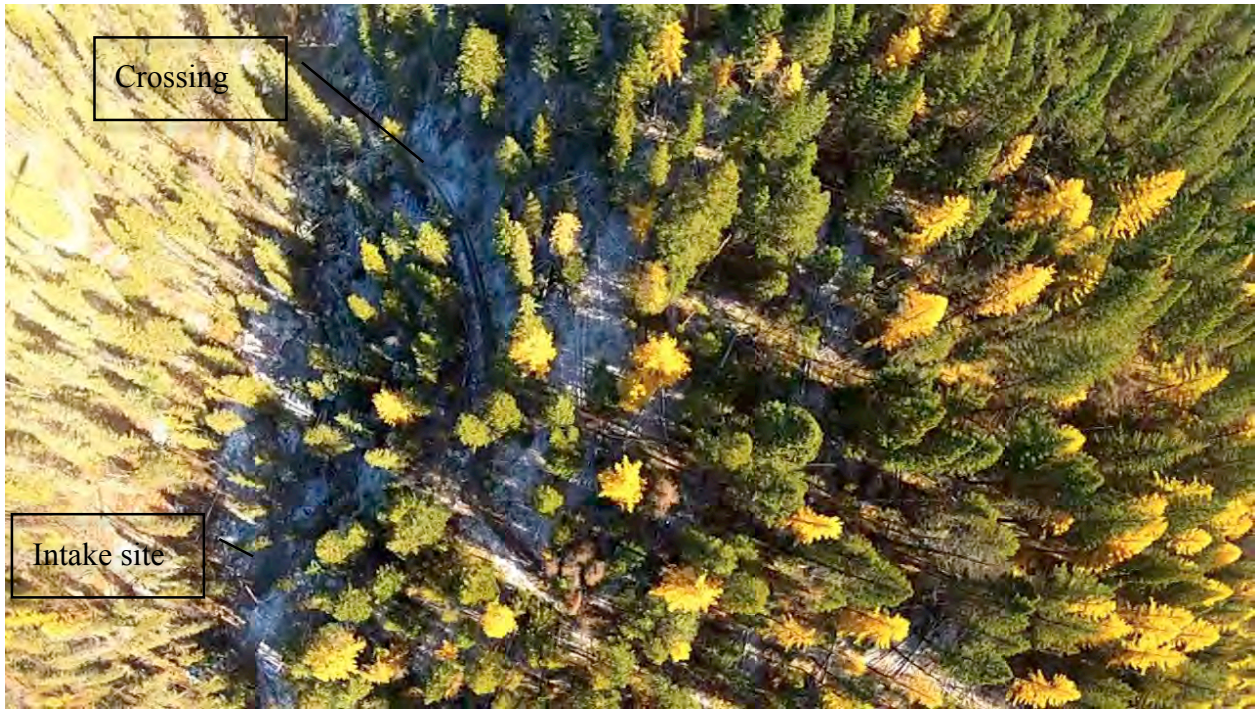
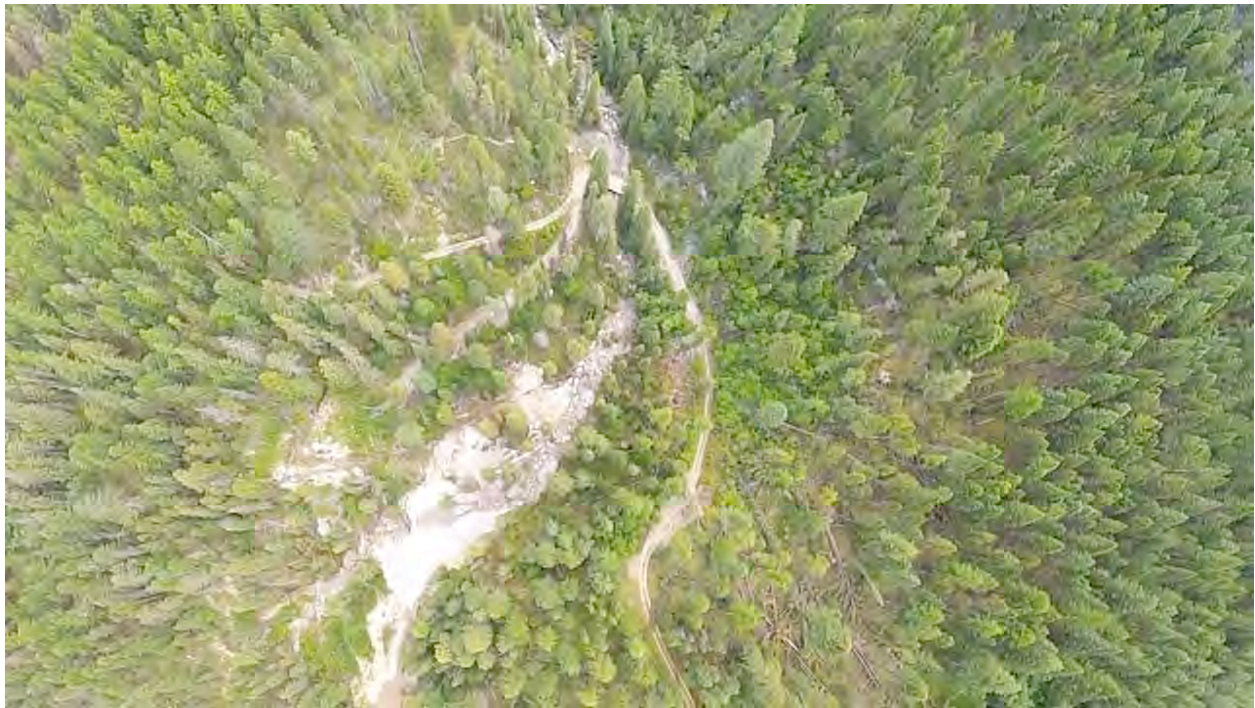
Project: Overview-Level Hazard Assessment of Cold Spring Creek (2013)	
Date: October 21, 2013	Title: Intake Site
Scale: n.t.s.	Figure No.: 3

Mid-watershed reaches of Cold Spring Creek are moderately steep and considered a transition zone between debris flow transport and deposition. Steep valley side slopes comprised of erodible bedrock, colluvium, and/or glacial deposits characterize the mid-watershed reaches. In several places, exposed slopes contribute sediment directly to the mainstem channel. Although forest cover partially obscures the channel, the mid-watershed reaches appear to be heavily sediment-laden. Water works associated with an intake structure registered to Fairmont Hot Springs Utilities Ltd., are situated in the mid-elevation reach (see Photo 3). Comparable imagery indicates that the intake site experienced sedimentation and scour associated with the 2013 flooding (Figure 3).

October 2012 FHSR Intake Site and Road Crossing (indicated with arrows)

July 2013 FHSR Intake Site and Road Crossing

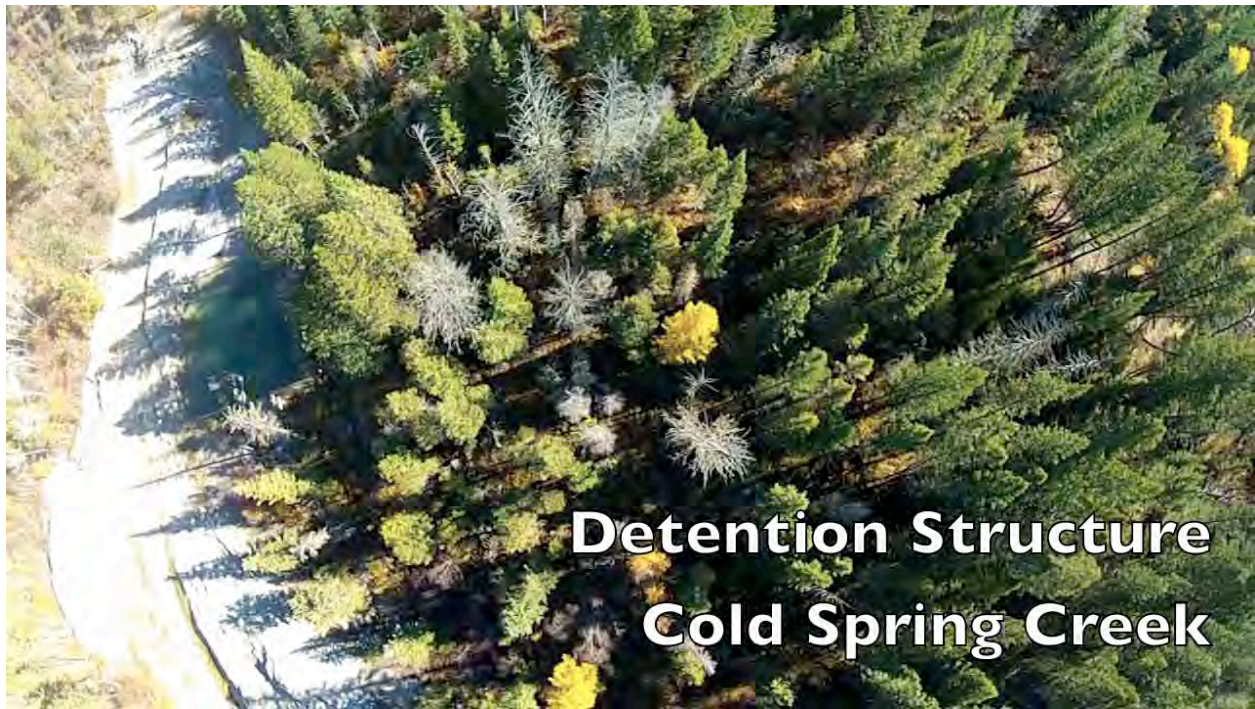
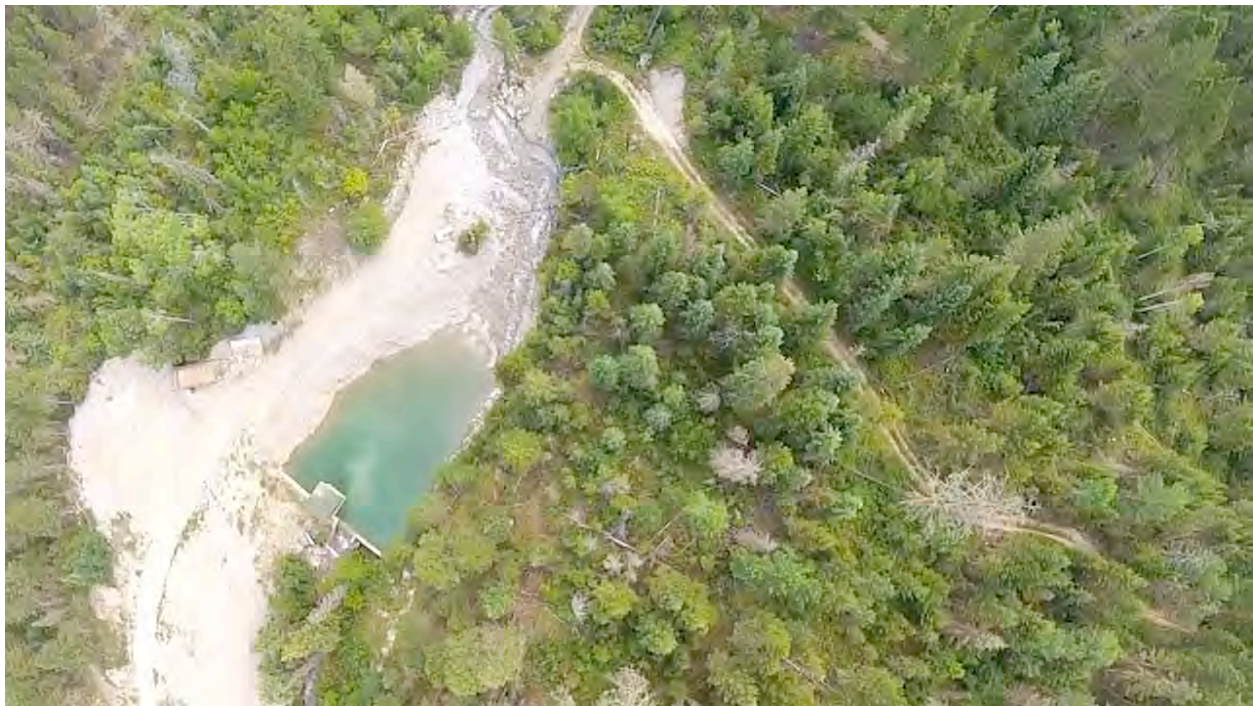
Project: Overview-Level Hazard Assessment of Cold Spring Creek (2013)	
Date: October 21, 2013	Title: Cold Spring Creek Dam
Scale: n.t.s.	Figure No.: 4

A concrete dam structure is situated on Cold Spring Creek at the apex of the fan. The 3 m high Cold Spring Dam is owned by Fairmont Hot Springs Resort Ltd. and functions to divert water for consumptive purposes. The upstream reservoir is fairly small but also functions to detain sediment transported downstream. At the time of the overview assessment, approximately 1000 m³ of material had recently been excavated and stockpiles were evident in the reservoir area. Comparable imagery of the dam site is provided in Figure 4.

October 2012 Cold Spring Creek Dam

July 2013 Cold Spring Creek Dam

Relevant to the downstream risk to the Fairmont Hot Springs Community is the function of the Cold Spring Creek Dam. It is recommended that this function be reviewed in the context of an integrated flood control system. It is also recommended that jurisdictional responsibilities be clarified and that a review of dam safety documentation, including inspections and audits be completed.

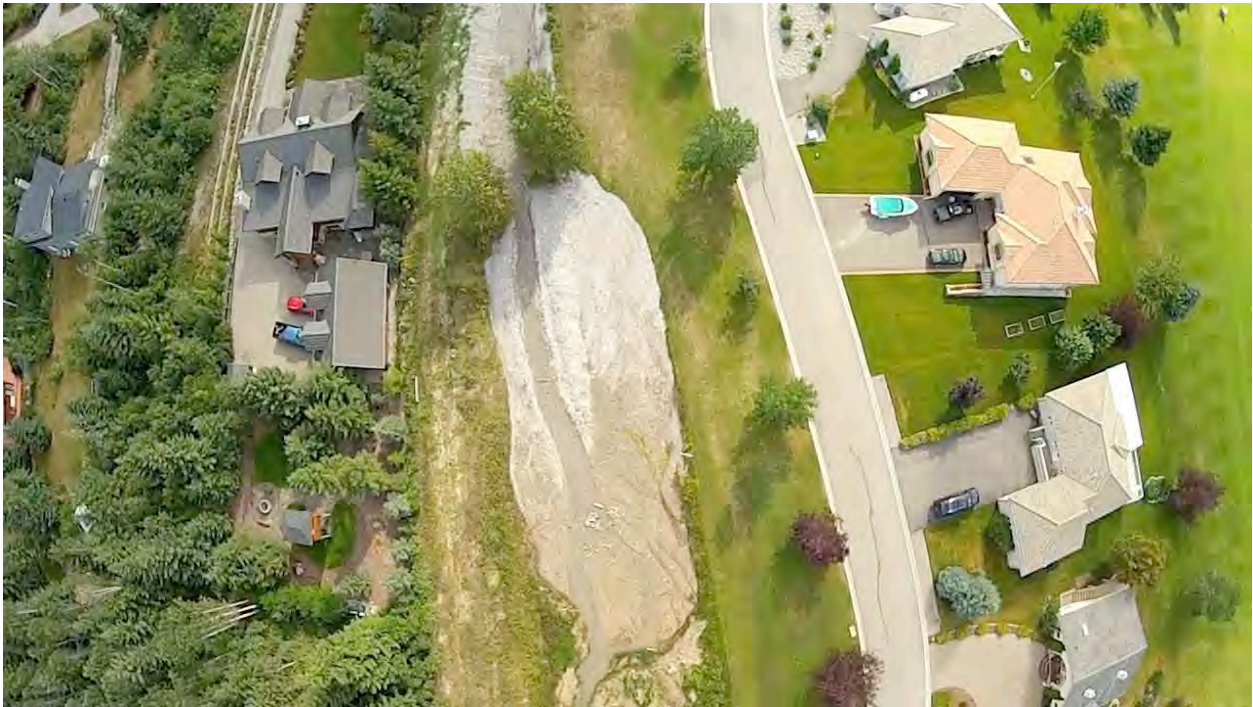
Project: Overview-Level Hazard Assessment of Cold Spring Creek (2013)	
Date: October 21, 2013	Title: Lower Reach of Cold Spring Creek
Scale: n.t.s.	Figure No.: 5

Downstream of the Cold Spring Creek Dam, the channel traverses the fan area, which includes residential/commercial development and three golf courses. Cold Spring Creek flows through three (3) culverts, one of which crosses the sole access road to the Fairmont Hot Springs Resort, before flowing under Highway 93/95. Downstream of the highway, Cold Spring Creek flows through a residential area and the Riverside Golf Course into a diked section of channel and a debris trap before reaching the Columbia River. The dike is a flood protection structure registered to RDEK that extends 484 m along the channel (Provincial Flood Control Structures database). The dike functions in conjunction with a debris trap to contain approximately 1000 m³ of sediment transported below the dam through the downstream reach of Cold Spring Creek. At the time of the overview assessment, the sediment trap was partially infilled with approximately 500 m³ of sediment (Figure 5) (B. Funke, RDEK, *personal communication*). Photo 4 shows the

July 2013 Lower Reach of Cold Spring Creek showing partially infilled sediment basin
