Cold Spring Creek Debris Flow Basin Mitigation (preliminary design) – Environmental Assessment & Best Management Practices

Version 2 – Permit application

November 2022

Prepared by
Lotic Environmental Ltd.
2193 Mazur Road
Cranbrook, BC
V1C 6V9

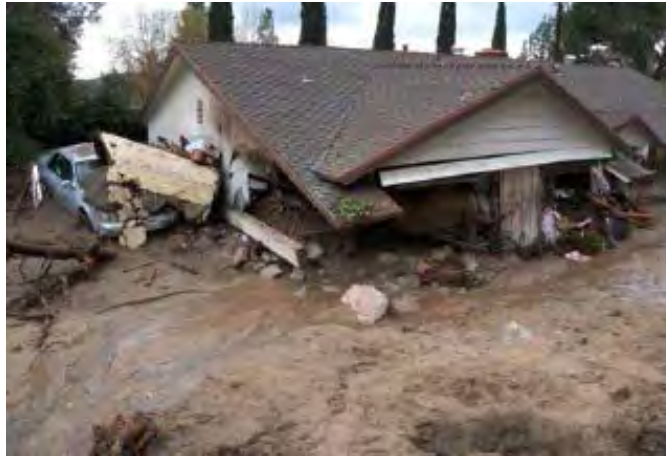
Figure 1. Downstream impacts of a post-fire debris-flow in California in 2010 (Source USGS); example of event possible at Cold Spring Creek (BGC 2020a).

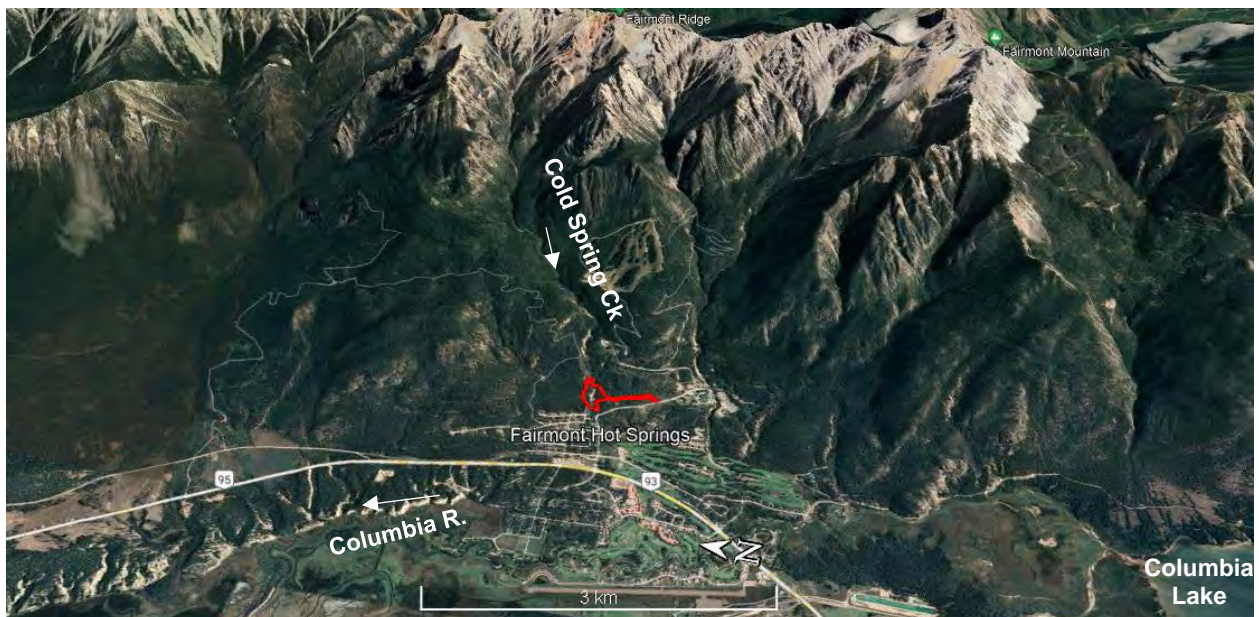
Figure 2. Project footprint relative to Cold Spring Creek drainage (Google Earth 2021).

Fairmont Hot Springs is an unincorporated resort community located in south-eastern BC. The community has a year-round population of 476, and receives frequent tourists, with the summer population being several times larger than the permanent resident population (Wikipedia 2022). The project is in the middle of the Cold Spring Creek watershed, with the barrier located immediately downstream of the Fairmont Hot Springs Resort (FHSR) irrigation reservoir and dam, and immediately upslope of residences (Figure 2, Figure 3).

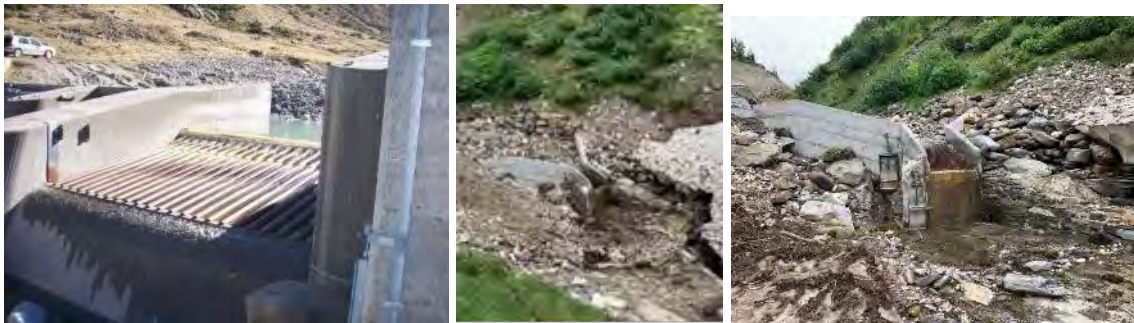
Figure 6. Tyrolean weir examples (BGC and McElhanney 2022).

The Tyrolean weir will intercept flow under most conditions (i.e., most of the time), where it will be conveyed through a 600 mm diameter culvert to the FHSR reservoir. When flow exceeds ~ 0.8 m³/s, the excess flow will continue over the weir into the debris basin. The bar size and spacing on the weir will restrict the size of sediment/bedload that can drop into the chamber to silts, sands, and small gravels. Larger calibre sediment and debris, typically mobilized during larger flow events, will continue over the weir, and drop into the debris basin.

Smaller sediment entrained in the water column during low flows, and a portion of the smaller calibre sediment during larger flows, will drop into the weir's chamber and be conveyed to the FSHR reservoir; this is unavoidable. However, the amount of maintenance to the reservoir, in the form of sediment removal, will be dramatically reduced from present conditions. Most of the weir details will be developed during the detailed design stage.

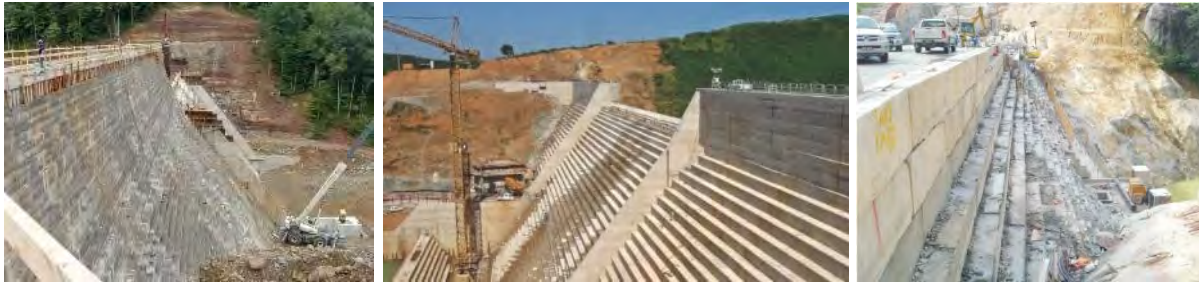
Figure 7. Examples of RCC downstream face with flat face and benching (BGC & McElhanney 2022).

The debris-flow barrier is located across the natural constriction in the valley. Its purpose is to capture debris flows up to the design storage volume, and convey flows before, during, and after design events. The barrier is a concrete gravity dam made of roller compacted concrete (RCC), which can withstand overtopping and impacts that may occur during extreme debris-flows. The bottom of the barrier will be sloped and there will be a vertical portion at the top. The barrier crest width is 5 m. The barrier height is designed to achieve the design storage volume and direct flows that exceed the design storage level to the spillway. The centerline height above the existing Cold Spring Creek is 7 m (above the outlet invert), which increases to a 15 m maximum height away from the outlet. A permanent access road is designed to be located on the south side only. Vertical joints, perpendicular to the barrier alignment, from base to crest are included to control the locations of cracks. Control joints and other RCC cracks that occur throughout operation of the barrier will be monitored for change as part of the operation and maintenance plan. The vertical face of the barrier located along the outlet opening has a structural concrete facing, to resist weathering, abrasion and erosion (Figure 7). Steel facing plates cover the lower concrete at the outlet constriction to further protect against abrasion caused by sediment transport.

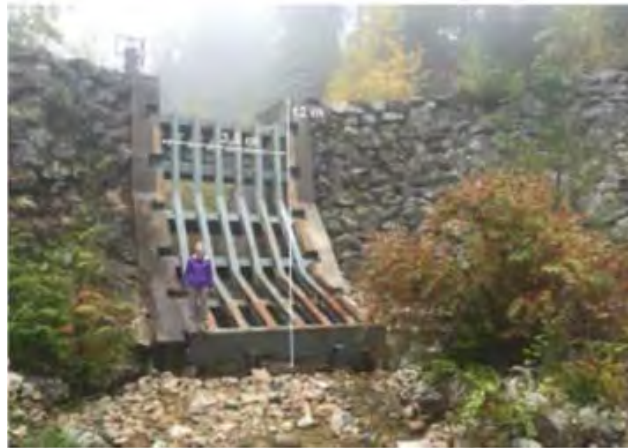
Figure 8. Example of proposed sloping outlet steel at McKay Creek East, District of North Vancouver (BGC and McElhanney 2022).

The outlet structure is located within the existing creek channel, so will require diversion and dewatering during construction to allow for placement of cast in place concrete. The creek diversion plan is the responsibility of the contractor, guided by the project specifications written by the design engineers (Section 4). It is envisioned that a temporary channel will be constructed to the north of the outlet structure and the creek will be diverted into that channel while the outlet is constructed. After the base of the outlet structure is cured and it is safe to do so, the creek will be diverted back into the permanent channel and through the outlet. High groundwater conditions are expected within the outlet foundation excavation, which will be managed with pumps. The creek diversion for the outlet structure is anticipated to last 2 to 3 months (Section 2.5).

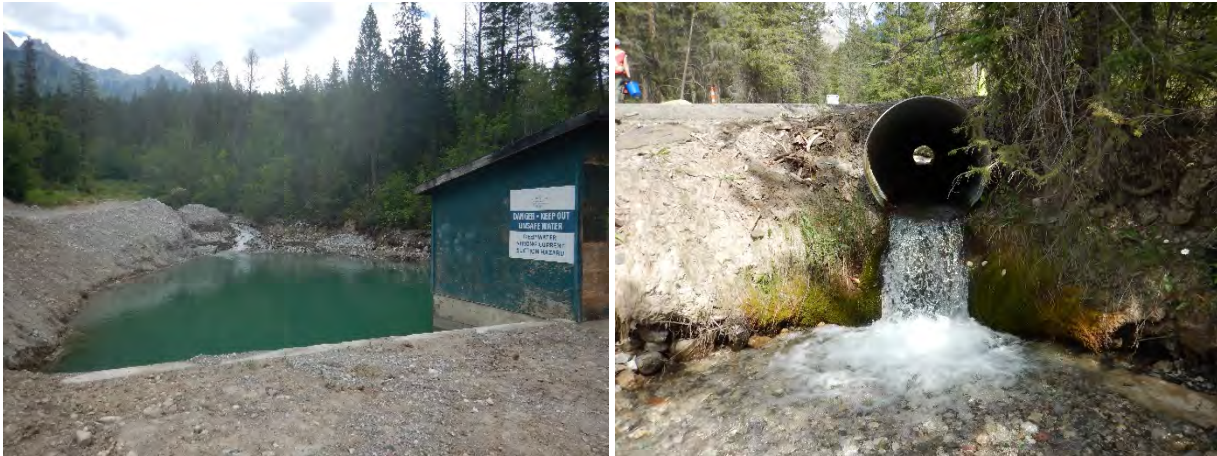
Figure 9. Fairmont Hot Springs Resort dam and irrigation reservoir within the project footprint (left), and Fairmont Resort Road crossing immediately downstream from the project (right); both are fish migration barriers.

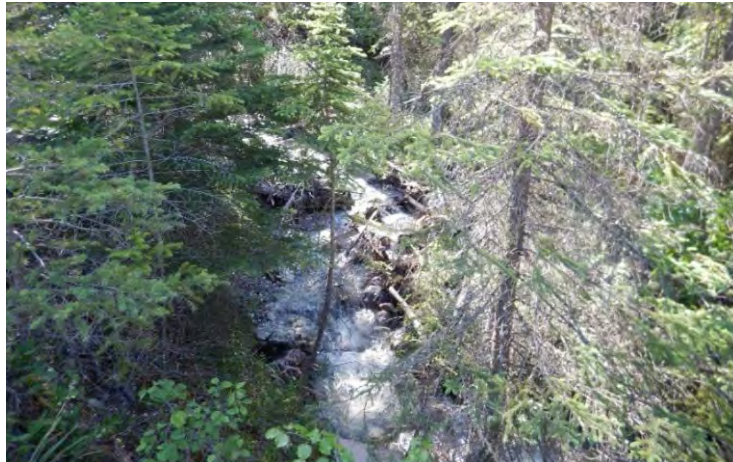
Figure 10. Cold Spring Creek near the proposed barrier location, June 21, 2021.

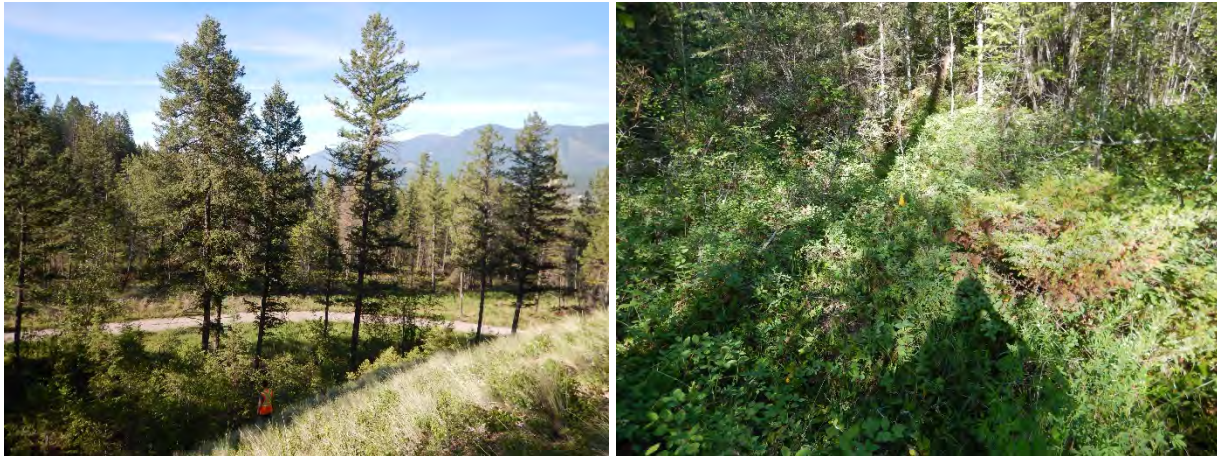
Figure 12. Representative photos of proposed north west basin area: looking south from top of north slope (left), and the forested valley at the base of the slope (right).

Plants identified were as follows (Figure 12 - Figure 14):

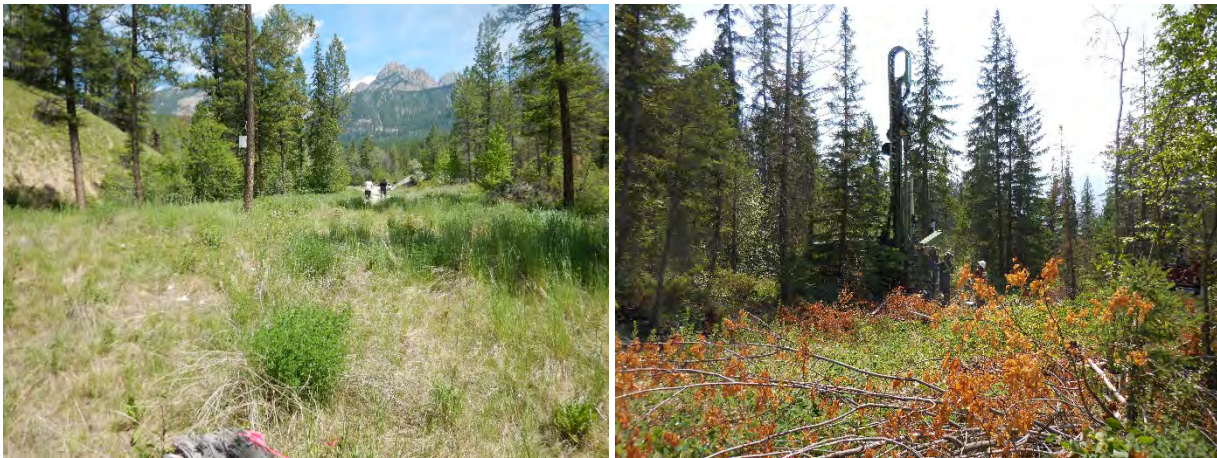
Figure 13. Proposed lower laydown area, in the previously disturbed area set back from the stream (left) and nearer to the stream (right).

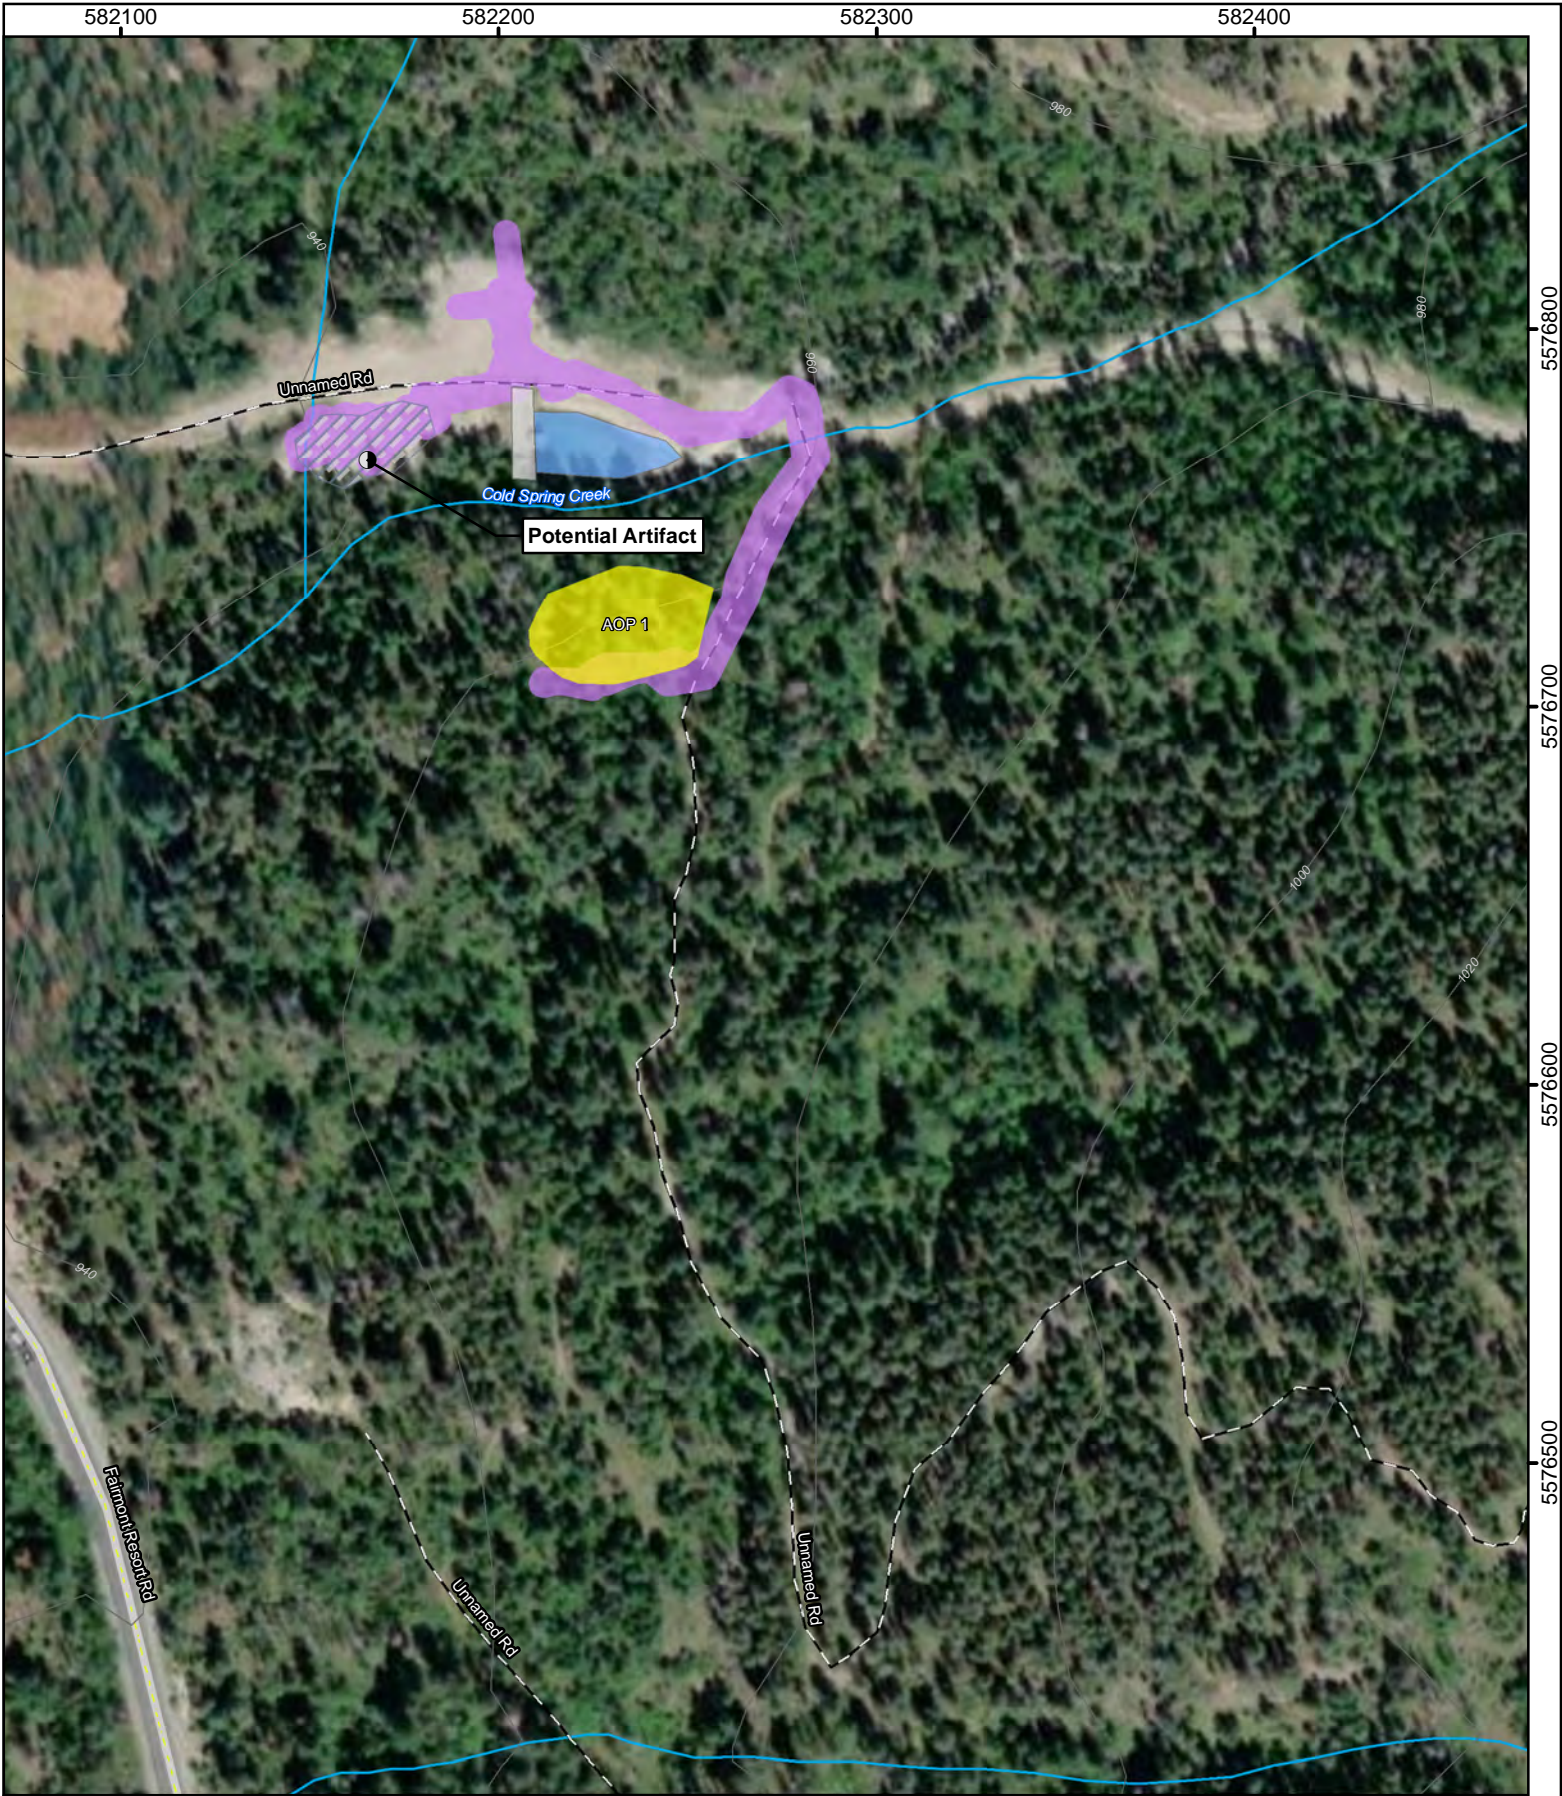
| Figure: 3 | Client: McElhanney | UTM11 - NAD83 - NTS 82G12 | | Legend: <ul style="list-style-type: none"> Area of Potential Cold Spring Creek Reservoir Cold Spring Creek Dam Secondary Road Water Feature Contour Lines Debris pile to be removed off site Potential Artifact Traverse Primary Road |

Results: The Project is situated on the northern bank of Cold Spring Creek, which has been subject to previous ground disturbance in the form of a dam and manmade reservoir, existing road and a debris pile of excess sediment and rocks removed from the reservoir (*Appendix A: Figure 3, Appendix B: Photos 1-3*). It is evident that this area has been subject to sediment extraction, mechanical levelling and flooding, all of which has extensively impacted the local terrain and would have removed or displaced potentially culturally-relevant stratum.

The potential artifact was situated in an increasingly disturbed context, on the south side of the (approx.) 500 m³ debris pile situated north of the reservoir (location flagged by McElhanney); excess sediment was regularly excavated from the reservoir as it would obstruct the dam's water intake system (*Appendix B: Photos 4 and 5*). The potential artifact consists of a brown argillite material with bifacial scarring along one lateral edge and visible crushing on either end of the rock. Upon extensive examination of the rock, it was determined the observed scarring and crushing was more conducive to water transport than precontact tool manufacture. The specimen had likely travelled downstream, via water current, from an unknown location and the crushing/impact points were created by contact with submerged stationary rocks in the creek.

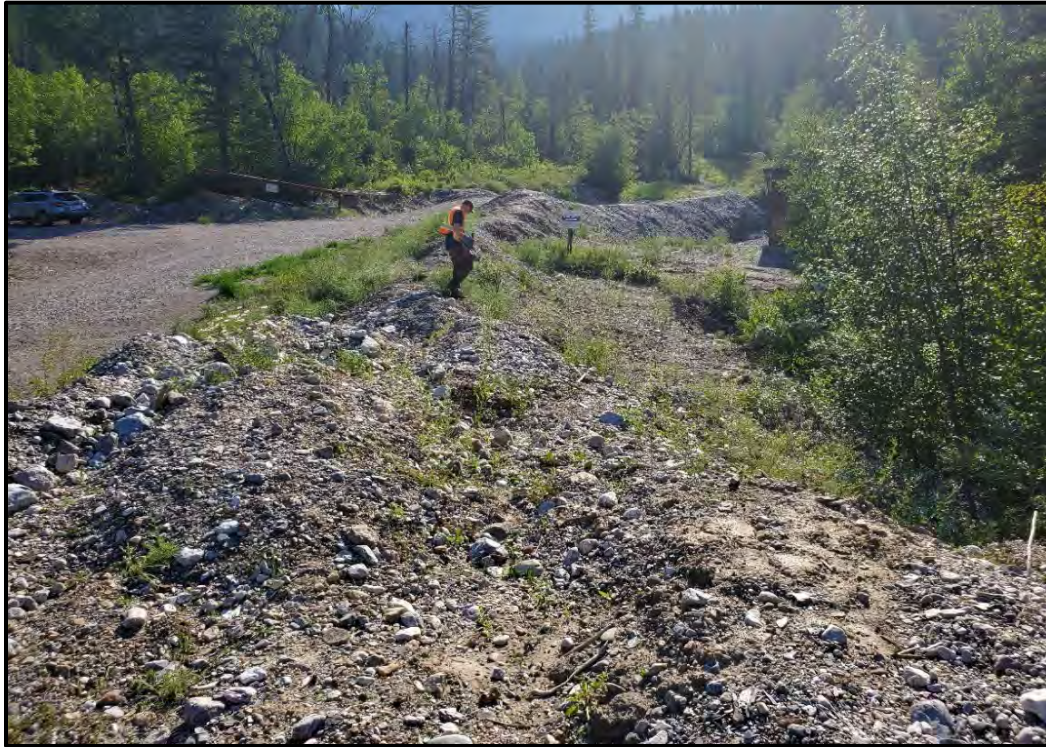
Photo 1. Existing road and evidence of flooding (view: east)

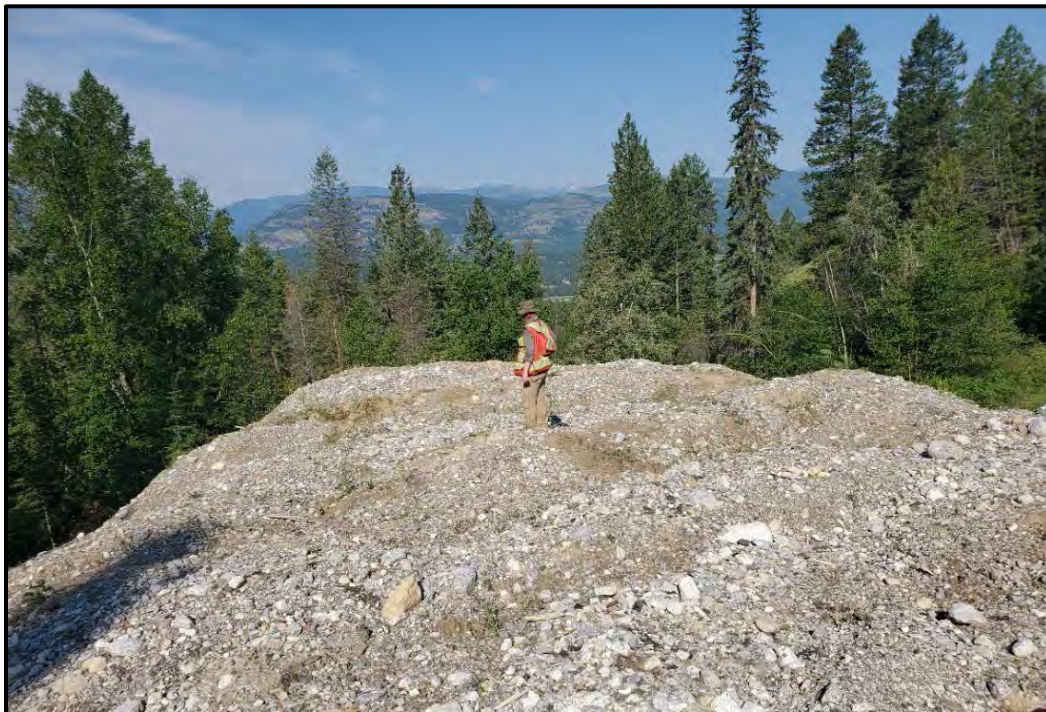
Photo 2. Debris pile from excess sediment/rocks flowing into reservoir, situated to the south and left out of the line of sight in this photo (view: west).

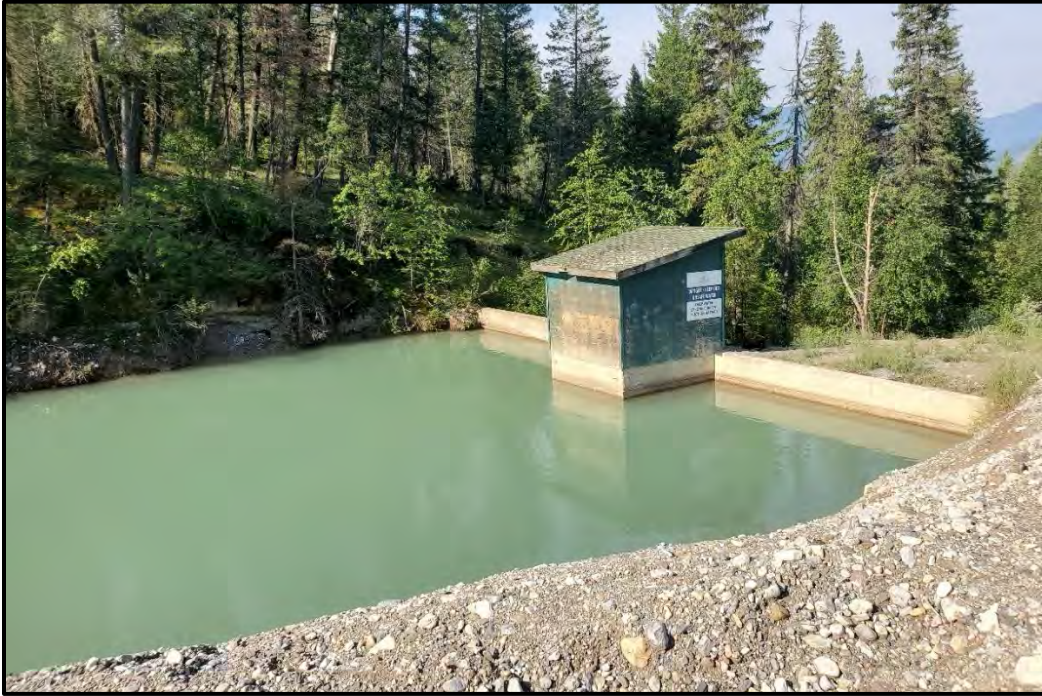
Photo 3. Cold Spring Creek reservoir and dam (view: southwest).

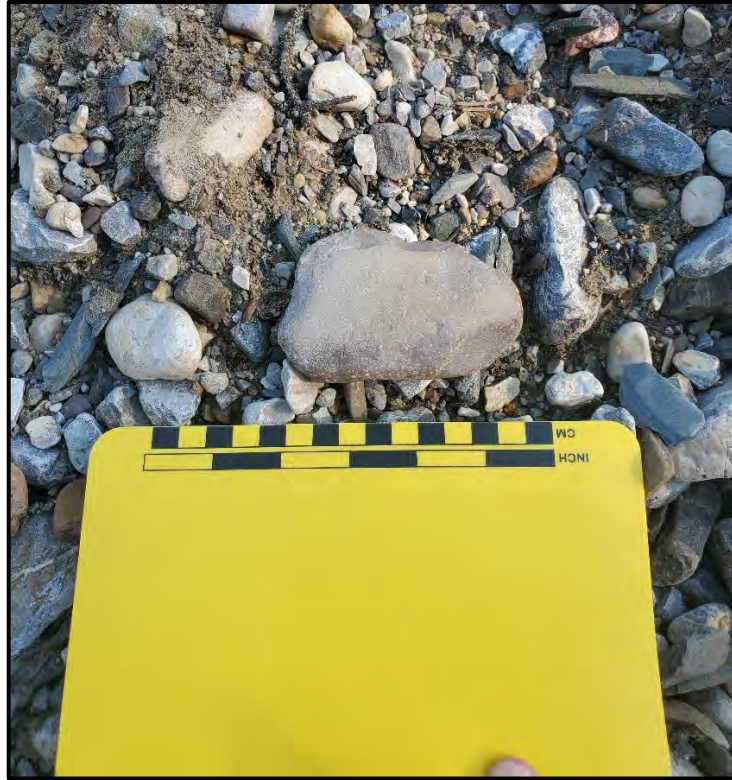
Photo 5. Potential artifact at flagged location, confirmed to be naturally scarred.

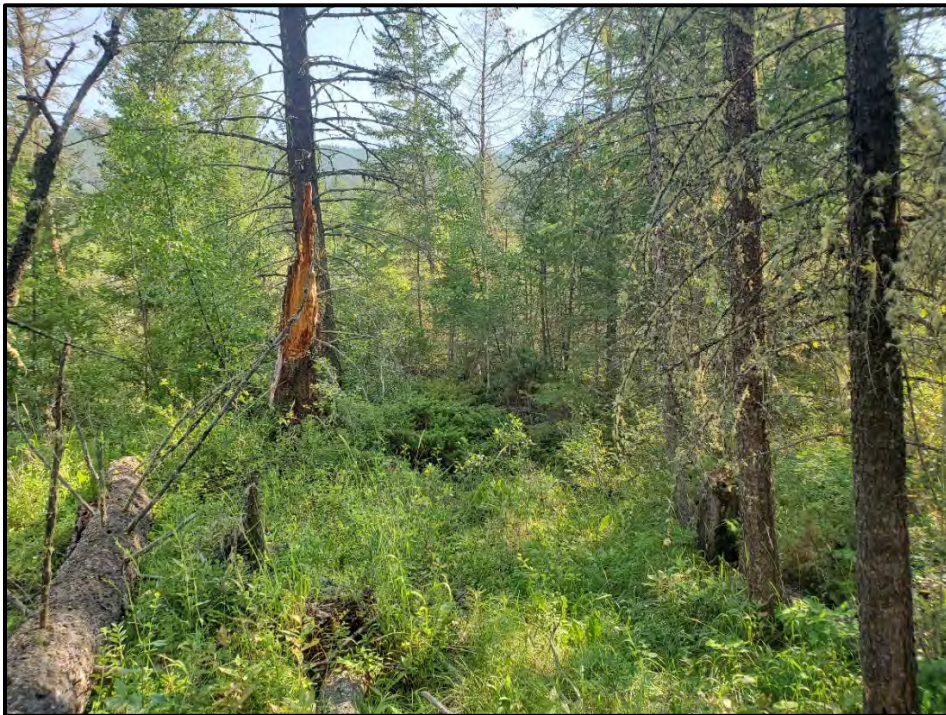
Photo 6. AOP 1: north of the existing road and south of Cold Spring Creek (view: north).

The Proponent indicated that a proposed road is situated on the south side of Cold Spring Creek and would be subject to geotechnical test pits in the near future. The proposed road is situated within the footprint of an existing road, adjacent to (south of) irregular terrain, sloping approximately 5 to 7° to the north (*Appendix A: Figure 3, Appendix B: Photo 6*). Terrain north of the proposed road was identified as an area of archaeological potential (AOP 1) as it may contain archaeological materials due to its location overlooking the drainage to the north, topography, and intact cultural strata (*Appendix A: Figures 2-3*). AOP 1 was not flagged in the field, as the Proponent was present in the field and could identify the AOP.

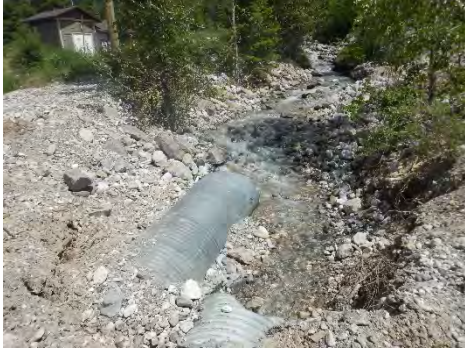
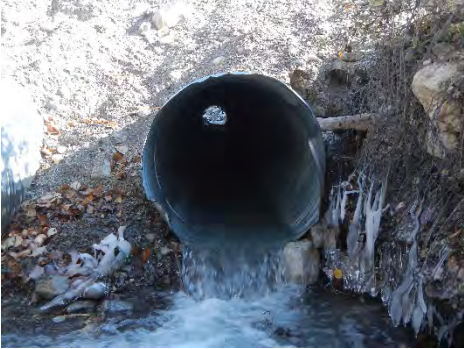
| Location | Inlet | Outlet |
|---|---|---|
| Hot Springs Road | | <p data-bbox="971 632 1442 688">Left bank outlet, right bank was elevated and dry (Oct 10, 2019)</p> |
