# APPENDIX A

## DETAILS OF INFRASTRUCTURE ON FAIRMONT CREEK

# APPENDIX C

# **APPENDIX D**

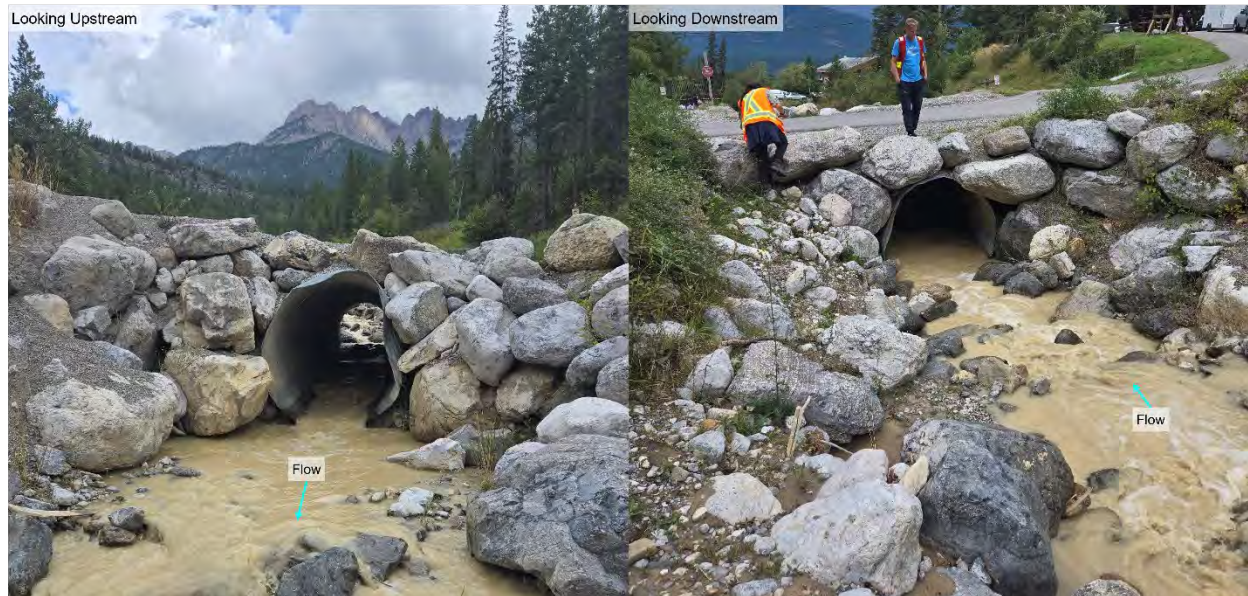
**Figure A-4 Upstream and downstream views of campground access road culvert. Photos taken by BGC on August 27, 2024.**

An access road crosses Fairmont Creek from the main FHSR development to the portion of the campground on the south side of the creek. Fairmont Creek passes through an 1800 mm diameter, corrugated steel pipe that is abutted by rounded boulders (Figure A-4). BGC estimates the capacity of the culvert to be 5 to 7 m<sup>3</sup>/s.

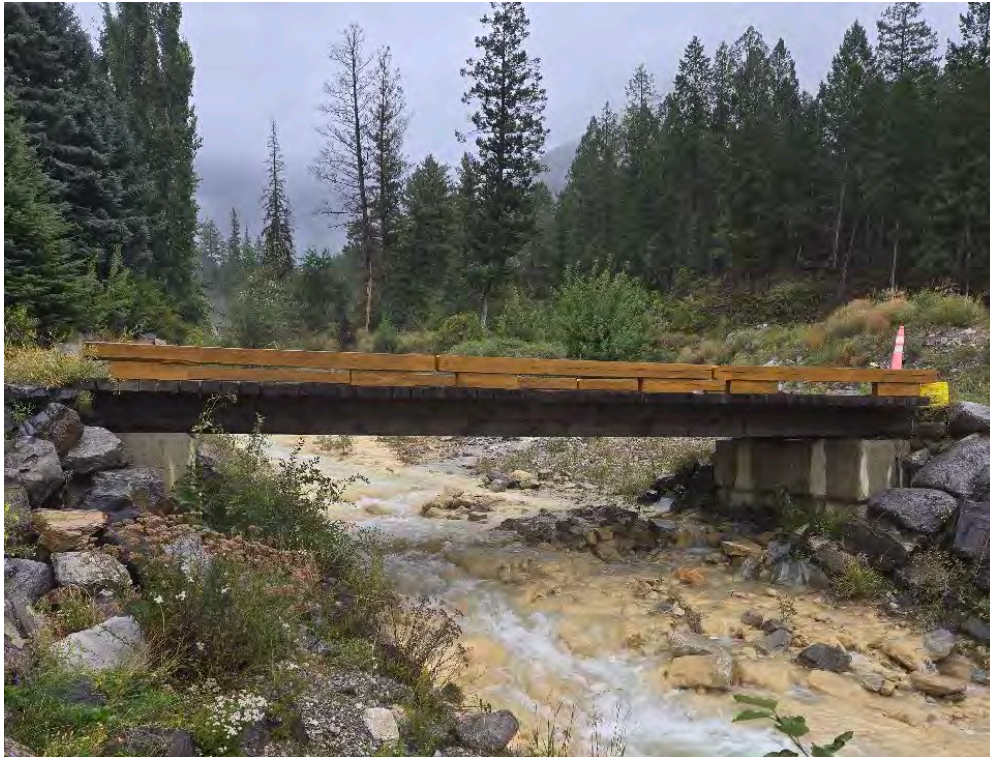
**Figure A-5 Golf course bridge 1 at the downstream end of Marble Canyon. Photo taken looking upstream by BGC on August 28, 2024.**

A golf cart and pedestrian bridge crosses Fairmont Creek at the downstream end of Marble Canyon (Figure A-5). The bridge is wooden with lock block abutments, is 10 m wide across the channel and 2 m above the channel bed. BGC estimates the capacity to be 60 to 70 m<sup>3</sup>/s. This bridge was damaged and/or washed out during the 2012 event.

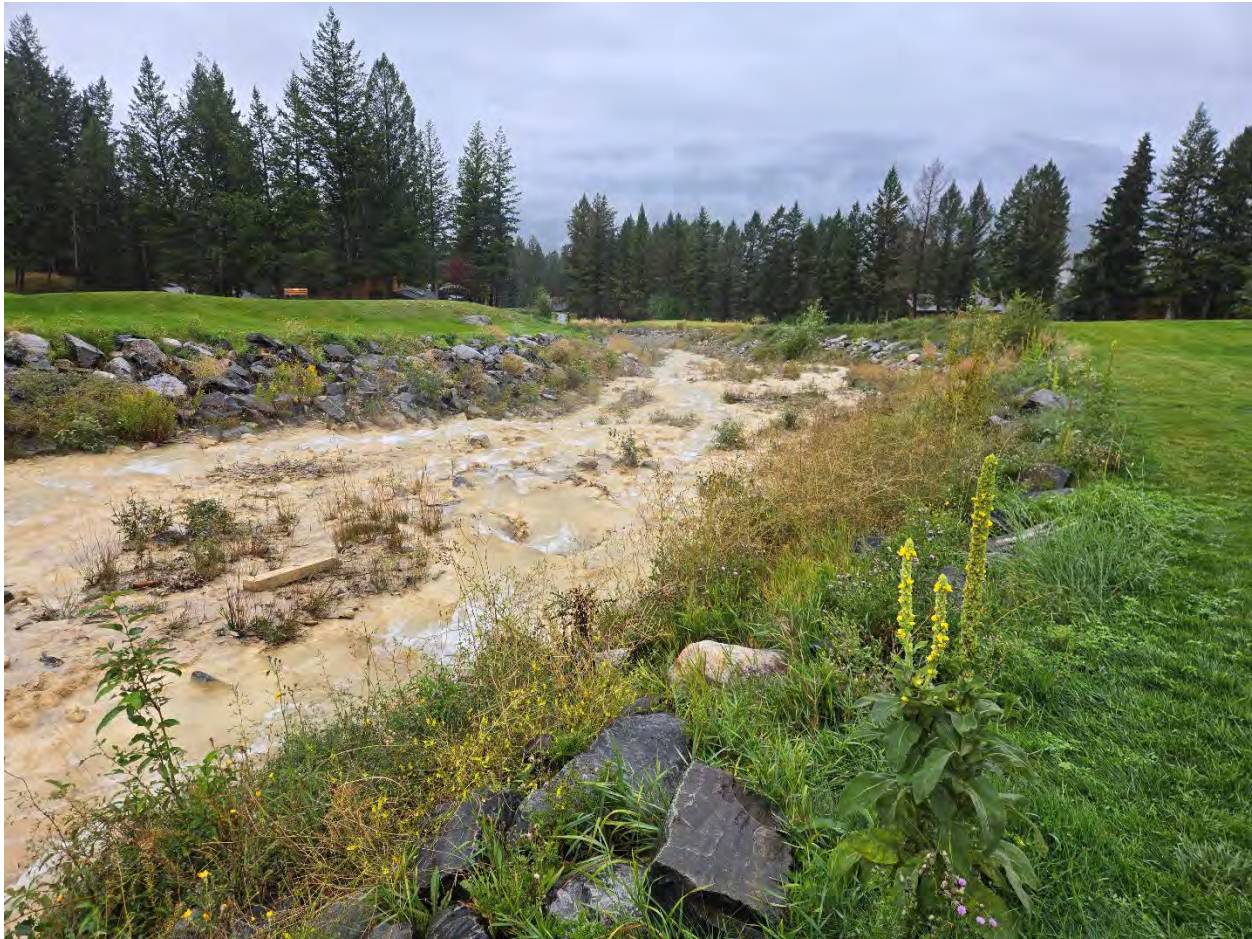
**Figure A-7 Downstream view of Fairmont Creek between Marble Canyon and the golf course pond with built up and armoured banks. BGC photograph of August 28, 2024.**

Generally, the berms beyond the banks of the creek are up to 1 m higher than the surrounding ground, have gentle slopes to blend with the golf course fairways and are unarmoured. The banks were built up and armoured to achieve better conveyance (Figure A-7). Urban Systems Ltd. (September 16, 2015) suggested the berms and bank armouring as constructed can store up to 13,800 m<sup>3</sup> assuming a uniform 1 m deposition across the areas behind the berms.

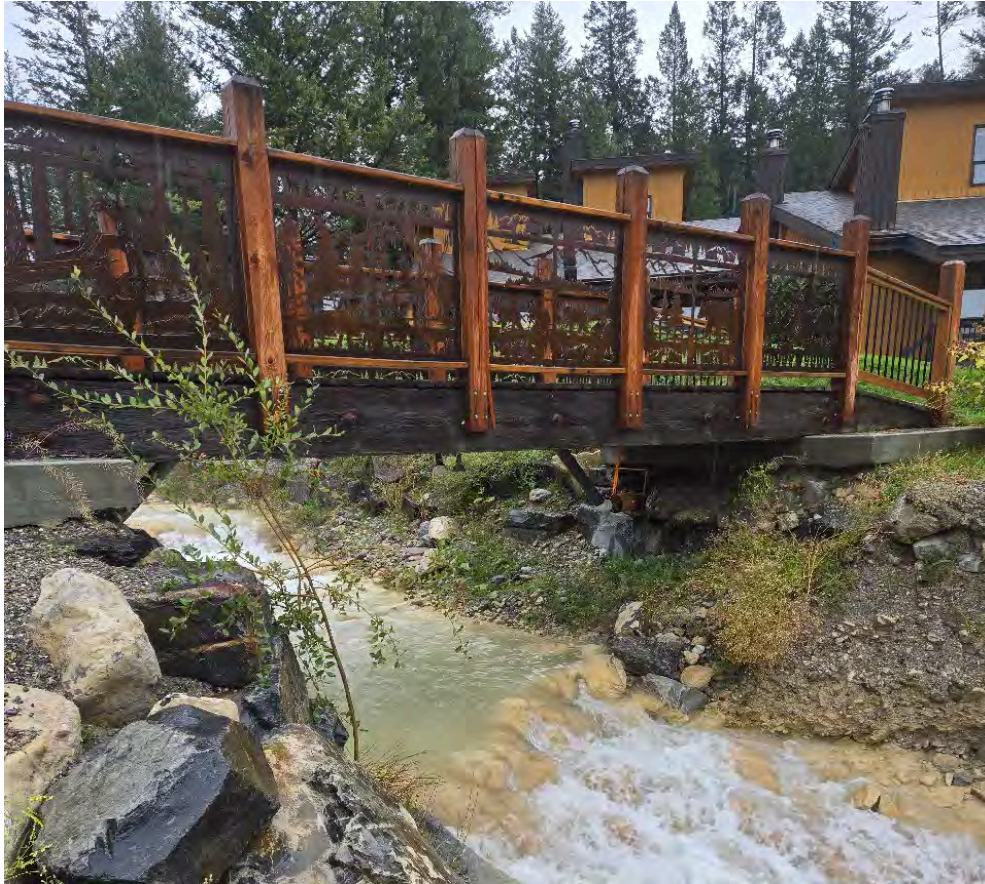
**Figure A-8 Upstream view of Golf course bridge 2 at the inlet to the golf course pond. BGC photograph of August 28, 2024.**

At the inlet of Fairmont Creek to the golf course pond there is a pedestrian bridge (Figure A-8). The wooden bridge is on concrete pads, approximately 4 m wide across the creek and 2 m above the channel bottom. BGC estimates the capacity to be 15 to 20 m<sup>3</sup>/s. This bridge was washed out during the 2012 event.

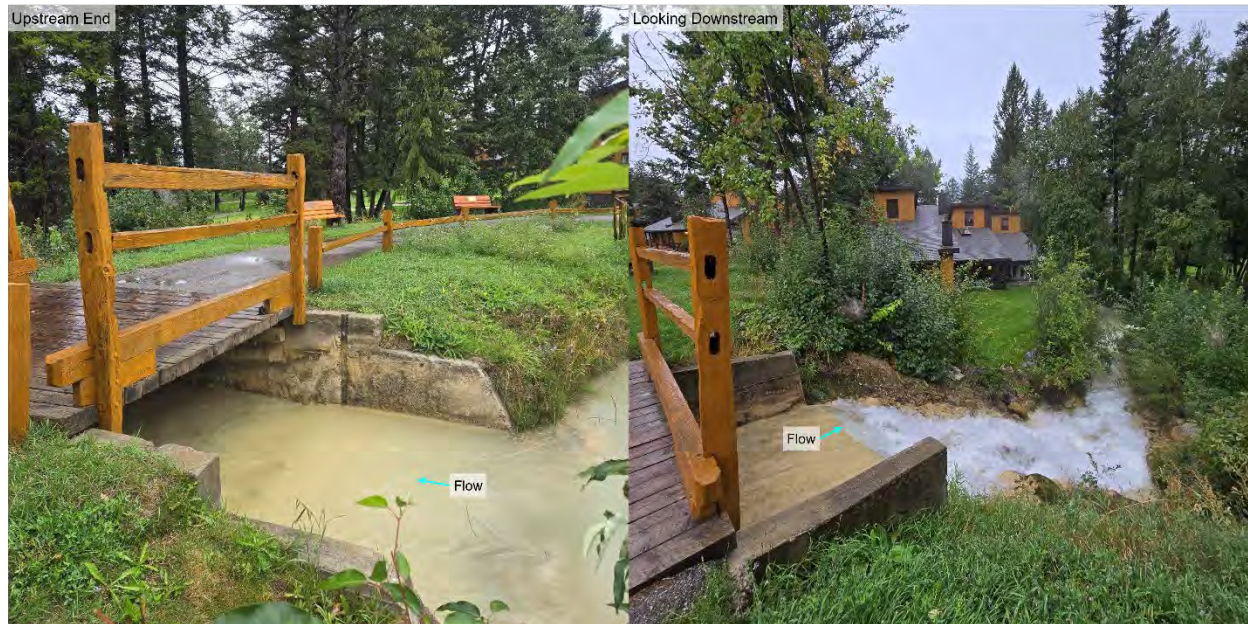
**Figure A-9 Upstream and downstream views of the golf course pond outlet bridge and weir structure. BGC photographs of August 28, 2024.**

At the outlet of the golf course pond there is a pedestrian bridge (Figure A-9). The wooden bridge is on a concrete channel that acts as a weir, approximately 3 m wide across the creek and 2 m above the channel bottom. BGC estimates the capacity to be 15 to 20 m<sup>3</sup>/s. This bridge was washed out during the 2012 event.

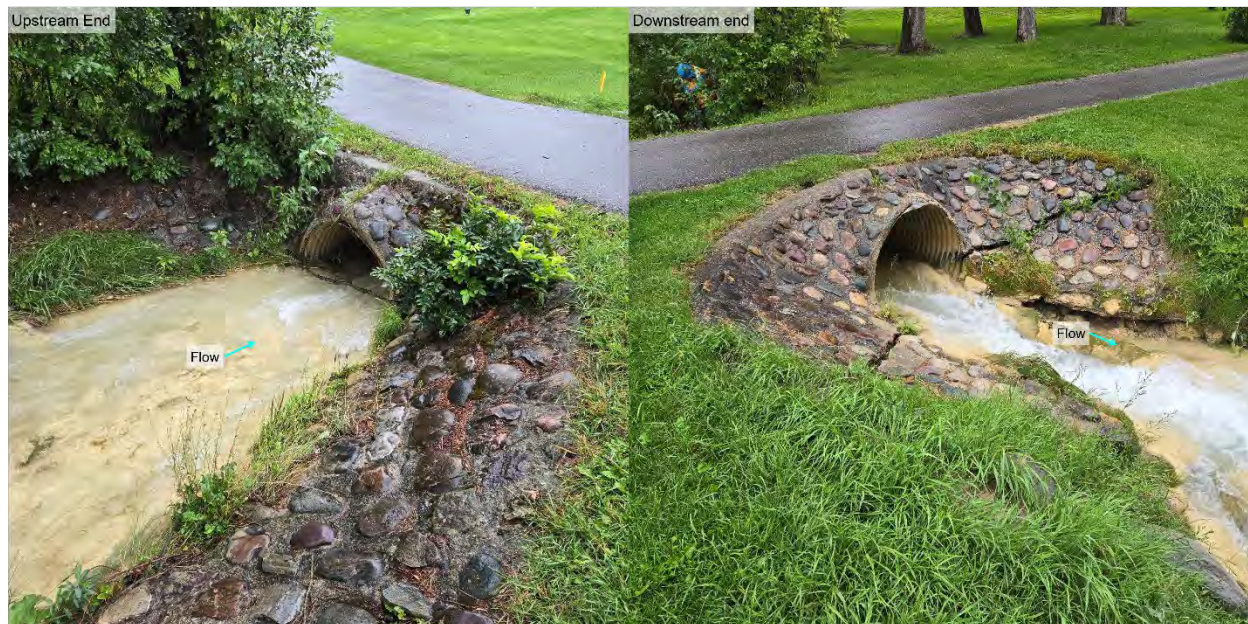
**Figure A-10 Upstream and downstream views of the golf cart path culvert. Photos taken by BGC on August 28, 2024.**

Between the golf course pond and the Mountain Villas access road, there is a golf cart path that crosses Fairmont Creek with a culvert (Figure A-10). The culvert is an 1100 mm diameter, steel corrugated pipe with grouted, stone pitching wingwalls. BGC estimates the capacity to be 1 to 2 m<sup>3</sup>/s. This culvert was flooded during the 2012 and 2020 events.

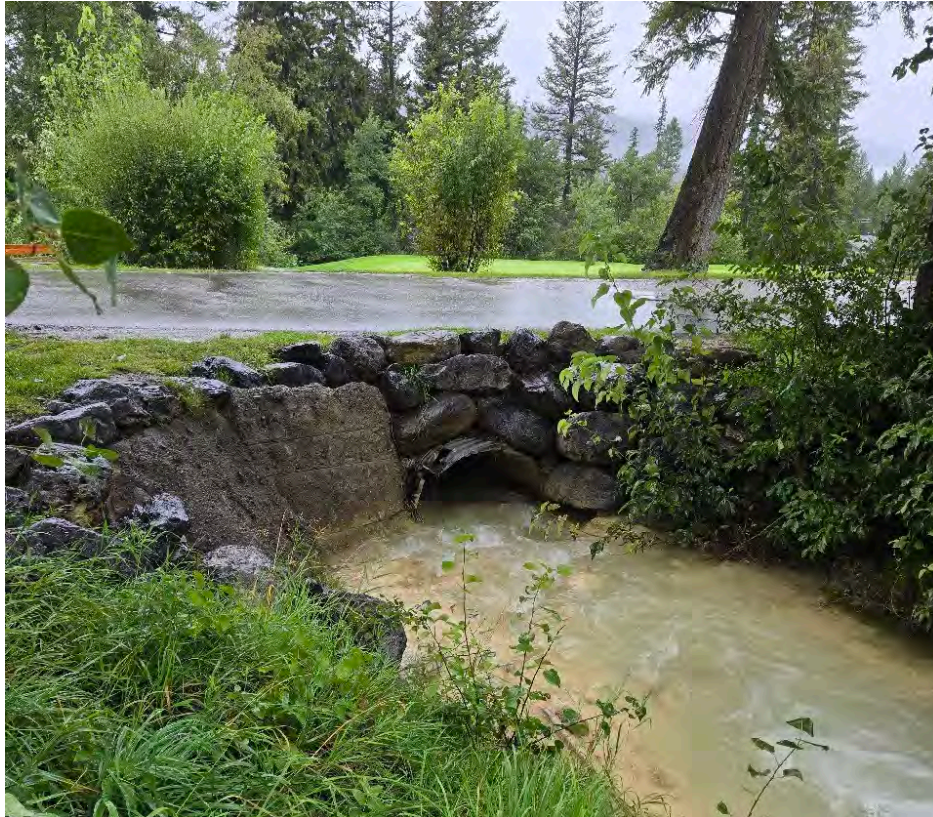
**Figure A-11 Upstream view of the Mountainside Villas culvert. Photo taken by BGC on August 28, 2024.**

At the Mountainside Villas access road, Fairmont Creek passes through a culvert (Figure A-11). The culvert is an 1100 mm diameter, steel corrugated pipe with riprap and cast-in-place concrete wingwalls. BGC estimates the capacity to be 1 to 3 m<sup>3</sup>/s.

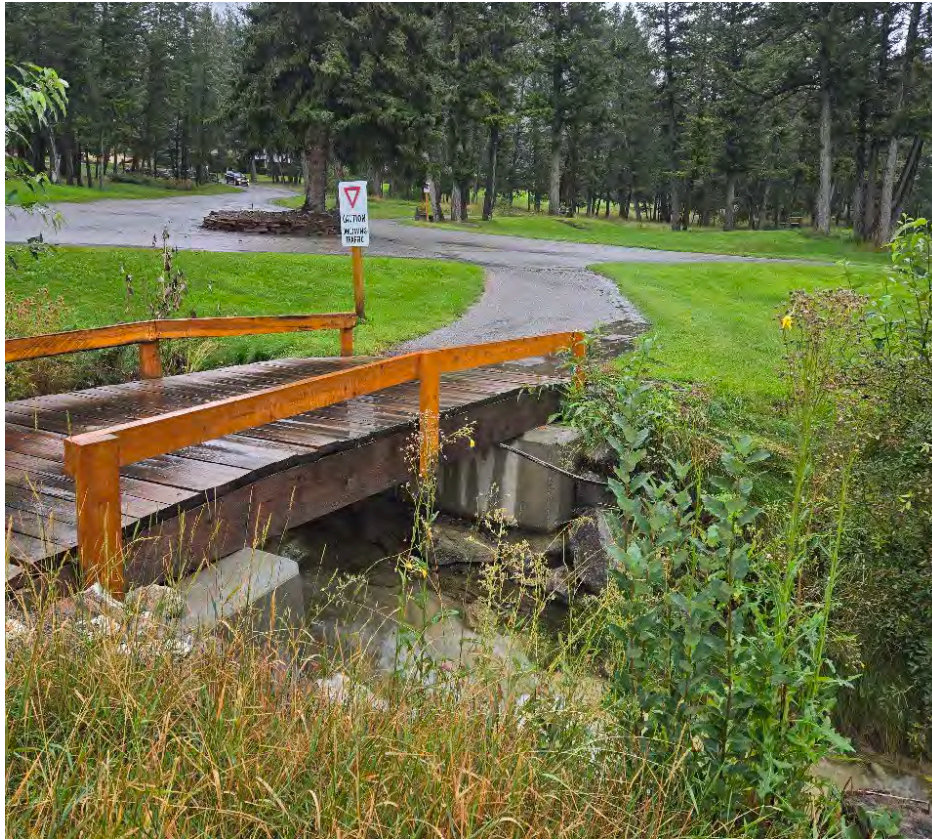
**Figure A-12 Downstream end of the golf cart path bridge. Photo taken by BGC on August 28, 2024.**

As the creek runs adjacent to the most downstream golf fairway, it crosses under a golf cart path bridge (Figure A-12). The wooden bridge is on lock block abutments, 3 m wide across the channel and 1.5 m above the channel. BGC estimates the capacity to be 10 to 15 m<sup>3</sup>/s.

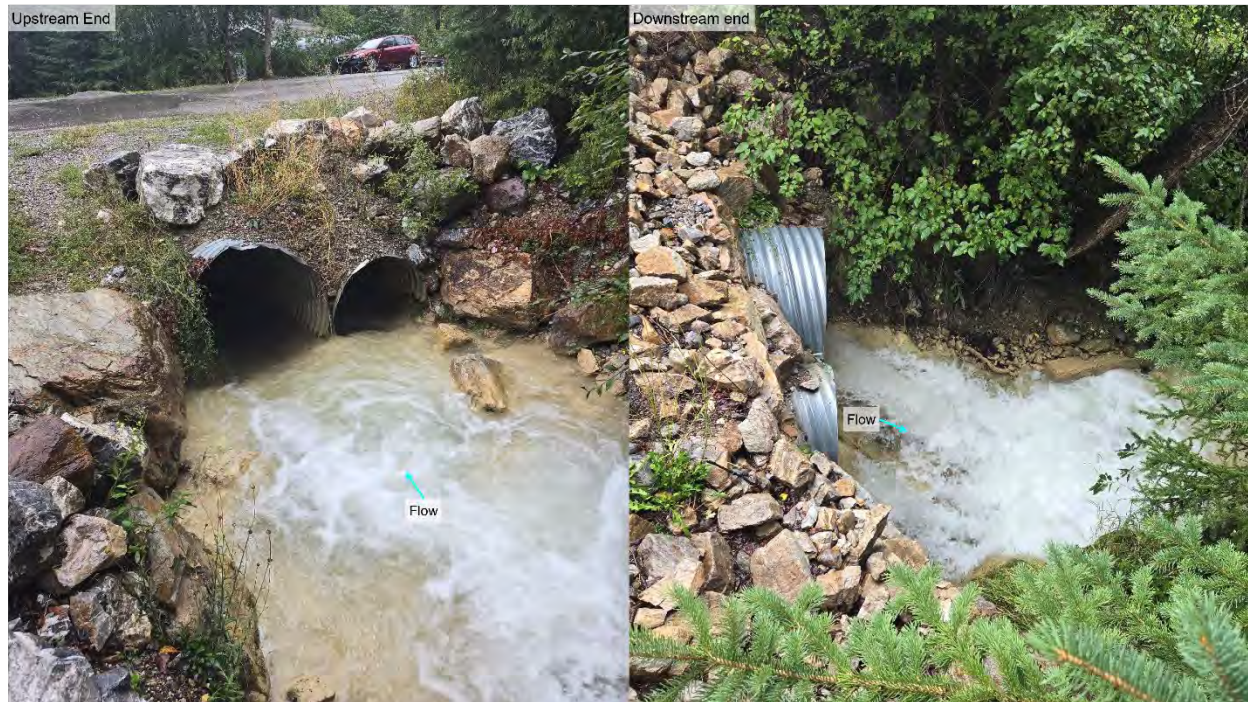
**Figure A-13 Twinned culverts at Columbia River Road crossing. Photos taken by BGC on August 28, 2024.**

At Columbia River Road, Fairmont Creek passes through twinned culverts (Figure A-13). The culverts are 1200- and 1000-mm diameter, steel corrugated pipes with riprap wingwalls. BGC estimates their combined capacity to be 3 to 7 m<sup>3</sup>/s.

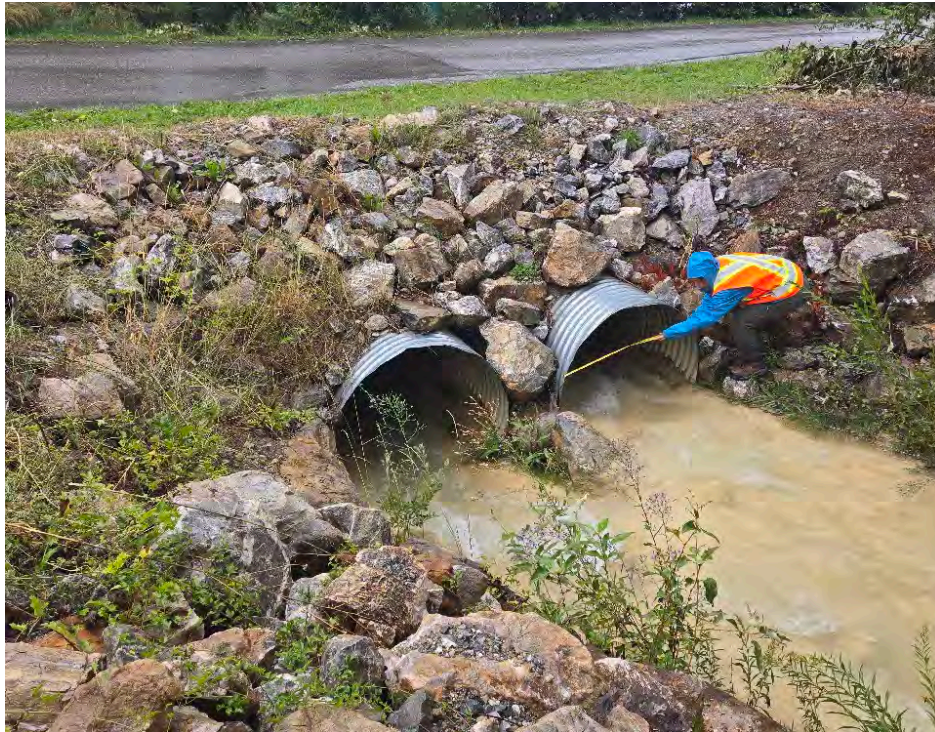
**Figure A-14 Upstream end of the twinned culverts at Fairmont Creek Road. Photo taken by BGC on August 28, 2024.**

At Fairmont Creek Road, Fairmont Creek passes through twinned culverts (Figure A-14). The culverts are both 1100 mm diameter, steel corrugated pipes with riprap wingwalls. BGC estimates their combined capacity to be 3 to 6 m<sup>3</sup>/s.

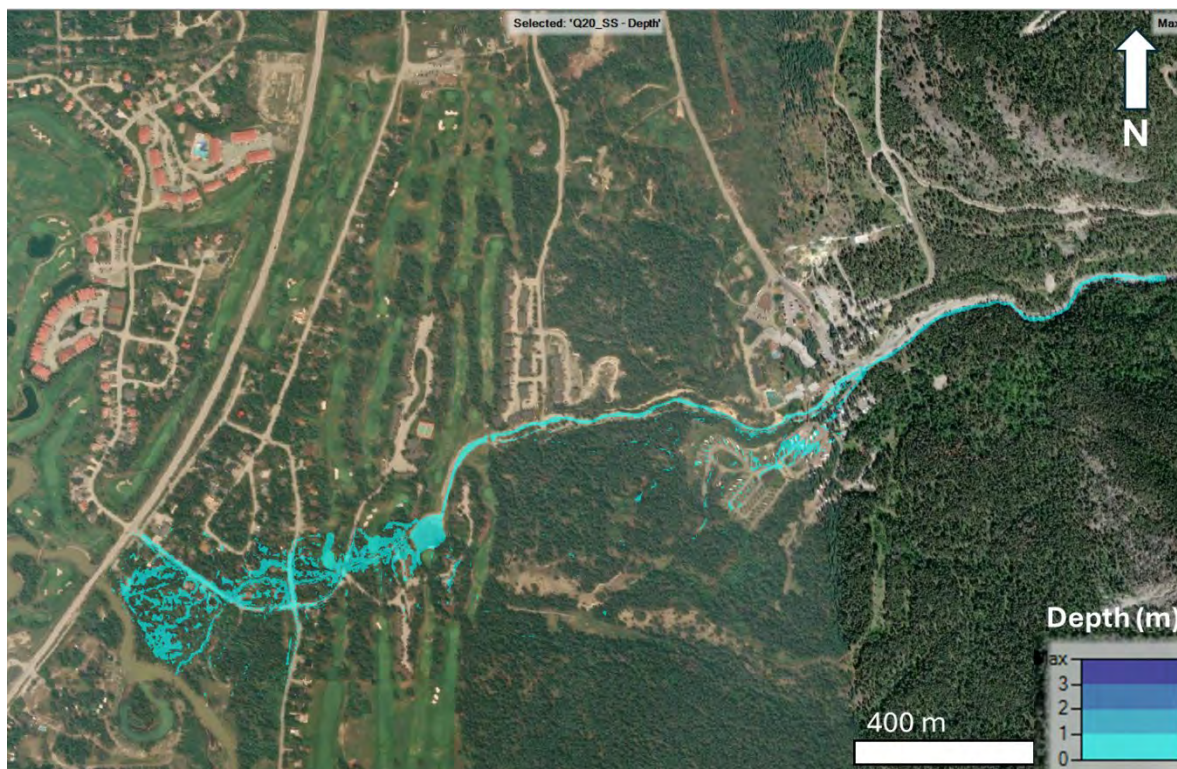
Figure D-2 10 to 30- year return period debris flood maximum modelled depth.

Figures showing peak flow depth for each modelled hazard scenario are provided in Figure D-2 to Figure D-6. Raw model results are on file at BGC and available upon request.

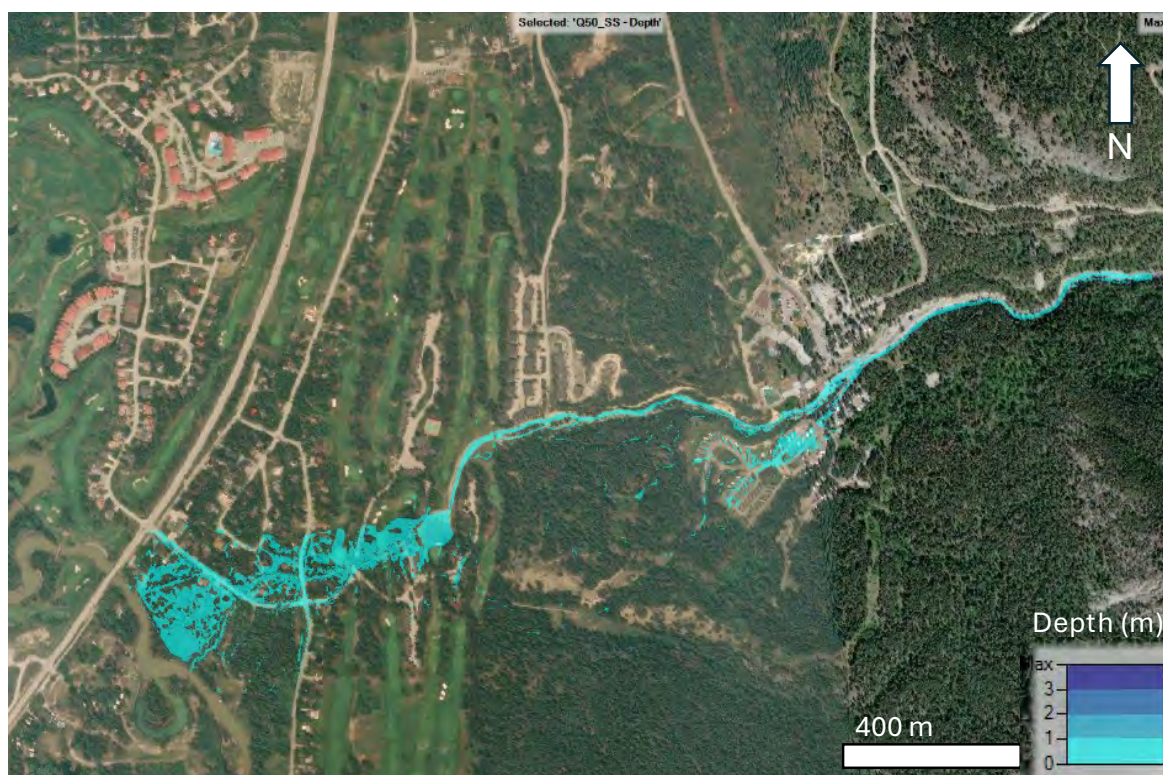
Figure D-3 30 to 100- year return period debris flood maximum modelled depth.
