# Fairmont Creek Updated Hazard and Risk Assessment

Prepared by **BGC Engineering Inc.** for:  
**Regional District of East Kootenay**

October 24, 2025

Project 1127008

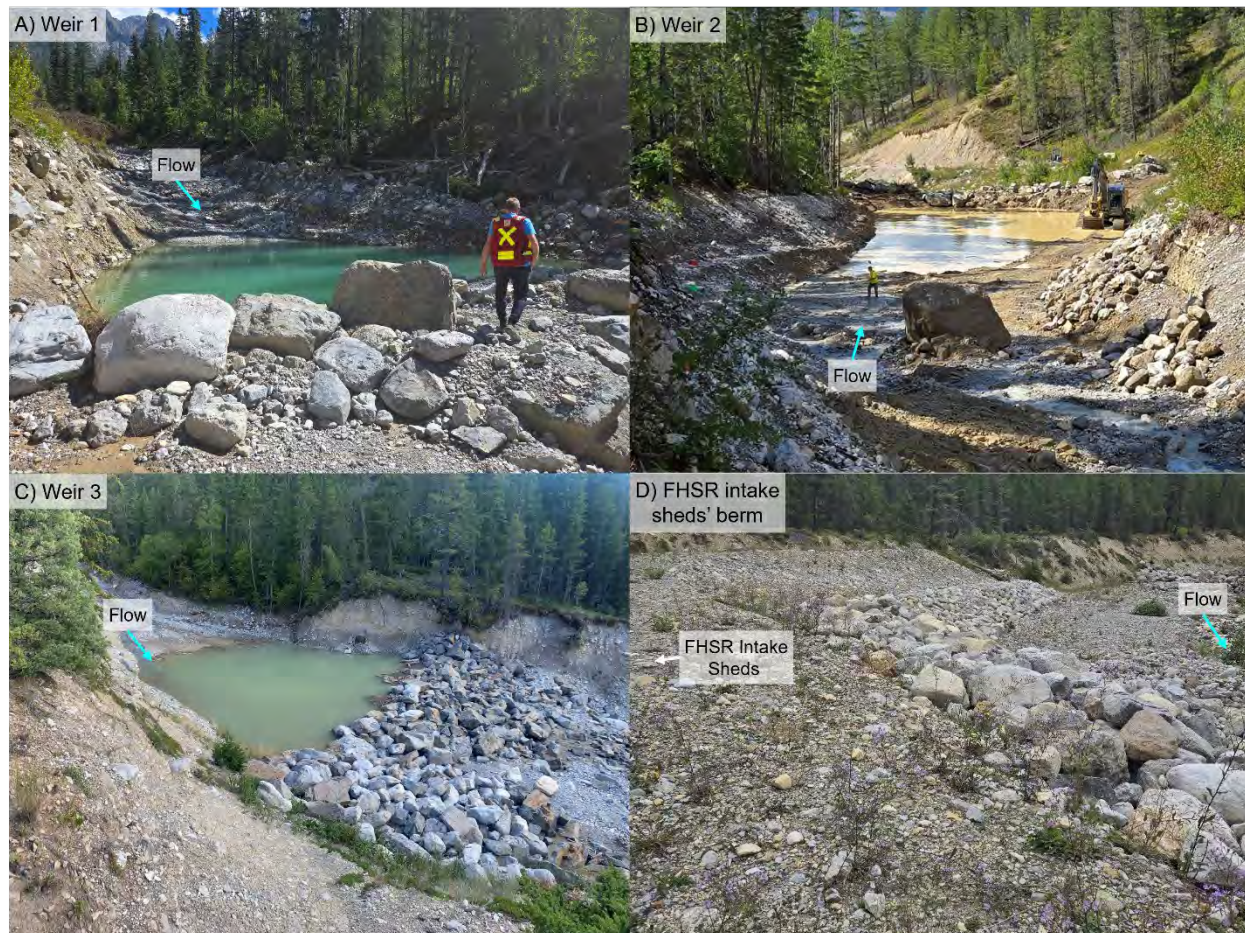
**Figure 1-4** Photos of the weirs and berm taken during BGC's August 2024 field visit. The photo of the berm shows the general condition and structure of the berm but does not show the entire extent.

configuration of the weirs and basins may not exactly match the design drawings. BGC has not reviewed the construction completion documentation. Figure 1-4 shows photos from BGC's field visit in August 2024.

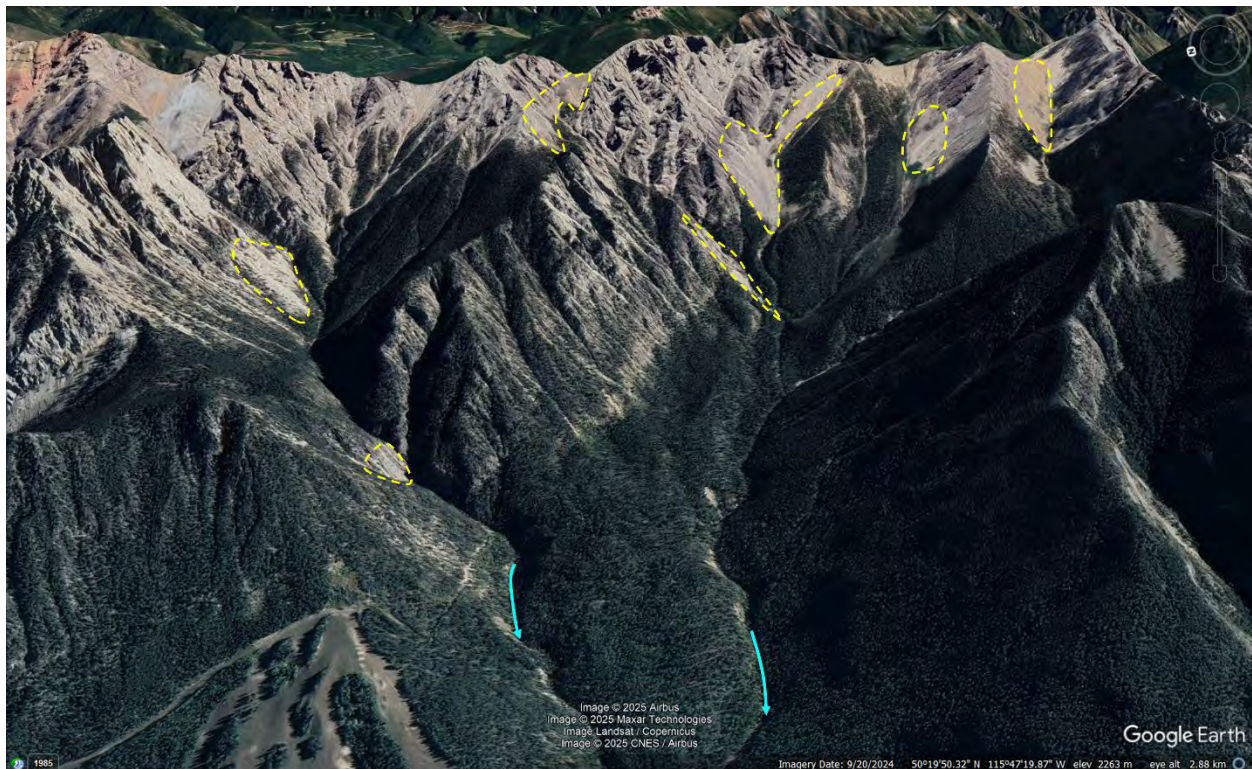
**Figure 2-1 View of upper Fairmont Creek watershed highlighting unvegetated talus slopes (dashed yellow areas). Imagery from Google Earth.**

The bedrock geology in the watershed consists of meta-sedimentary rocks of the Horsethief, Beaverfoot and Sullivan formations (Höy et al., 1994). The rocks vary from limestones and dolomites to phyllites but can generally be categorized as highly weatherable carbonaceous or calcareous rocks. Due to the high weathering potential of these rock types, there is an abundance of sediment available for transport in the form of talus slopes in the upper watershed and bedrock colluvium in the mid to lower watershed (Figure 2-1).

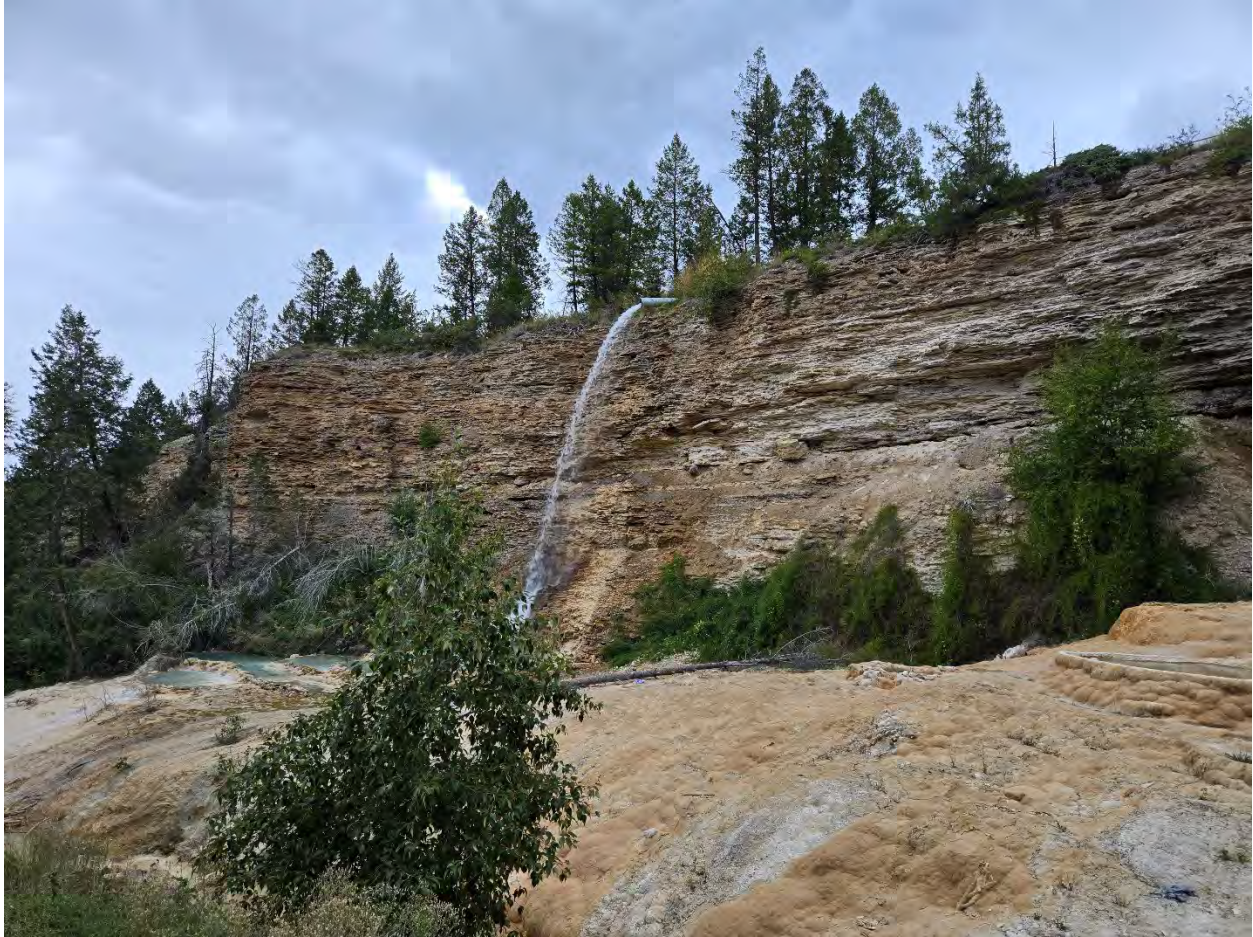
**Figure 2-2** Vertical carbonate spring deposits on the right (north) sidewall of Marble Canyon with the FHSR spring water outlet. Photo taken by BGC on August 27, 2024.

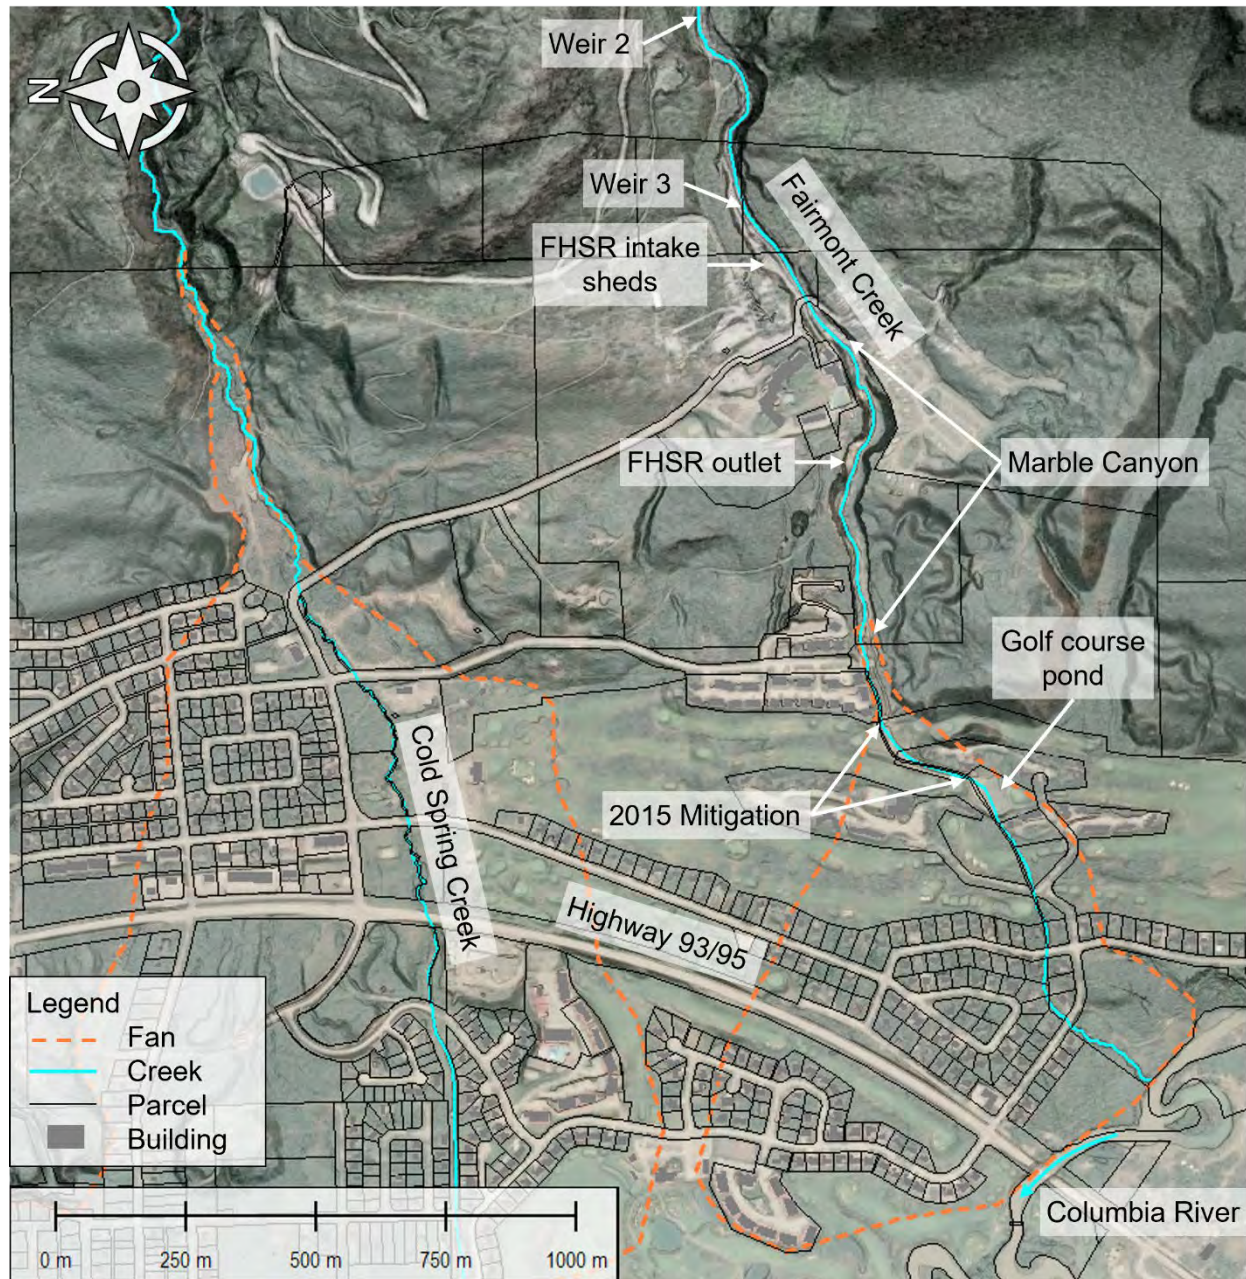
**Figure 2-4 Key locations along Fairmont Creek. The background imagery is a combination of 2018 lidar hillshade and 2023 imagery.**

Marble Canyon is up to 25 m deep and 30 m wide (Figure 2-4). The active channel is 5 to 10 m wide with a recreational trail parallel to the channel through the canyon. FHSR outlets their spring water to Fairmont Creek 300 m upstream from the fan apex (Figure 2-4). Some pools have been formed under the outlet providing freely accessible hot springs to the public. From this outlet point downstream to the golf course pond, there are observable deposits of carbonates on the channel bed.

From the Marble Canyon outlet, the creek turns to flow south through the Mountainside Golf Course as it enters the fan. From the fan apex to the golf course pond, the creek is approximately 6 to 13 m wide since the 2015 mitigation work. The golf course pond is approximately 400 m downstream of the fan apex and has a surface area of 3,000 m<sup>2</sup>. This pond has acted like a sediment retention basin in previous events in 2012 and 2020. In the 2020 debris flood, the golf course pond was estimated to have contained 8,000 m<sup>3</sup> of debris (NHC, June 24, 2020), which is close to Clarke and Golder (2013)'s capacity estimate of 7,000 m<sup>3</sup>.

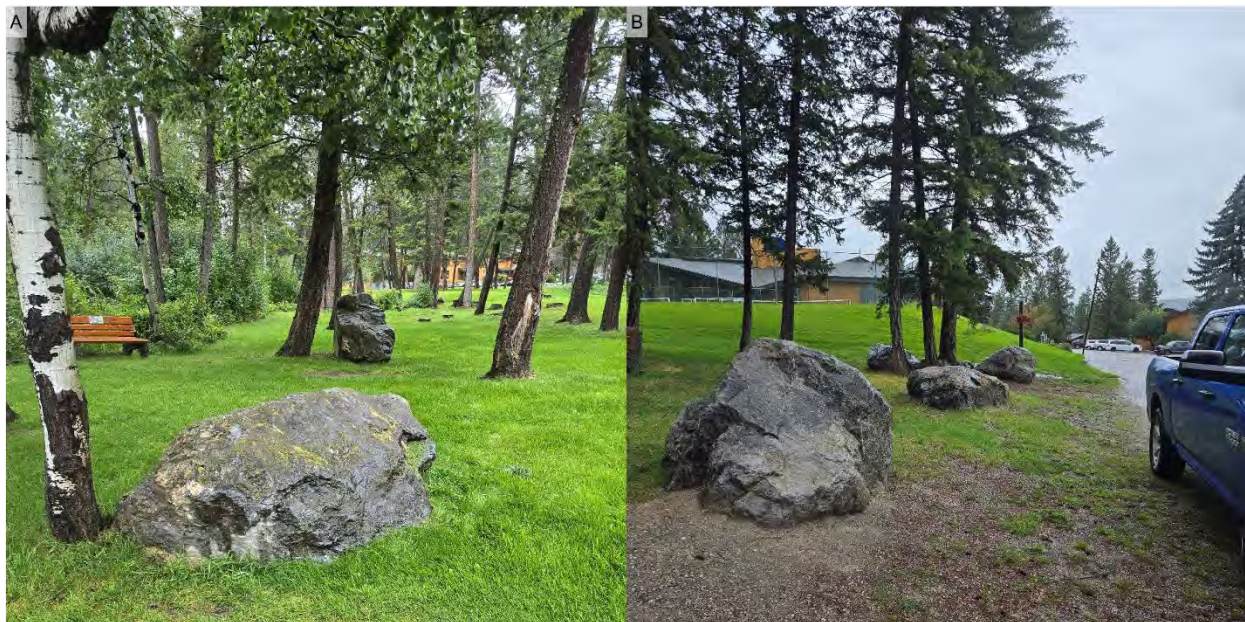
**Figure 3-2 Boulders found on the mid-fan that are interpreted to be from historical debris flows. Photos taken by BGC on August 28, 2024.**

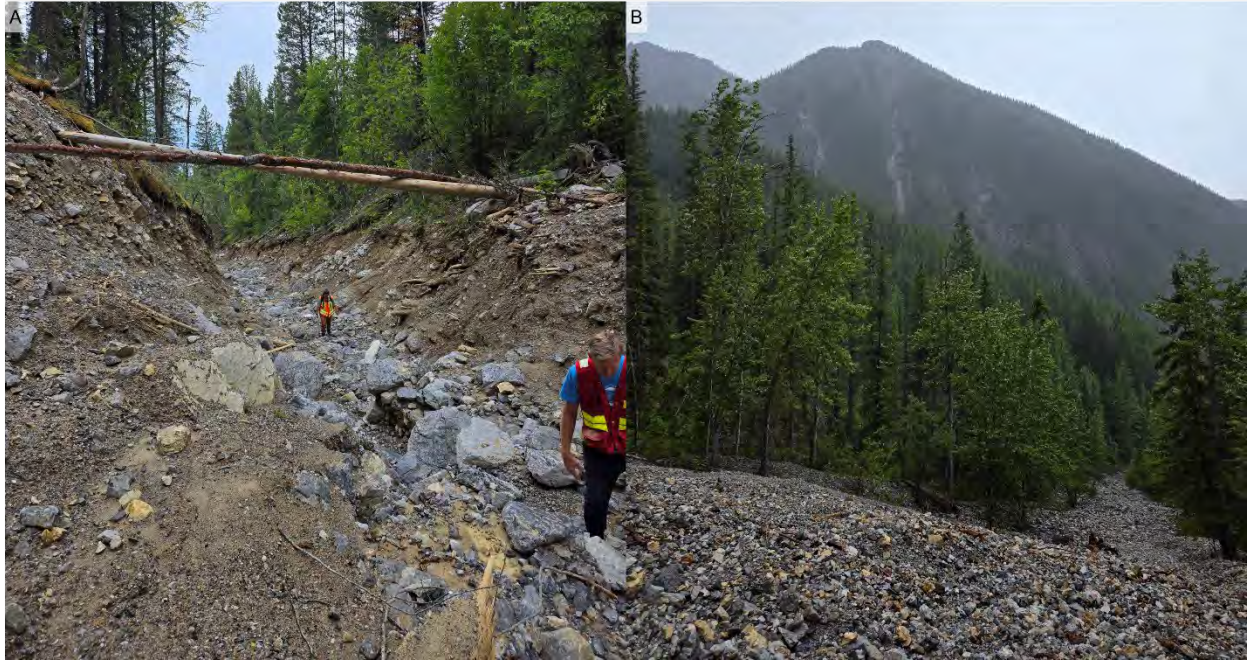
**Figure 3-3** Extensive sediment supply in the watershed. A) From erodible materials in the banks and B) weak, weathering bedrock and talus slopes. Photos taken by BGC on August 27, 2024.

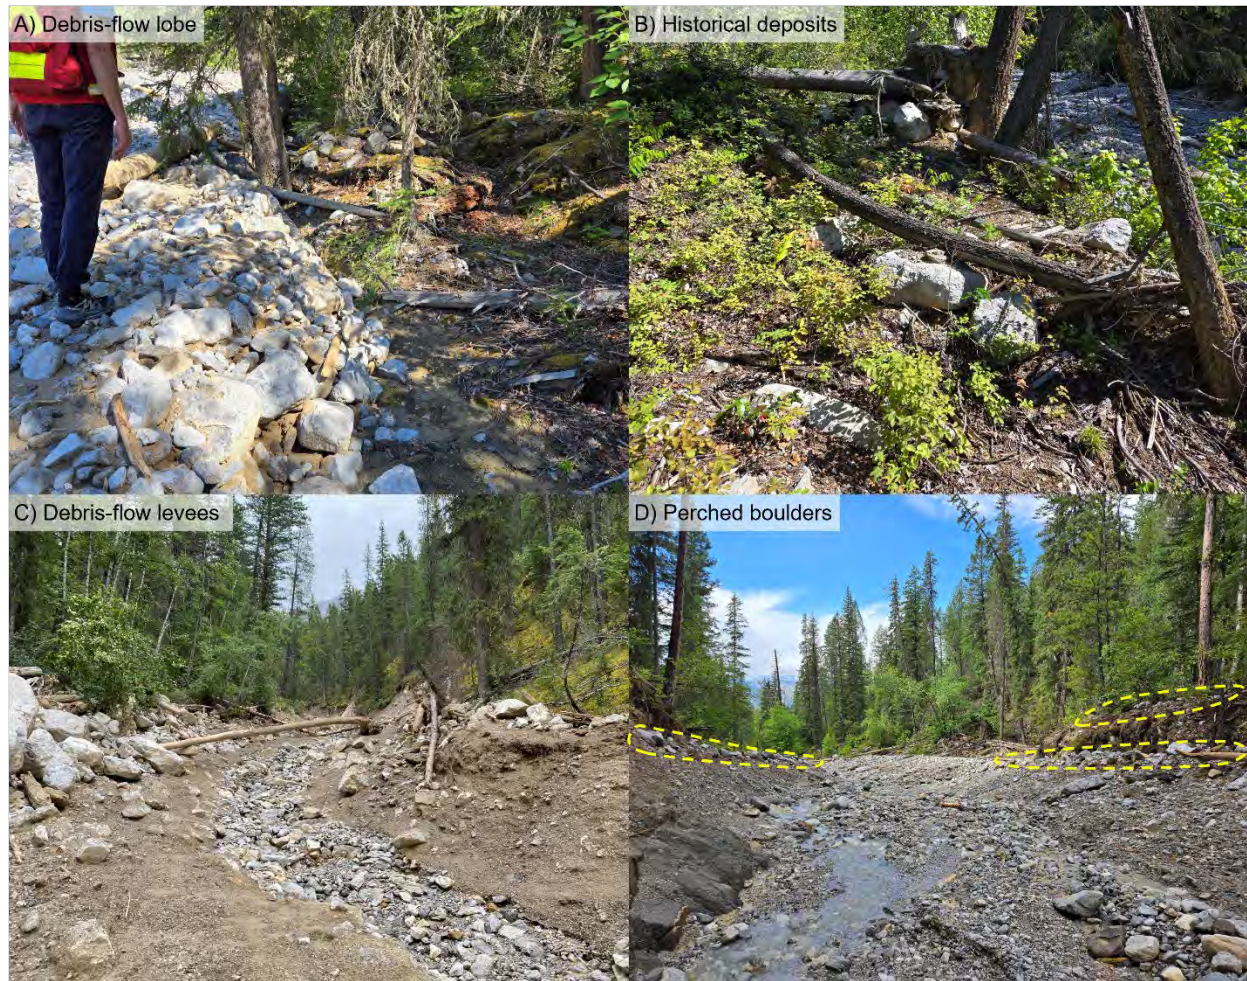
**Figure 3-4 Debris flow geomorphology observed in the watershed on both main tributaries. Photos taken by BGC on August 26 and 27, 2024.**

- The creek produced a debris flow in 2012 and several debris floods in the last decade
- The average channel gradient above the fan apex is 29%, which allows sustained debris flow transport
- Large, subangular boulders are found at surface around the fan that are likely to have been transported by past debris flows (Figure 3-2)
- BGC interprets the watershed to be supply-unlimited, i.e., event sizes are limited by the transport capacity of the creek rather than sediment availability (Figure 3-3)
- BGC observed debris-flow geomorphology in the watershed while in the field, e.g., historical deposits, levees, debris lobes, and high-water marks well above typical creek levels (Figure 3-4).

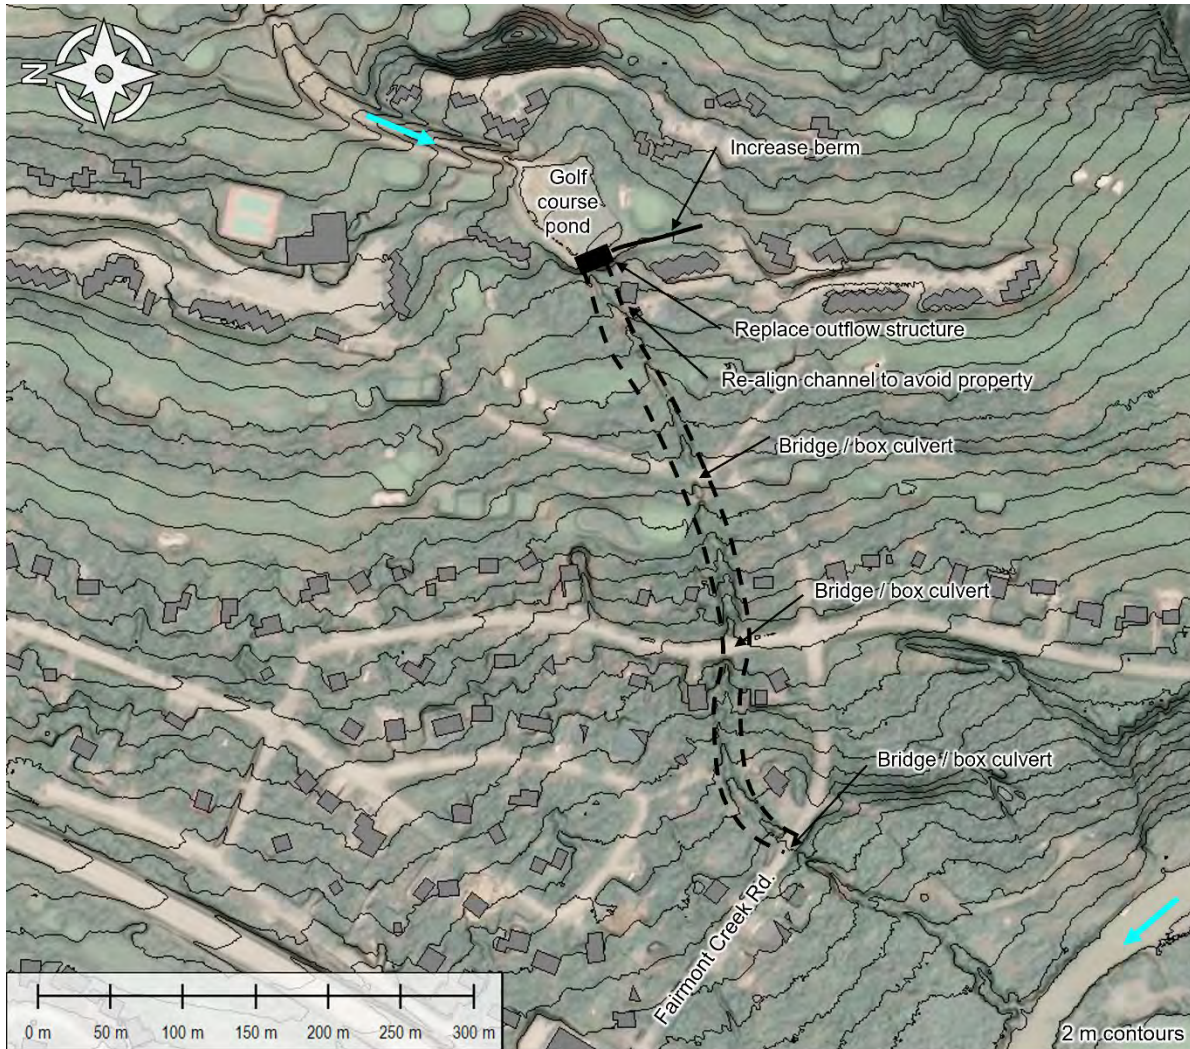
**Figure 6-4 Conceptual layout of improved channel conveyance (dashed black line) on the Fairmont Creek fan. Sketches are not to scale.**

This option would require channel improvements to approximately 450 m of channel and the upgrade of three road crossings to higher conveyance structures such as bridges or box culverts. BGC estimates the order of magnitude cost for this option to be \$5M to \$15M. The large range in the cost is due to the uncertainty of what space would be afforded for this option and what type of channel improvements would be made (e.g., berms, grouted riprap armouring).

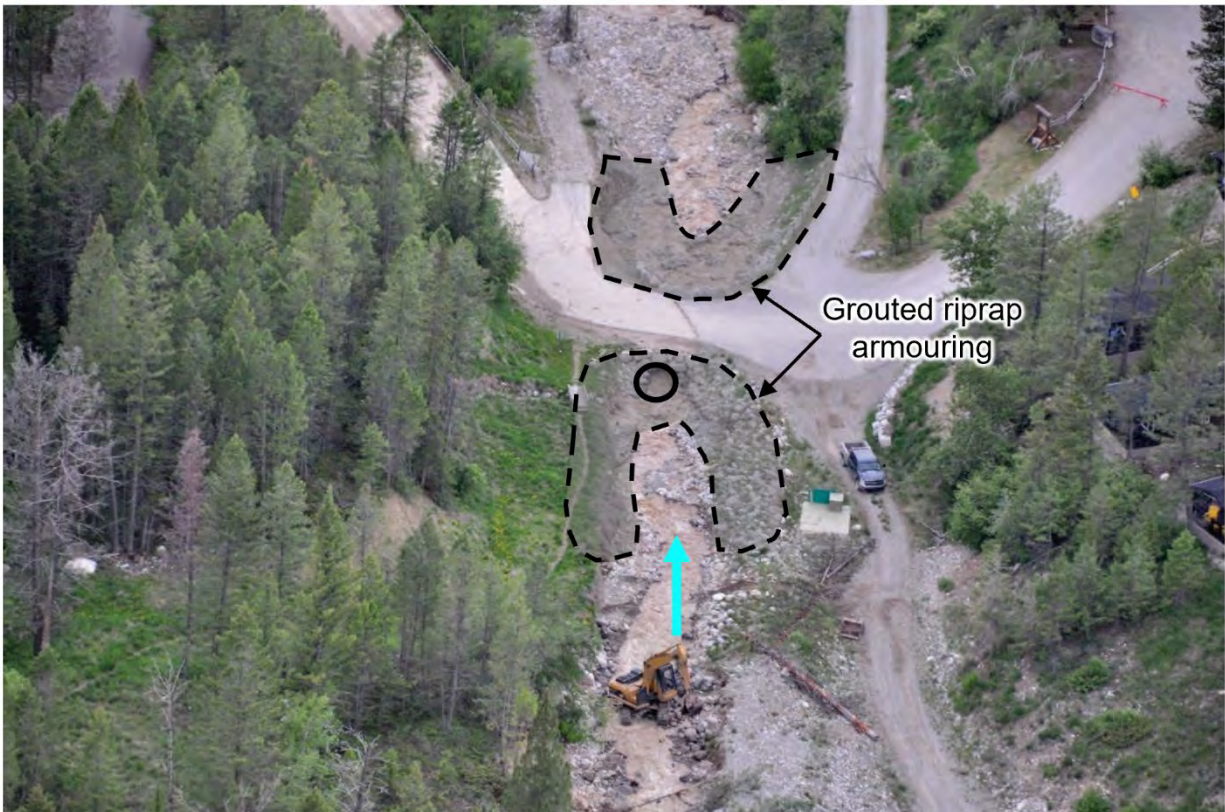
**Figure 6-5** Conceptual layout of armouring around campground access road culvert crossing. Background image is an aerial photo taken after the 2020 event looking west (NHC, 2020). Sketches are not to scale.

The conceptual layout of this design requires an area of approximately 400 m<sup>2</sup> to be armoured. Grouted riprap armouring is likely the most effective armouring material to resist debris flows. BGC estimates the order of magnitude cost for this option to be \$0.5M to \$1M.
