FAIRMONT HOT SPRINGS DEBRIS FLOODS

COMMUNITY UPDATE // SEPTEMBER 2020

MAY 31, 2020 EVENT

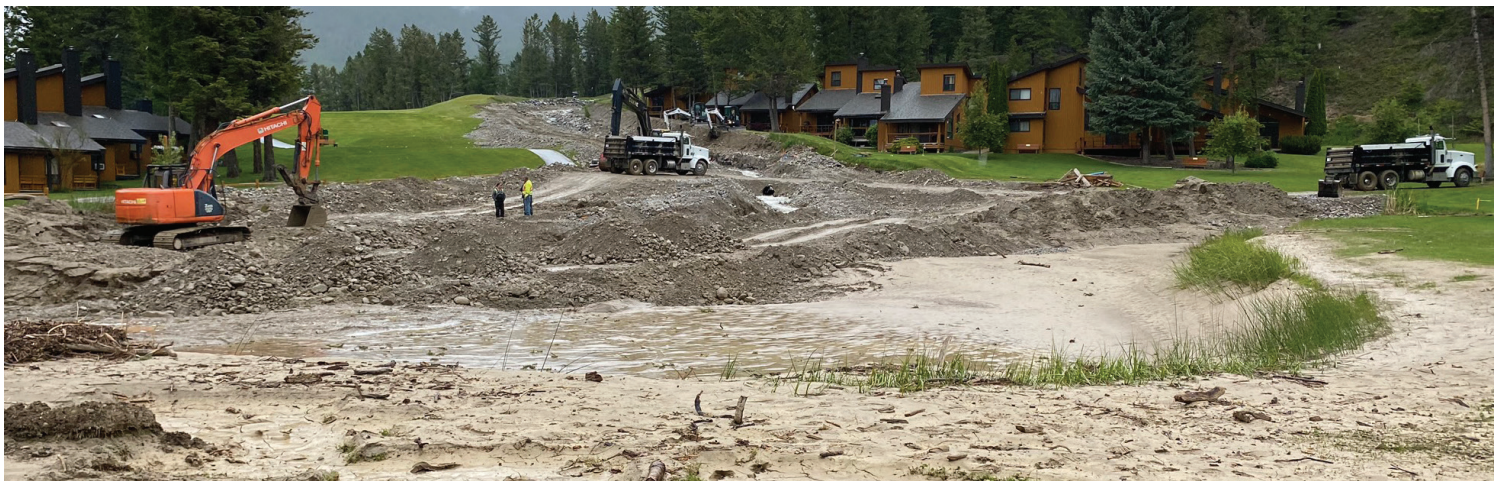
In Fairmont Creek, approximately 20,000 cubic meters of debris was deposited in the upper catchment basins upstream of the resort and an additional 10,000 cubic meters was deposited in the armoured channel that flows through the golf course and into the golf course pond. This is approximately 50% of the volume of material that was deposited on the fan in the 2012 event. The 2020 event was estimated to be roughly a

In Cold Spring Creek, approximately 2,000 cubic meters of debris was deposited in the Cold Spring Reservoir and an additional 2,000 cubic meters was deposited in the lower Cold Spring Debris Trap.

In addition to the large volumes of debris that were captured in the traps, the high flows overwhelmed culverts along both creeks causing minor localized flooding.

- Approximately 12,500 cubic meters of debris has been removed from behind the upper Weirs 1 and 2 (combined).
- Approximately 5,500 cubic meters of debris has been removed from behind Weir 3.
- The creek channel and berm upstream of the campground access road has been repaired.
- The creek channel immediately upstream of the Fairmont Ridge development has been repaired.
- The widened and armoured creek channel through the golf course has been cleared of debris (approximately 2,500 cubic meters) and the storage pond on Hole 12 of the golf course has had approximately 9,500 cubic meters of material removed.
- Blocked culverts have been cleared.

- Material has been removed from the reservoir behind the Cold Spring Creek Dam to restore capacity to 100%.
- Some minor repairs of the armoured channel in the lower part of the creek.
- Blocked culverts have been cleared.
