DEBRIS TORRENT CONCERNS
COLD SPRING AND FAIRMONT CREEKS

By: Dwain Boyer, P.Eng.
Water Management Branch
Nelson, B.C.

March 8, 1989

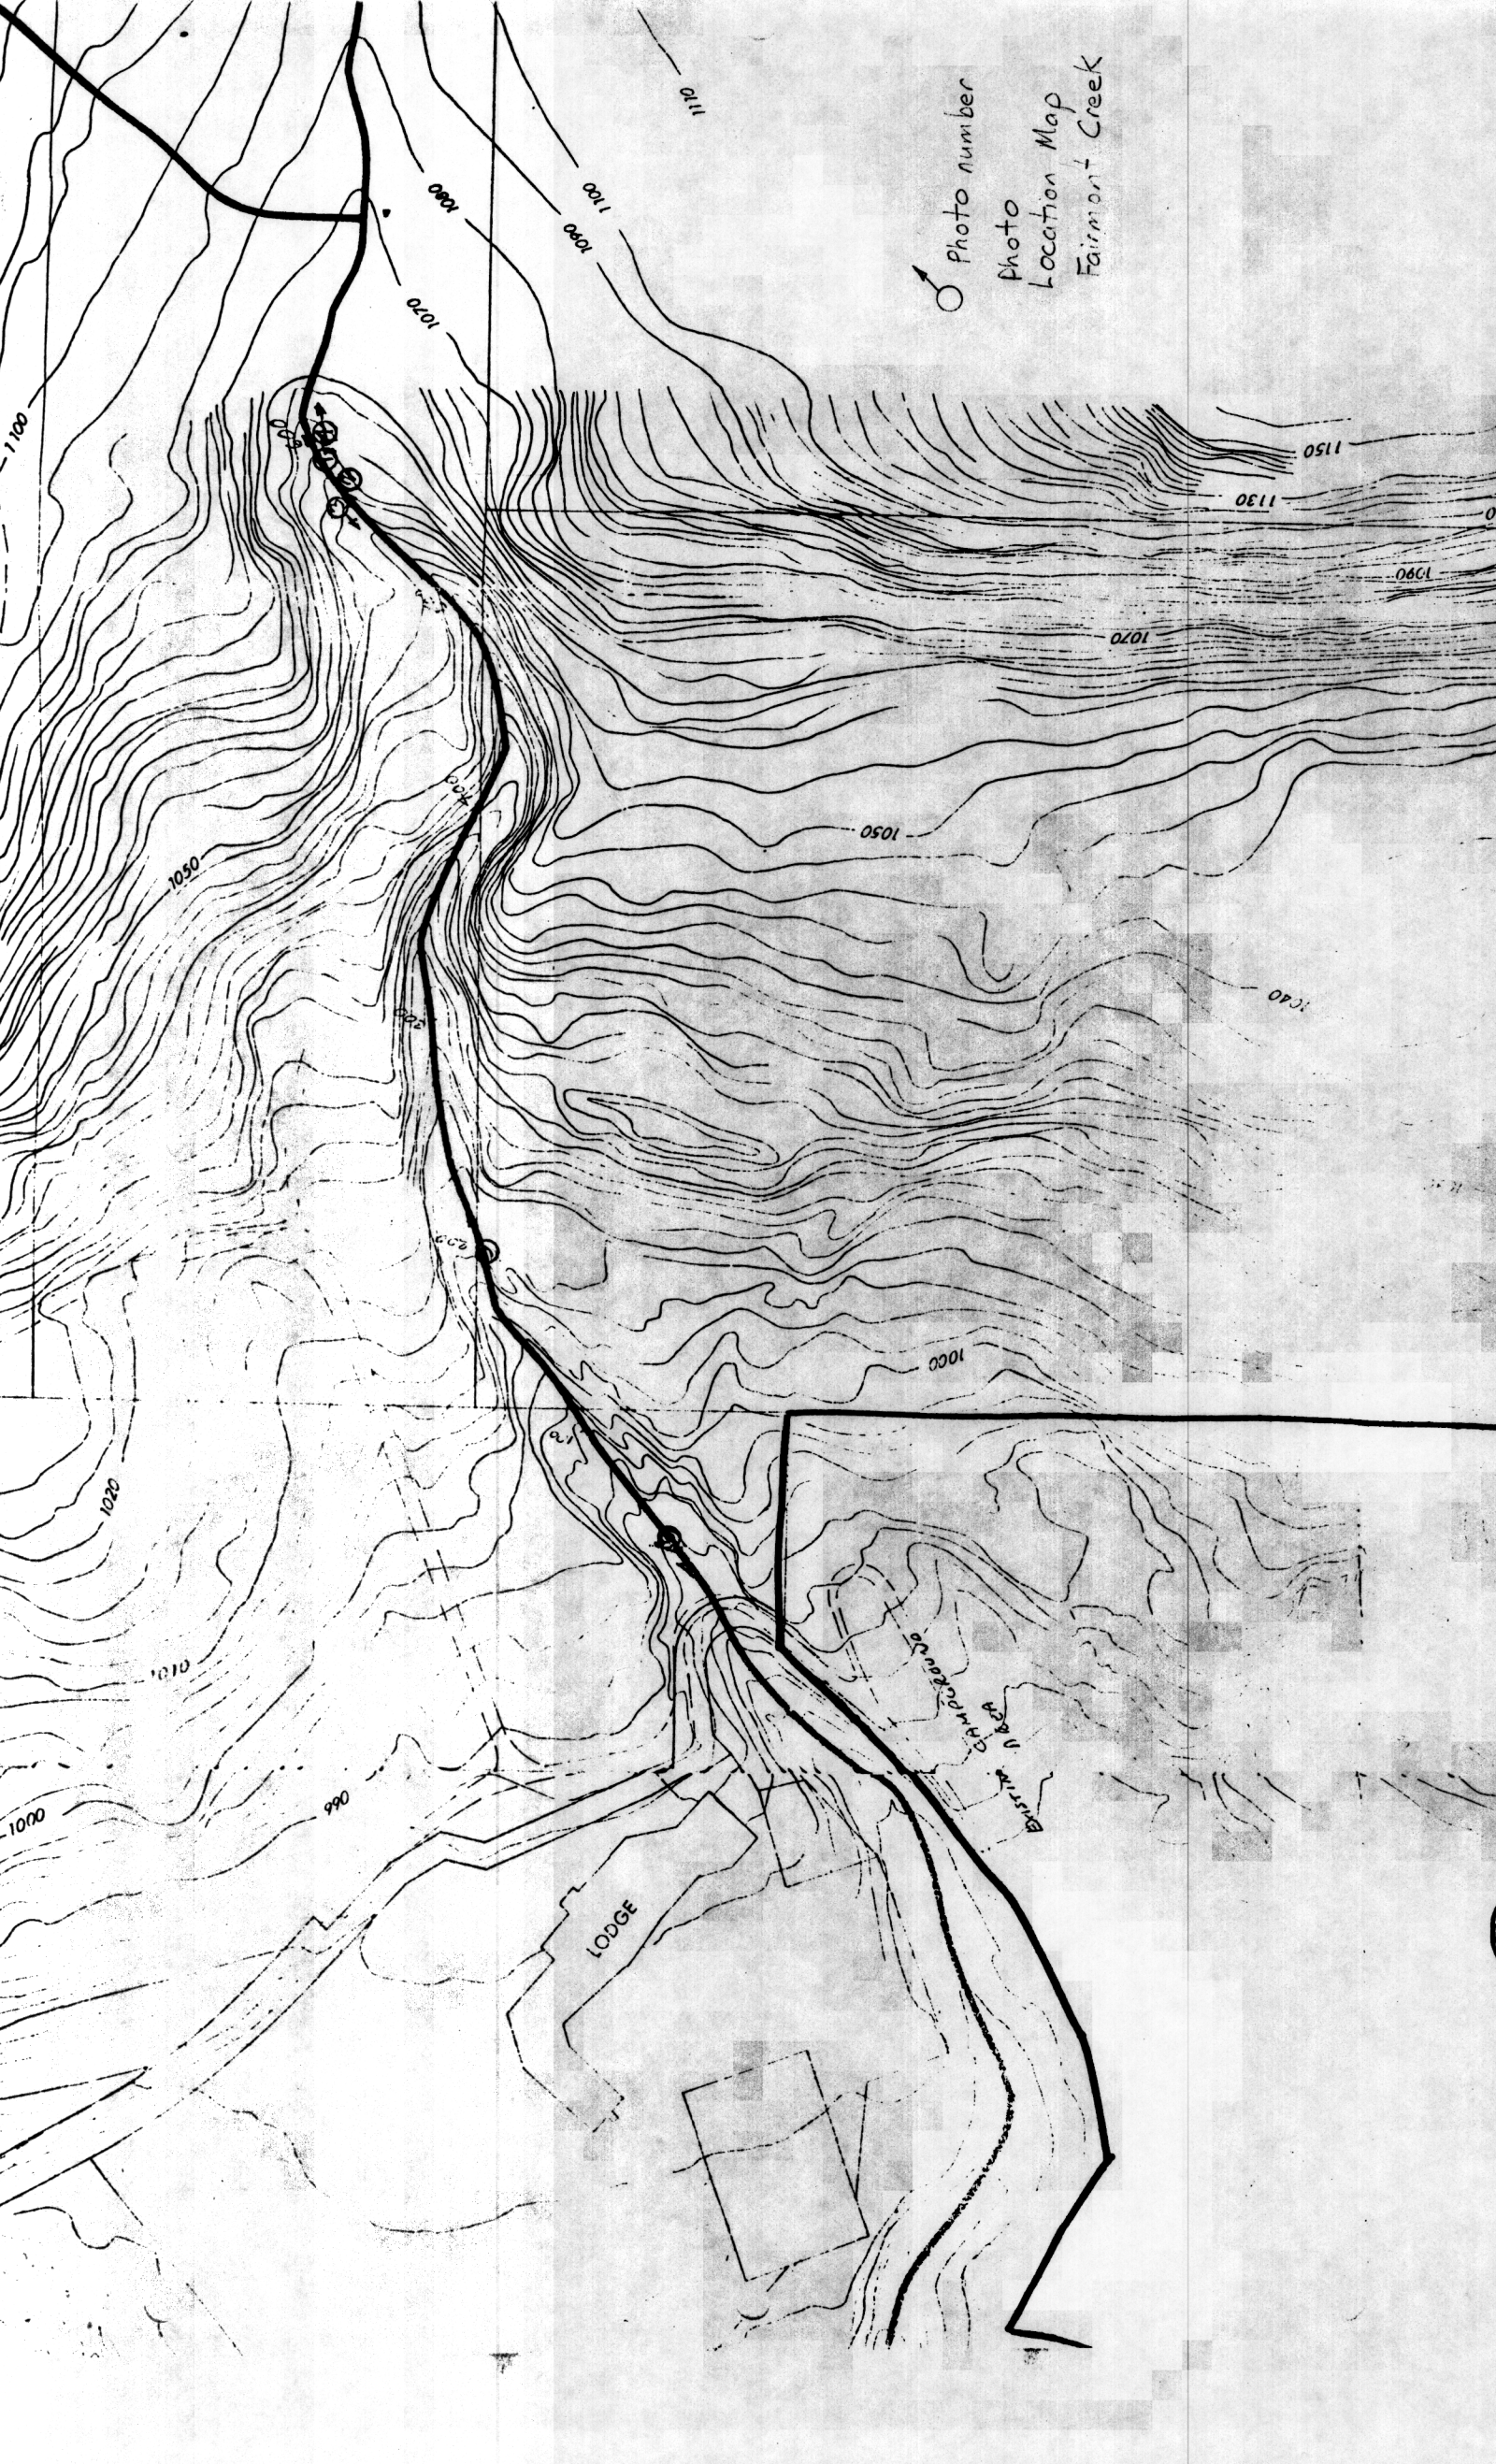
Figure 7. Plot of tangent of fan slope versus Melton's ruggedness number ($H_b A_b^{-0.5}$) for 42 fans from three study areas. H_b is basin height measured from fan apex to basin high point, and A_b is basin area above fan apex. B refers to Bow Valley; S, Kananaskis Valley/Spray Lakes Reservoir; C, Crowsnest Pass. Broken line separates fans presently having and presently lacking debris flow hazard.
