Fairmont Creek Debris Basins May 31, 2020 Flood Assessment

Final Report

Dale Muir, P. Eng.
Principal Engineer
June 24, 2020
NHC Ref no. 3005607

Regional District of East Kootenay

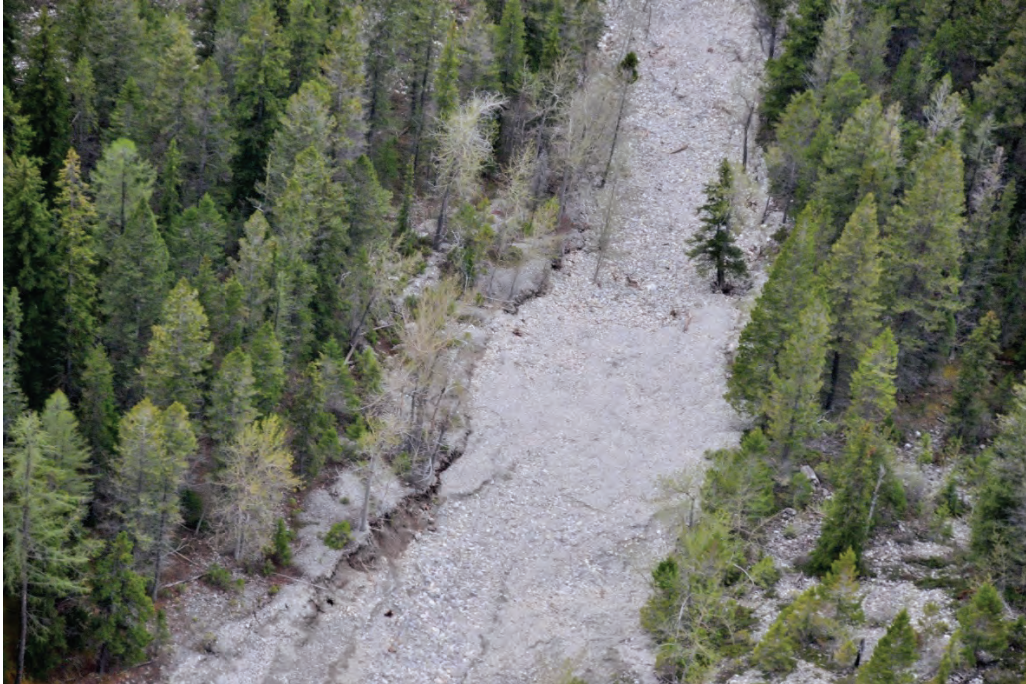
Photo 3.5 Middle tributary approximately 700 m upstream of confluence with main channel. Debris flow deposit with no identifiable channel Indicates that mass movement processes dominated the transport of material in this region of the creek.

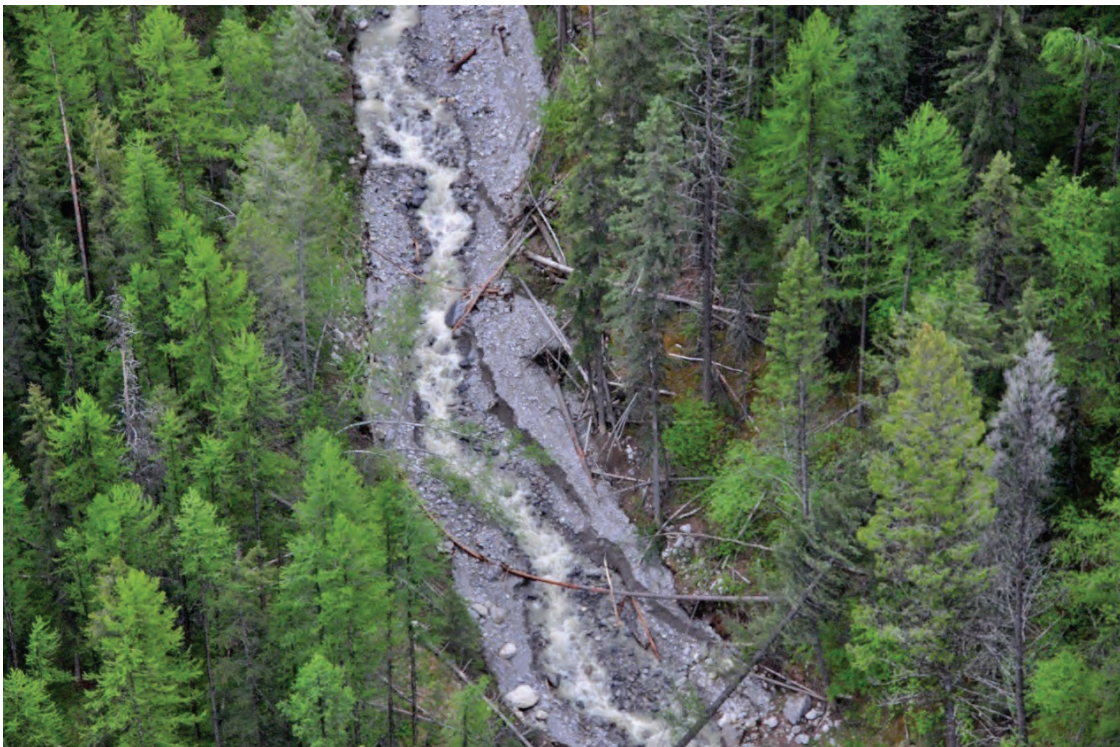
Photo 3.10 Fairmont Creek 1 km upstream of the upstream most debris containment weir and upstream of where the northern most tributary joins Fairmont Creek.

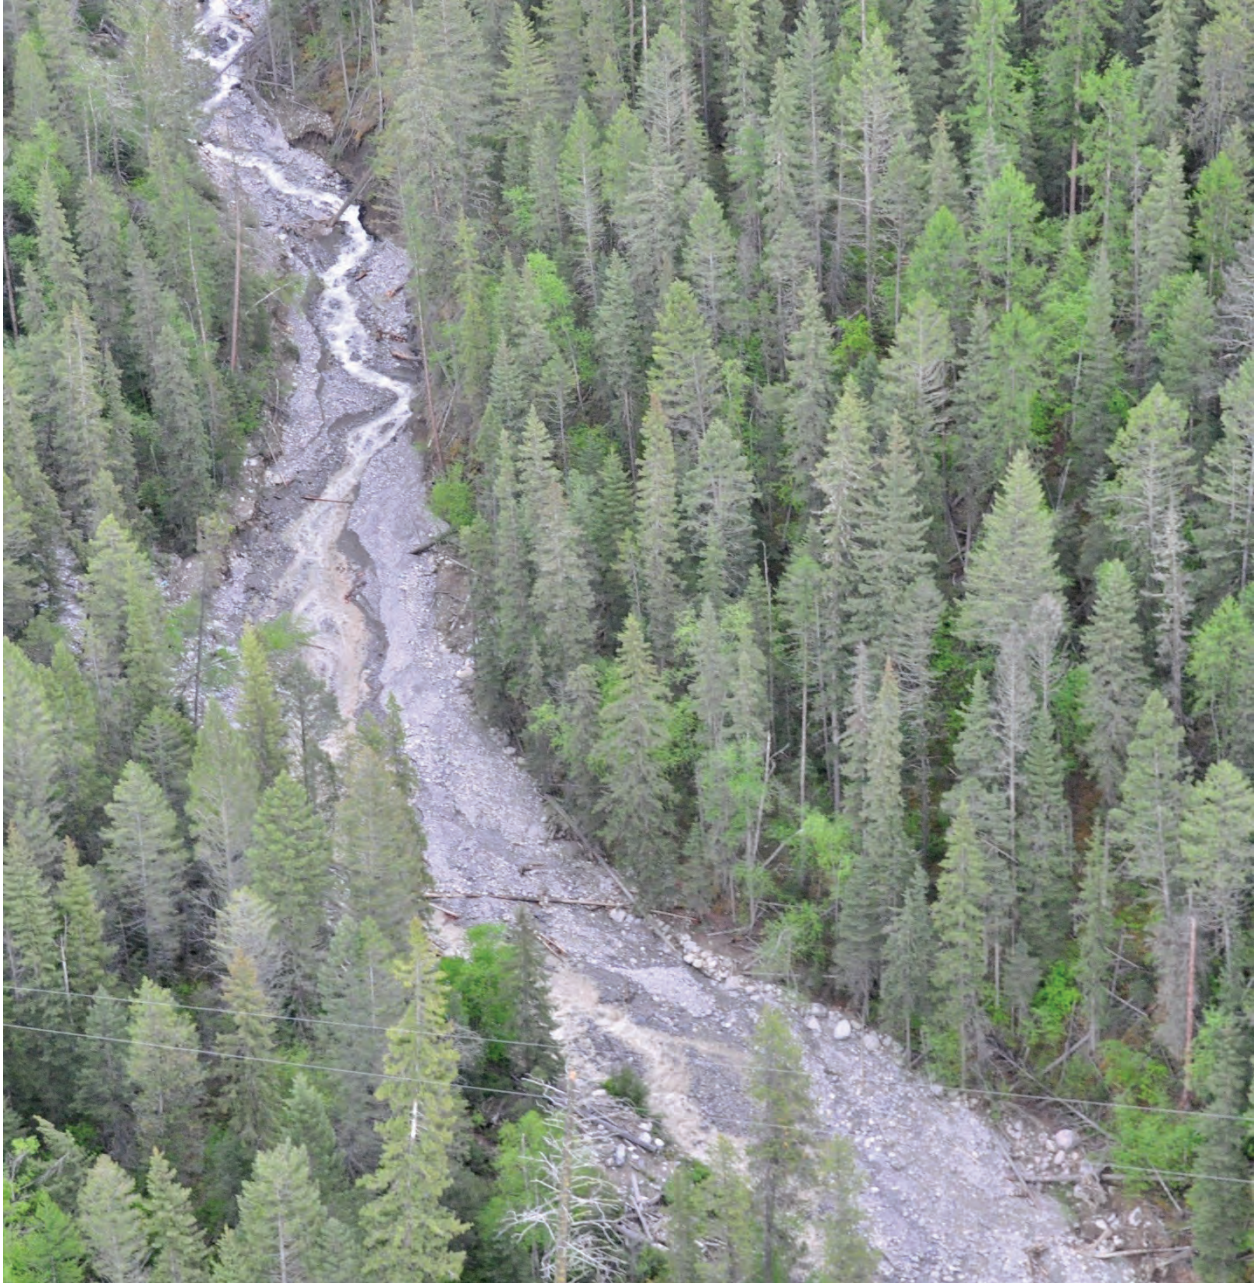
Photo 3.11 Fairmont Creek 450 m upstream of upstream most debris containment weir. This is downstream of the confluence with the northern most tributary. Most up-valley zipline is visible in image.

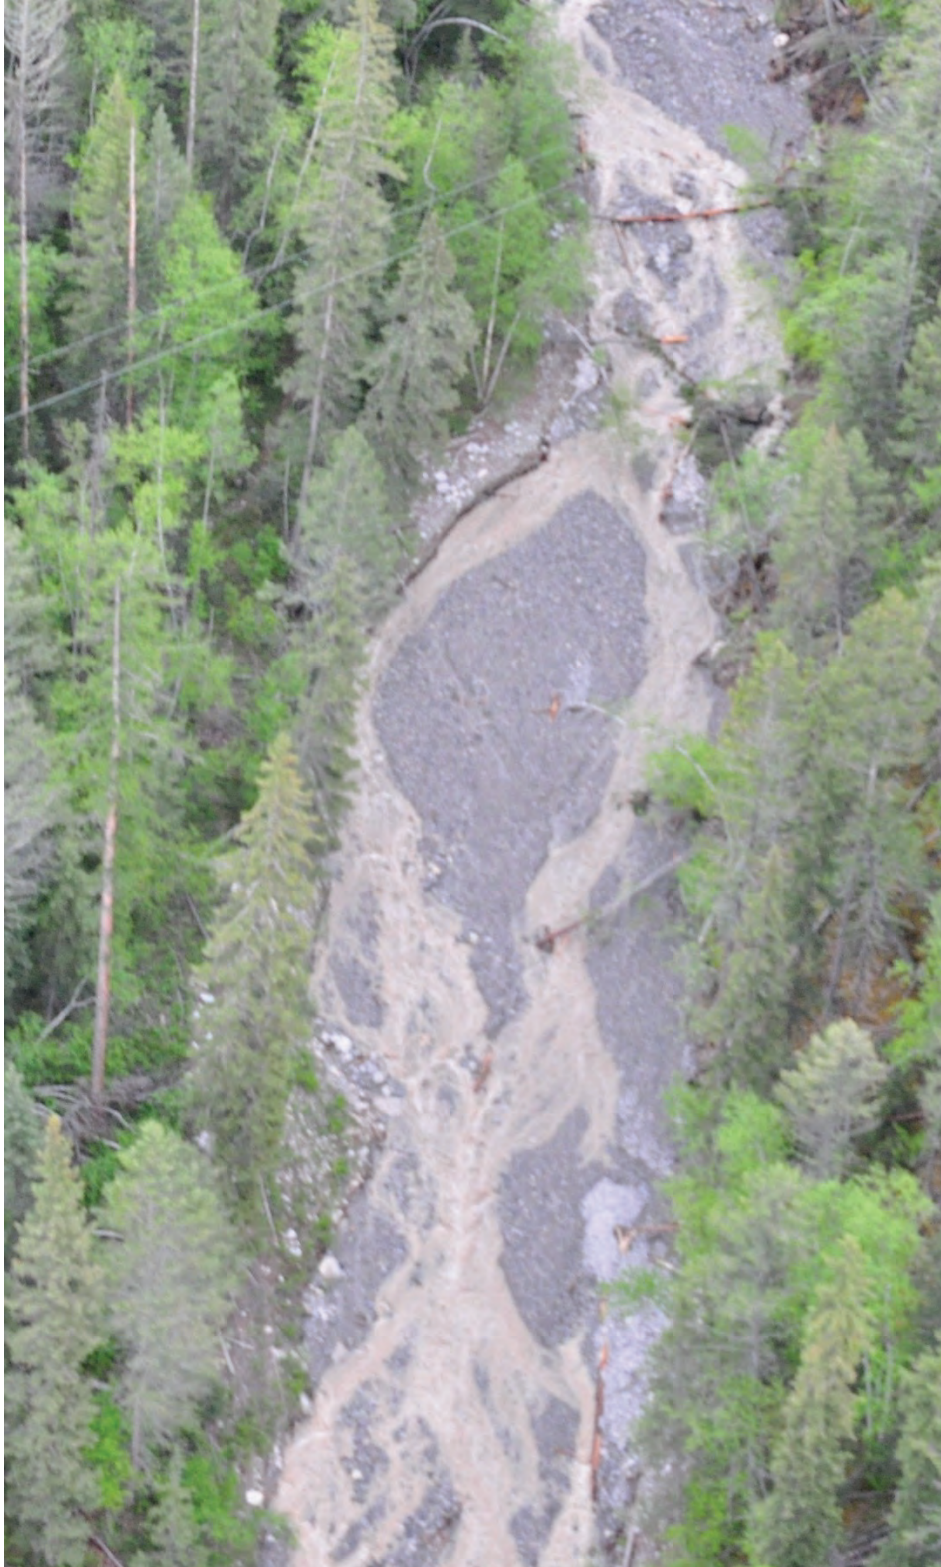
Photo 3.12 Fairmont Creek 300 m upstream of the upstream most debris containment weir. 2nd upstream most zipline is visible in the image.

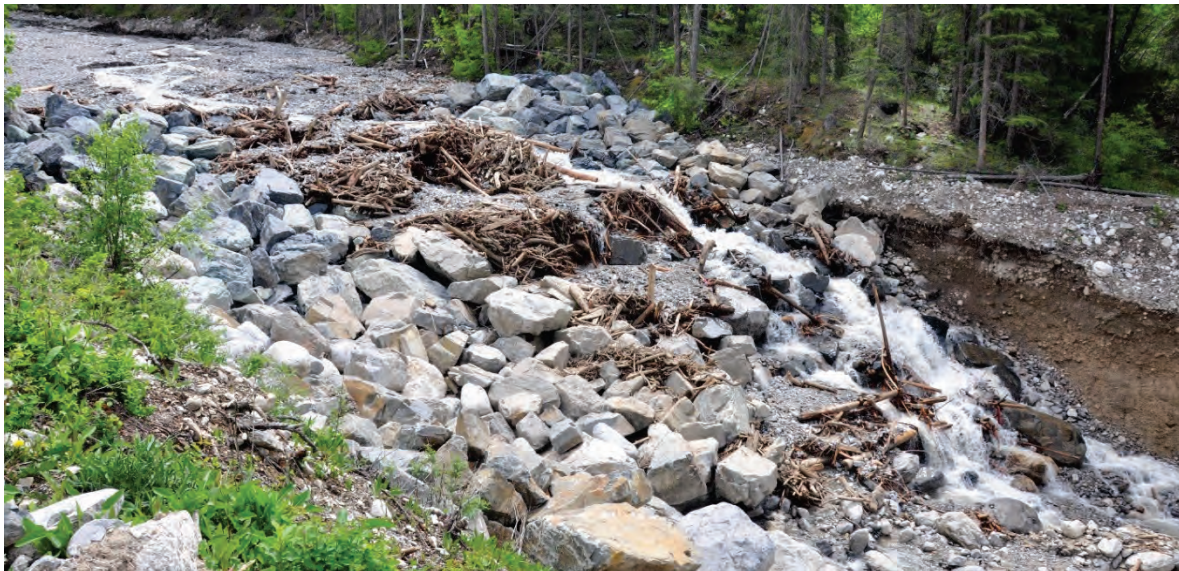
Photo 3.15 Sediment and debris that overtopped weir # 2 during the May 31, 2020 event.

- Restore 5000 m³ of storage capacity in weir # 2 by excavating material and have a plan to remove the remaining material within the next few weeks.
- Remove the sediment and debris that is directly in front of the culverts and reducing the capacity of the existing culverts.
- Remove 4000 m³ of sediment from the golf course pond to restore 40 to 70% of storage capacity and have a plan to remove the remaining material within the next few weeks.
- Repair channel bank protection between Fairmont Creek and the hot water intake buildings to provide 1 meter of water depth along the stream channel from the downstream end of the 2018 construction work to the downstream culvert crossing.
- Have a plan in motion with a defined timeline to repair the channel bed downstream of weir # 2 to ensure the channel is not left in its current conditions throughout the summer and fall of 2020.

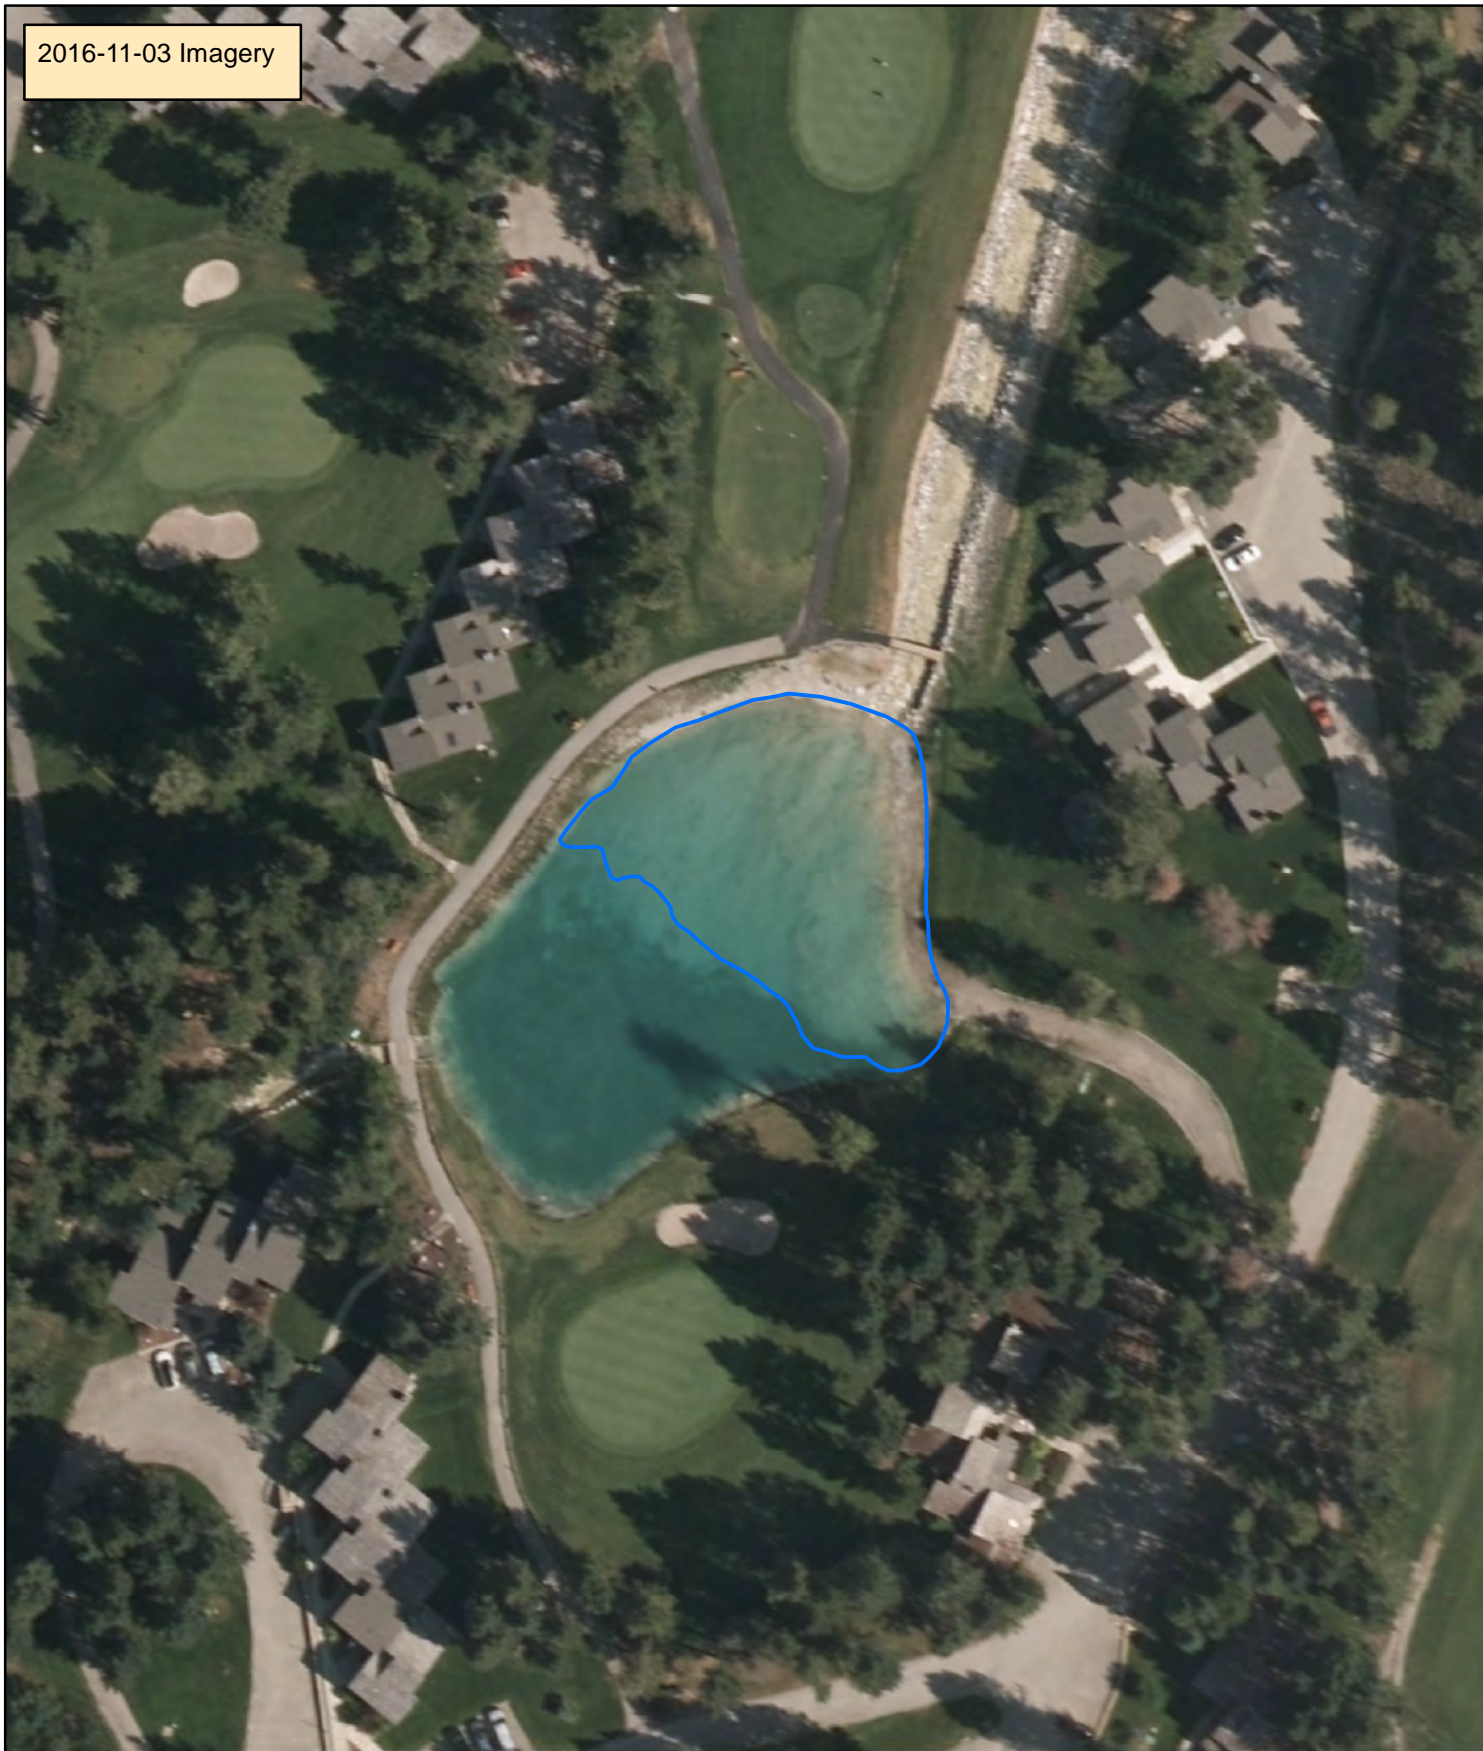
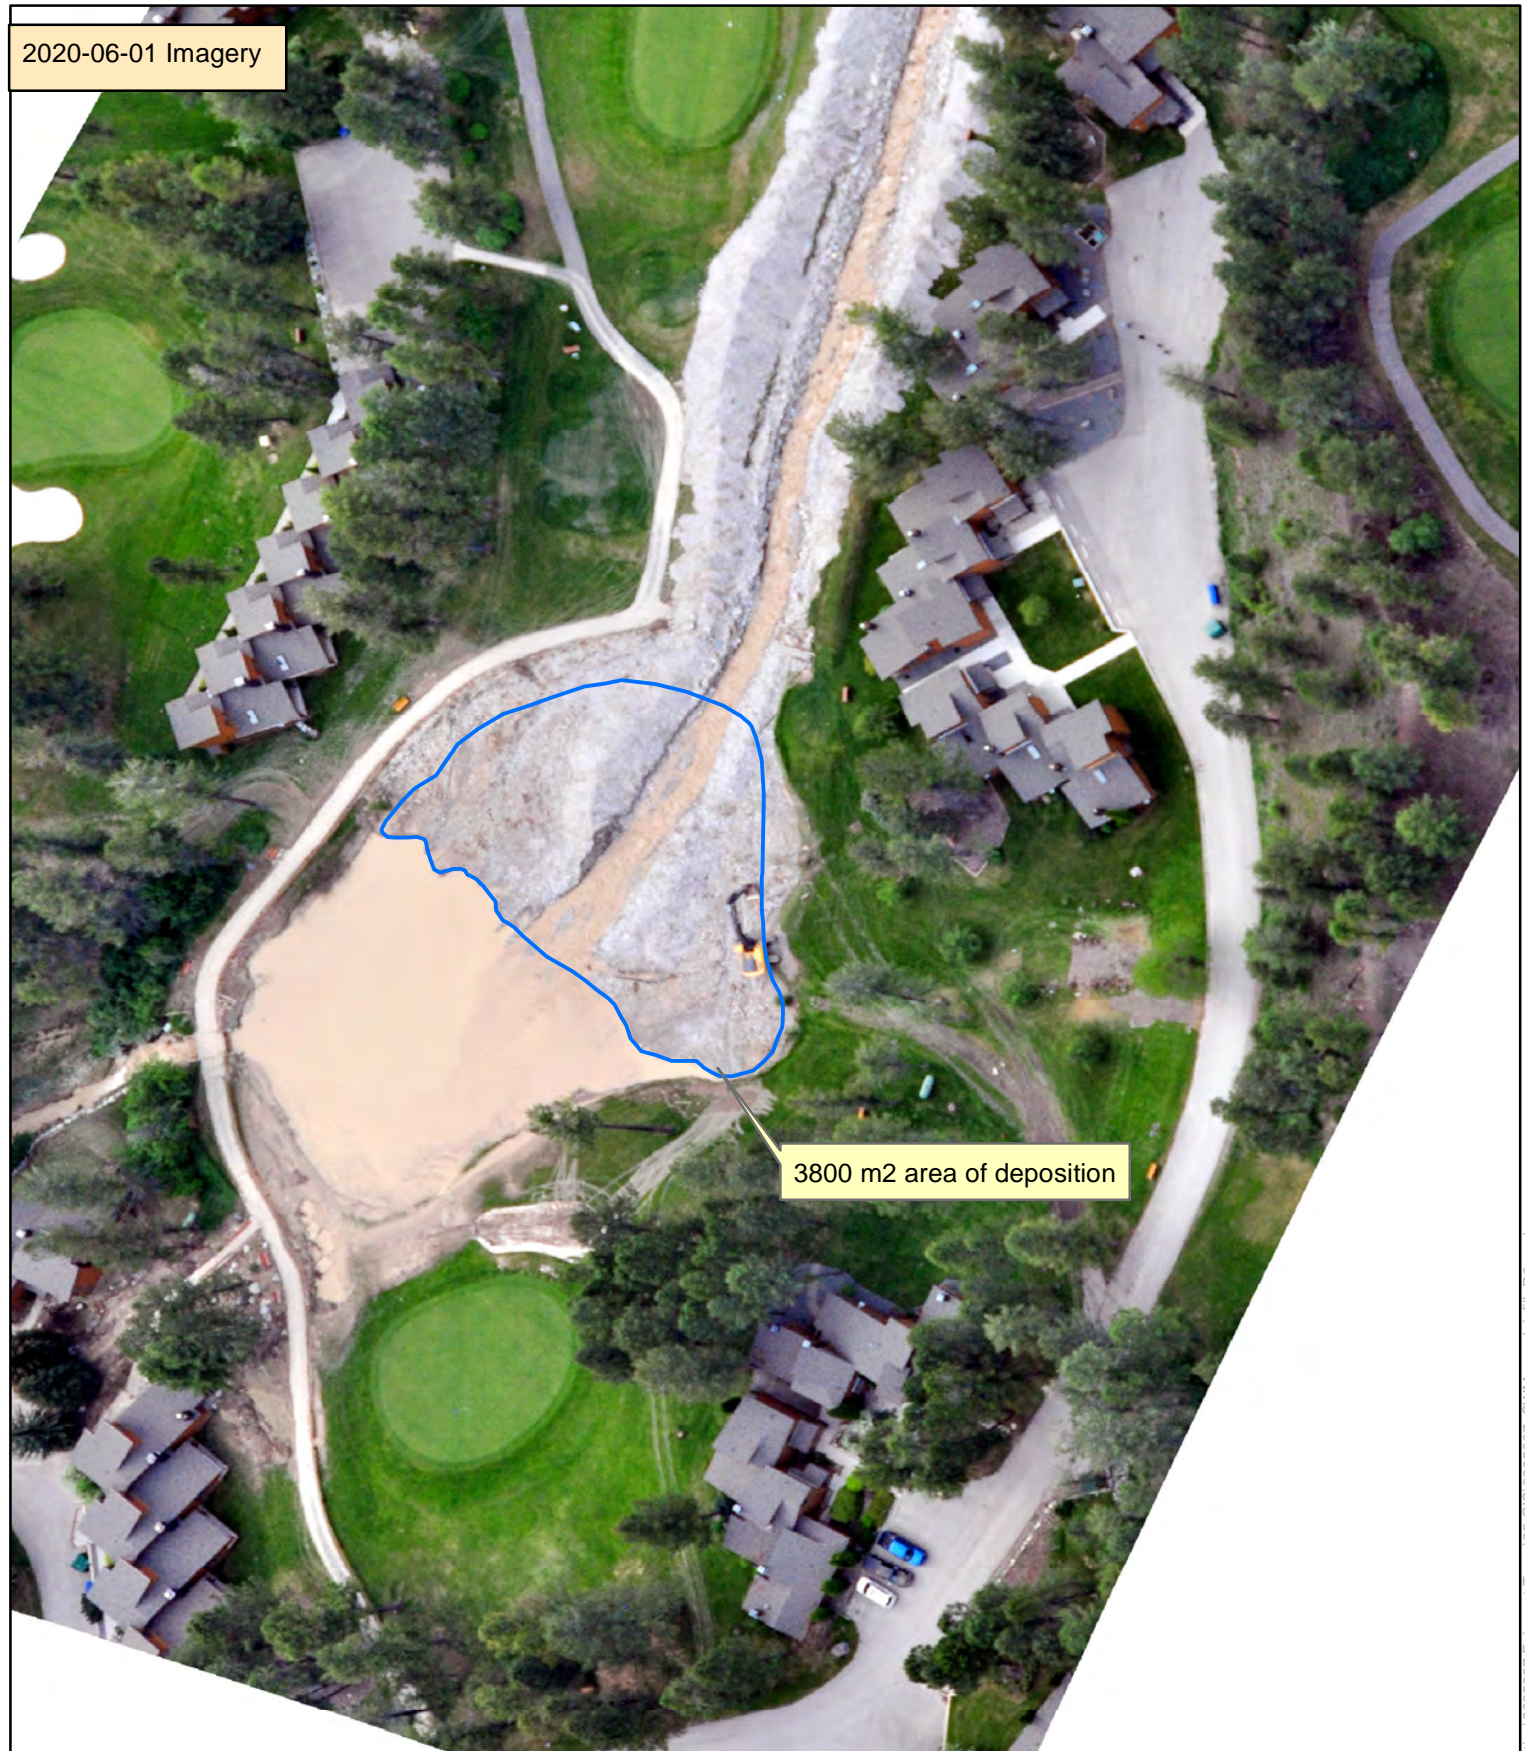
Sediment mobilized in the reach immediately upstream of the golf course was transported by the flood and deposited on the golf course and in the golf course pond. Map 3-1 illustrates the extent of sediment infilling along this reach. The channel upstream of the golf course successfully contained the sediment that was mobilized, transporting it to the pond. It is estimated that about 8,000 m³ of sediment was deposited in this pond and along the channel upstream; however, this estimate is rough as the thickness of the deposit is difficult to judge without a survey. Nevertheless, it is clear that the pond and channel functioned as intended as it captured sediment in a manner that prevented the stream from avulsing to a different route down the fan.

3800 m2 area of deposition

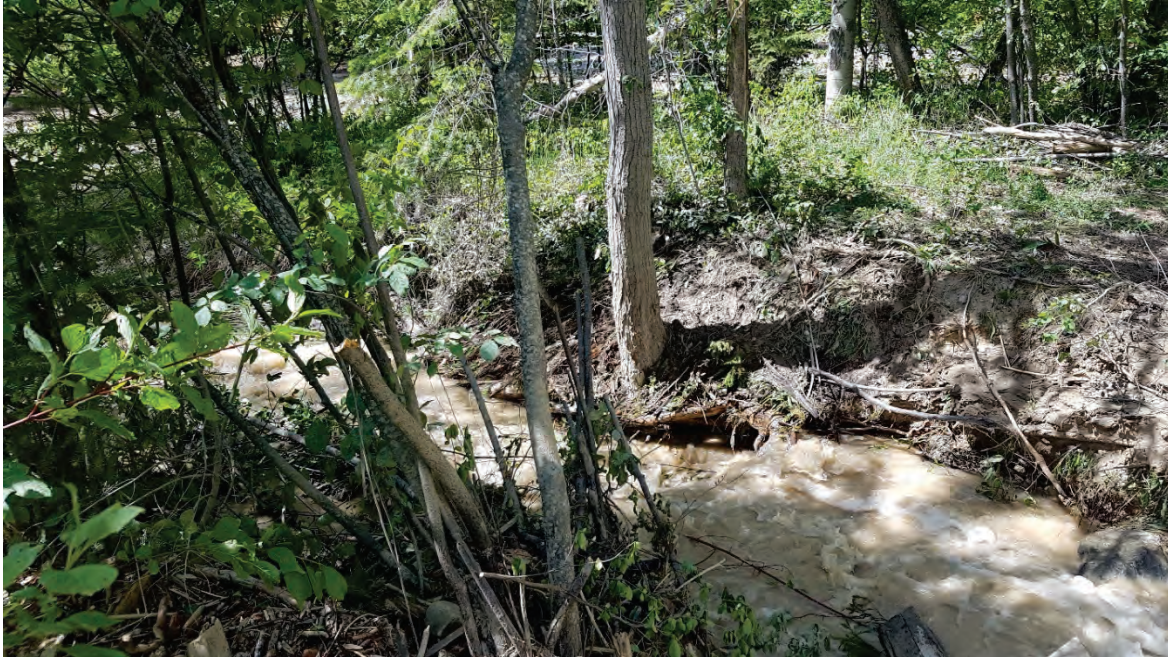
Photo 3.34 Lower Fairmont Creek in a section of channel with a very narrow channel bed and lots of established vegetation.

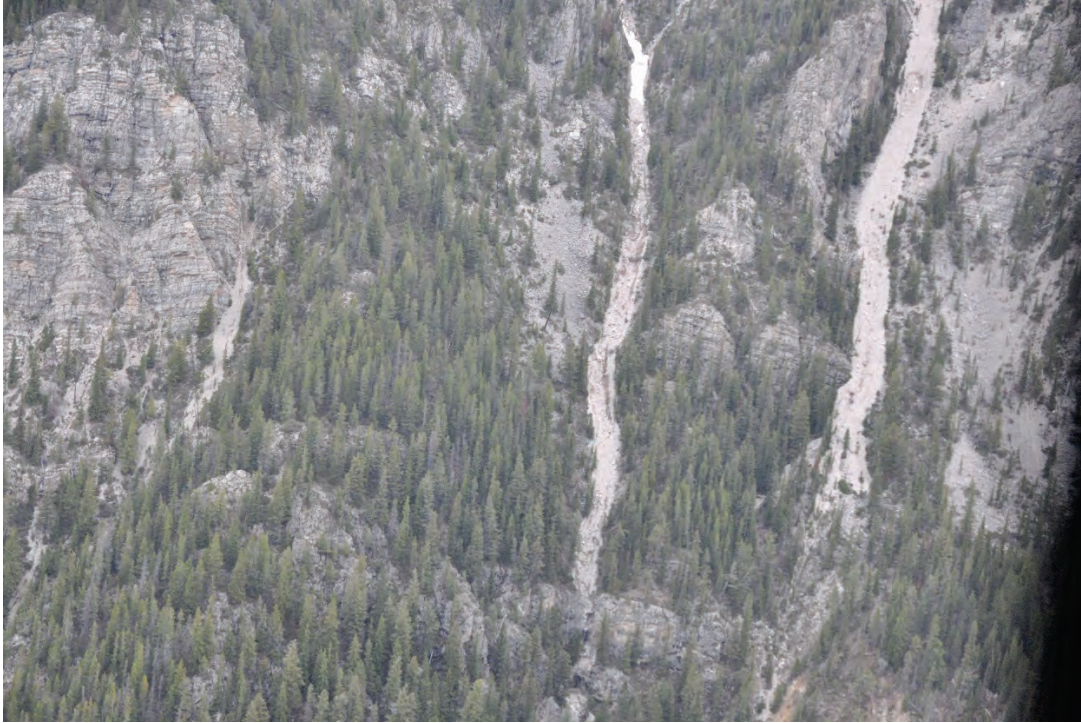
The upper portion of Cold Spring Creek contains two primary basins that supply sediment, with the northern, larger basin producing the majority of the sediment. A large debris flow gully 5.7 km upstream from the dam (Photo 3-36) is a substantial source of sediment fed by rock fall, rock avalanches and debris flows that originate further up the slope in two distinct gully systems (Photo 3-37). These sediments are washed downstream as debris flows that transition to debris floods (Photo 3-38). This sediment and water continues to move downstream and has caused localized bank erosion and a few relatively small landslides (e.g. Photo 3-39). At this time there appears to be no large landslides in the lower basin that could block the channel entirely. As the channel approaches the Fairmont Resort dam shown on Map 1-1 the sediment and water is flowing both through the channel and through the adjacent forest and the sediment deposits are clearly thick and extensive (Photo 3-40 and Photo 3-41).

Photo 3.37 Upslope debris flow channels that merged and then enter Cold Spring Creek at the location shown in Photo 3-36.

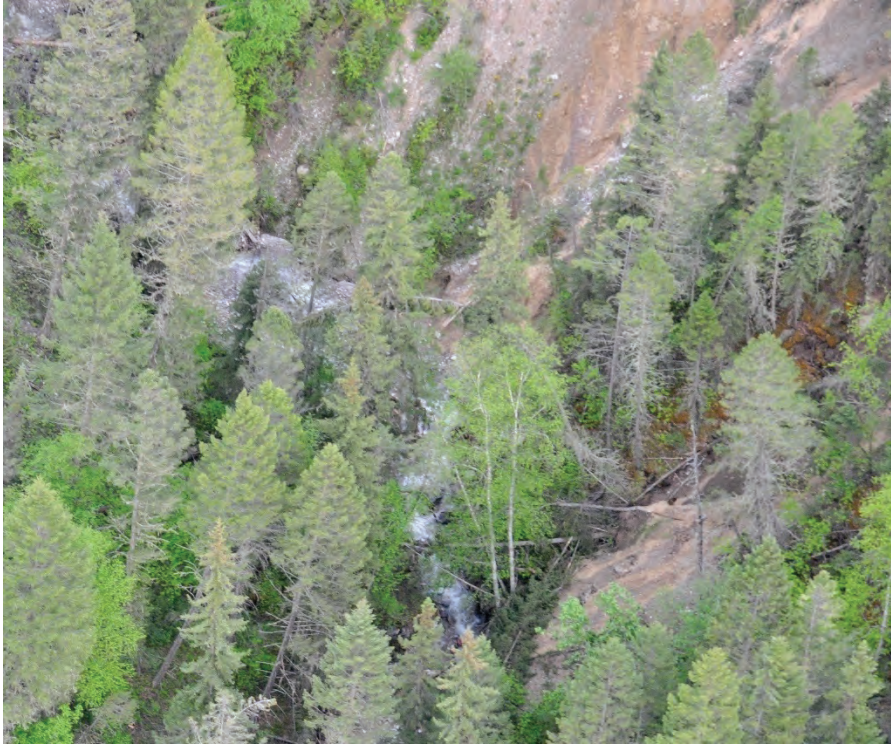
Photo 3.39 Two small landslides on south side of creek 1.5 km upstream of the dam. An old road appears to cut across the top of these slides.

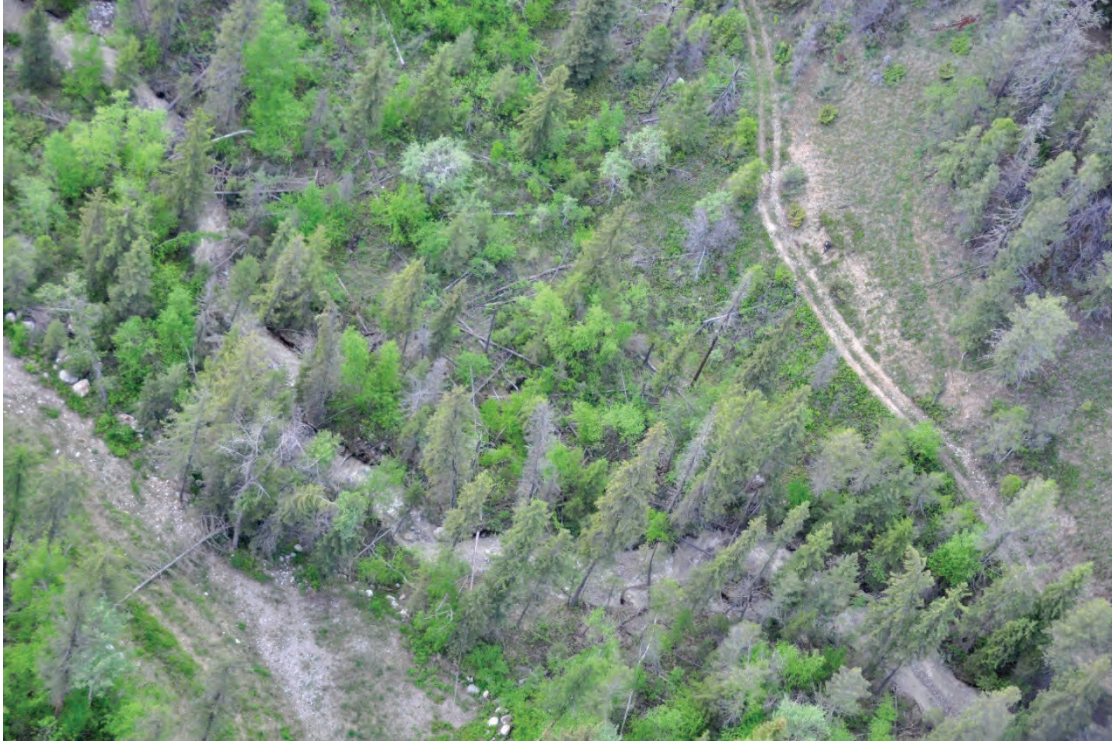
Photo 3.41 Cold Spring Creek 300 m upstream of the dam.

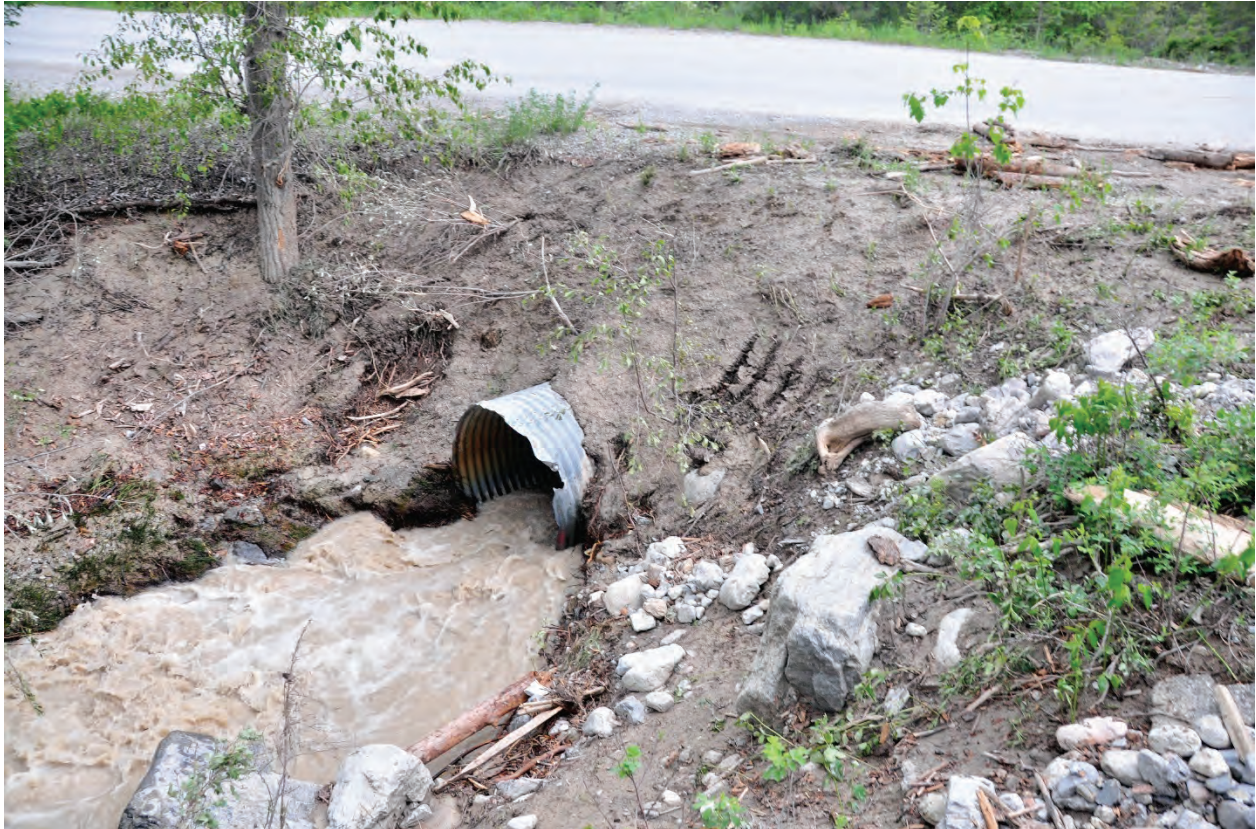
A short distance downstream of the dam the stream crosses Fairmont Resort Road through a culvert that appears undersized, shown in Photo 3-45. During the flood event the road was overtopped; the culvert entrance was cleaned out before the photo was taken. There are no signs of extensive sediment accumulation through this reach; however, rocks could be heard moving through the culvert at the time the photo was taken. Cold Spring Creek downstream of this culvert was not evaluated during the site inspection.

Photo 3.45 Cold Spring Creek crossing under Fairmont Resort Road downstream of Fairmont Resort dam.

- Replace road crossings with structures able to pass the 200 year flood event. At present most of the structures failed to pass the estimated 20 year storm. On account of climate change it is anticipated that extreme rainfall events will become more common in the future and flood volumes will on the whole increase.

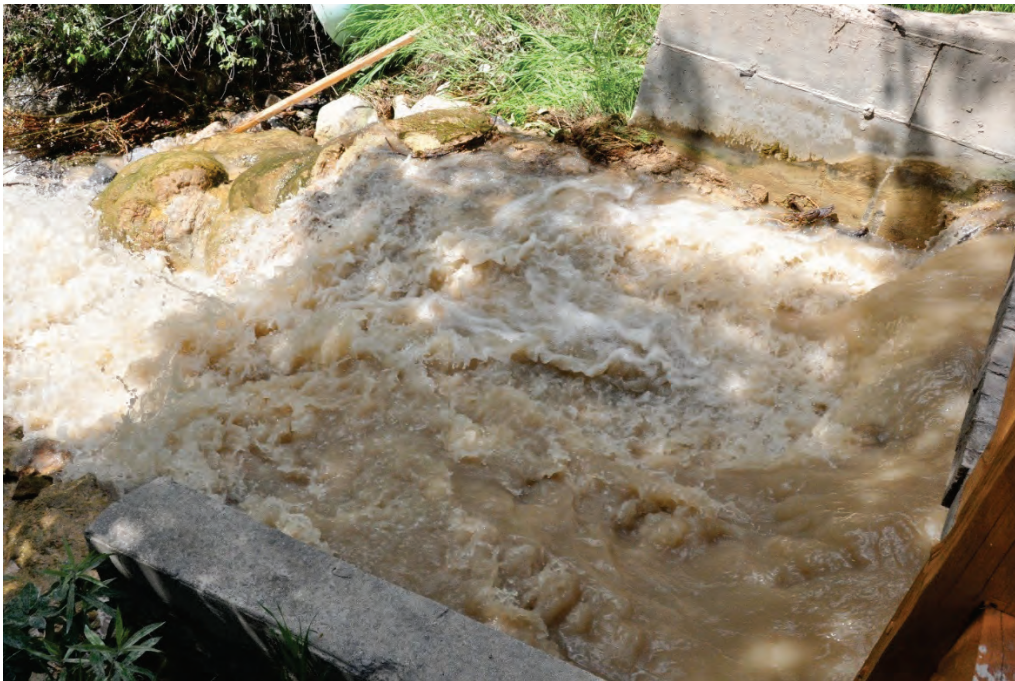
Photo 6.2 Current outlet of golf course pond and 4 meter tall cascading channel that leads into Fairmont Creek. It appears that a sill is currently blocking water passage below the boardwalk on the right side of the image.

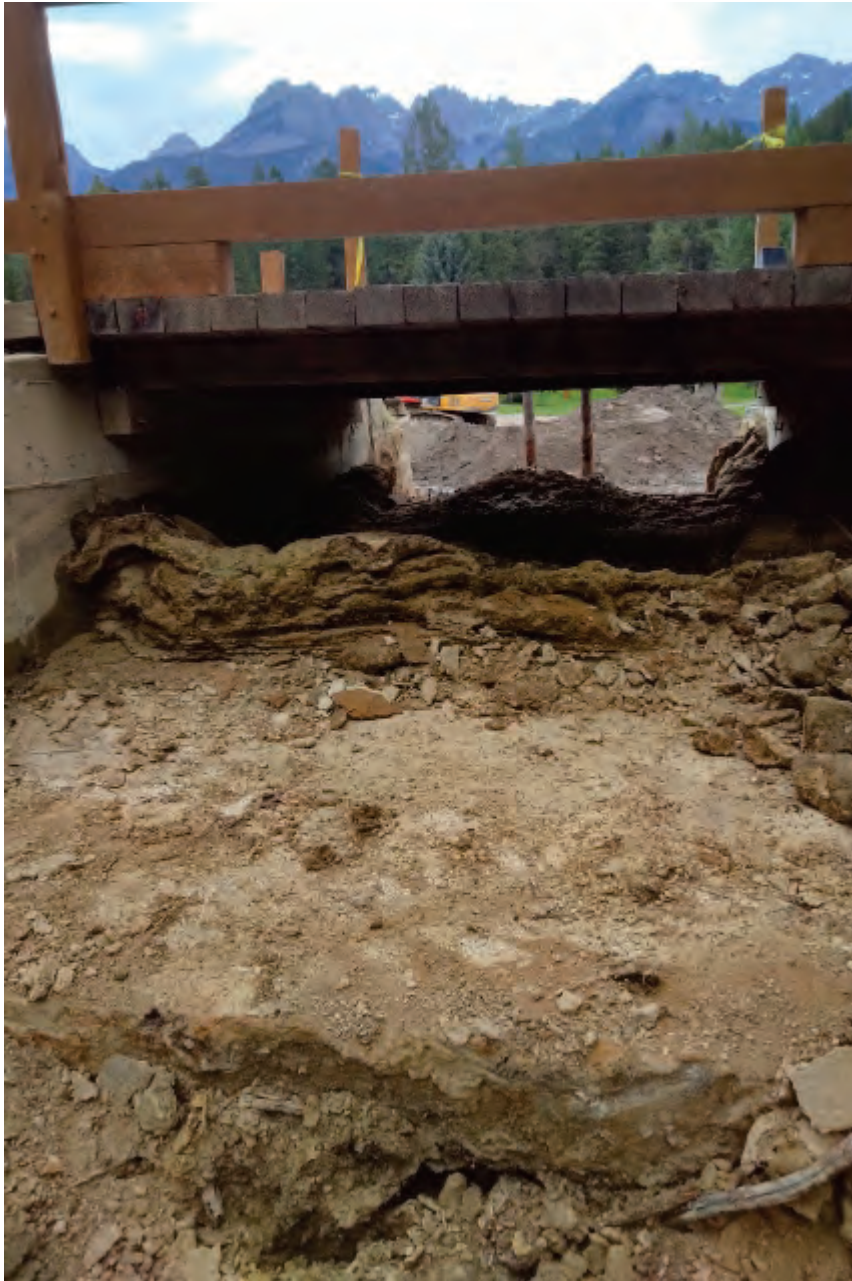
Photo 6.3 Downstream end of channel at pond outlet following flood event. Photo provided by contractor removing sediment from pond.

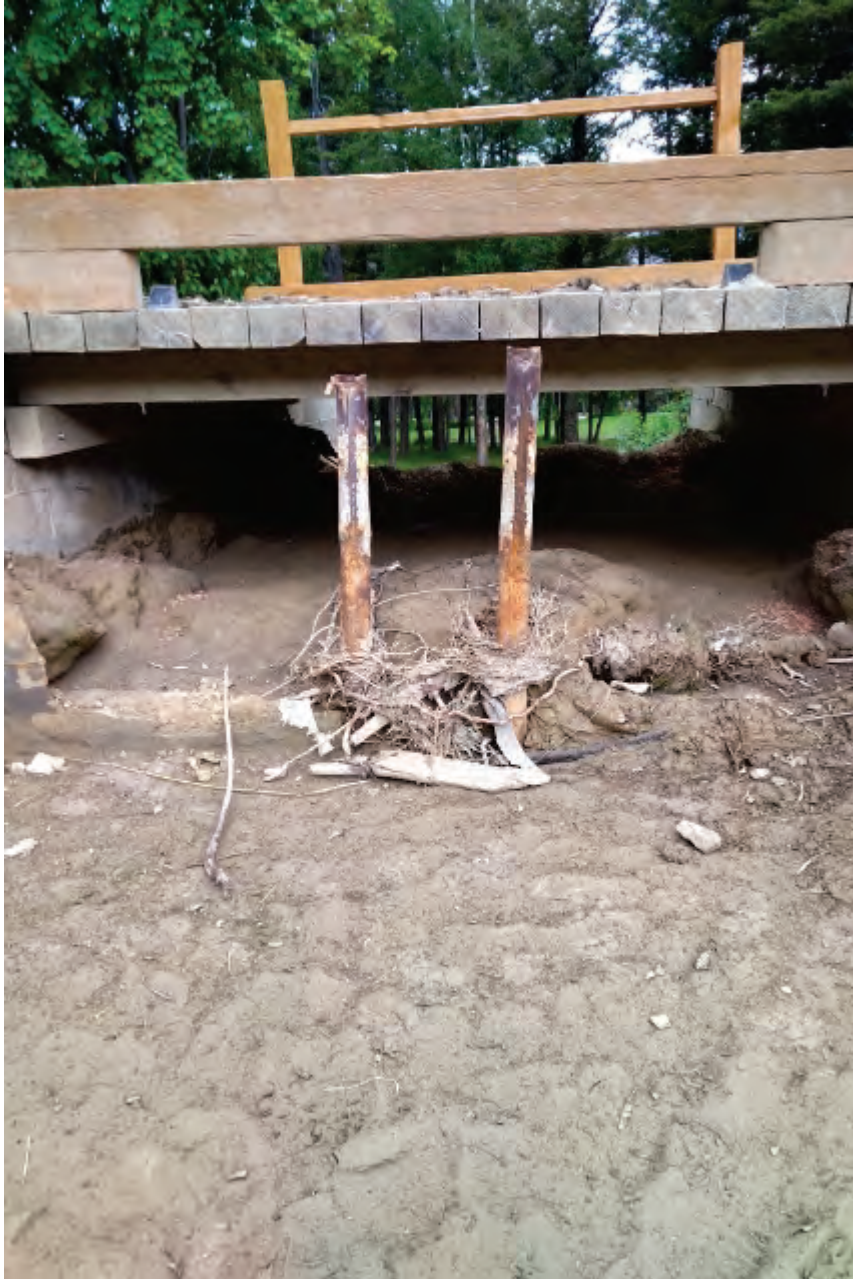
Photo 6.4 Upstream end of channel leaving golf course pond following May 2020 flood event. Photo provided by contractor excavating sediment.

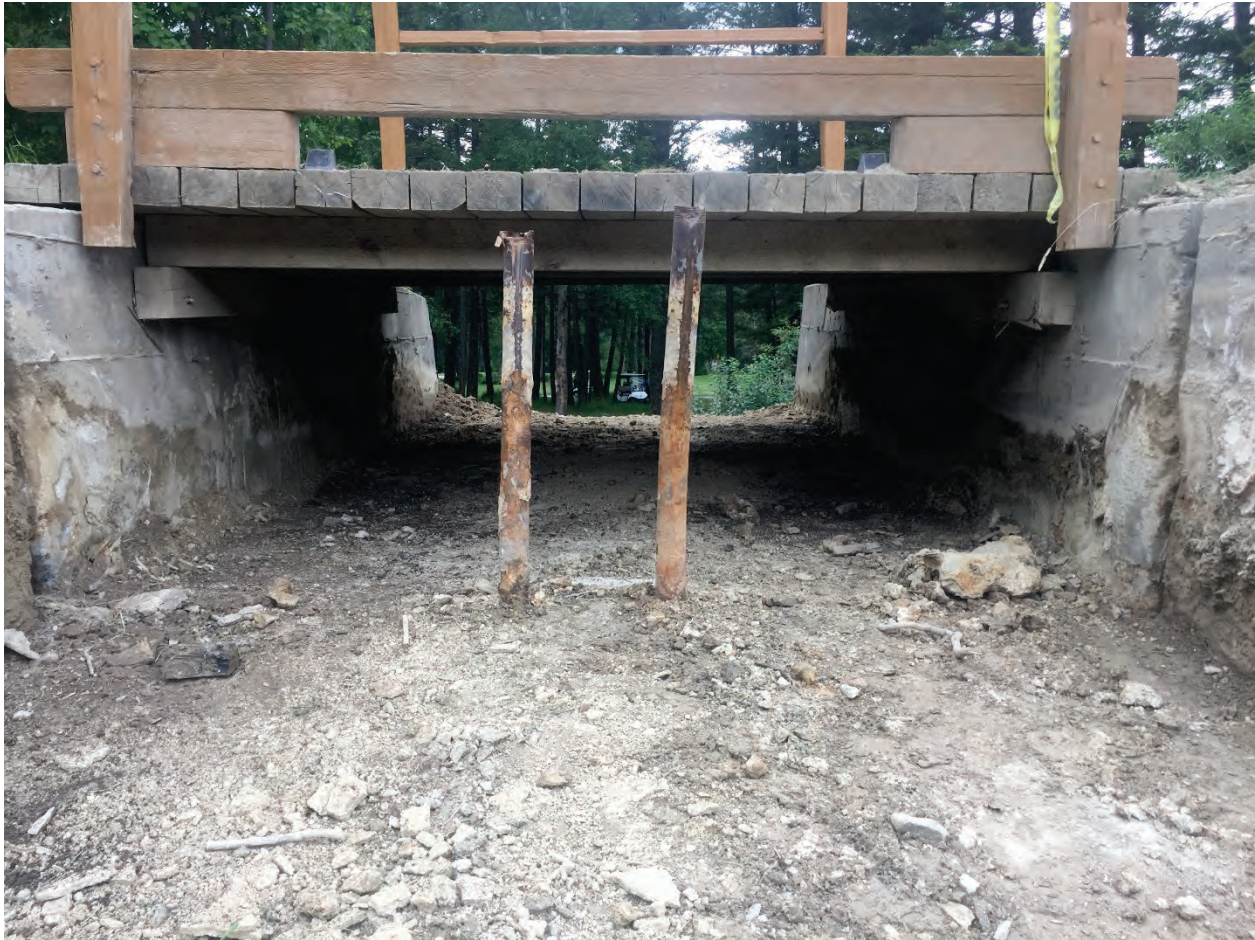
Photo 6.5 Channel draining golf course pond after accumulated sediment had been removed by contractor. Photo by Kara Zandbergen.

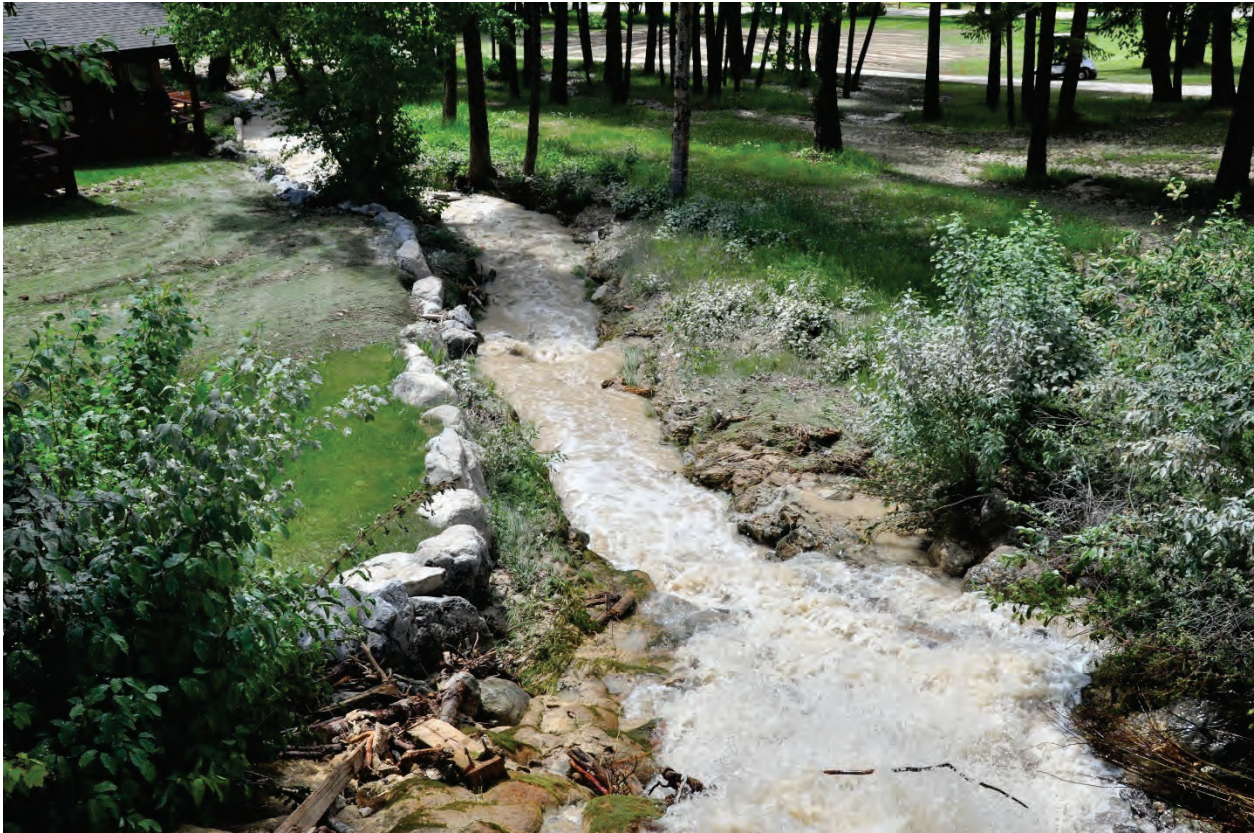
Photo 6.6 Fairmont Creek immediately downstream of golf course sediment retainment pond.

To accommodate the anticipated flood flows the channel needs to be given a wider area to flow and the banks need to be raised. Furthermore, a means of managing vegetation encroachment and debris accumulation in the channel needs to be implemented. As part of this, residents and land owners along the channel are likely going to have to modify their properties to accept and maintain a portion of the floodway in order to accommodate the flood flows that are going to occur in Fairmont Creek. On account of the ongoing accumulation of limestone in the channel and the long term maintenance

challenges associated with infrastructure, channelizing flood flows into engineered conduits is not advised.

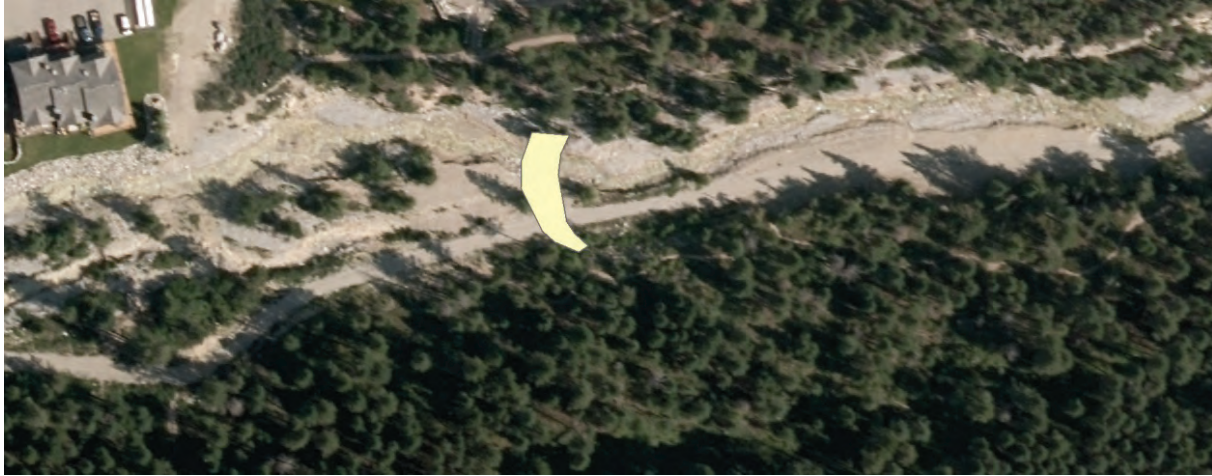
Figure 6.1 Potential location of additional debris catchment weir upstream of golf course sediment retention pond.

During the site inspection it was recognized that containing the sediment that is eroded out of Fairmont Creek between the hot springs and the golf course would reduce the risk of flood and avulsion to the downstream homes along the creek. A site that was identified as having tall stable bedrock banks and potentially sufficient room for downstream scour protection is illustrated in Figure 6.1. The structure could possibly be a weir similar in form to the ones upstream.
