DECEMBER 3, 2020

# MAY 31 FAIRMONT DEBRIS FLOOD EVENT

Kara Zandbergen, RDEK Engineering Technician

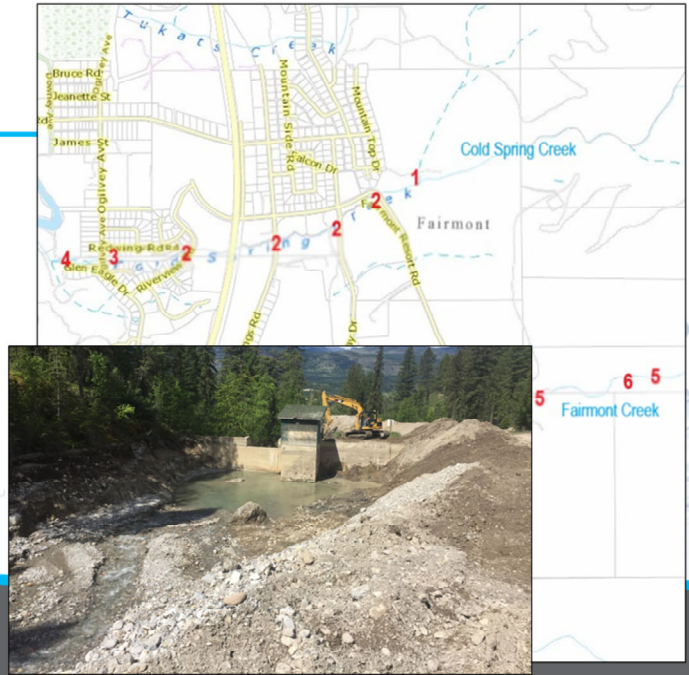
## 1. Reservoir – 3,600 m<sup>3</sup>

The reservoir site is the uppermost debris containment location on Cold Spring Creek and is currently the only containment site upstream of the community. It is marked on the map with a "1". Restoring capacity at this location was a high priority as it is the only debris containment location upstream of the community and this work was completed very early in the response. Approximately 3,600 cubic meters of material was removed from the reservoir. To make that volume more understandable, if we assume 9 cubic meters per truckload, that is 400 dump truck loads of material.

The picture on the left shows the full reservoir on May 31 and the picture on the right shows the cleaned reservoir.

This work was considered response.

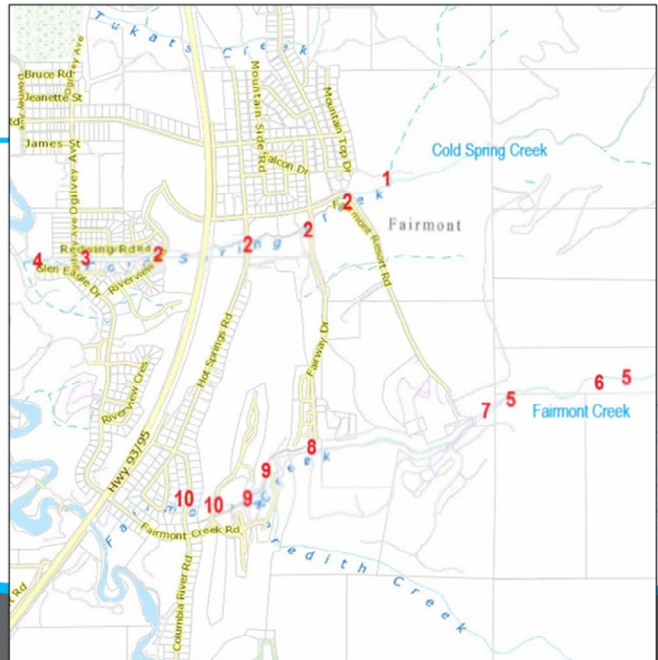
## 2. Culverts

Because we were able to contain the debris so effectively, the biggest impact to the residents and community on both creeks were the culverts that were blocked, unable to pass the flows and overtopped the roads. There were four locations on Cold Spring creek represented by the “2” on the map where the creek overtopped the roads. The culverts were addressed immediately with assistance from local contractors and the Resort.

This was considered response.

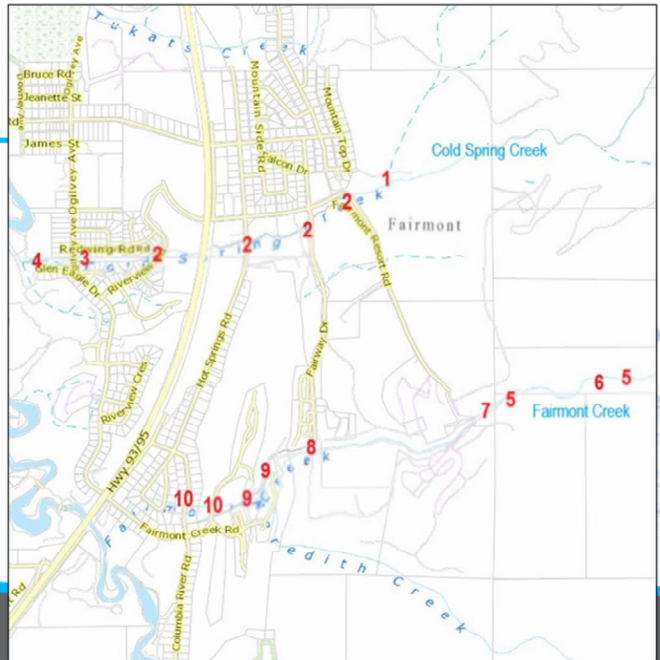
- 3. Lower Channel
- 4. Lower Debris Trap – 2,500 m<sup>3</sup>

The next sites on Cold Spring Creek were damage to the armoring on the lower channel and some infilling of small debris traps (3 on the map) and the lower debris trap (4 on the map) that was completely filled with material.

The repair of damage to the armoring in the channel was completed right away in anticipation of high flows and the material removal in the channel and pond was completed in late fall.

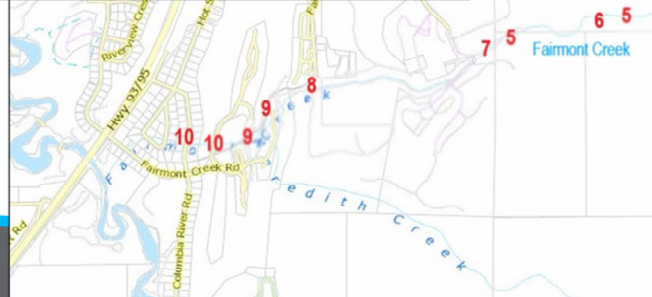
### 5. Upper Traps – 18,000 m<sup>3</sup>

Moving over to Fairmont Creek, there are three large weirs and debris containment basins upstream of the resort and community. The three basins are marked by the 5's on the map (the right-hand "5" indicates basins 1 and 2) and contained a total debris volume of approximately 18,000 cubic meters, all of which has been removed.

The picture on the left was taken upstream of the uppermost weir which is located roughly where you see the access road coming down. This weir was buried under about 2 meters of debris. The pic on the right is taken from weir 1 looking towards weir 2 in the distance and shows the cleaned basin. A tremendous amount of material was removed from this site.

The removal of 10,000 cubic meters of debris from the upper two basins was considered response and the remainder was considered recovery.

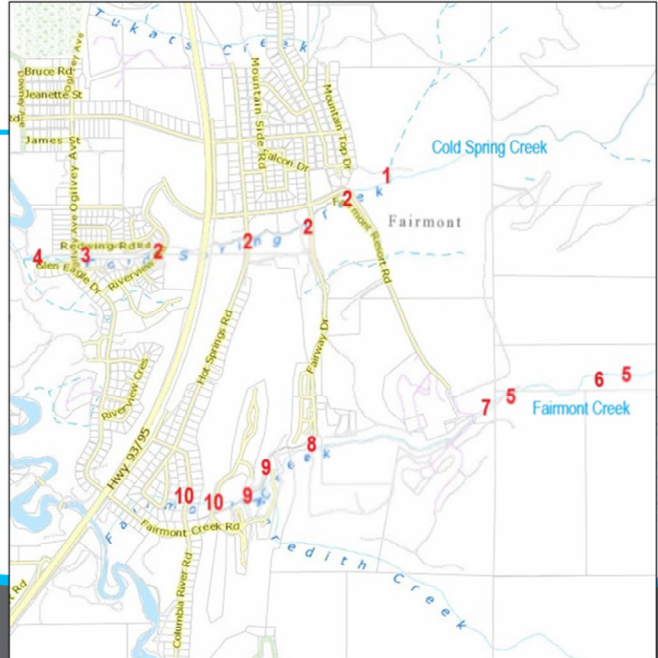
## 6. Weir 2 Scour

There was scour downstream of Weir 2 that needs to be repaired. This is shown in the lower picture and is marked by the 6 on the map.

This work will be completed in 2021 and will be considered recovery.

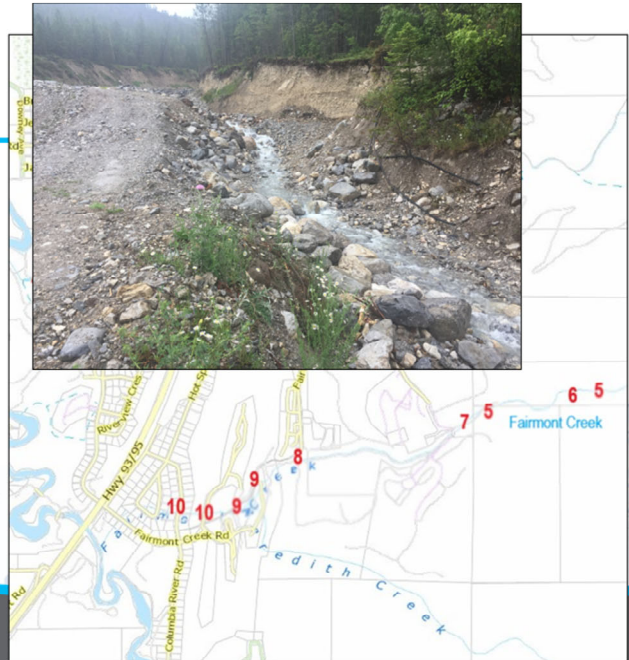
- 7. Damage to Berm
- 8. Fairmont Ridge Channel – 1,240 m<sup>3</sup>

The berm marked with a 7 upstream of the resort and community was damaged as shown in the lower picture. This was a high priority site and was repaired very early in the response. The picture on the right shows the repaired bank. This was considered response.

The Fairmont Ridge site is marked by an 8. There was bank erosion and channel infilling and the site was considered high priority as a second highwater event could have forced the creek out of the channel. Approximately 1,200 cubic meters was removed and the bank was repaired. This was considered response.

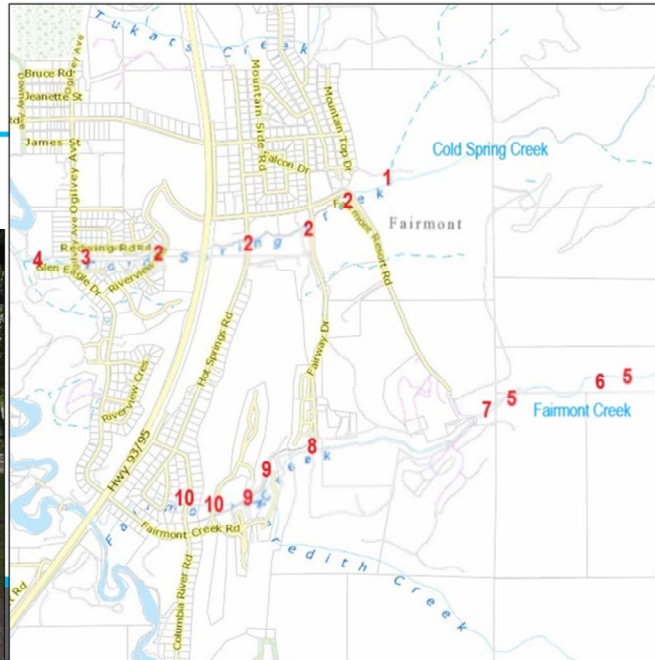
## 10. Culverts

The two trouble culvert locations on Fairmont Creek are marked with 10's. Similar to the culverts on Cold Spring, the culverts were addressed immediately with assistance from local contractors, the Resort and the Mountainside Villas. There were properties impacted by these overflowing culverts – mostly yards but there was damage to a garage foundation.
